HOME INSPECTION REPORT

**Howard St
Upland, CA 91786**

Monday, May 18, 2026

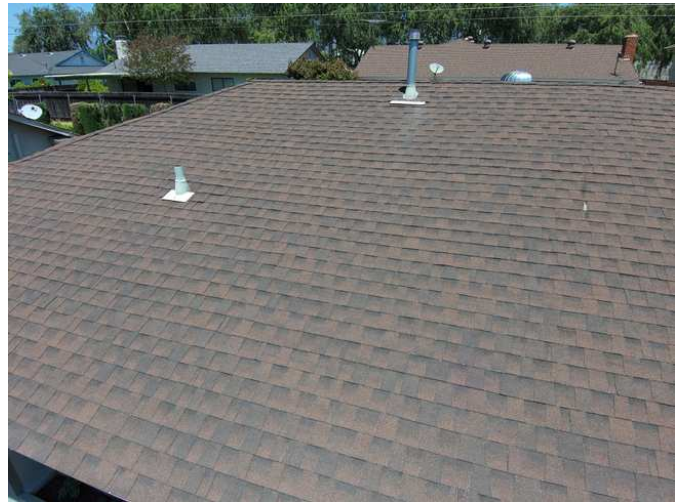
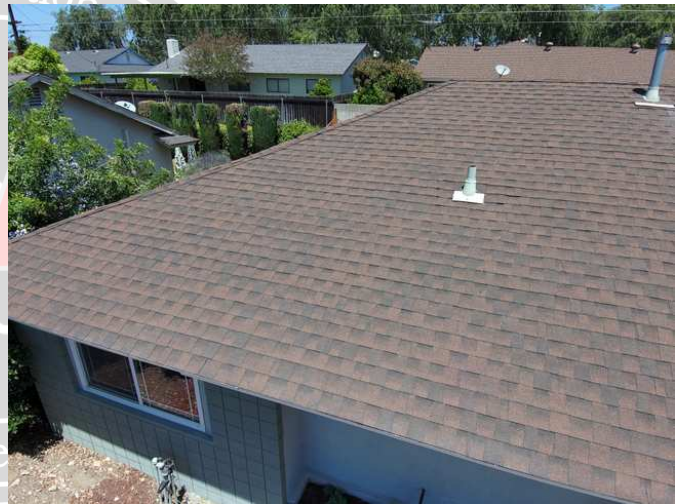
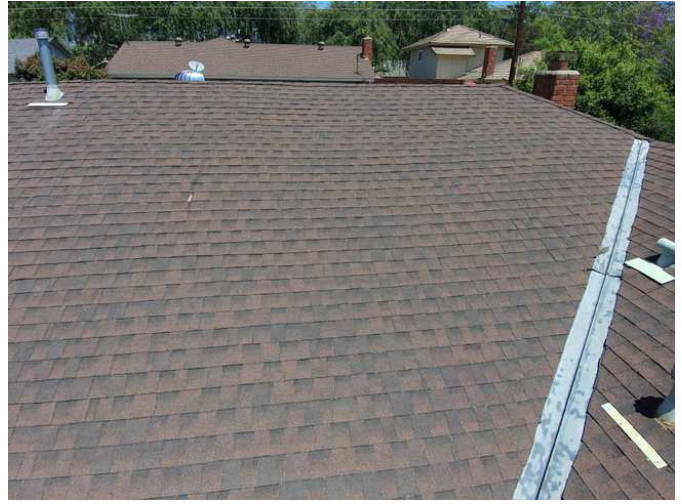
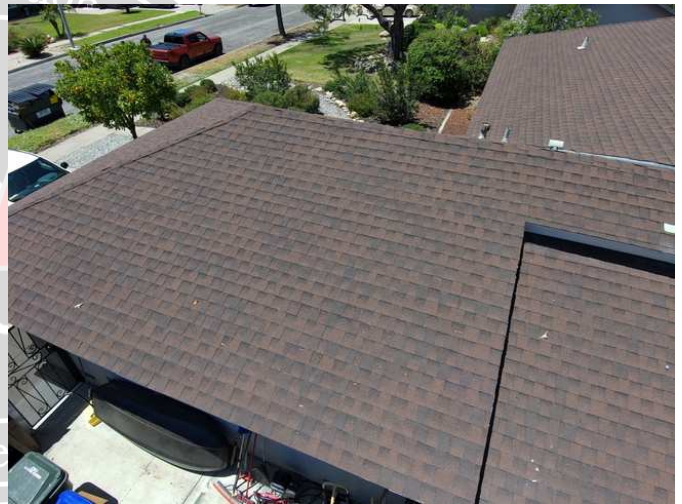
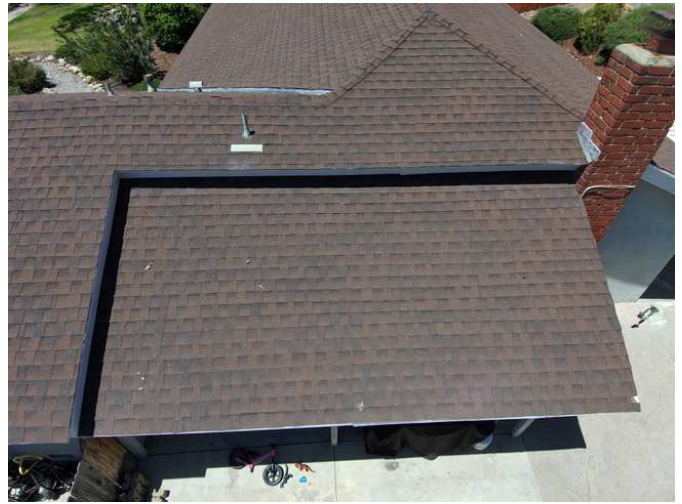
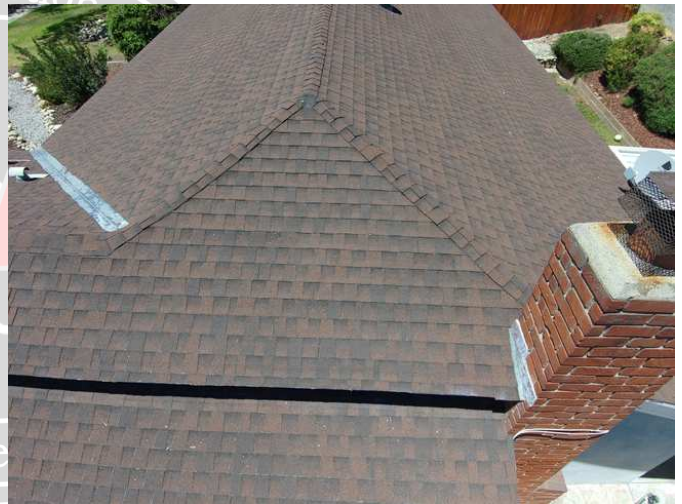
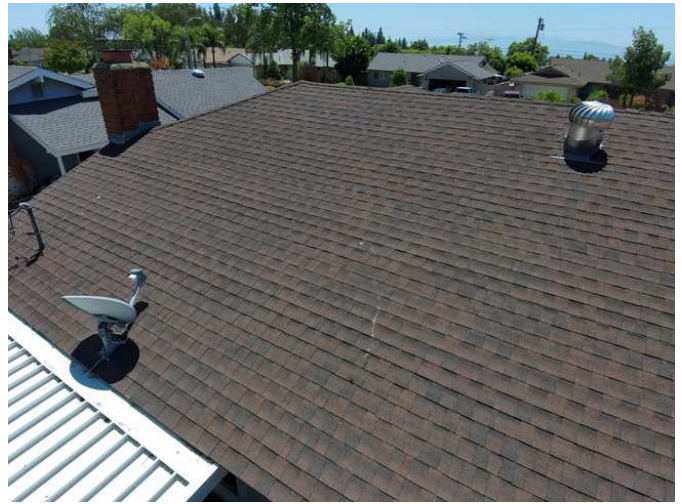
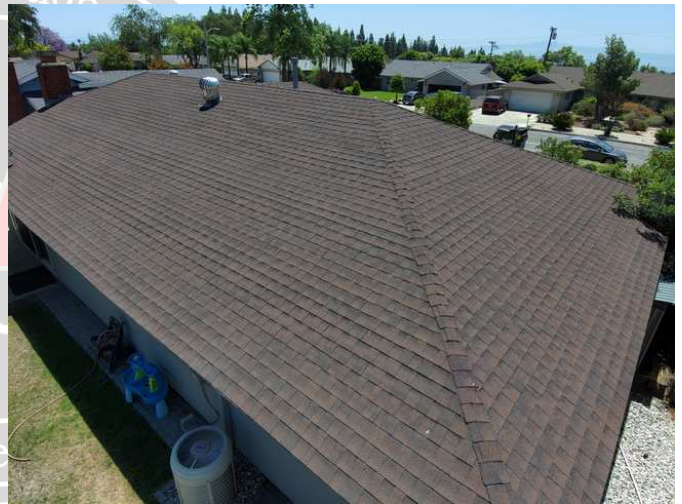
W2: Directly Over Wood Shingles

Life expectancy is 3 to 5 years. The roof is subject to leaks at any time due to its age and current condition. The asphalt shingles appear to have been installed directly over the original wood shingles. The asphalt shingles may show inconsistencies at the surface areas. Minor lifting of the shingles was observed. The existing conditions will most likely reduce the life expectancy of the roof.

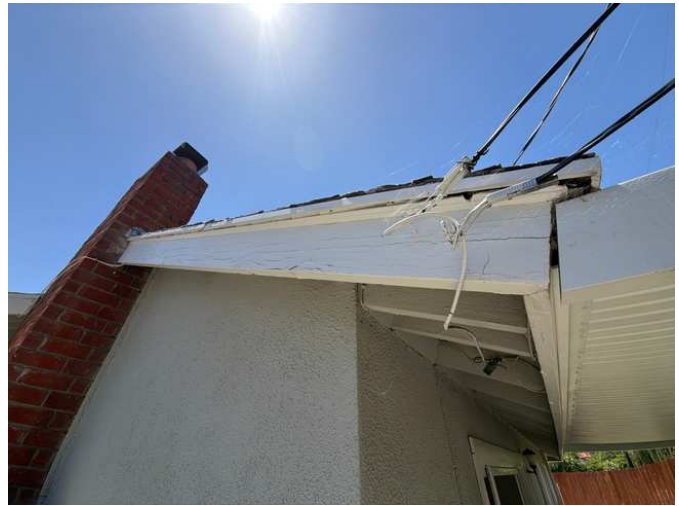
W3:

The leaderboard exhibited signs of damage caused by wood, destroying insects and organisms. This can add substantial cost to the replacement of the roof. Buyer beware.

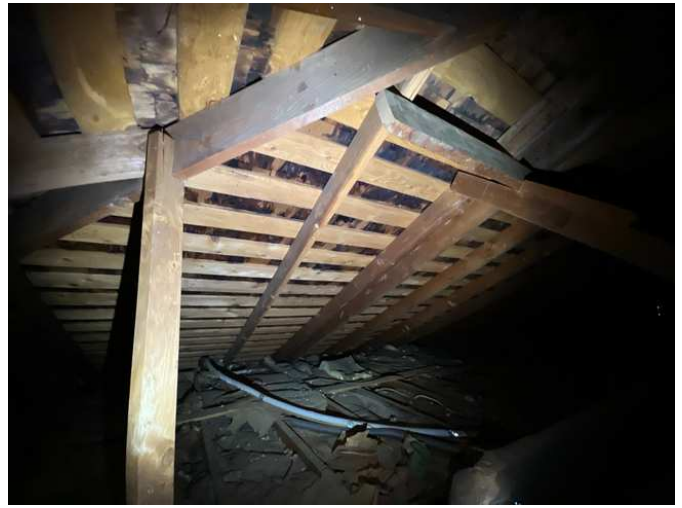
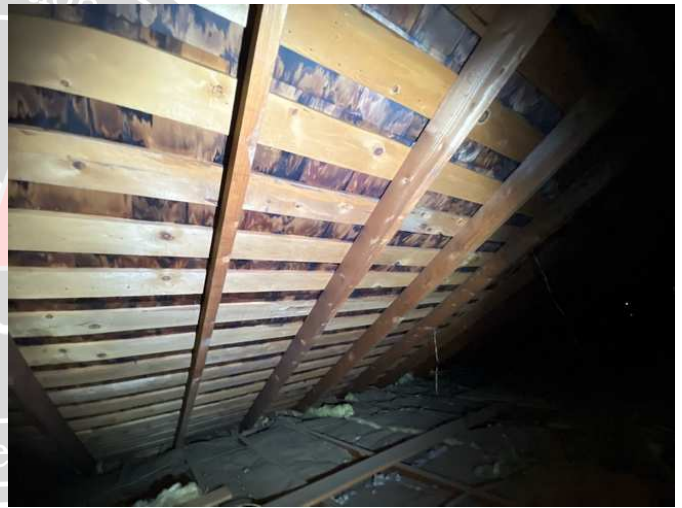
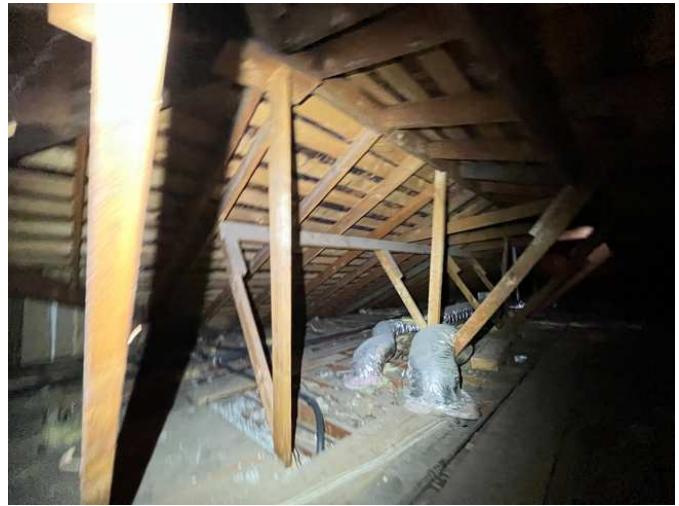
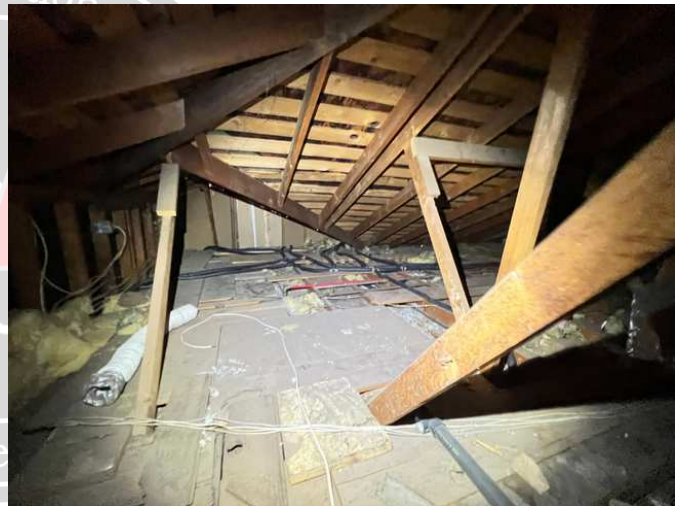
W5:

1x6 skip sheathing with wood shingles. The underside of the wood shake shingles, exhibited signs of old water stains. This is indicative of this type of system. Radiant barrier plywood decking will be needed when the roof system is replaced. This comes at a substantial extra cost.

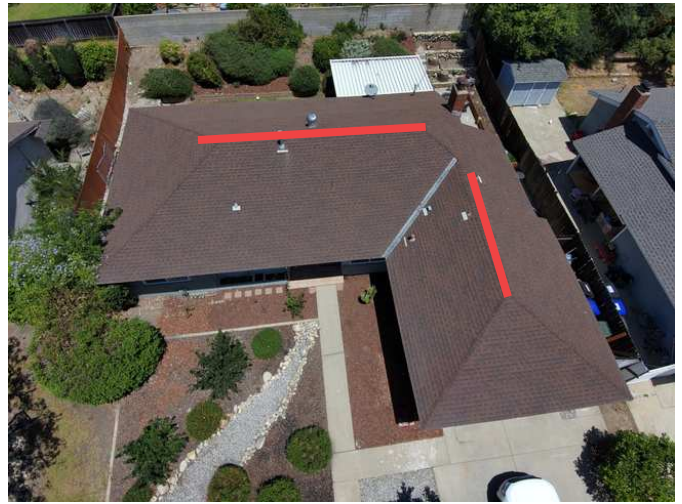
W6: Missing Ridge Vent

Manufacturers of composition shingles recommend continuous roof vent systems to maintain the manufacturer's warranty. Dormer vents were utilized. A lack of ventilation will result in early deterioration of the shingles. Upgrades recommended.

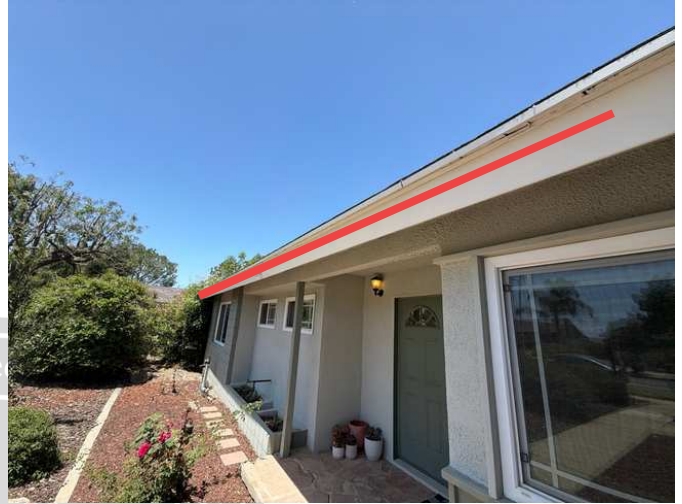
W8: No Rain Gutters Present

Gutters and downspouts direct roof water away from the foundation, reducing moisture, hydrostatic pressure, and soil erosion that can compromise foundation stability and cause water intrusion.

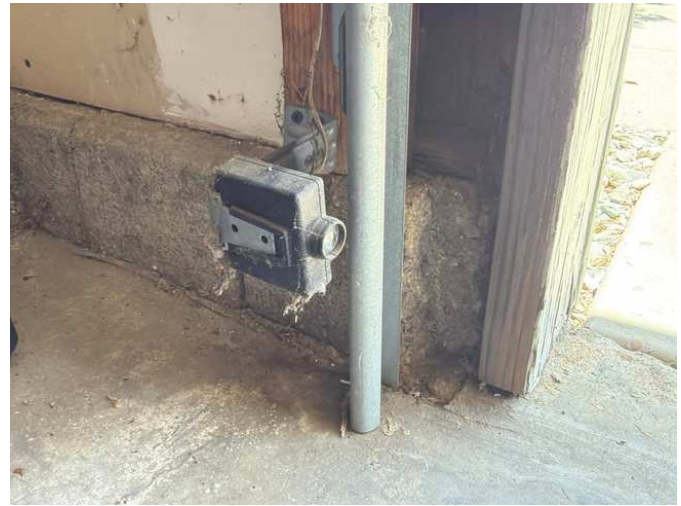
The garage door was not equipped with a battery back up system. In September 2018, California Governor Jerry Brown signed SB 969 into law. This requires all garage door openers sold in California after July 1, 2019, must have battery backups for occupant safety. It is for that reason we recommend a battery back up system be installed on the garage door for emergency operation. This law was enacted in response to the Wildfire season of 2017 when at least five people died from fire-related causes when their garage doors would not open due to a power outage.

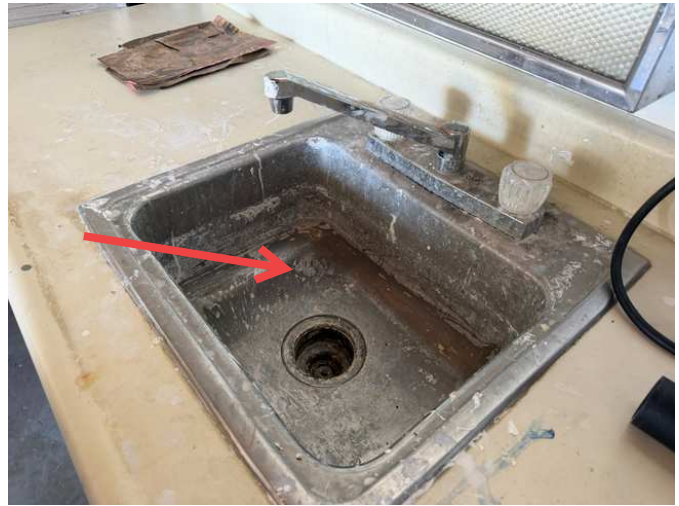
R47: Corrosion Under Sink

Plumbing component(s) below the sink exhibited signs of corrosion at P-trap assembly. We recommend the client consult with a qualified plumber for further evaluation and repair.

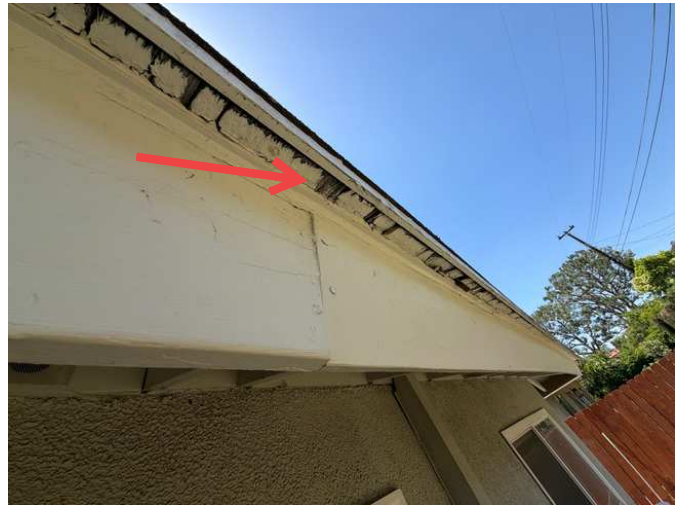
R53: Damaged Wood Trim Noted

Wood trim exhibited signs of WDO, peeling paint, fungi, splits. Consult with a qualified professional for further evaluation and repair.

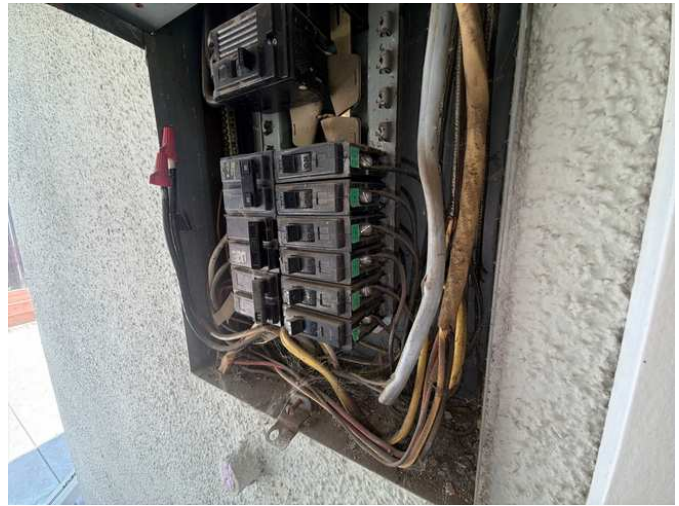
Clean and torque service is recommended for the main electrical panel. Consult a licensed electrician for service. Signs of charring on the buss bars were observed.

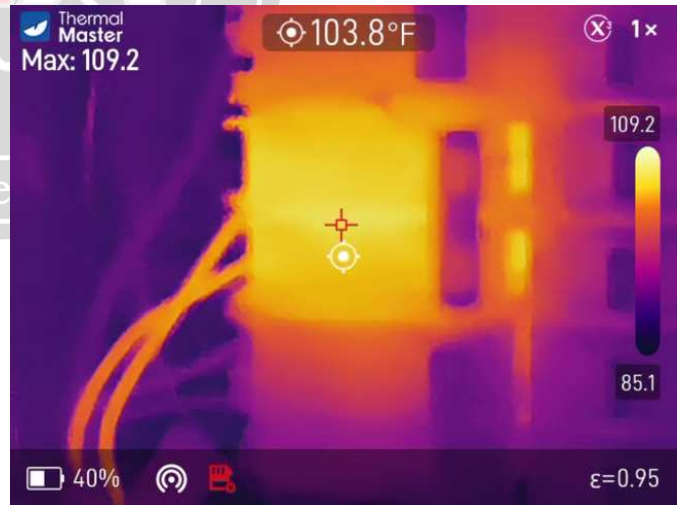
W67: Thermal Imaging

Thermal imaging was utilized to evaluate the panel components. Signs of overheating was observed. Consult with a qualified electrician for further evaluation and repair.

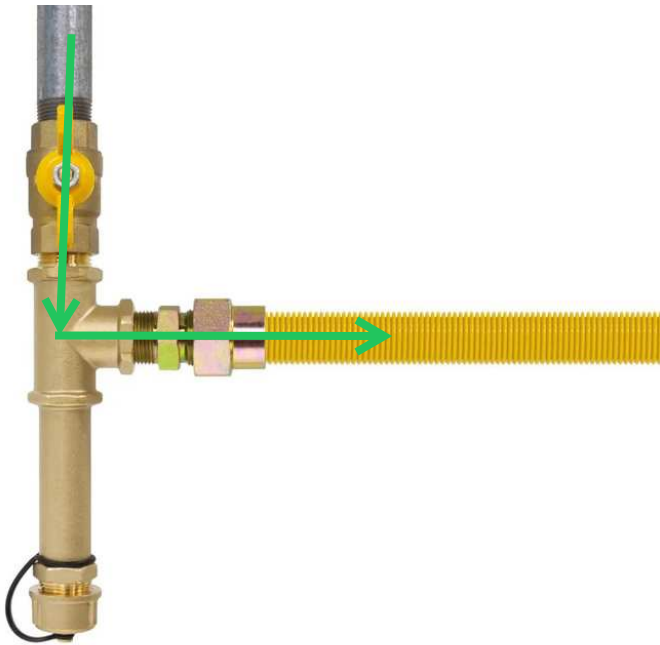
The sediment light was not installed in the right orientation. We recommend that a sediment leg be installed. This will help prevent sediment from clogging the gas valve or orifices.

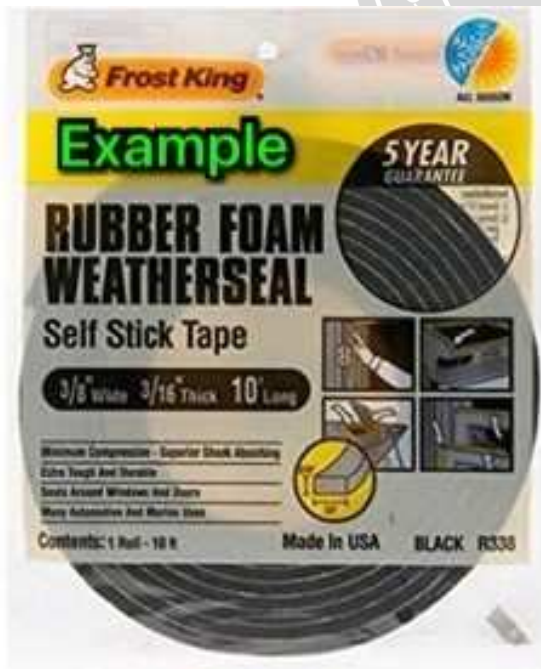
Because of the close proximity to the return air register. It is strongly recommended that the door to the heating system be properly sealed. This will prevent air scavenging from the furnace closet.

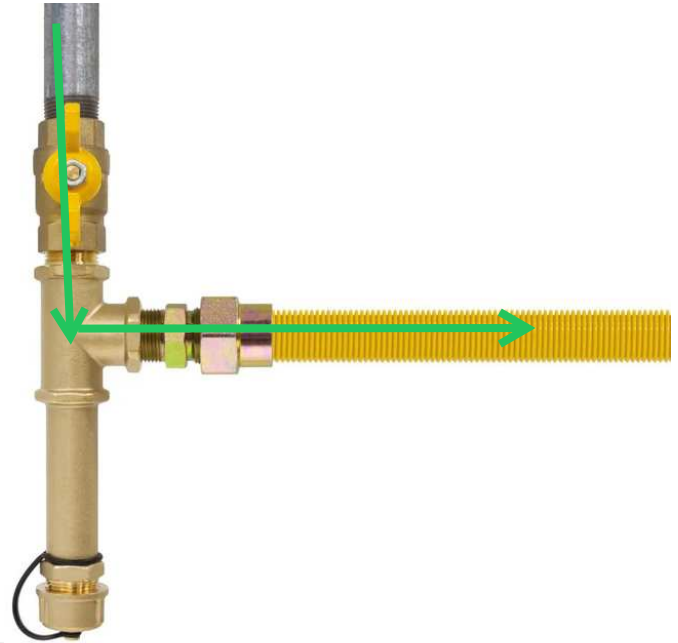
Sediment trap at the gas line was improperly installed at the time of inspection. Recommend further evaluation and correction by a qualified plumbing contractor.

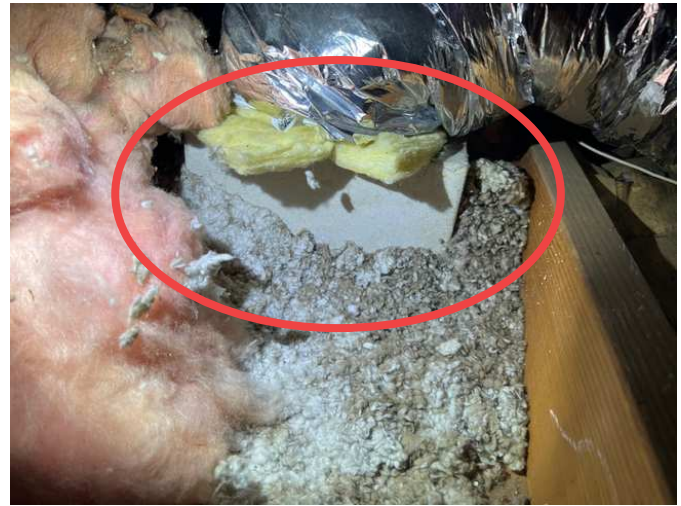
Asbestos like materials were noted at register heads. These materials were commonly used during the time of construction. It is highly recommended that the air distribution lines be tested for asbestos content prior to the close of escrow. Client should consider the cost of upgrades. Consult with a licensed HVAC contractor for full evaluation and cost of encapsulation or other resolution.

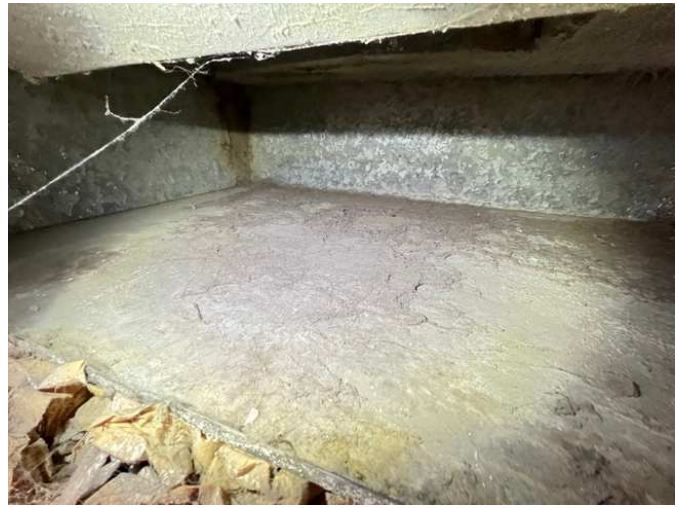
M109: Dirt And Debris

Dirt and debris is present in the lower plenum and/or return air cavity. Recommend this area be serviced prior to the closing of escrow.

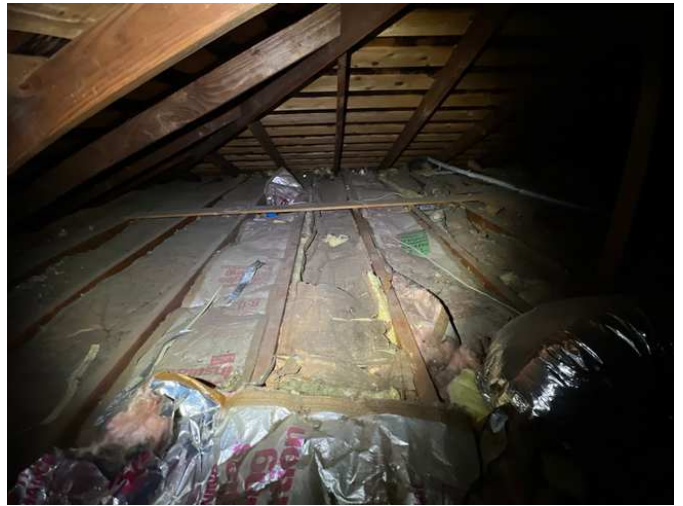
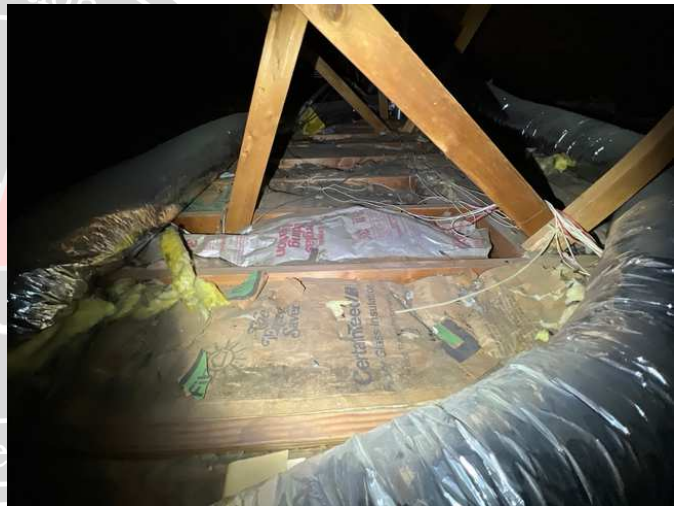
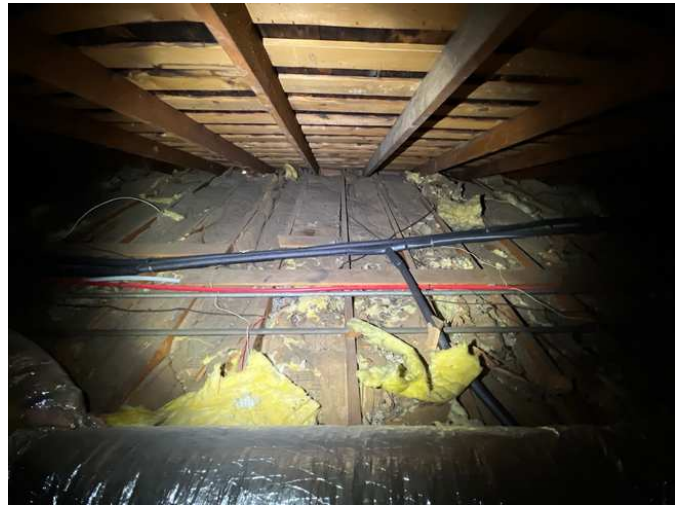
M183:

We recommend an additional 8 to 10 inches of insulation for energy savings and comfort.
