# HOME INSPECTION REPORT

PROFESSIONAL PROPERTY EVALUATION

INSPECTION DATE

Tuesday, July 7, 2026

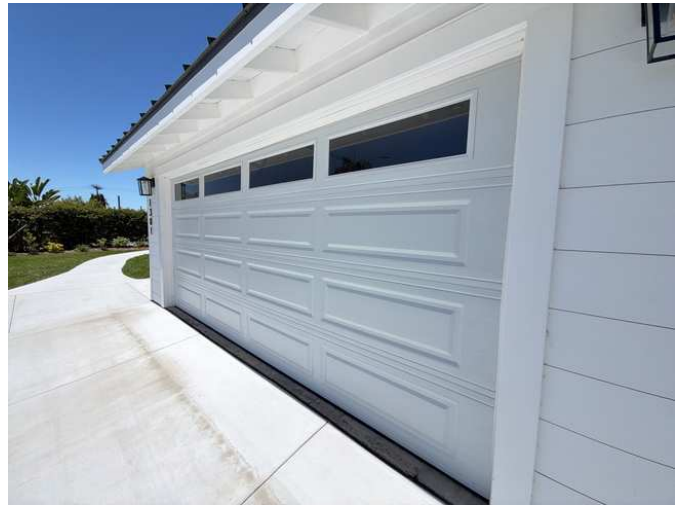
**9:**

The garage door was tested and found to be functional on the day of inspection. Signs of normal wear and tear were present.

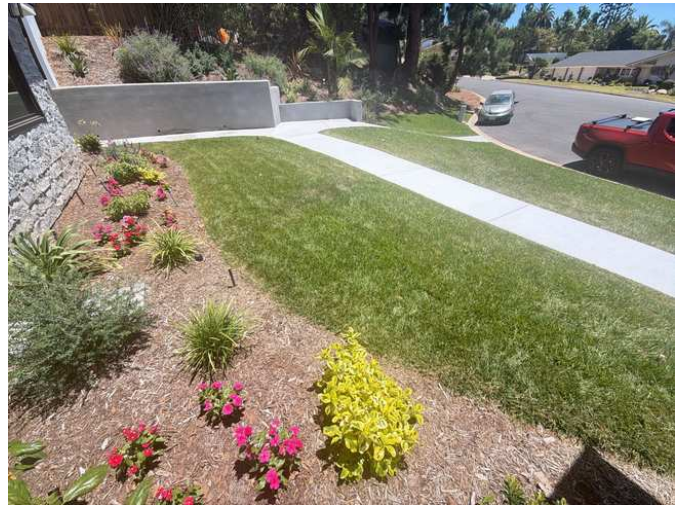
- ✓ **11:** Drainage at the front of the home is satisfactory.

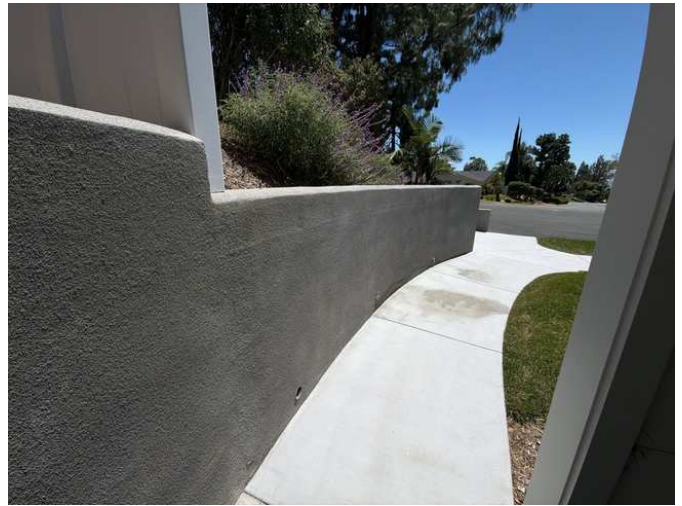
### ✓ 17: Appeared Serviceable

The visible and accessible portions of the retaining walls appeared to be in serviceable condition at the time of the inspection.

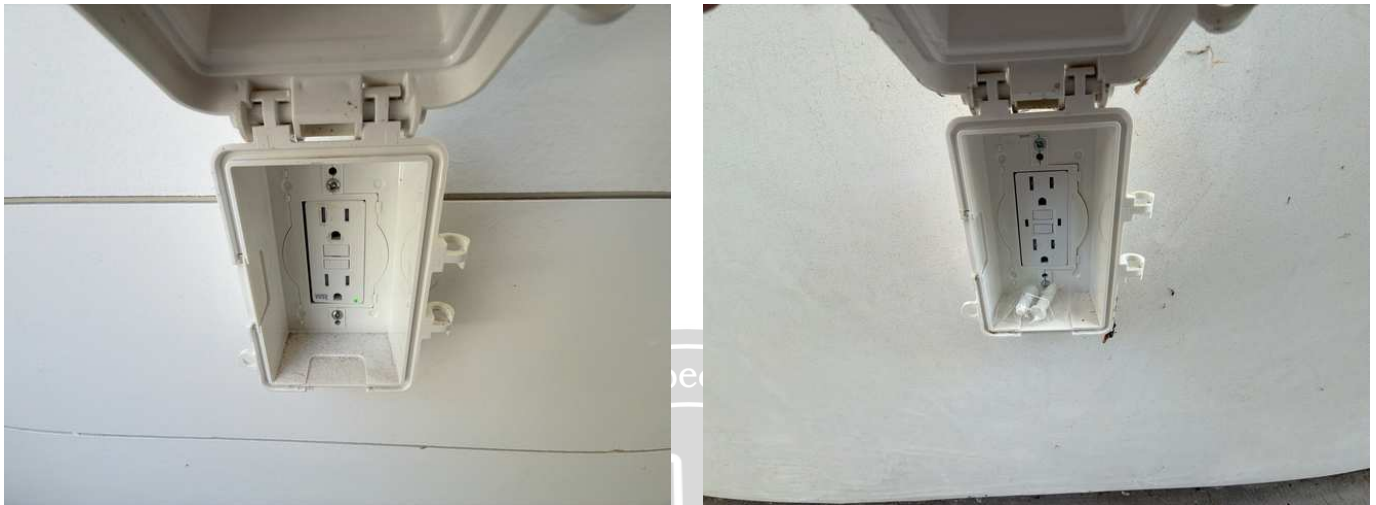
#### ✓ 22: GFCI's Satisfactory

The receptacle photographed was tested and found to be GFCI protected. The inspector will make an attempt to verify that all outlets are GFCI protected. However, some receptacles such as those hidden in flower planters or those that are outside view may-not be tested.

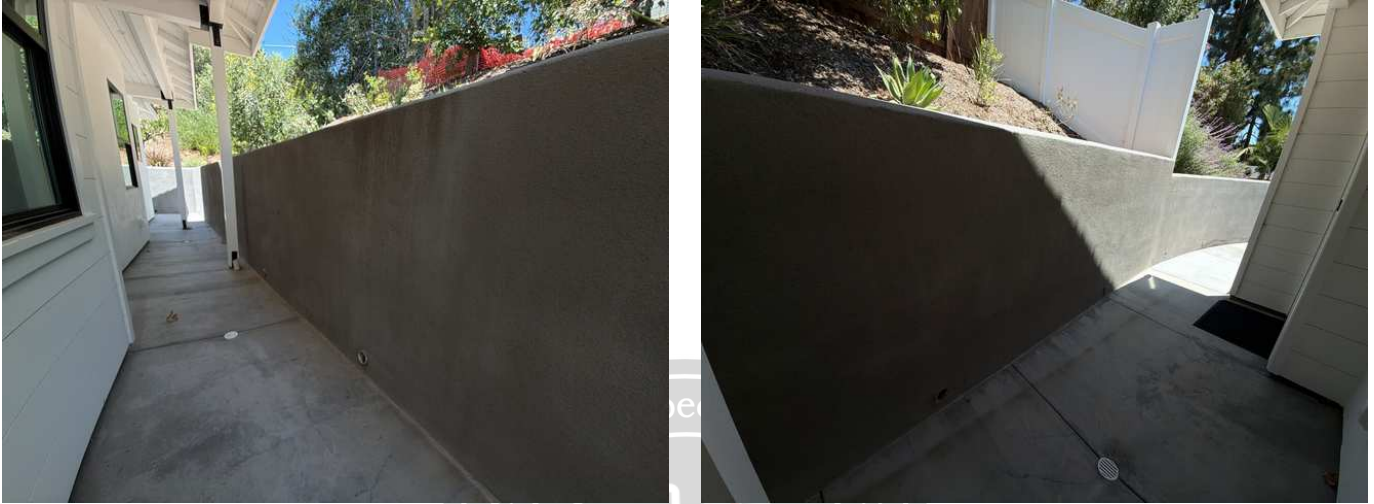
### ✓ **25: Appeared Serviceable**

The visible and accessible portions of the retaining walls appeared to be in serviceable condition at the time of the inspection.

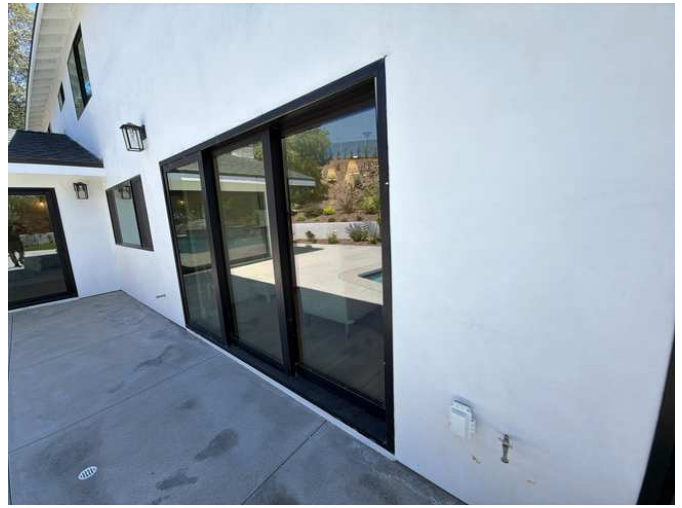
30:

Patio doors were tested and found to be functional on the day of inspection. Doors show signs of normal wear and tear.

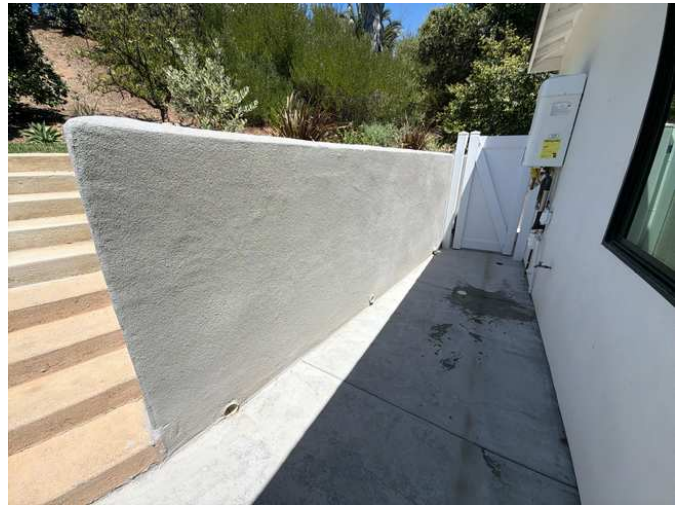
✓ **31: Appeared Serviceable**

The visible and accessible portions of the retaining walls appeared to be in serviceable condition at the time of the inspection.

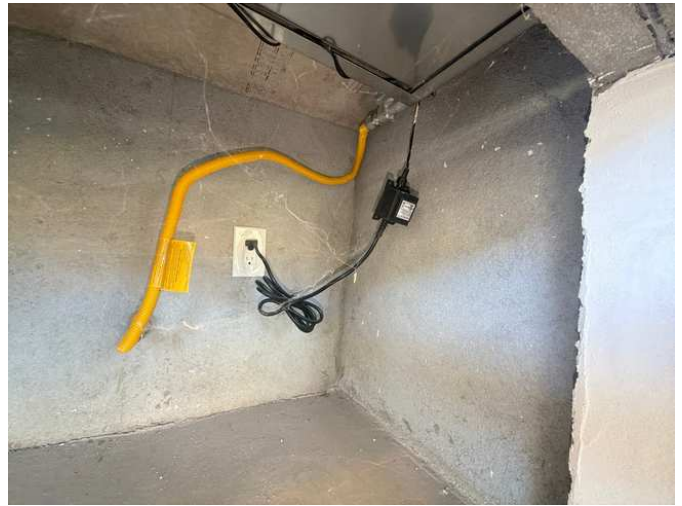
### ✓ 34: Not Inspected

Barbecue is in new condition and appear serviceable. Barbecues are excluded from the home inspection process. Furthermore barbecues are excluded from the industry standards of practice of which your home inspection was performed. The barbecue may have been tested for gas leaks as a courtesy to the client only.

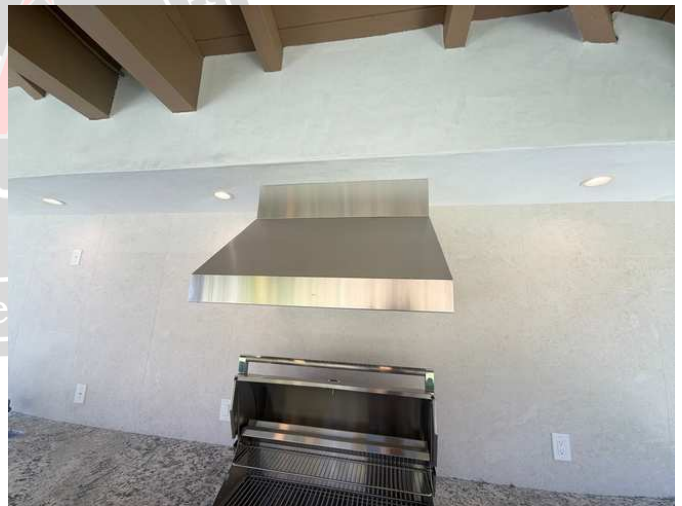
35:

Ventilator was tested and found to be functional on the day of Inspection.

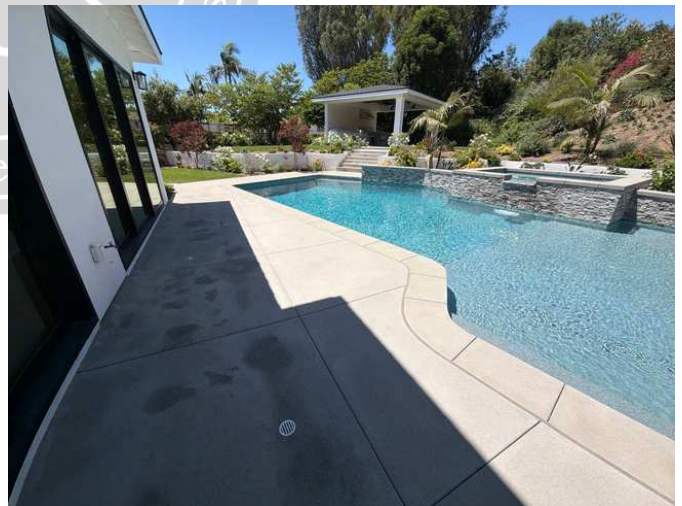
**39:**

The concrete decking surrounding the swimming pool was in satisfactory condition. Minor hairline cracks were noted but are considered normal.

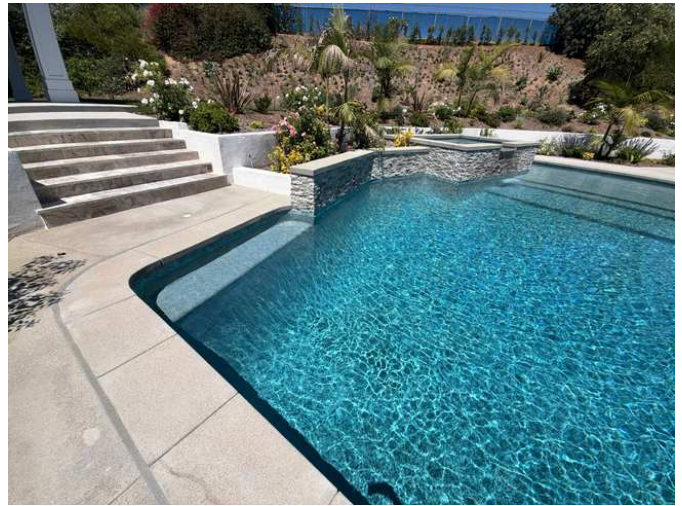
- ✓ **40:**  
Pebble-Tec liner was in satisfactory condition.

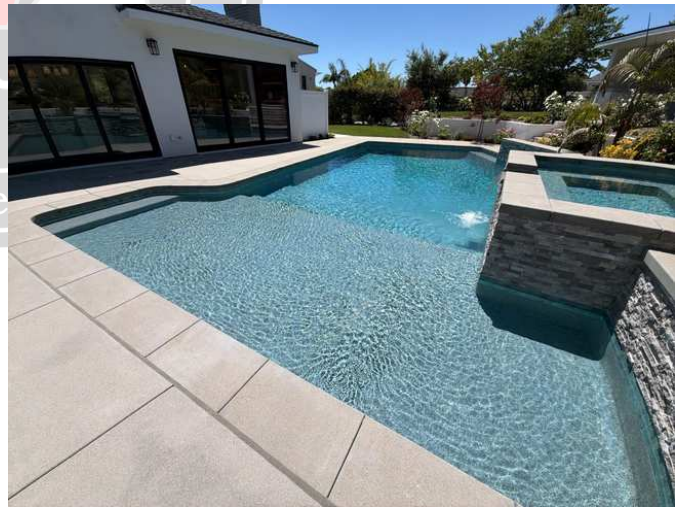
**42:**

The pool coping was in satisfactory condition.

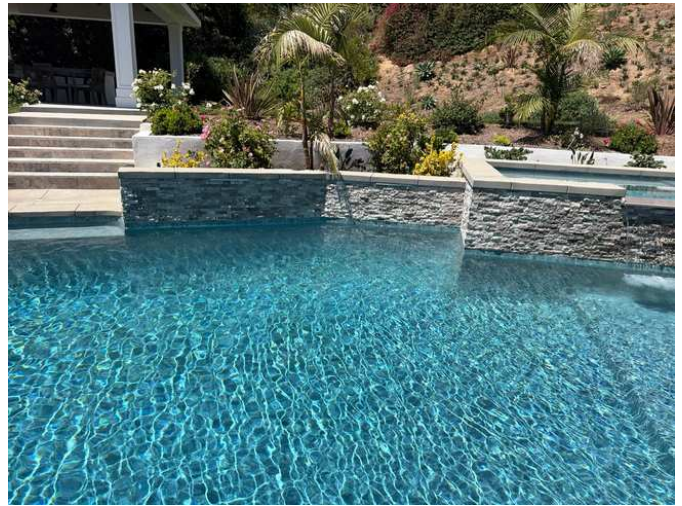
✓ **44:**

The pool tile surrounding the waterline was in satisfactory condition.

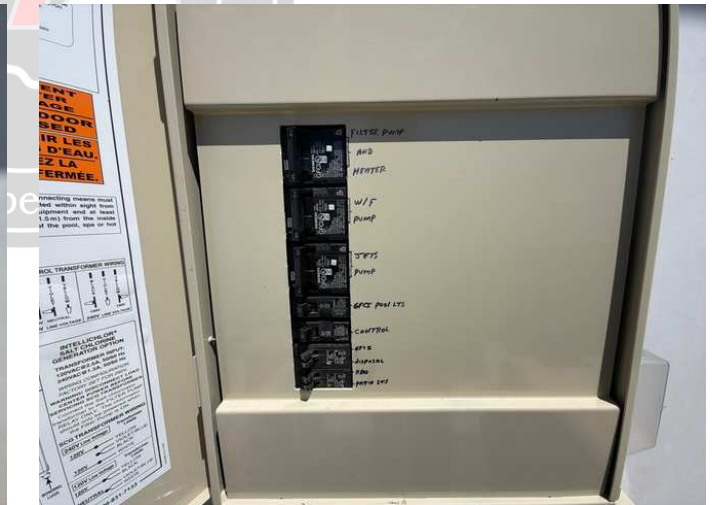
- ✓ **59:** Timeclock and controllers were in satisfactory condition.

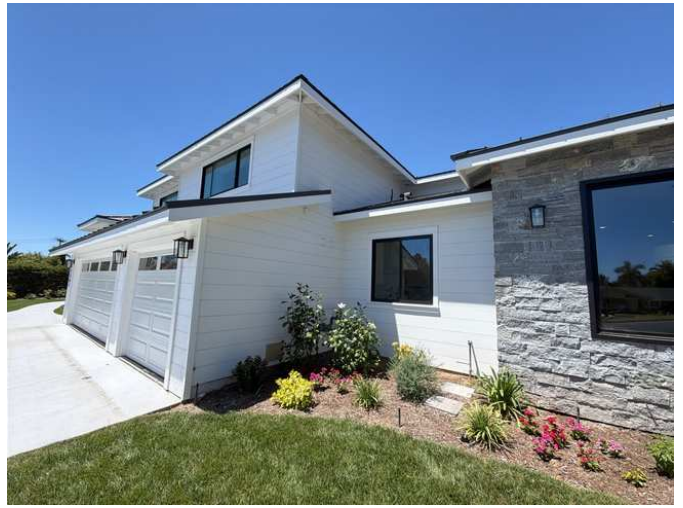
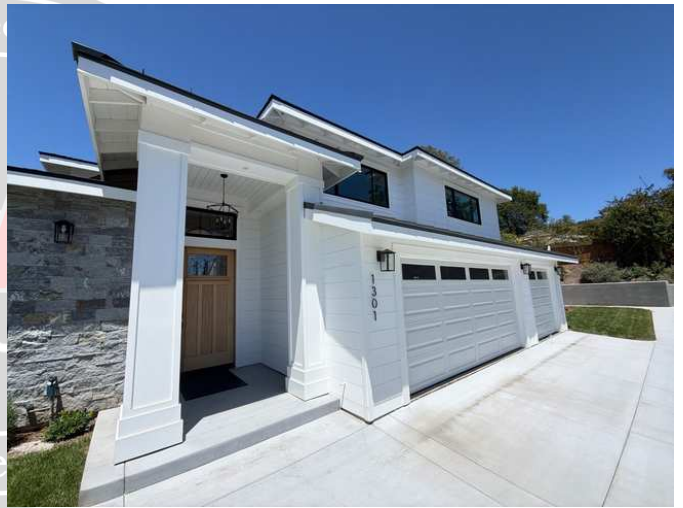
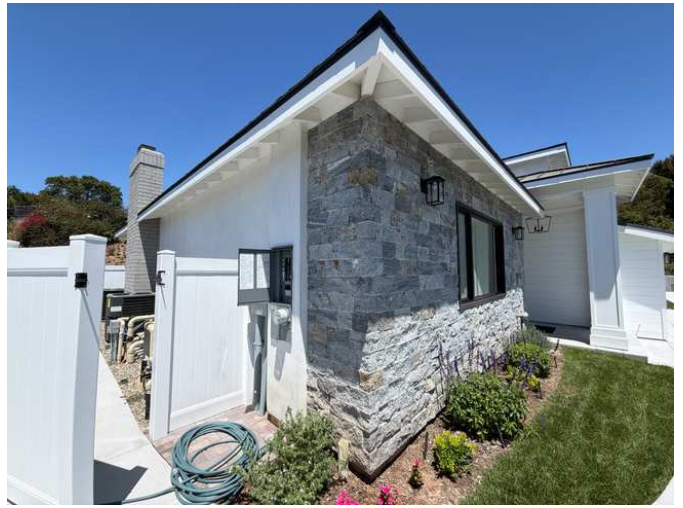
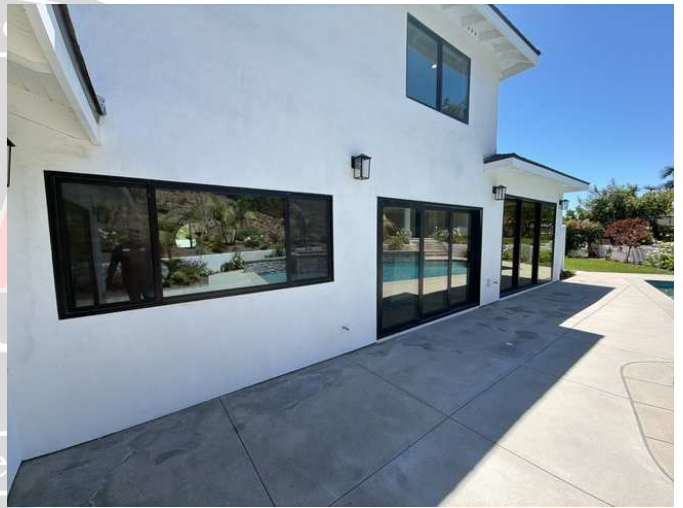
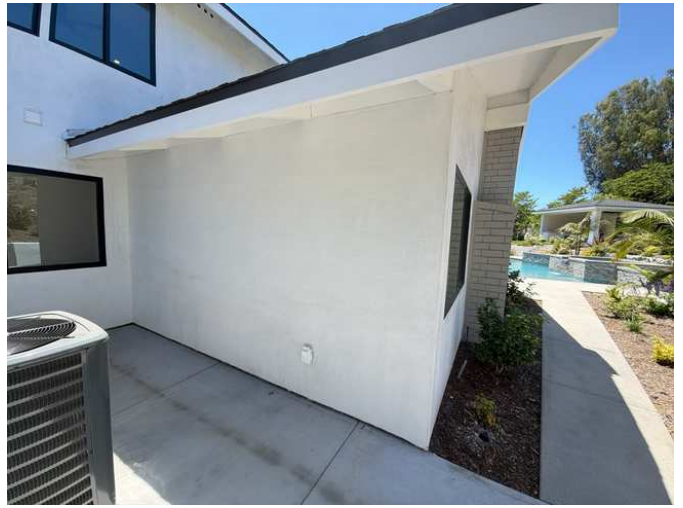
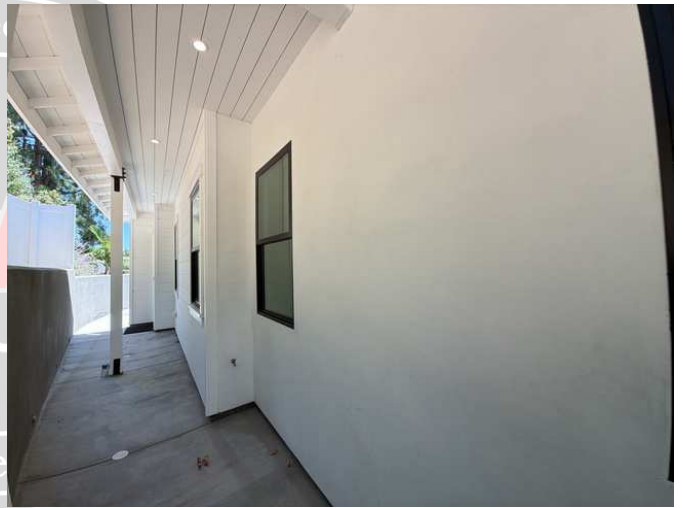
**63:**

Exterior wall surfaces are comprised of siding, stone, veneer, and stucco. Wall conditions appear to be normal and in good overall condition.

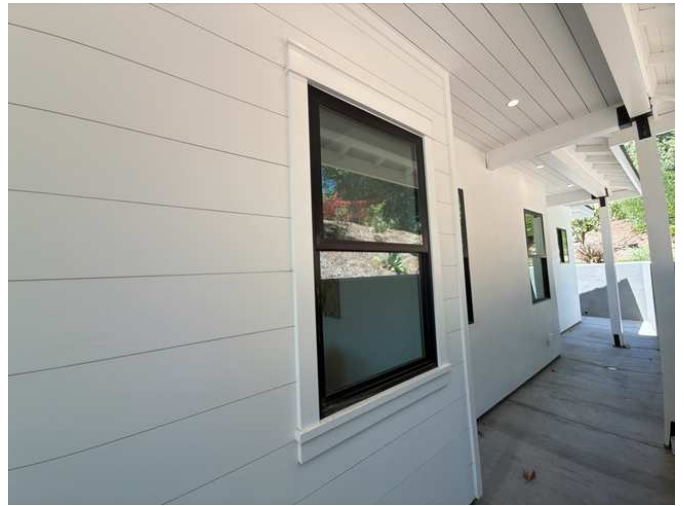
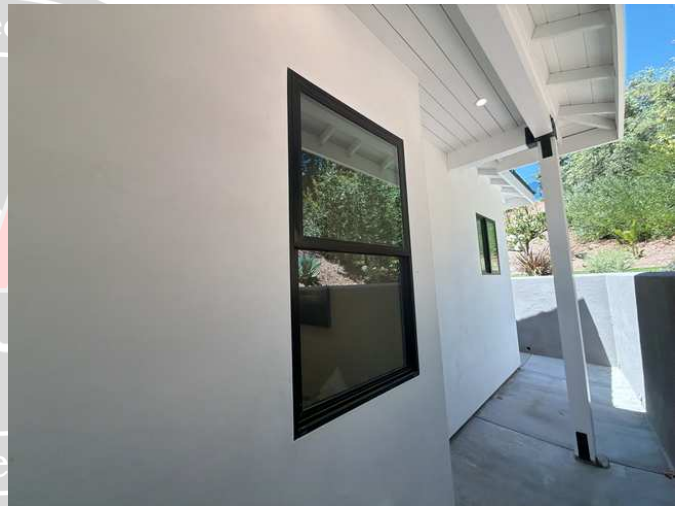
- ✓ **65:** Vinyl pane thermal windows were in satisfactory condition there were no cracked or broken window panes observed. Client should be aware that all vinyl windows are sealed using caulking and or other sealants that may break down overtime. Resealing vinyl windows is part of normal and regular home maintenance.

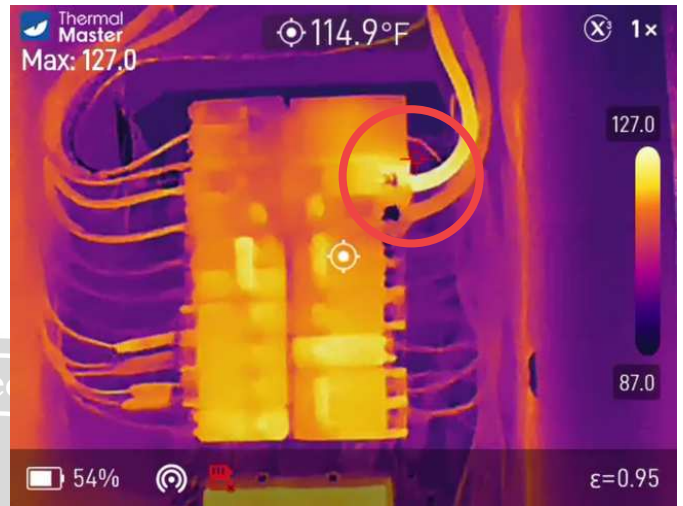
- i E84:** Thermal imaging inspection of the main electrical panel revealed abnormal temperature patterns or hotspots indicative of loose connections, overloaded circuits, or deteriorated components at the time of scanning. Consult with a qualified individual for further evaluation and resolution

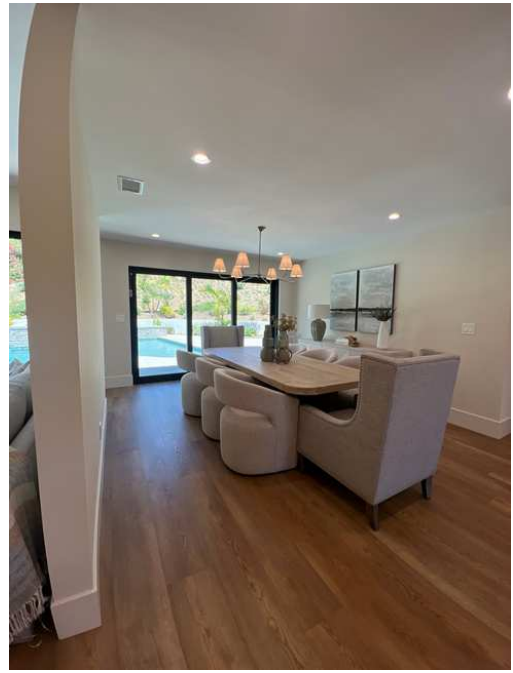
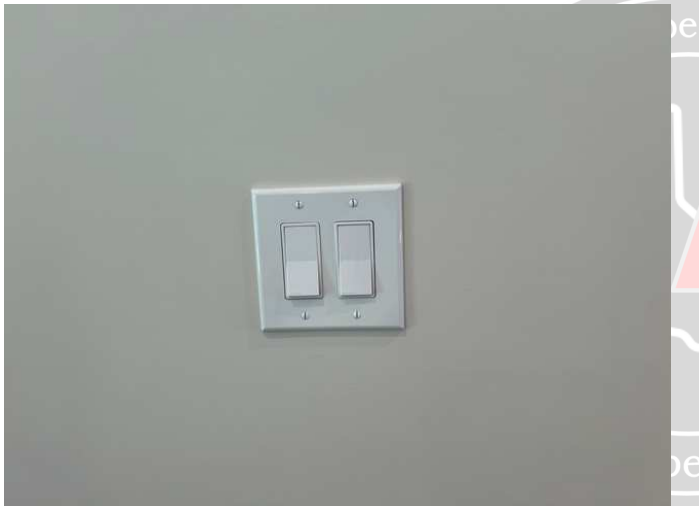
- ✓ **144:**  
The room was in satisfactory condition overall.

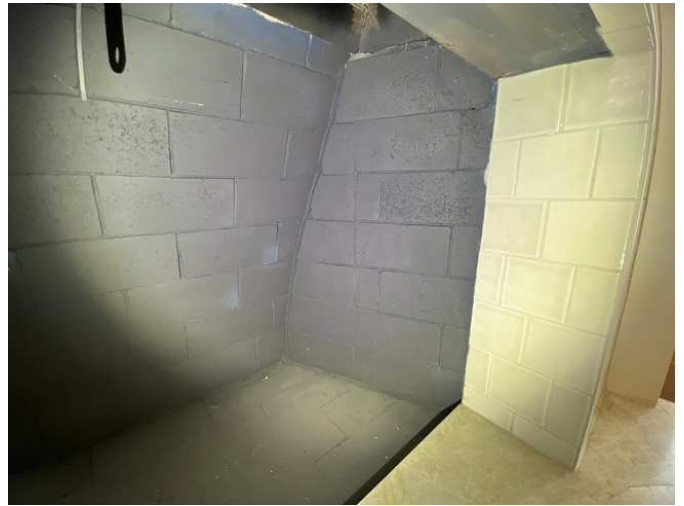
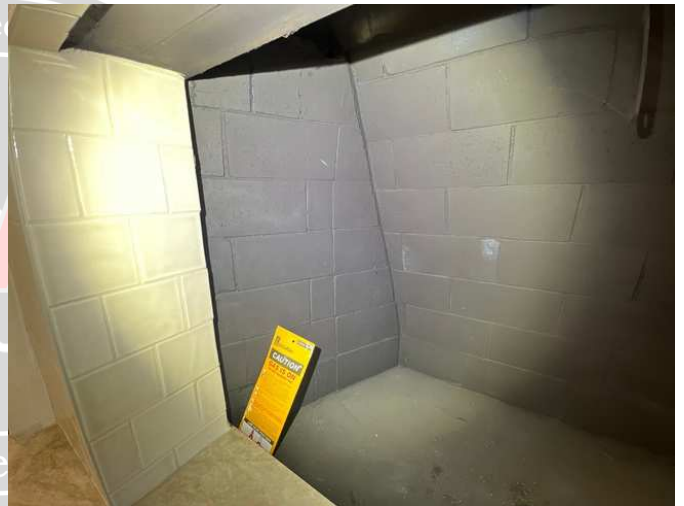
✓ **147: Satisfactory**

The fireplace was in satisfactory condition. Our inspection does not include actual operation of the fireplace and we cannot offer opinions regarding its performance. We suggest inquiries of the owner or occupant in this regard. Fireplaces should have annual maintenance performed. The client is advised to have the fireplace service by a qualified chimney specialist.

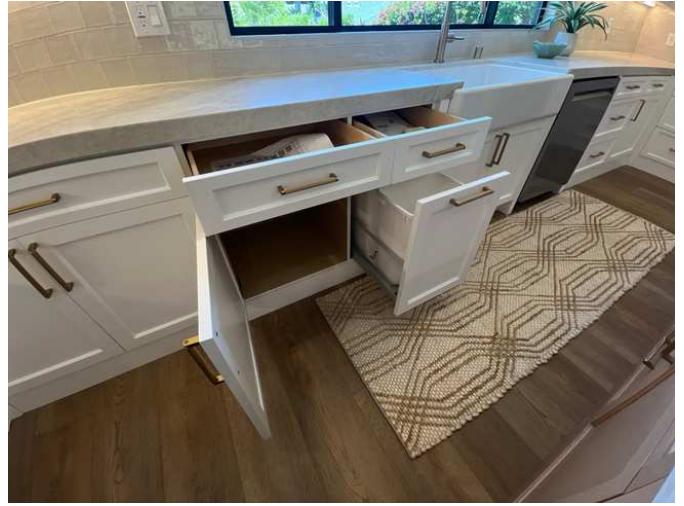
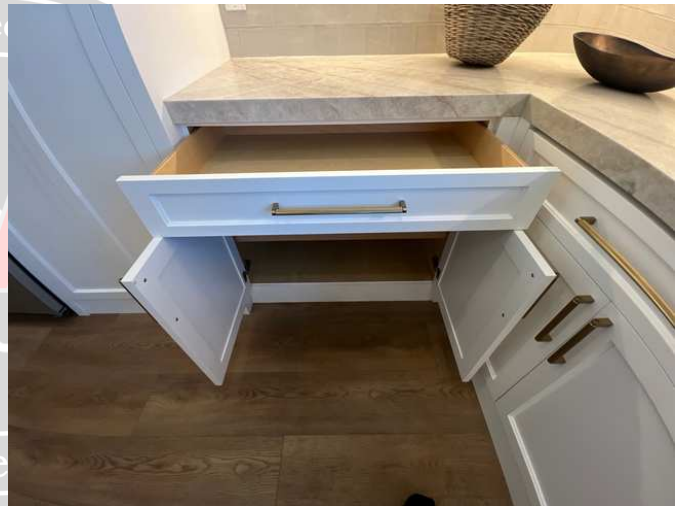
**156:**

Kitchen cabinets are in new condition. All doors and drawers function normally.

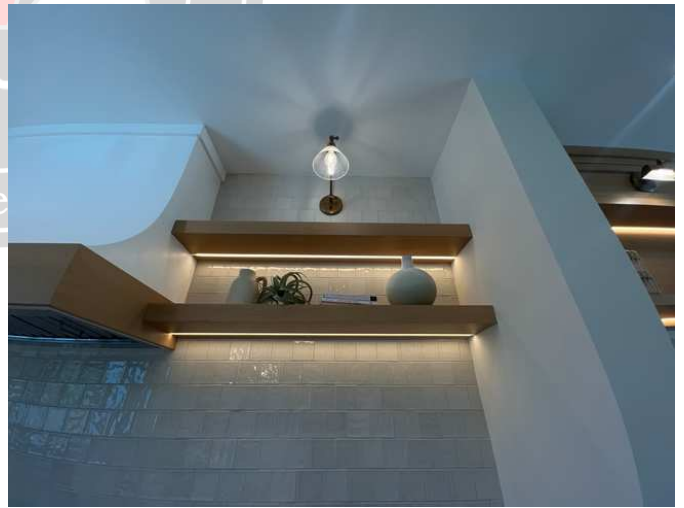
- ✓ **158:**  
Kitchen lighting was satisfactory.

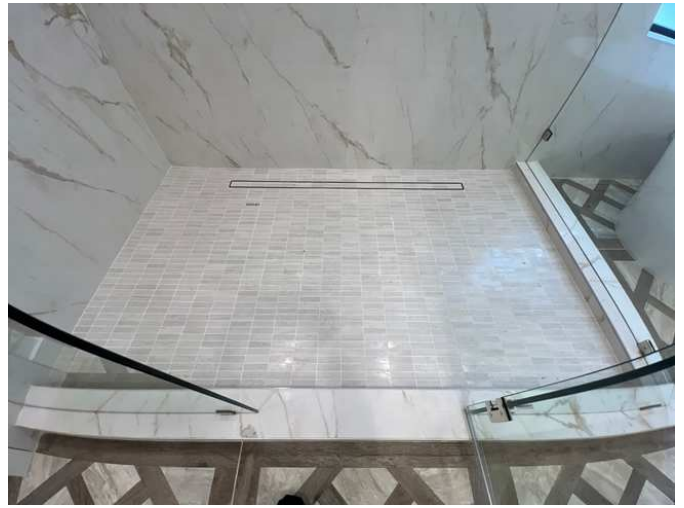
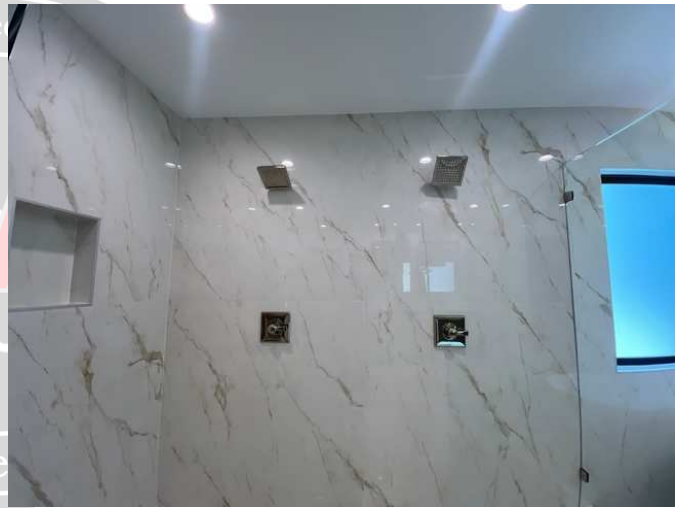
✓ **208:**

The shower was in new condition. Hot and cold running water was present. The drain was free flowing.

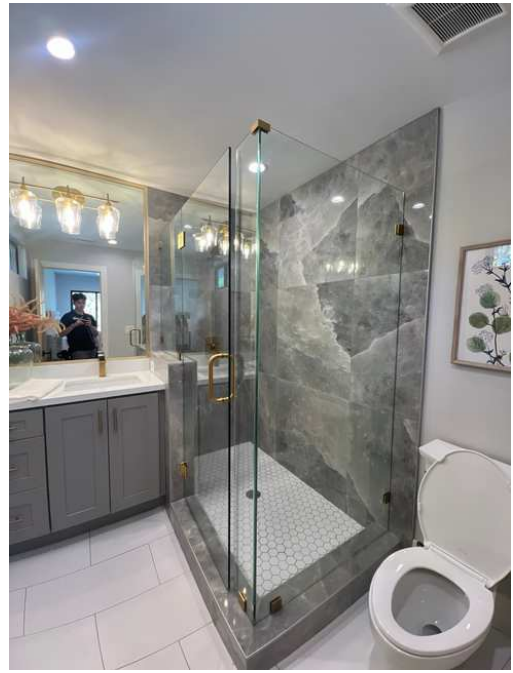
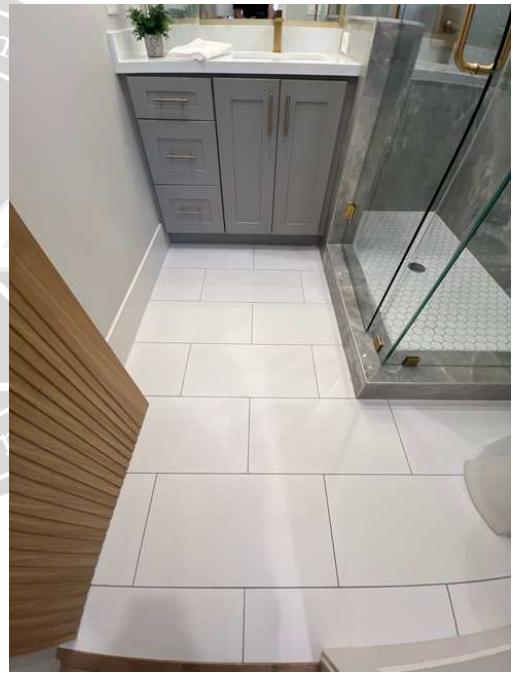
- ✓ **213:**  
The floor, walls and ceiling were in satisfactory condition. There were no significant deficiencies noted.

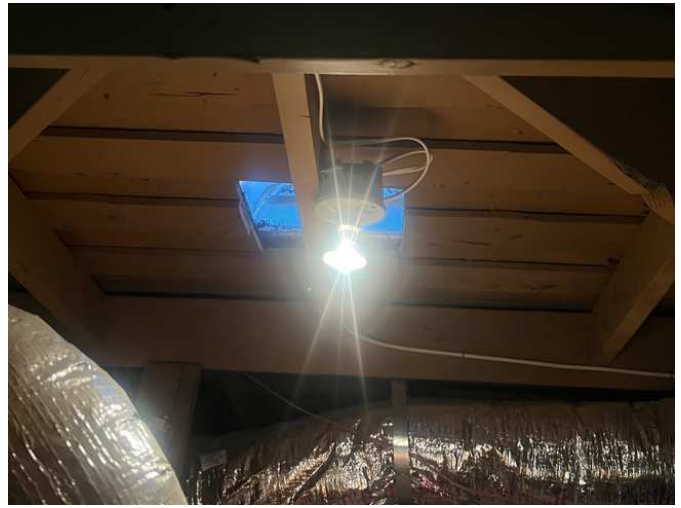
- ✓ **262:**  
The attic light was present and functional.

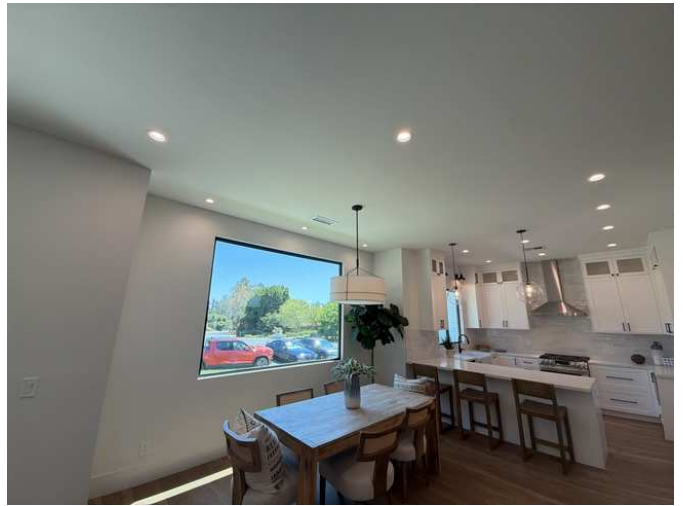
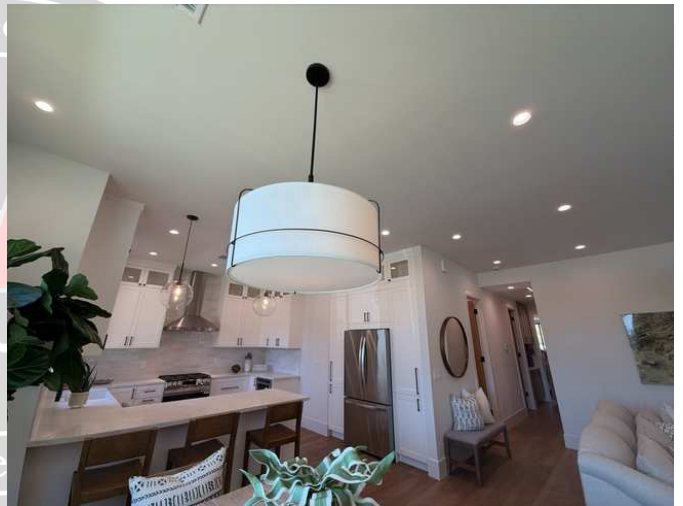
- ✓ **288:**  
The room was in satisfactory condition overall.

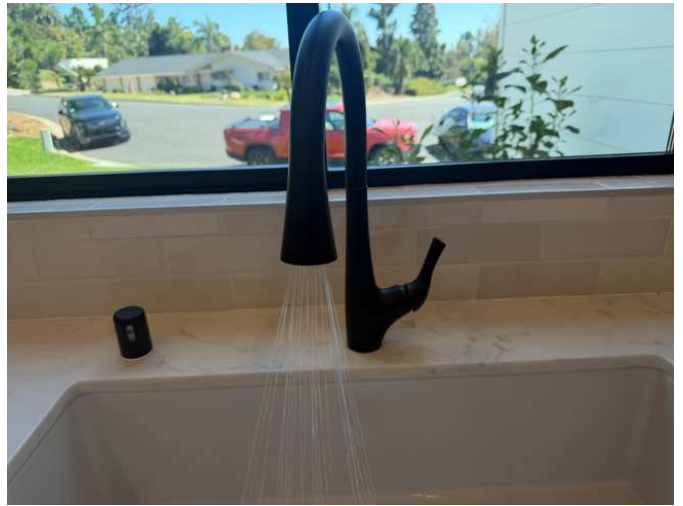
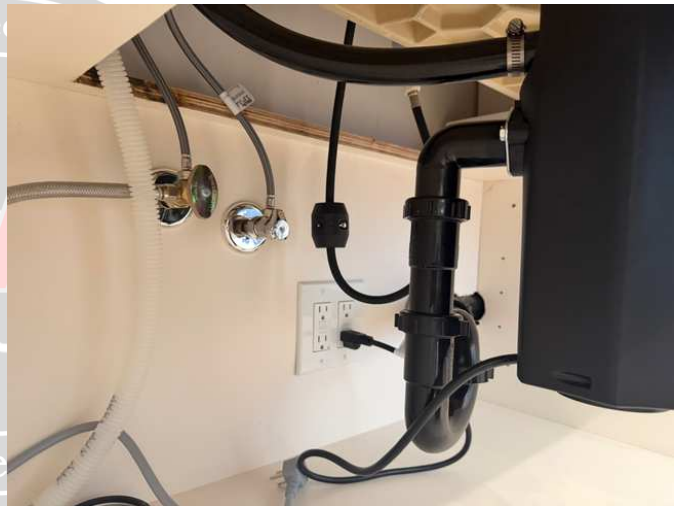
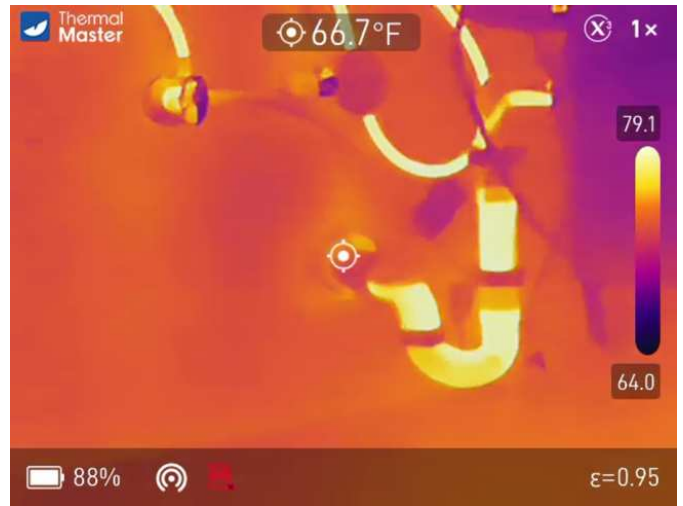
**290:**

The kitchen sink was in satisfactory condition. Faucet was functional.

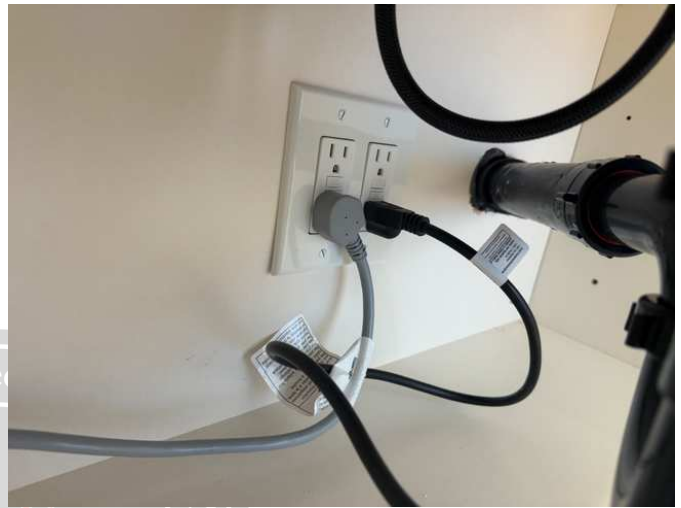
### ✓ 297: Satisfactory

The dishwasher was functional. The dishwasher was run through a full "NORMAL wash "cycle only. There were no defects or deficiencies to report. No representation is expressed or implied as to the effectiveness of the dishwashers cleaning capacity.

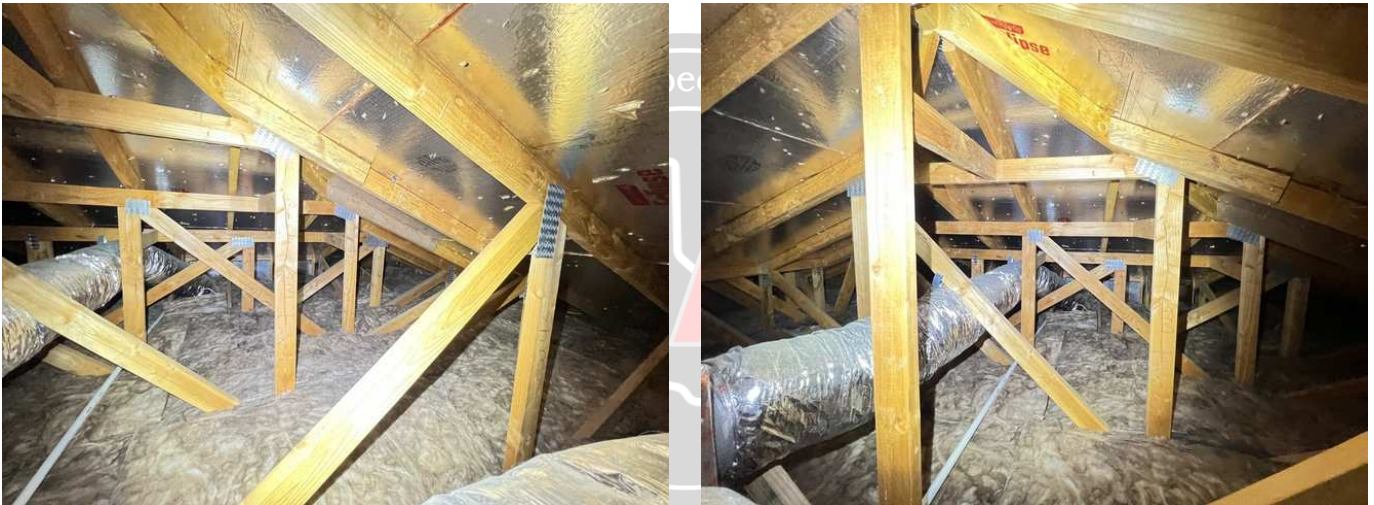
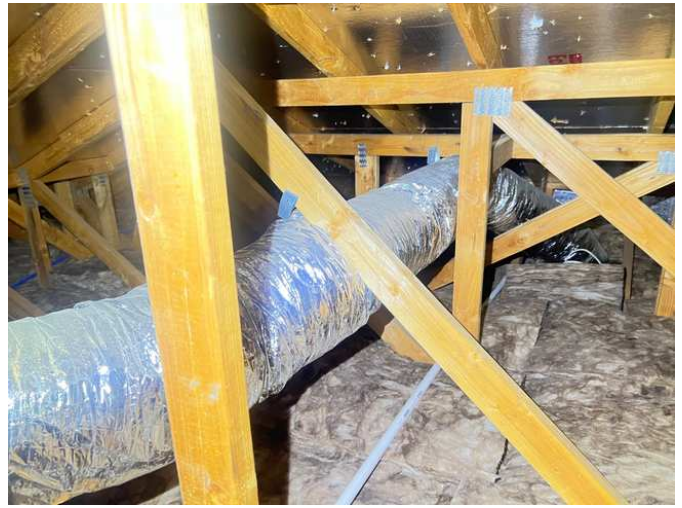
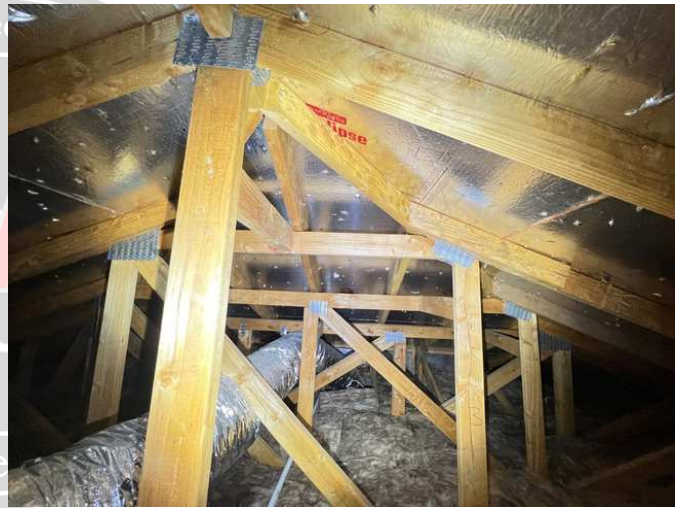
- ✓ **329:** The visible portions of the roof trusses were in good condition. There were no apparent signs of damage or alterations. There was no rust or corrosion noted on the visible truss connector plates.

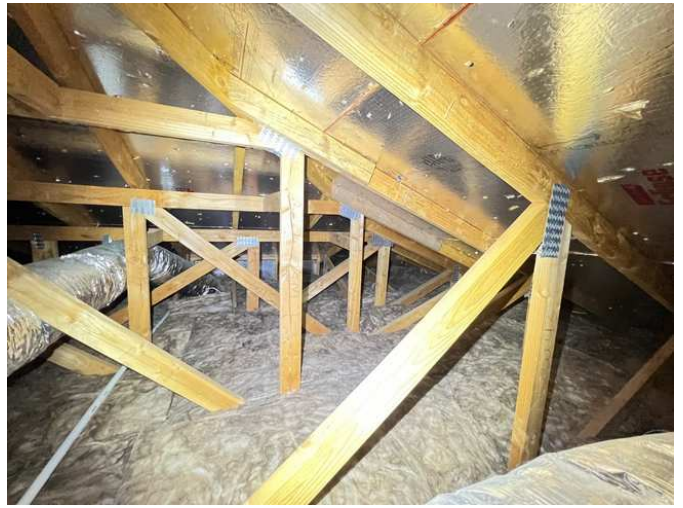
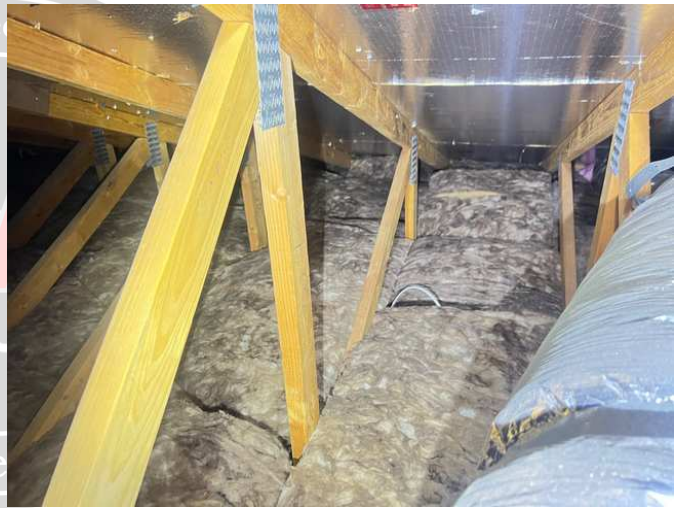
**330:**

Fiberglass batt insulation was utilized throughout the attic area. The installation was satisfactory.

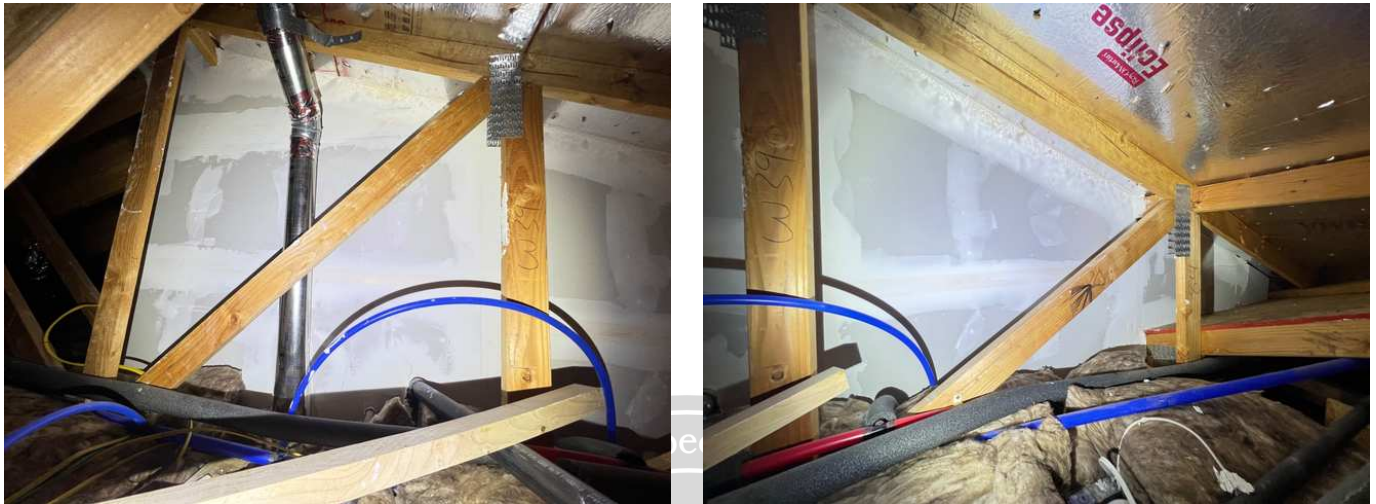
✓ **332: Satisfactory**

The visible portions of the firewall were in satisfactory condition.
