# HOME INSPECTION REPORT

PROFESSIONAL PROPERTY EVALUATION

Tuesday, July 7, 2026

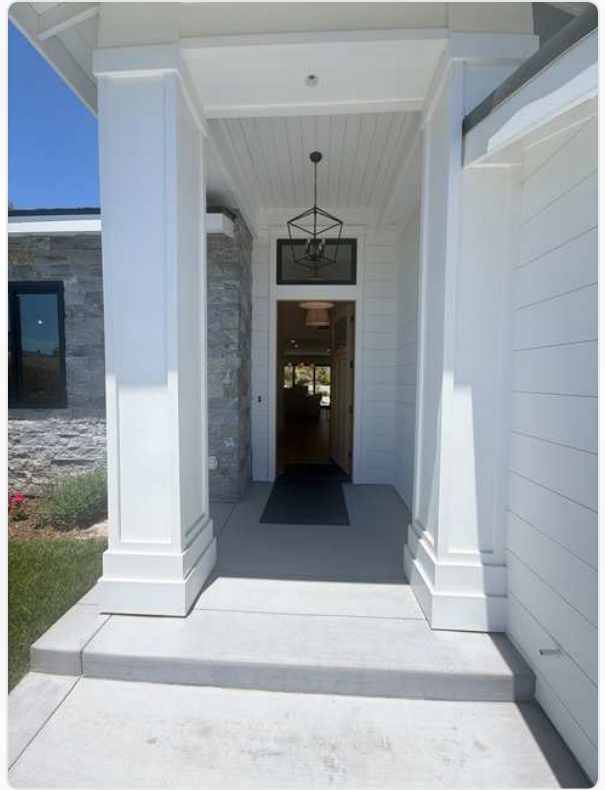
**SATISFACTORY 14**

Entry Door — The entry door was functional. Cosmetic deficiencies exist, but do not affect the door's performance, and there were no signs of water intrusion.

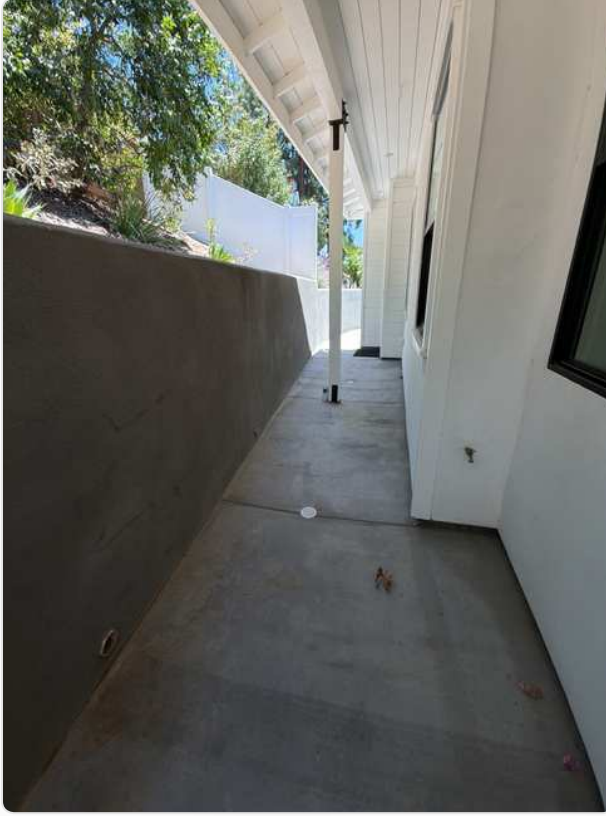
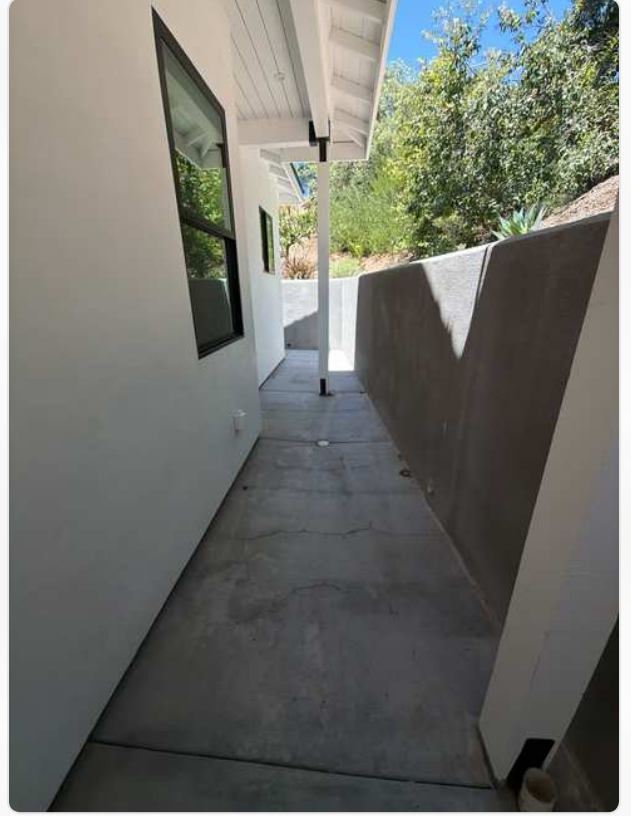
**WARNING** W20: Storm Drain  
**Warning**

Yard Conditions — It is vital to maintain clear storm drains. This will help prevent flooding during long sustained rains.

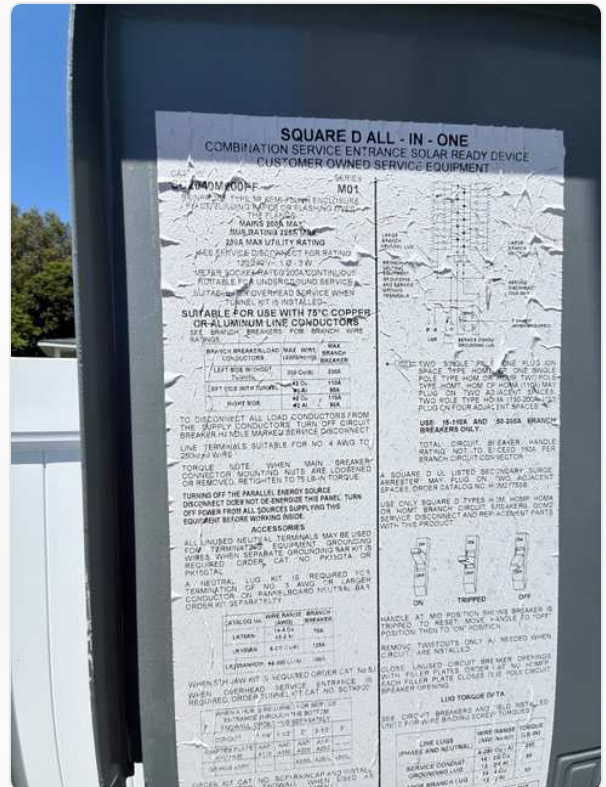
**FURTHER EVALUATION E84**

**General Condition** — Thermal imaging inspection of the main electrical panel revealed abnormal temperature patterns or hotspots indicative of loose connections, overloaded circuits, or deteriorated components at the time of scanning. Consult with a qualified individual for further evaluation and resolution.

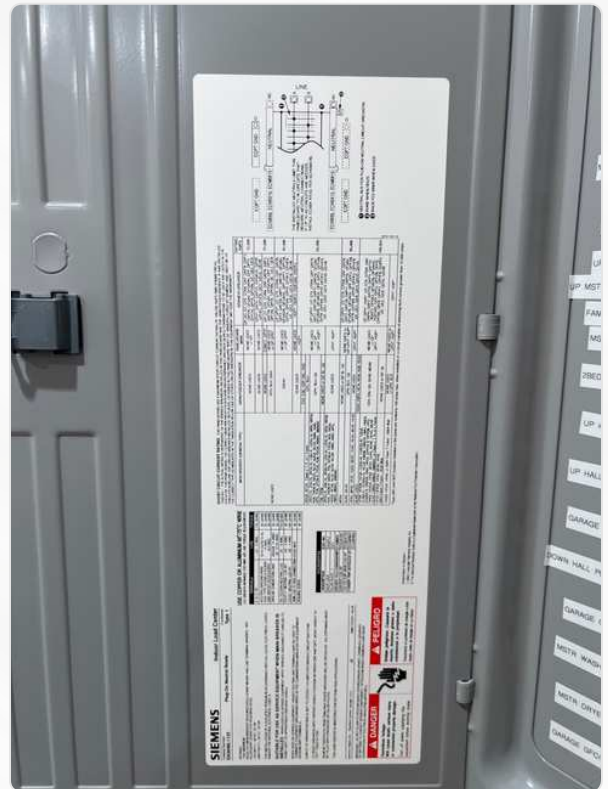
**SATISFACTORY 90**

General Condition — Thermal imaging inspection of the main electrical panel revealed no abnormal temperature patterns or hotspots indicative of loose connections, overloaded circuits, or deteriorated components at the time of scanning. All visible electrical components and connections within the panel are within normal operating temperatures, with no signs of overheating on the day of Inspection.

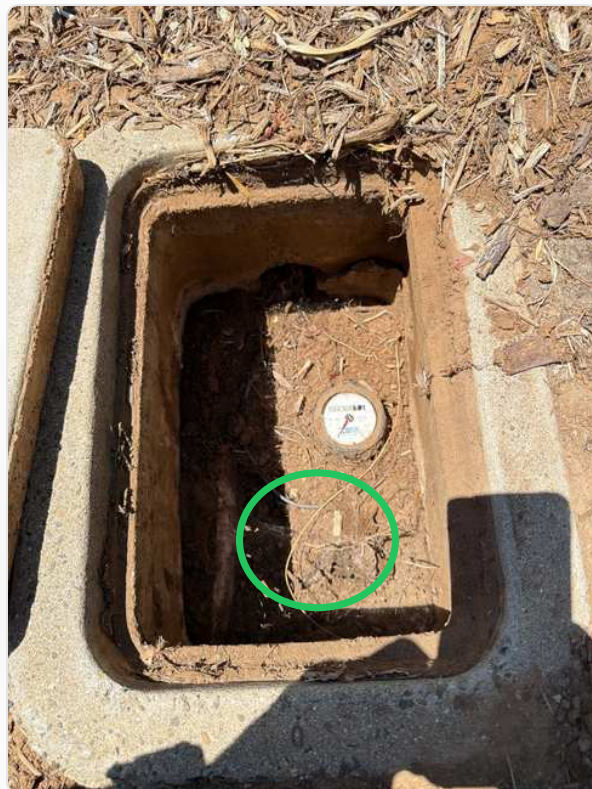
**NOTE 99**

Main Line Material — Copper was observed exiting the wall. Materials used underground are unknown.

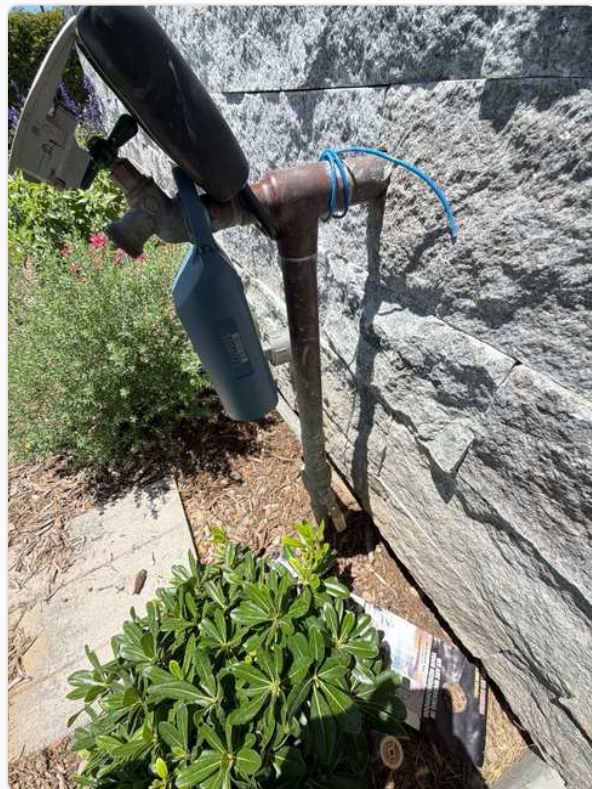
**SATISFACTORY** **100: Front of home location**

Main Shutoff Location — The main shutoff valve is located at the front of the home. The main water shutoff valve was in satisfactory condition.

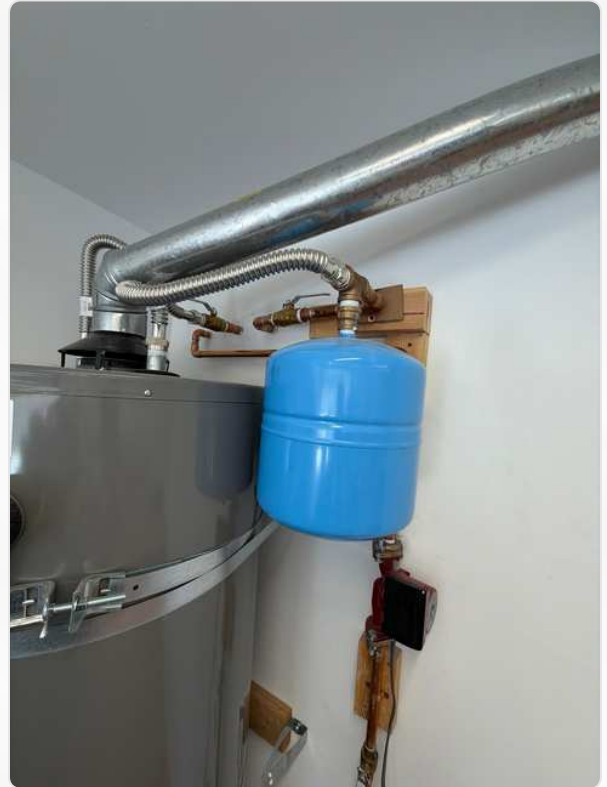
**SAFETY S112**

Temperature Control Valve — There was no whole house temperature control valve present. Temperature control valves help to prevent scalding at bathtubs and sink areas.

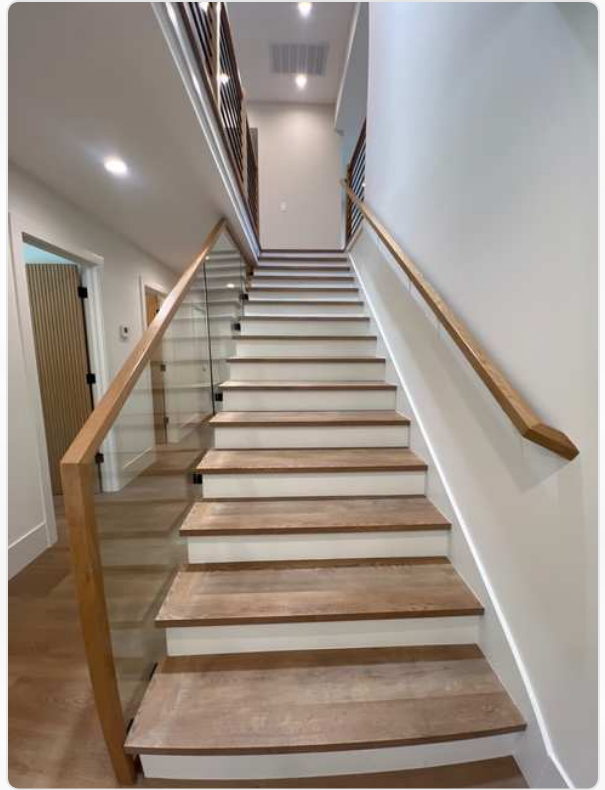
**WARNING W142: Ladder Type Guard Rail**

Stairwell — Ladder type guard rail pose a significant safety hazard for small children. Children can use the guard rail as a ladder to climb up and over the guard rail. Recommend improvements. Safety concern.

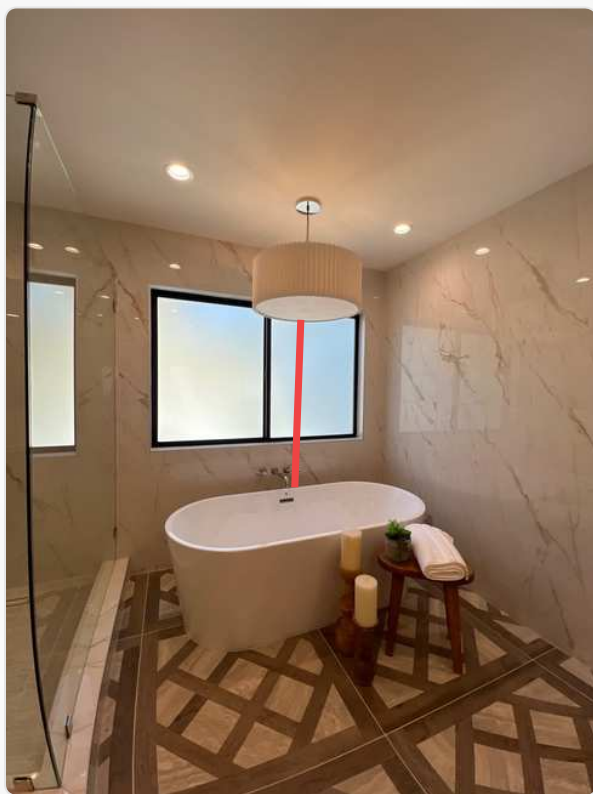
**SAFETY****S210: Missing Temperature Control Valve**

Tub and Showers — The shower/tub did not have the required temperature control valve install. This is a safety device. Consult with a plumbing contractor for cost of installation.

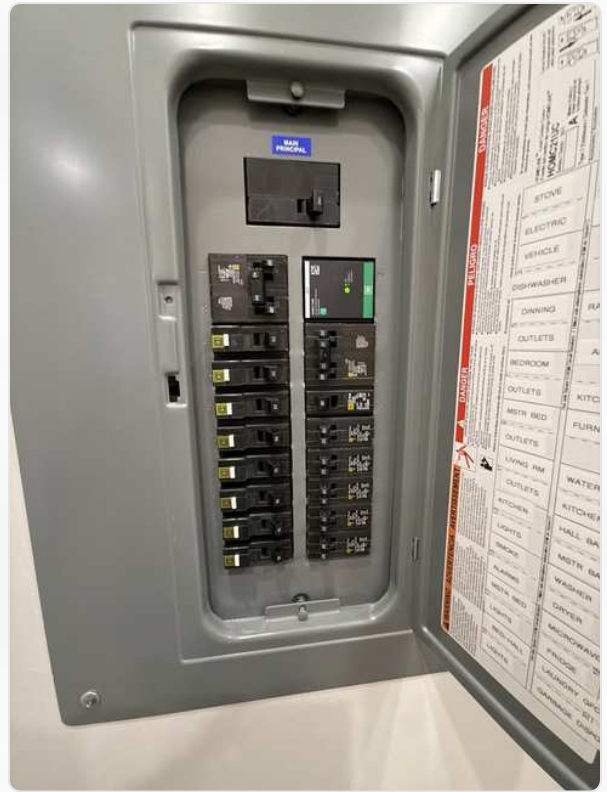
**NOTE 279**

General Condition — FLIR scan of sub panel. All temperatures were well within guidelines.

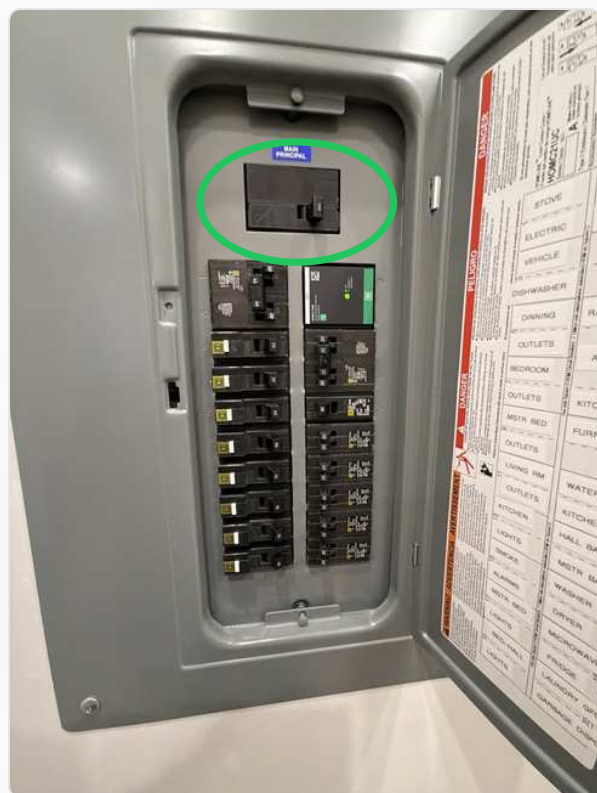
**WARNING W282**

**AFCI Circuit Breakers** — In 2008 the National Electrical Code (NEC) required that all 15 and 20 amp branch circuits feeding convenience receptacles be protected by an AFCI protection via outlet or circuit breaker. The National Fire Protection Authority (NFPA) recognizes that AFCI circuit breaker's can greatly reduce the risk of fire at receptacles throughout the dwelling caused by arc fault conditions. It is for that reason we at California Inspection Authority recommend the client consult with a licensed electrical contractor for installation of such safety devices.
