HOME INSPECTION REPORT

**Howard St
Upland, CA 91786**

Monday, May 18, 2026

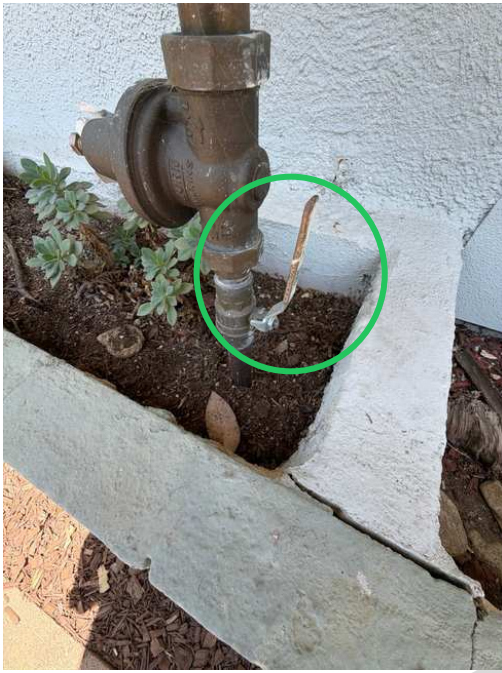
- **Main Water Shutoff:** The main shutoff valve is located at the front of the home. The main water shutoff valve was in satisfactory condition.

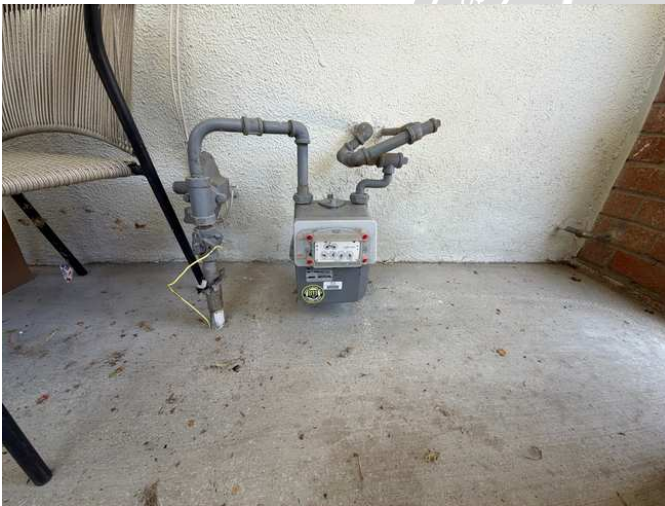
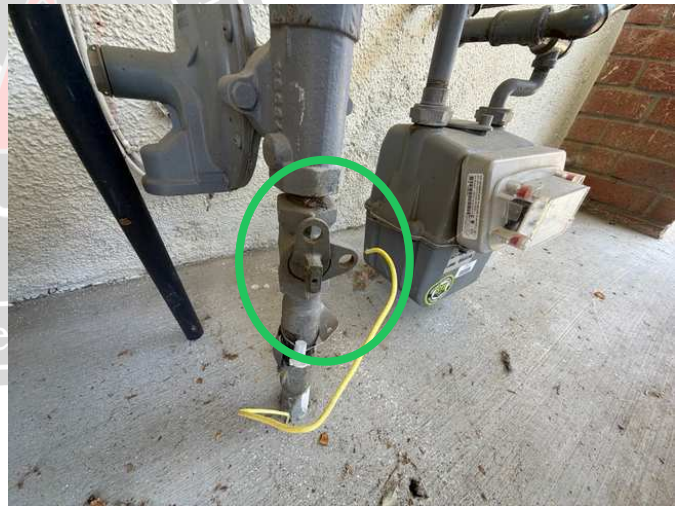
- **Gas Meter:** Natural gas service is provided to the home via public utility. Having a gas shut off wrench located at the gas utility will aid in the event of emergency shut off needs. The gas shut off valve can be shut off by turning the valve 90° in either direction.

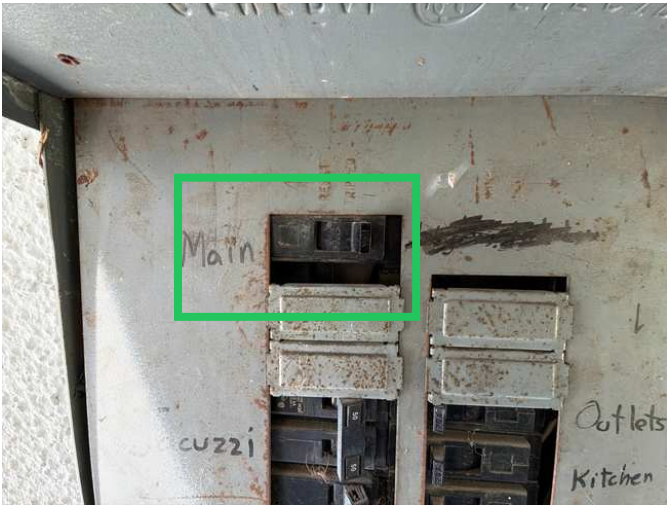
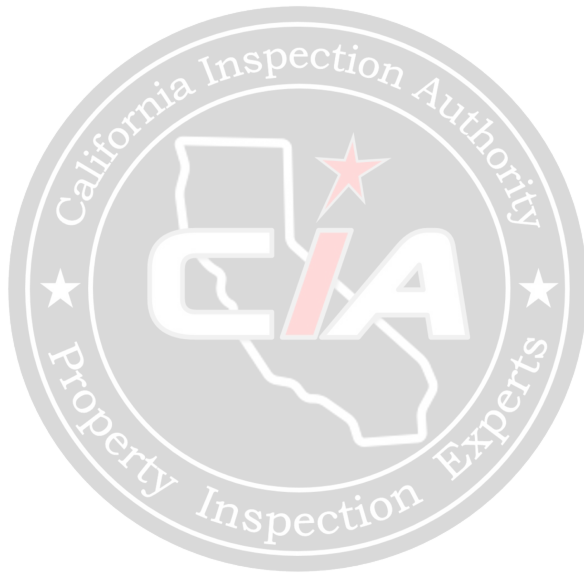
- **Electrical Panel Amperage:** The main electrical panel is rated for 125/250 Volts 100Amps. The main service disconnect switch is located at the main electrical panel.

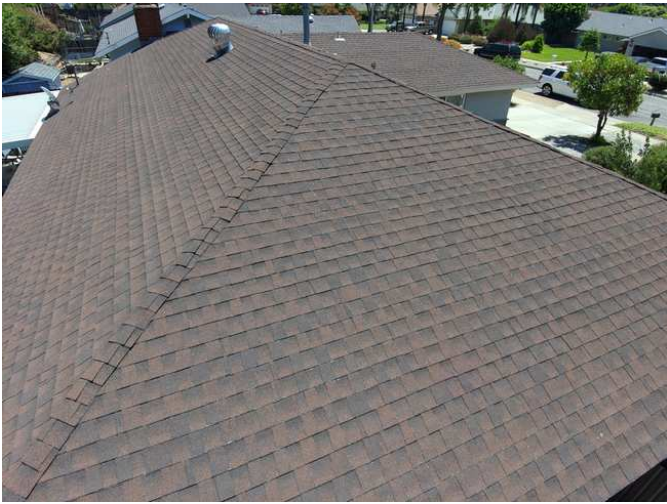
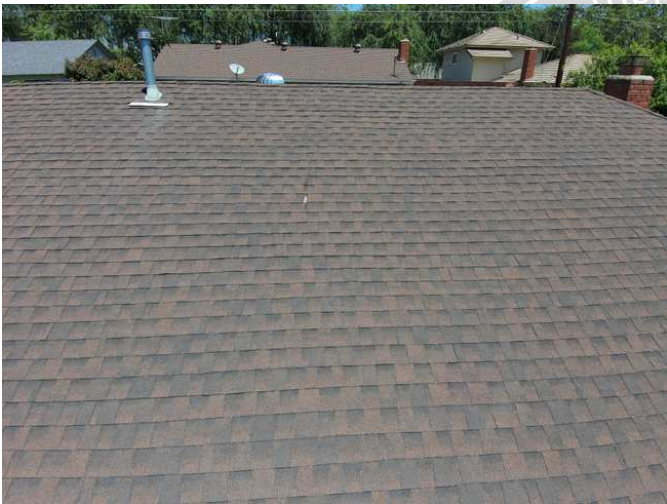
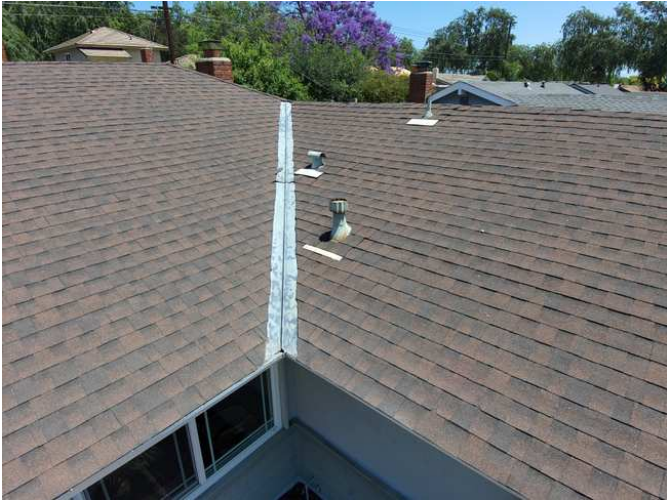
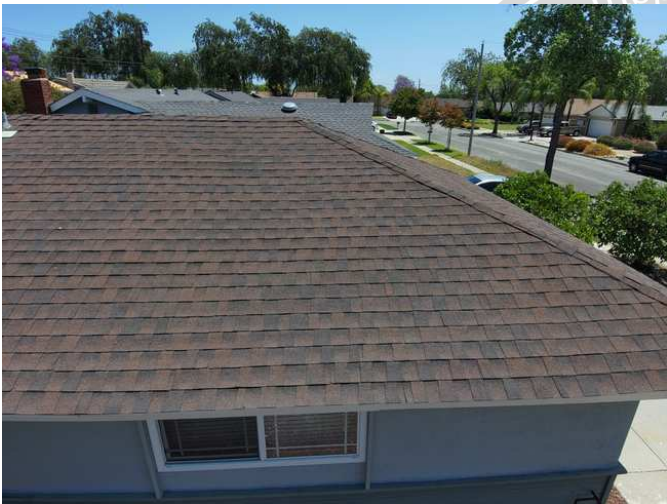
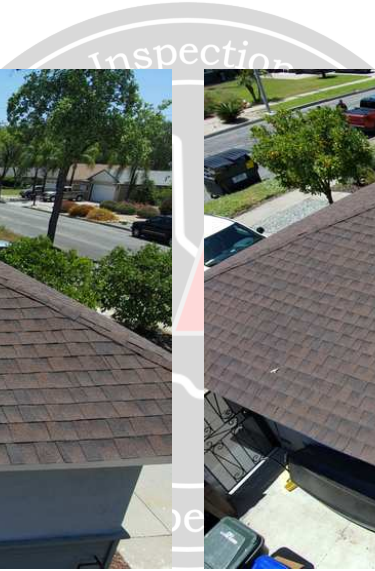
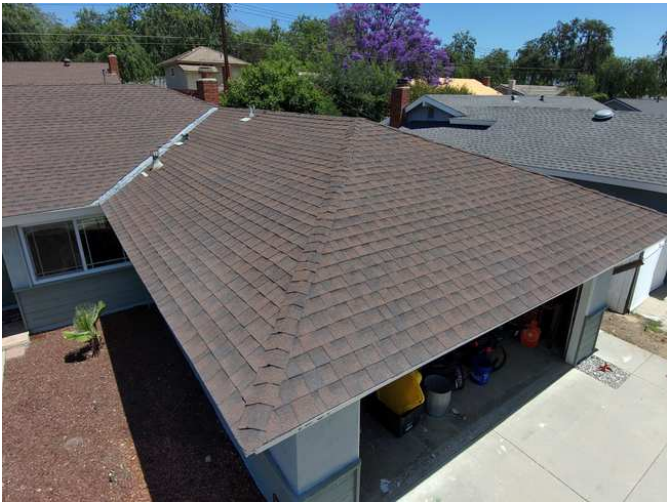
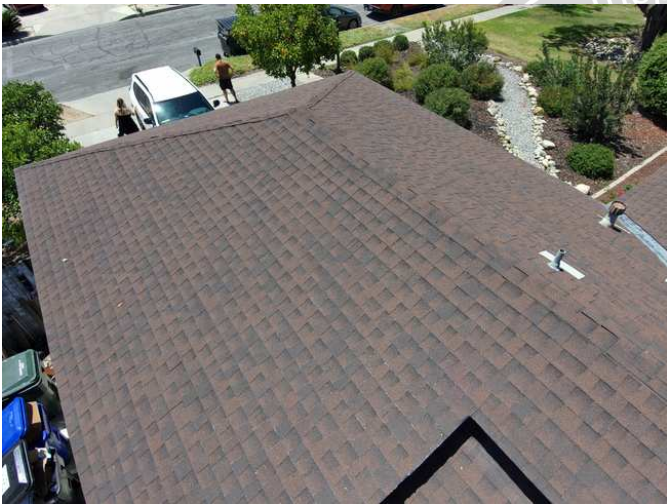
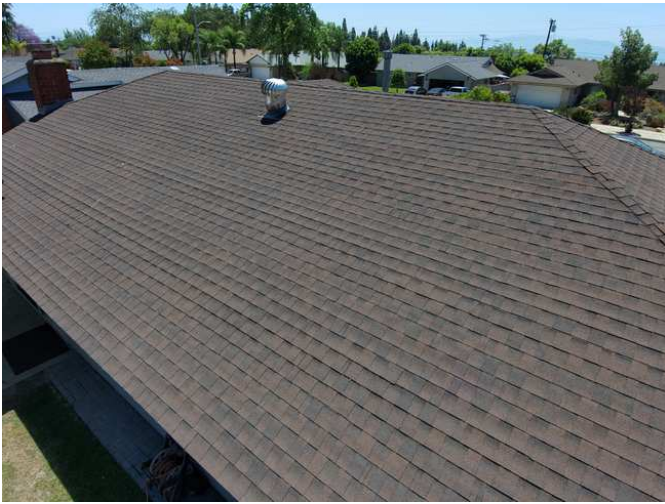
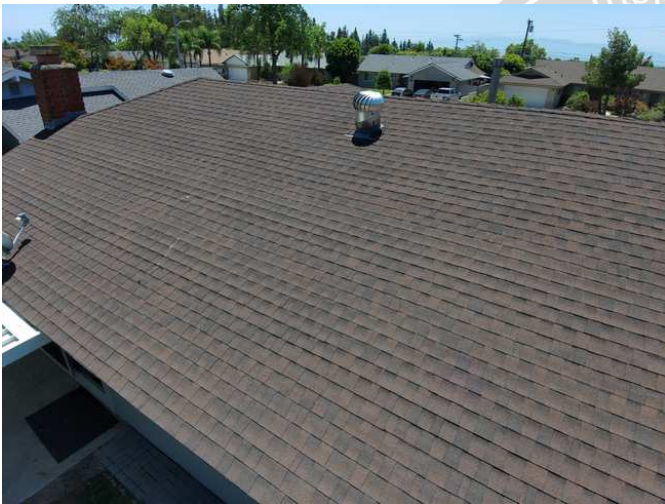
W2: Directly Over Wood Shingles

Life expectancy is 3 to 5 years. The roof is subject to leaks at any time due to its age and current condition. The asphalt shingles appear to have been installed directly over the original wood shingles. The asphalt shingles may show inconsistencies at the surface areas. Minor lifting of the shingles was observed. The existing conditions will most likely reduce the life expectancy of the roof.

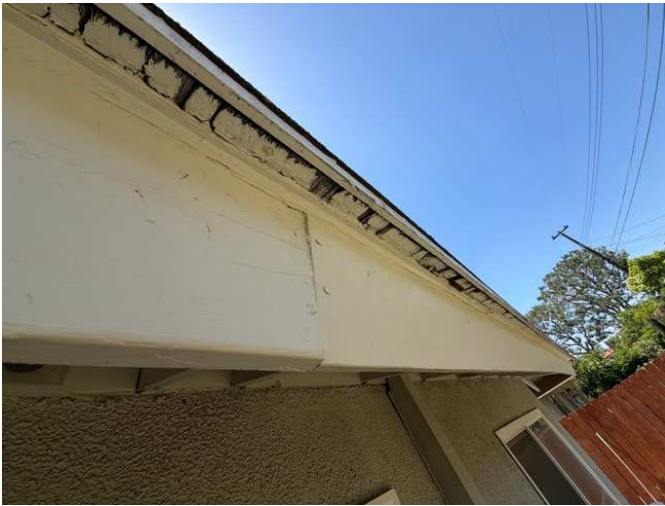
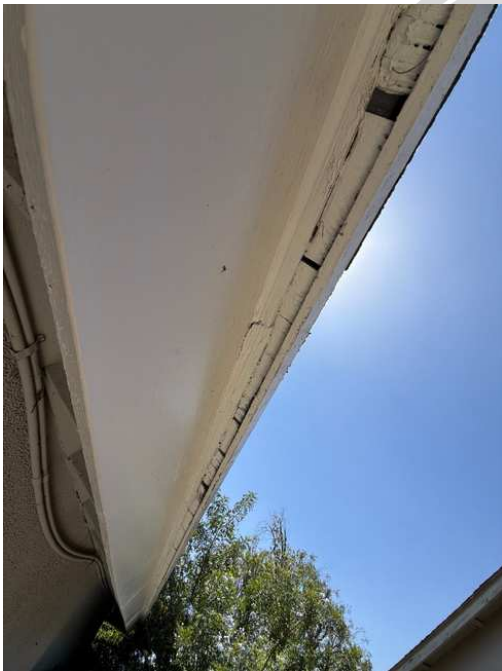
W3:

The leaderboard exhibited signs of damage caused by wood, destroying insects and organisms. This can add substantial cost to the replacement of the roof. Buyer beware.

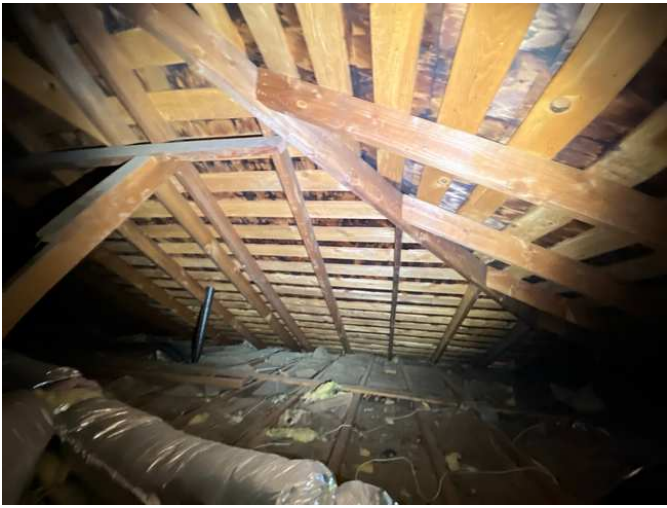
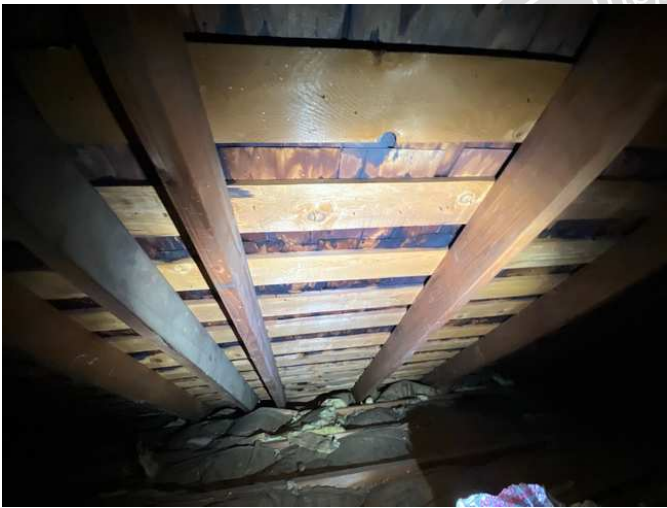
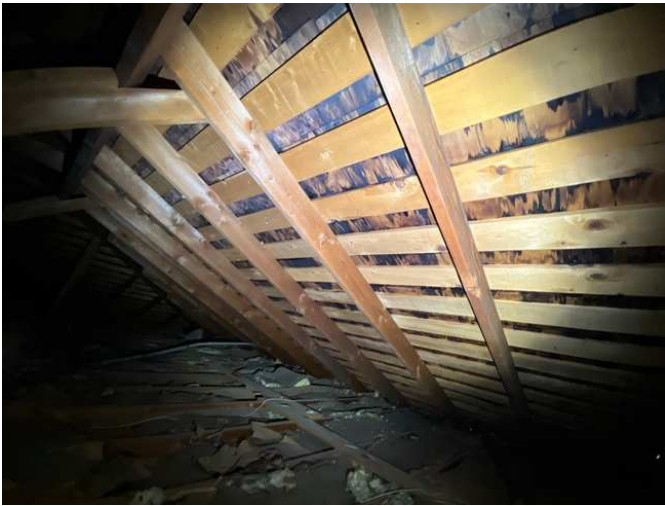
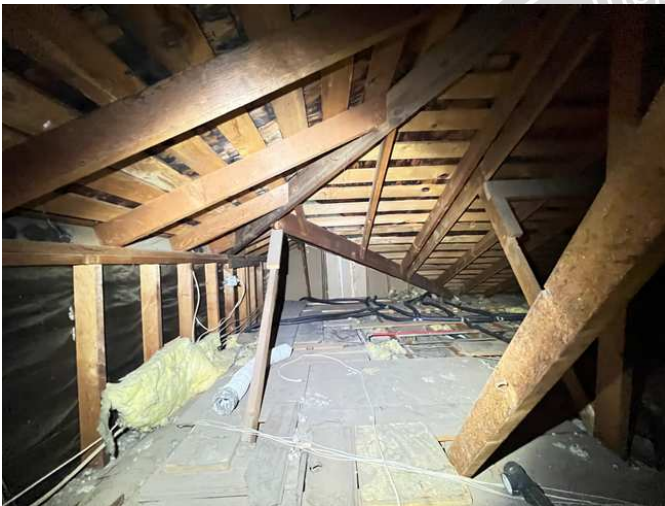
W5:

1x6 skip sheathing with wood shingles. The underside of the wood shake shingles, exhibited signs of old water stains. This is indicative of this type of system. Radiant barrier plywood decking will be needed when the roof system is replaced. This comes at a substantial extra cost.

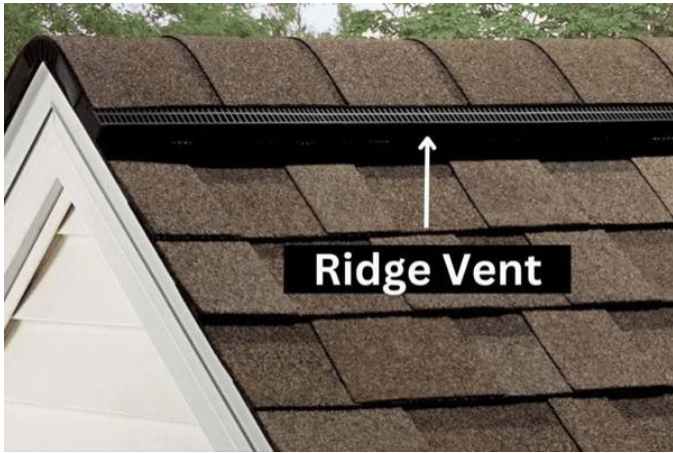
W6: Missing Ridge Vent

Manufacturers of composition shingles recommend continuous roof vent systems to maintain the manufacturer's warranty. Dormer vents were utilized. A lack of ventilation will result in early deterioration of the shingles. Upgrades recommended.

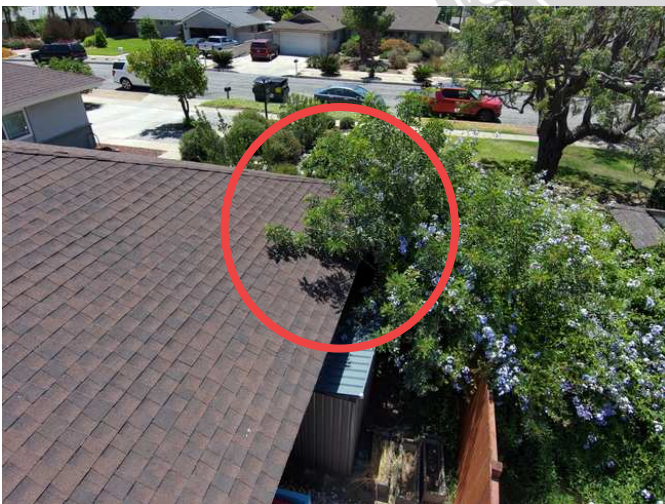
M7:

Tree trimming is needed. Trees over the roof system can cause early deterioration of the composition shingles leading to leaks.

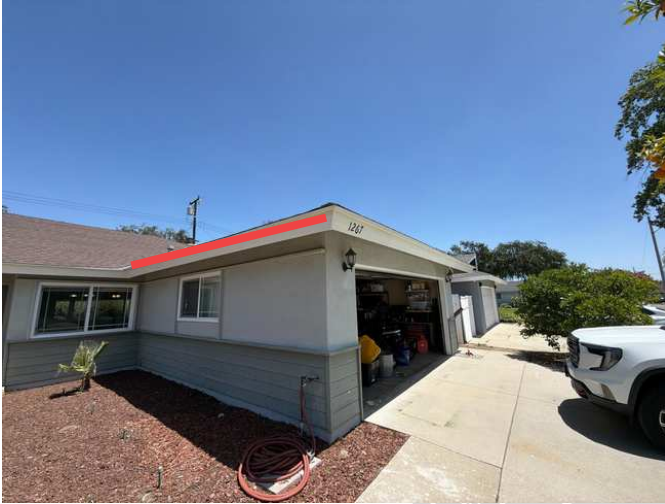
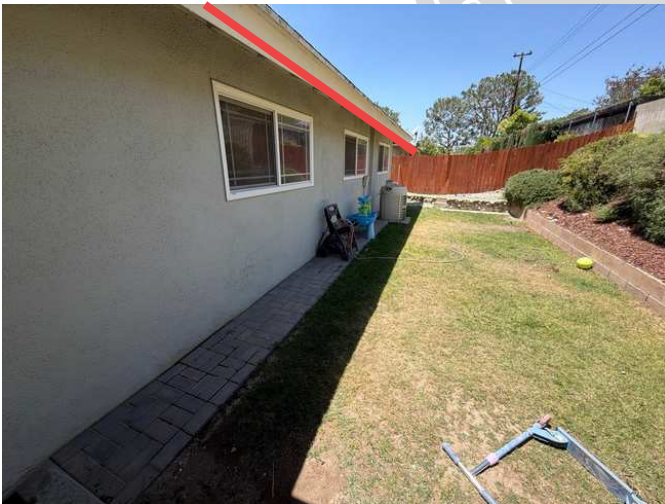
W8: No Rain Gutters Present

Gutters and downspouts direct roof water away from the foundation, reducing moisture, hydrostatic pressure, and soil erosion that can compromise foundation stability and cause water intrusion.

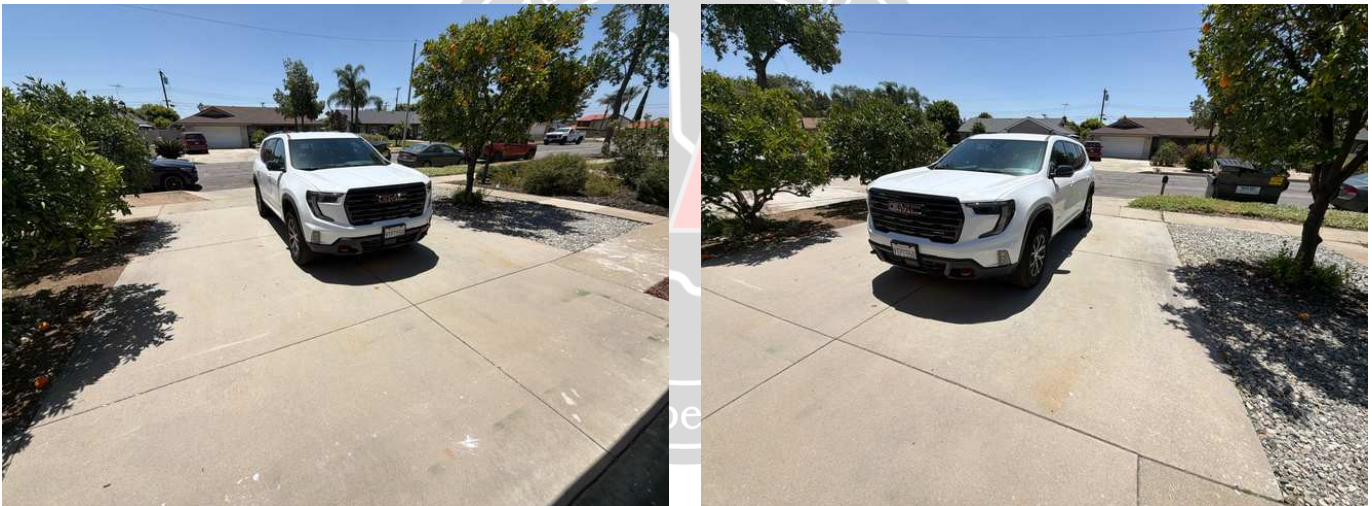
- ✓ **9:** The driveway appeared to be in satisfactory and usable condition at the time of the inspection.

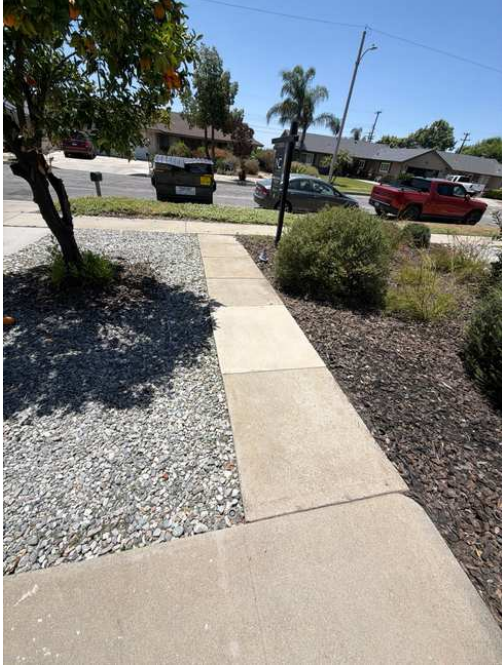
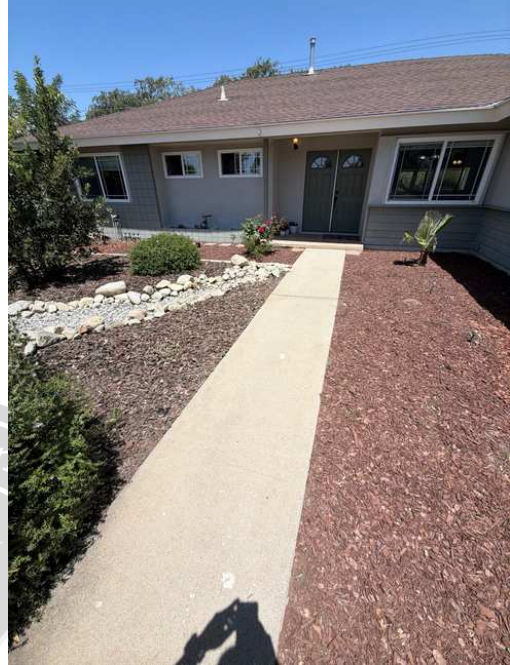
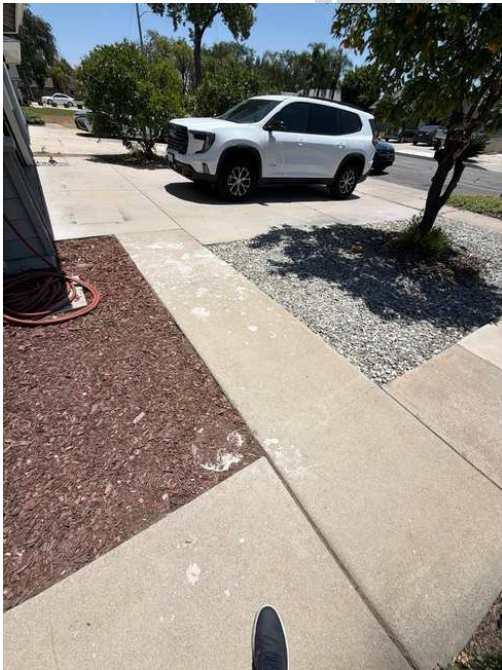
- ✓ **11:** The visible areas of the sidewalk appeared to be in serviceable condition at the time of the inspection.

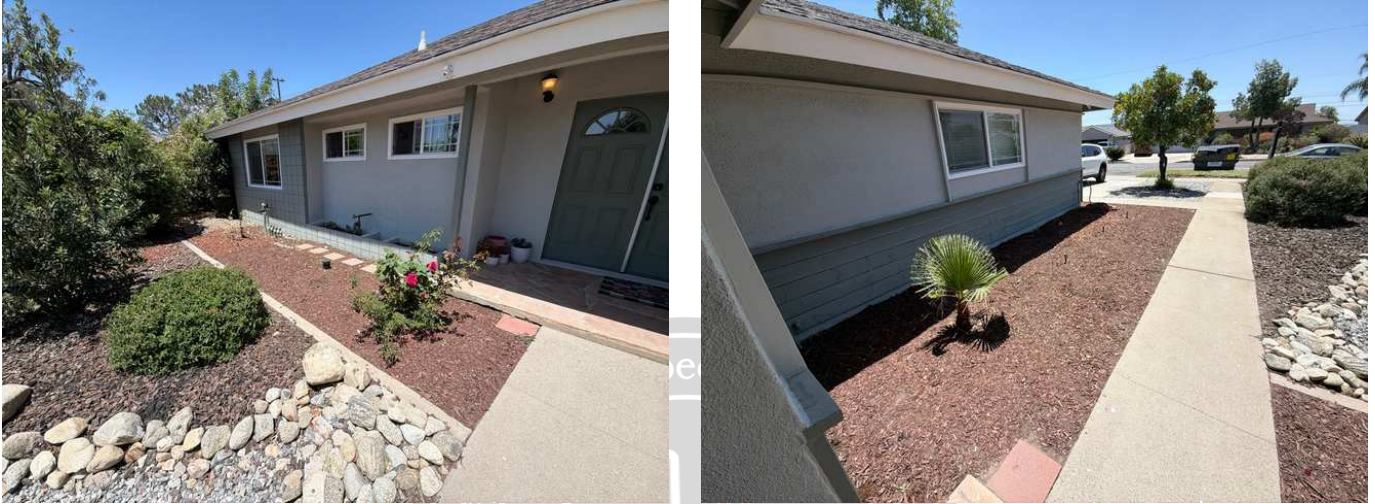
W12: Flat

The drainage at the front of the home was flat or nearly flat in some areas. A 5% grade away from the home is ideal.

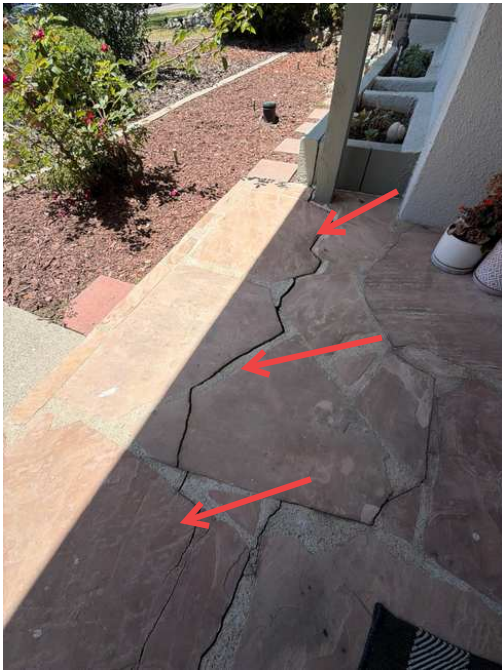
W13:

Signs of cracks and settling at the front porch. While this does not pose an immediate hazard. Buyer should be aware that the settling it's occurring and can pose a trip hazard in the future.

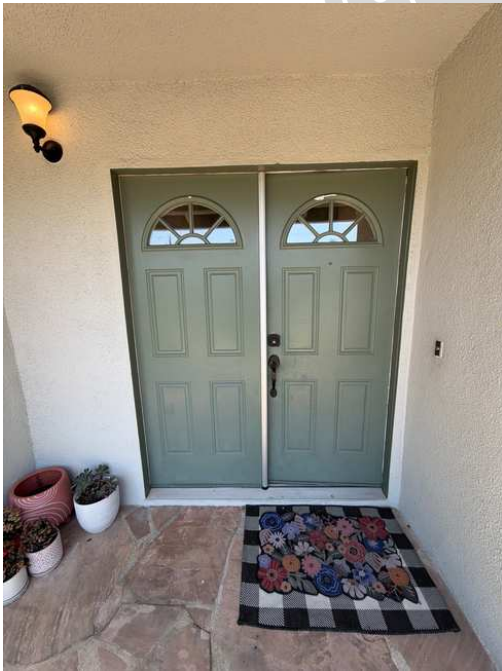
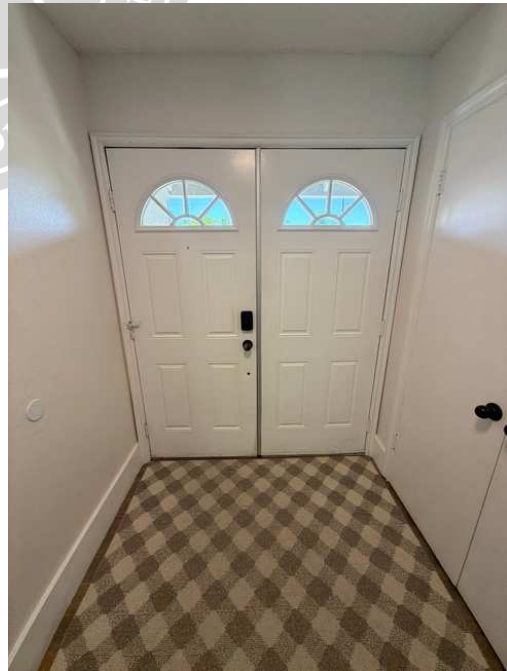
✓ 14:

The entry door was functional. Cosmetic deficiencies may exist, but do not affect the doors performance, and there was no signs of water intrusion.

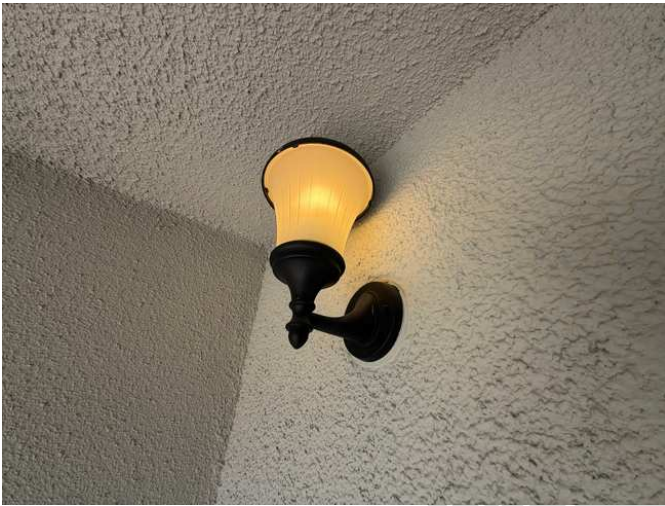
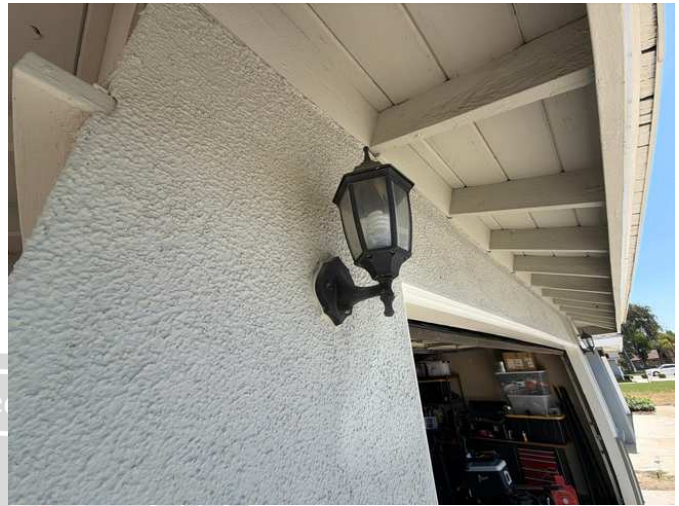
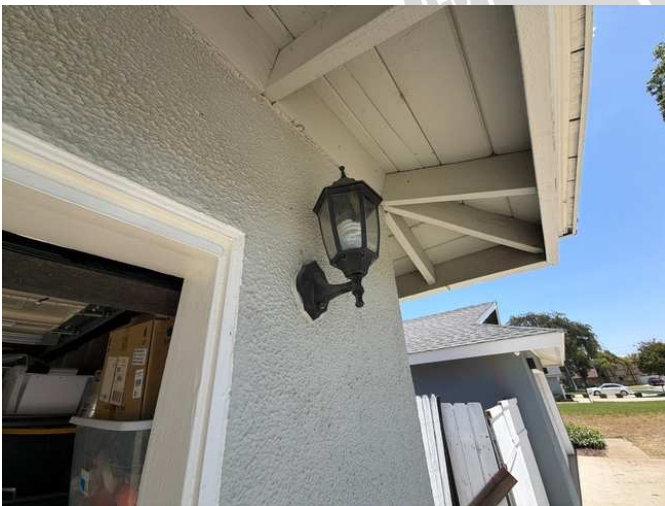
✓ **15: Satisfactory**

Light fixtures were satisfactory.

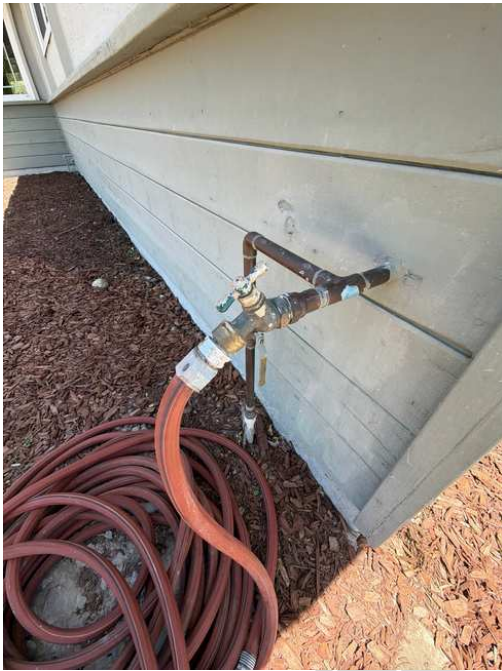
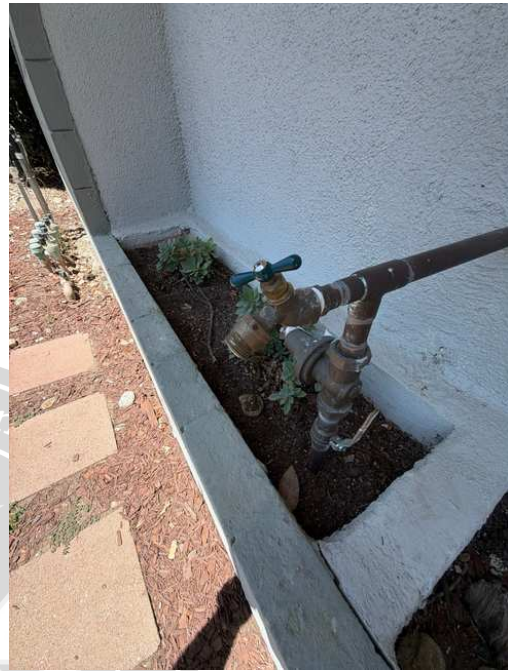
✓ **16: Satisfactory**

Hose bibs were in satisfactory condition.

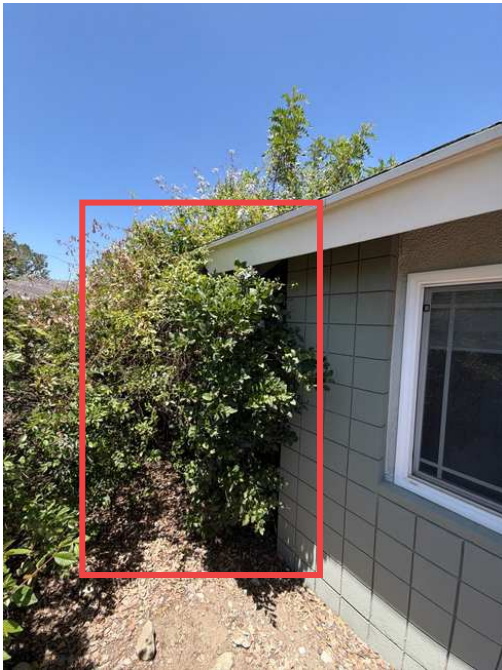
A 12" clearance between shrubs and plantings is recommended to help prevent the buildup of moisture. A 5' clearance between trees and the homes structure is recommended to help prevent damage.

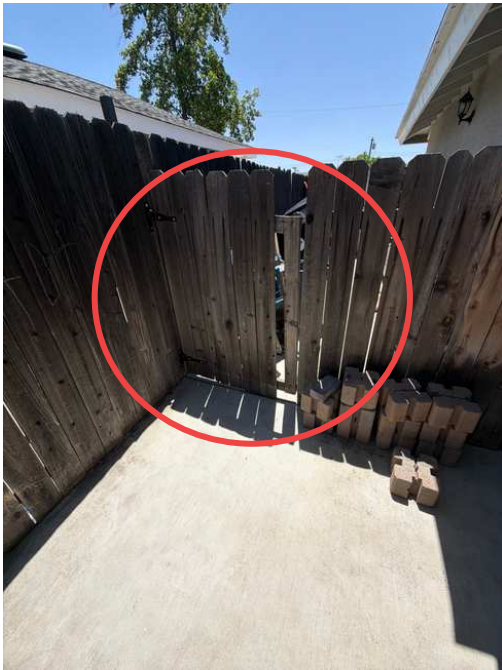
General repairs are needed at gates. Consult a handyman for evaluation and repair.

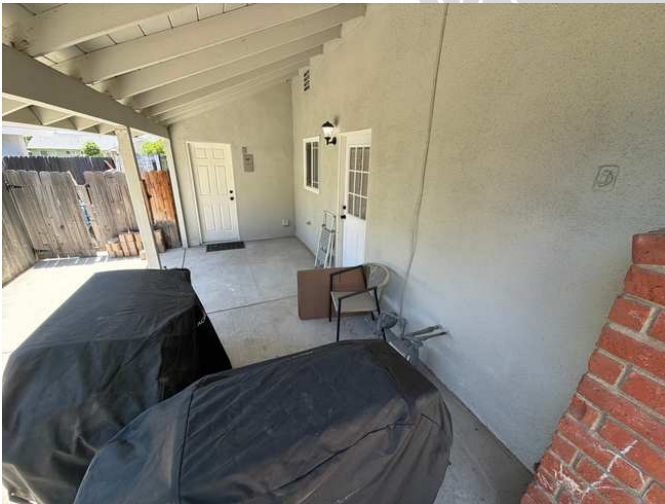
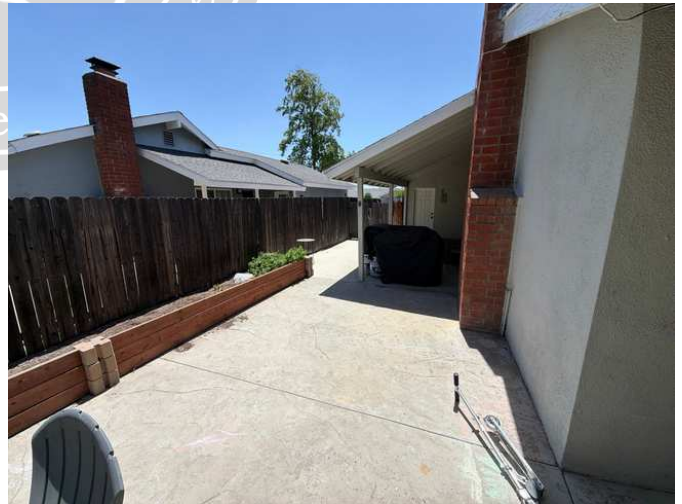
- ✓ **19:** Drainage at the side(s) yard is satisfactory.

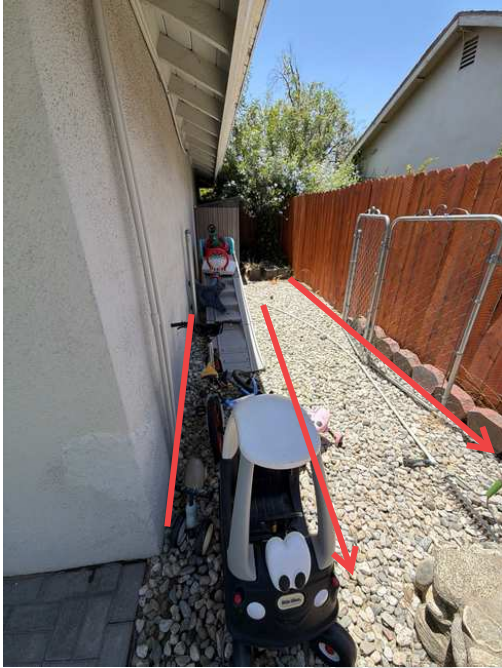
W20: Flat

The drainage at the side of the home was flat or nearly flat in some areas. A 5% grade away from the home is ideal.

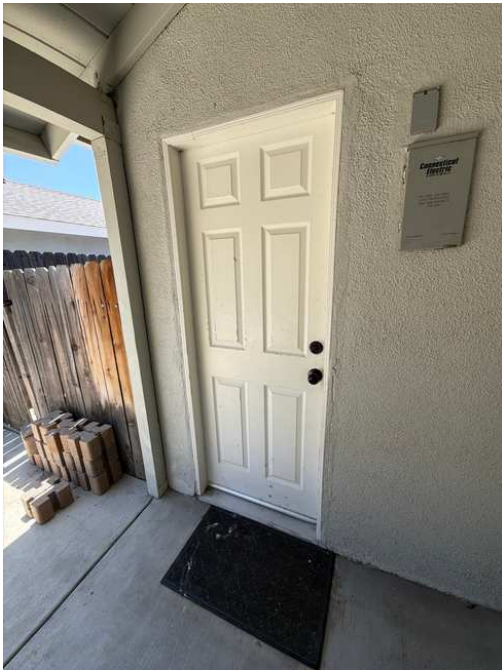
21:

The garage side entry door was functional. Cosmetic deficiencies may exist, but do not affect the doors performance, and there was no signs of water intrusion.

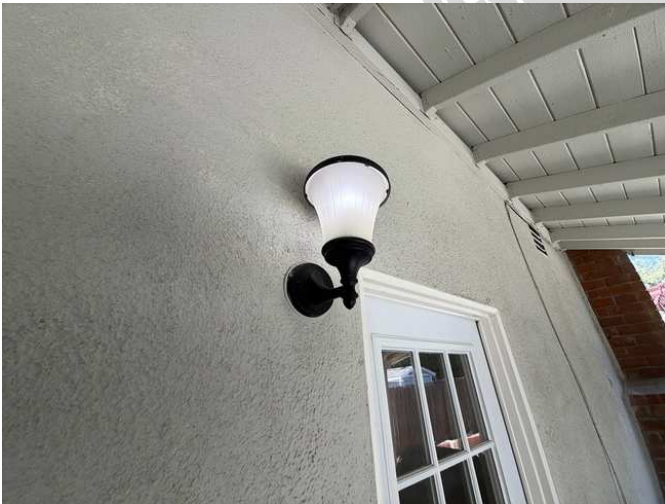
✓ **22: Satisfactory**

Light fixtures were satisfactory.

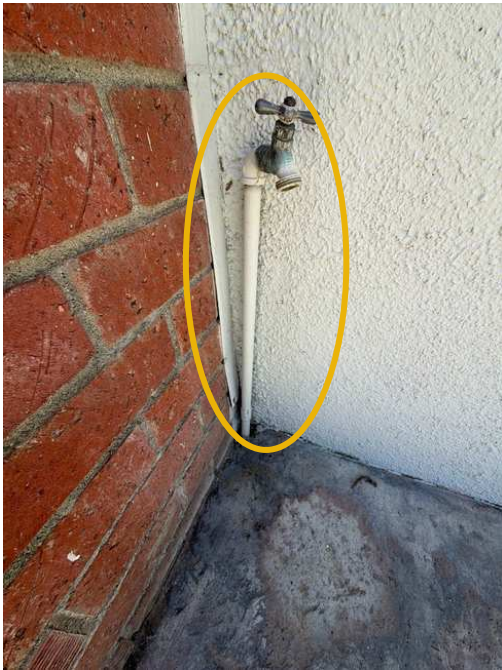
W24:

Galvanized hose bib was abandoned during the plumbing re-pipe. Not functional.

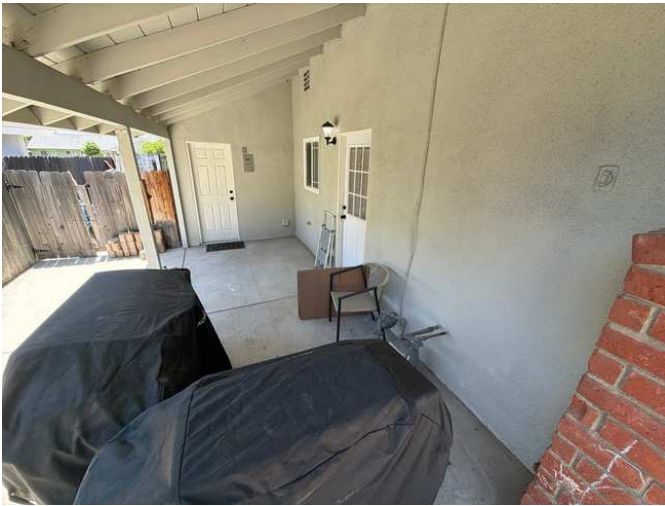
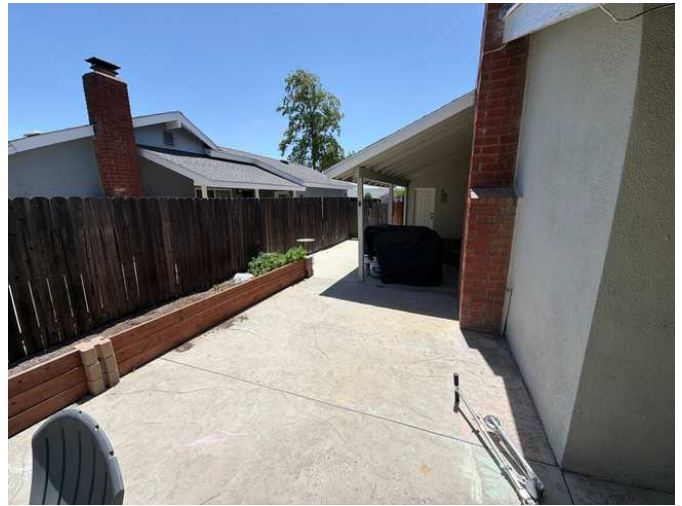
✓ **25: Satisfactory**

The patio was in satisfactory condition on the day of inspection. Small hairline cracks may be present or may occur as part of regular curing and settling.

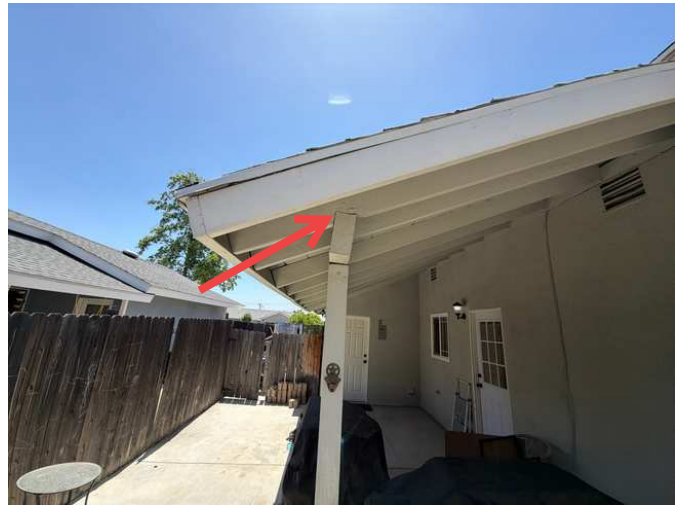
Beam rotation was noted. This can cause point loading at bearing points leaving some areas in properly supported. Consult with a structural engineer for further evaluation and cost of repairs.

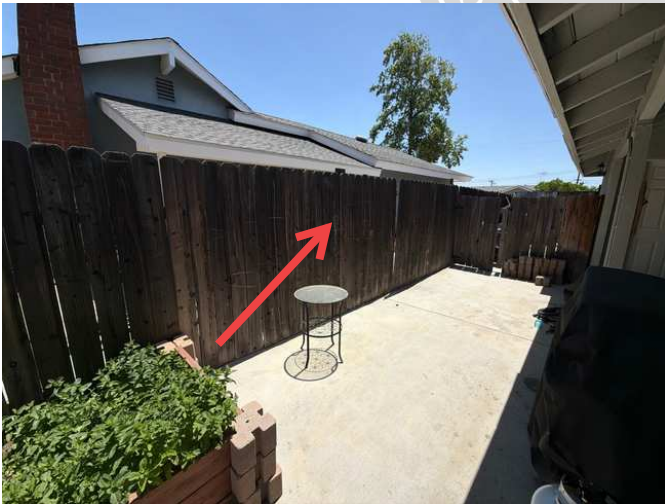
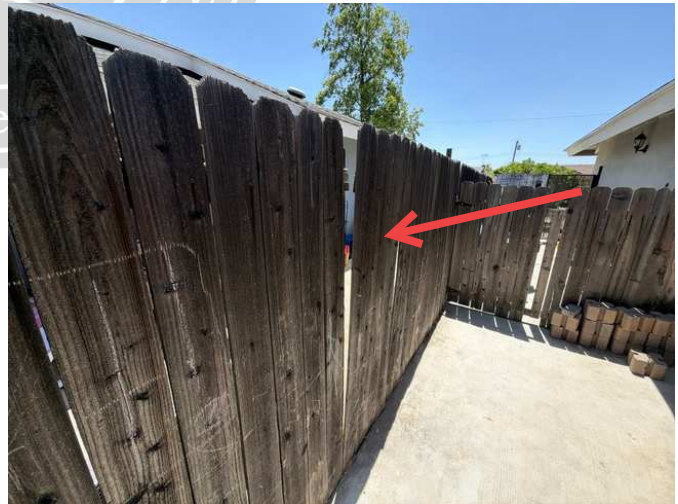
The wood fencing is showing signs of deferred maintenance. Minor repairs are needed. It is suggested that a "Licensed General Contractor" be contacted for further evaluation and repair.

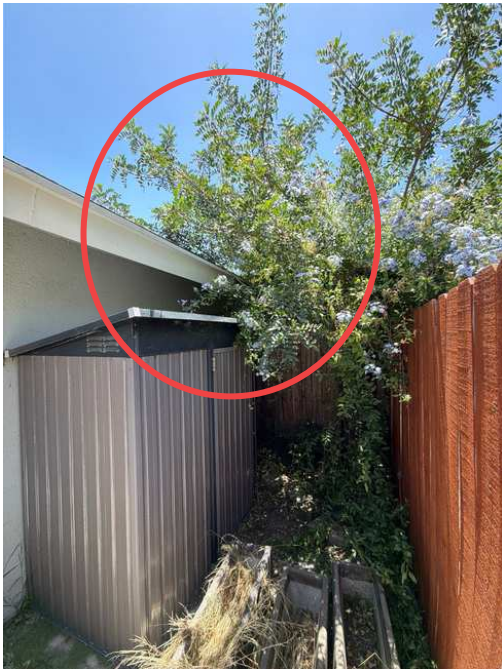
A 12" clearance between shrubs and plantings is recommended to help prevent the buildup of moisture. A 5' clearance between trees and the homes structure is recommended to help prevent damage.

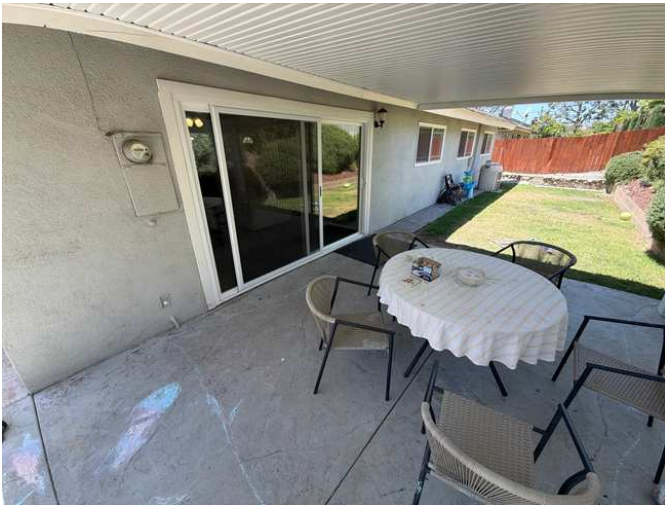
29:

Drainage at the rear patio is satisfactory. Water pooling can be expected during rains.

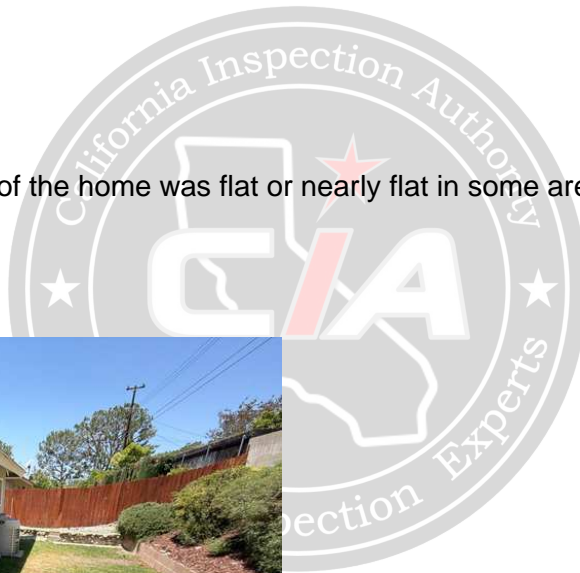
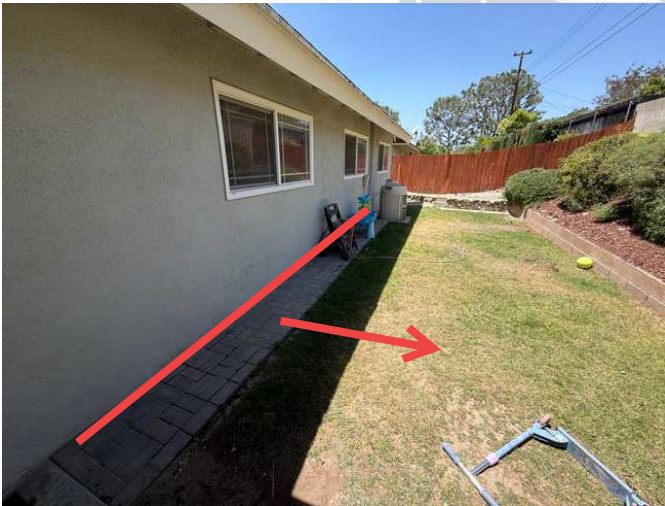
W30: Flat

The drainage at the rear of the home was flat or nearly flat in some areas. A 5% grade away from the home is ideal.

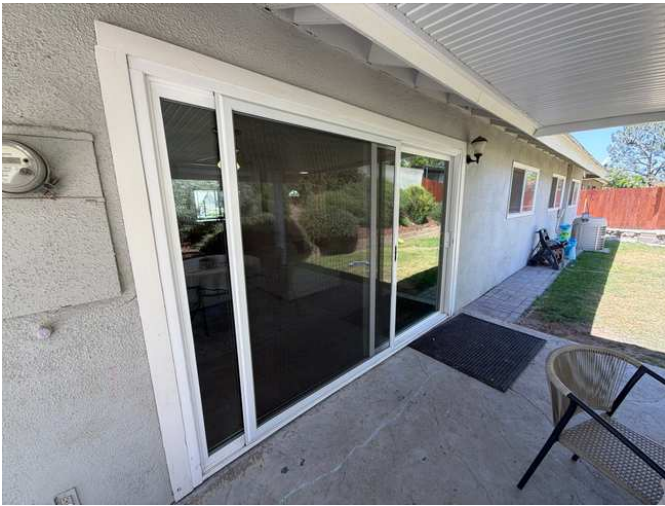
32:

Patio doors were tested and found to be functional on the day of inspection. Doors show signs of normal wear and tear.

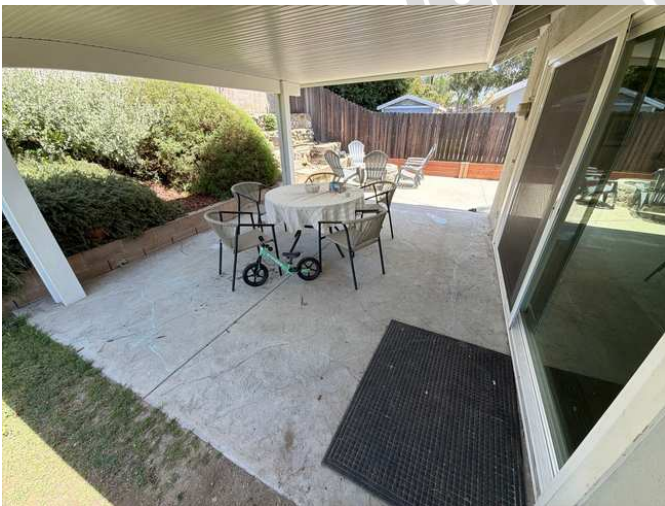
33:

The patio was in satisfactory condition on the day of inspection. Small hairline cracks may be present or may occur as part of regular curing and settling.

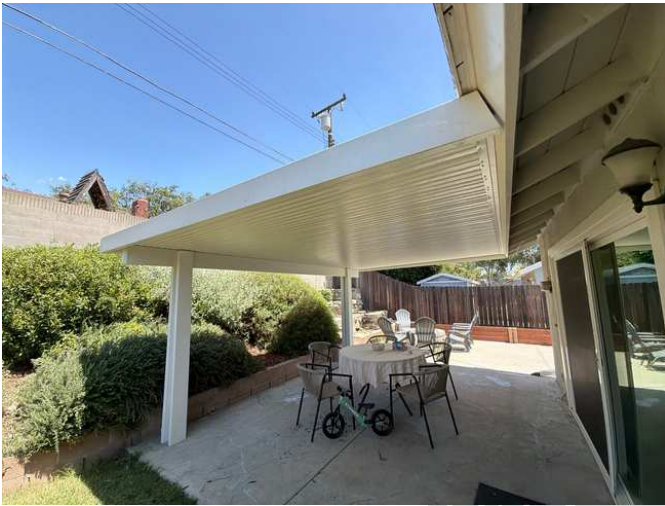
✓ **34: Satisfactory**

The patio cover was in satisfactory condition.

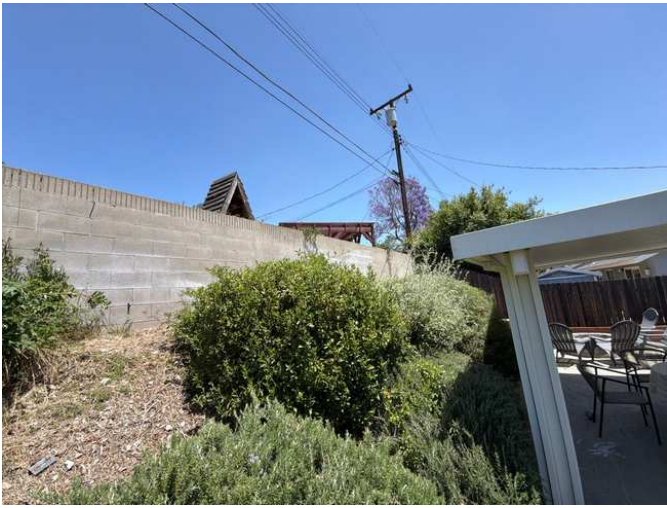
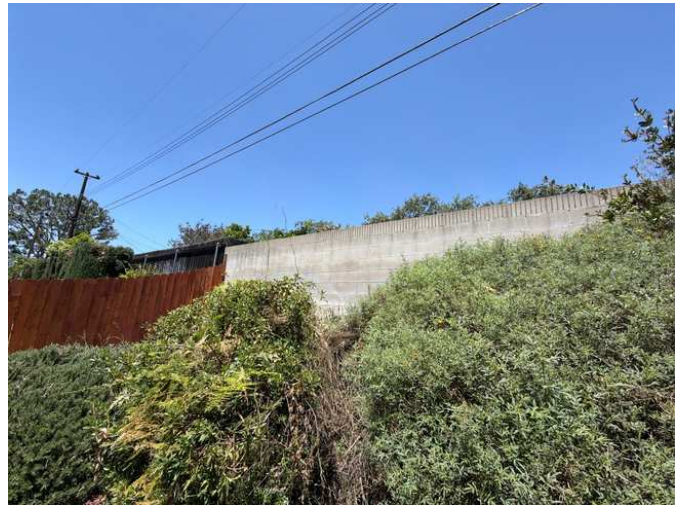
✓ **35: Property Wall Satisfactory**

The block wall was in good to excellent condition. No signs of settling or step cracks were noted.

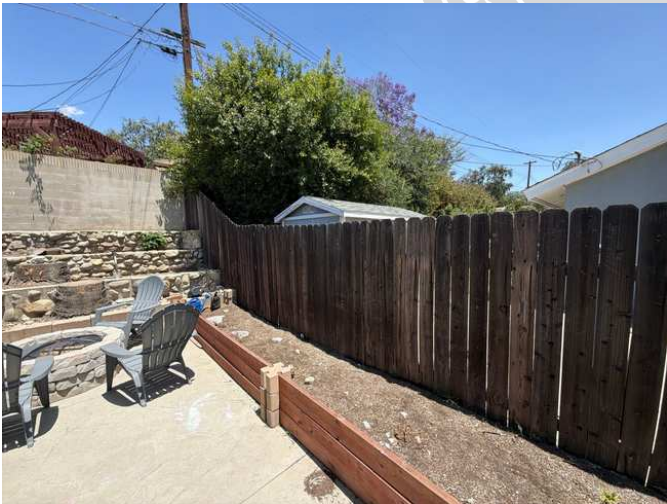
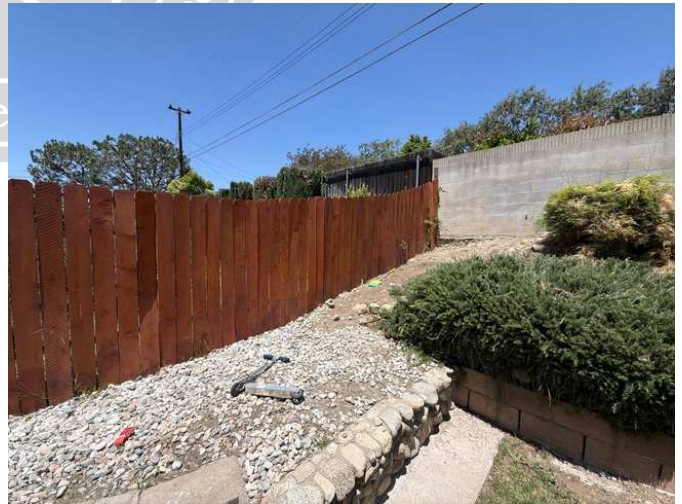
✓ **36: Satisfactory Condition**

The wood fencing was in satisfactory condition.

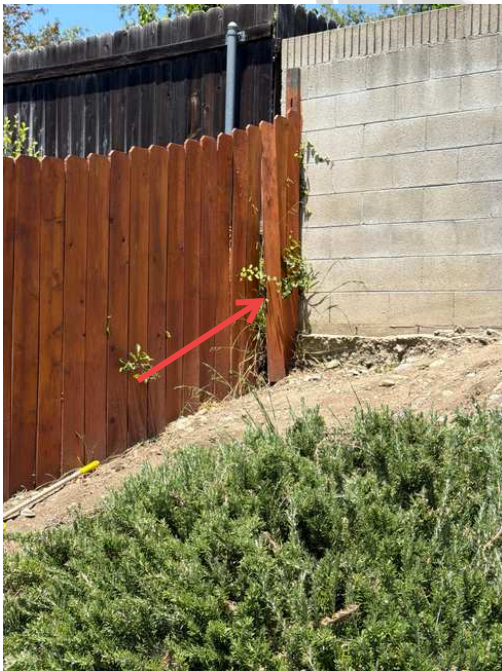
Wood Fence picket repair needed.
