HOME INSPECTION REPORT

**Howard St
Upland, CA 91786**

Monday, May 18, 2026

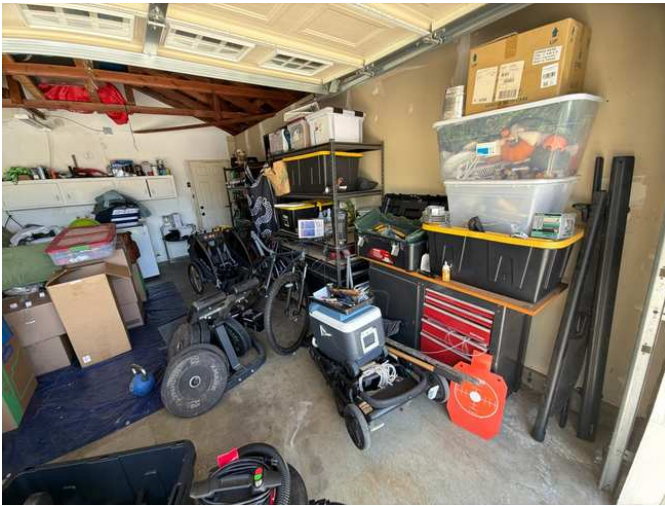
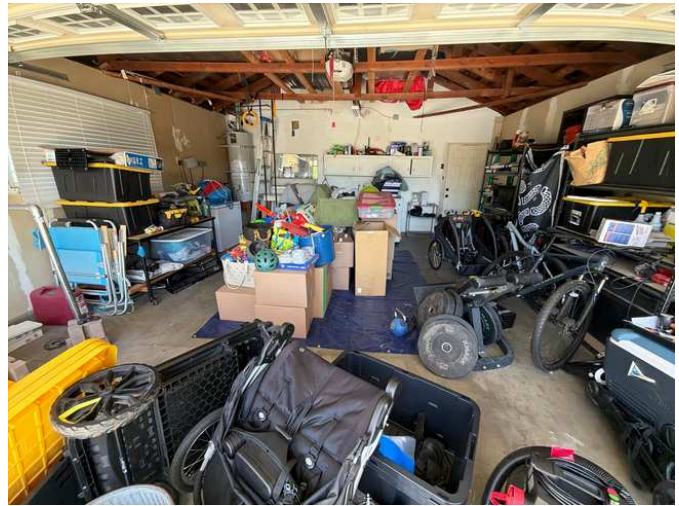
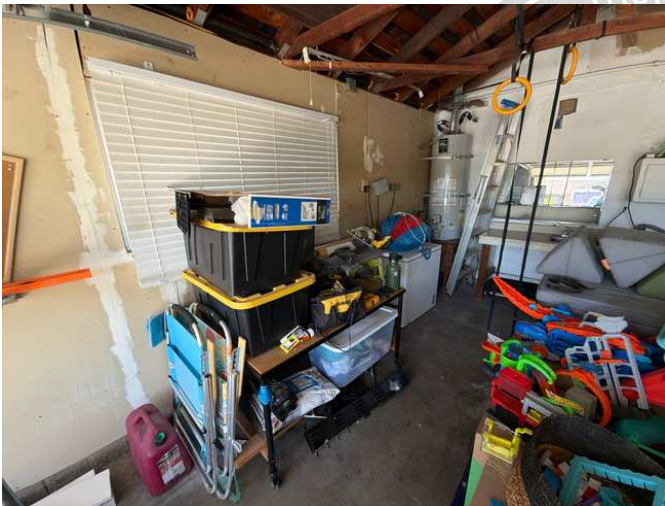
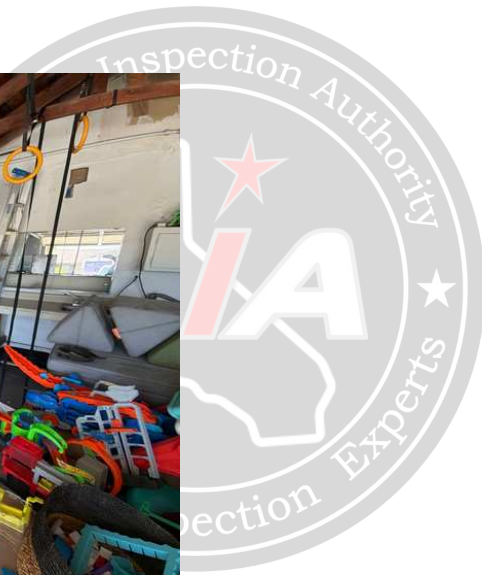
- ✓ **39:**
Personal items and storage obstructed a complete visual assessment of the garage area. Client may request clearing of said personal items and storage. Then call for re-inspection.

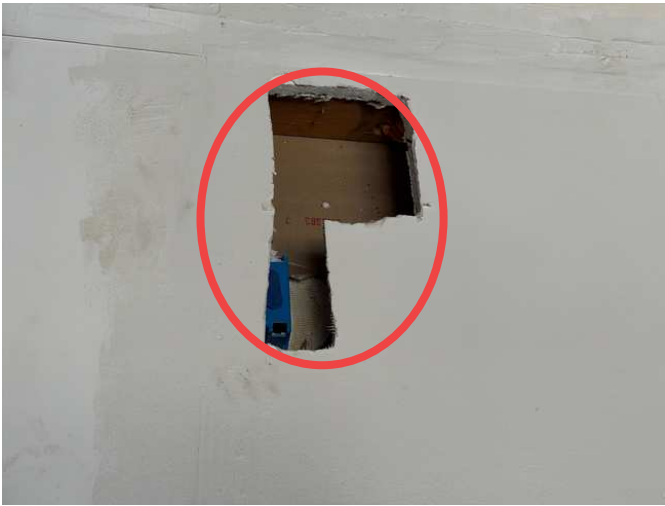
The fire containment envelope also referred to as the firewall has been compromised. Walls should be patched and repaired according to local codes and ordinances. Consult a general contractor for repairs.

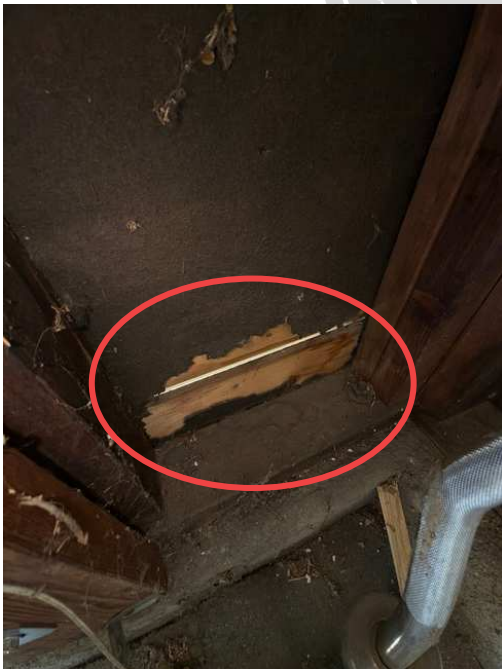
R41: Felt Deterioration

The felt has deteriorated and or was missing. This can lead to moisture related damage in the walls. Consult with a qualified contractor for complete evaluation and cost of repairs.

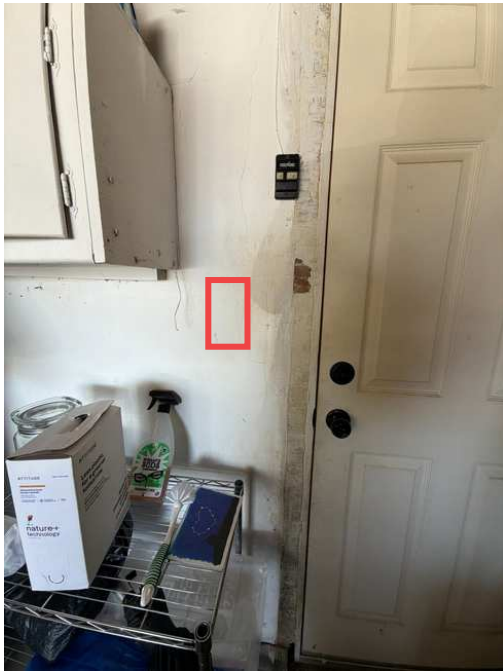
No lights provided at entry door. Consult with a licensed electrician for Installation. A three-way switch is recommended between the garage, entry door and the garage man door.

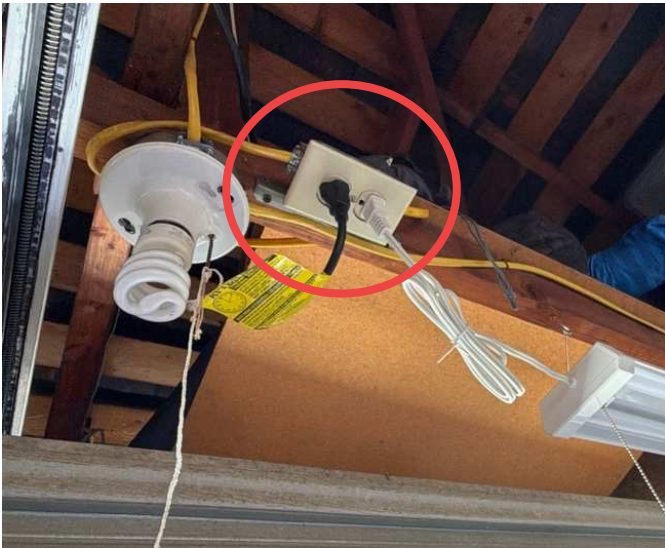
The garage door receptacle was not GFCI protected. Consult with a licensed electrical contractor to install GFCI protection at the main electrical panel.

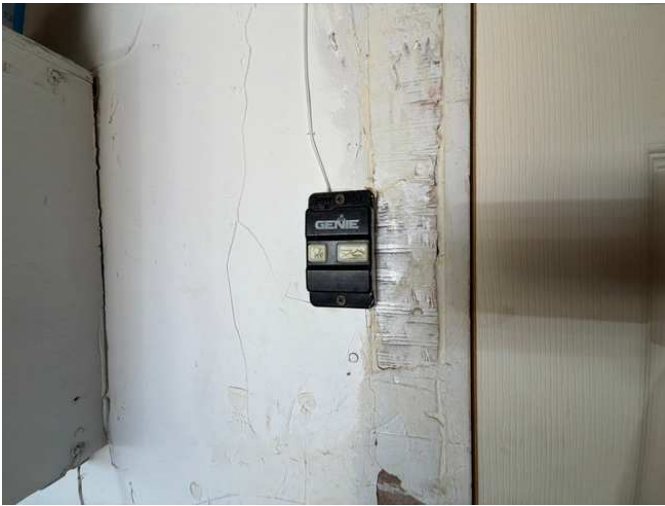
The operator button was in satisfactory condition and responded normally to testing.

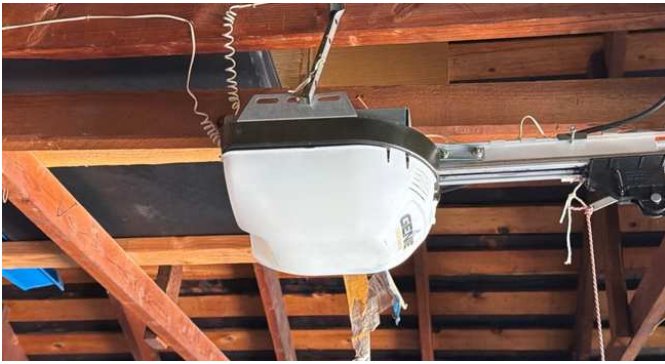
The garage door was not equipped with a battery back up system. In September 2018, California Governor Jerry Brown signed SB 969 into law. This requires all garage door openers sold in California after July 1, 2019, must have battery backups for occupant safety. It is for that reason we recommend a battery back up system be installed on the garage door for emergency operation. This law was enacted in response to the Wildfire season of 2017 when at least five people died from fire-related causes when their garage doors would not open due to a power outage.

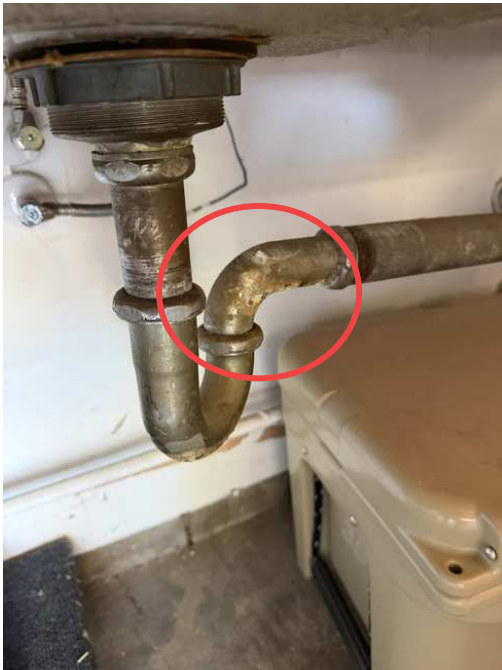
R47: Corrosion Under Sink

Plumbing component(s) below the sink exhibited signs of corrosion at P-trap assembly. We recommend the client consult with a qualified plumber for further evaluation and repair.

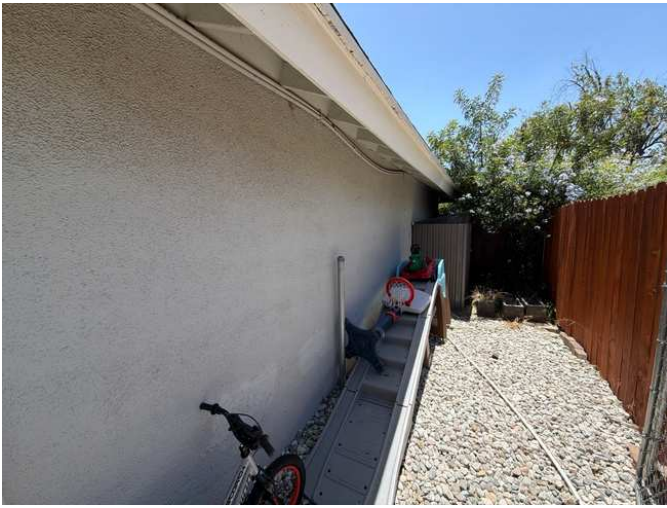
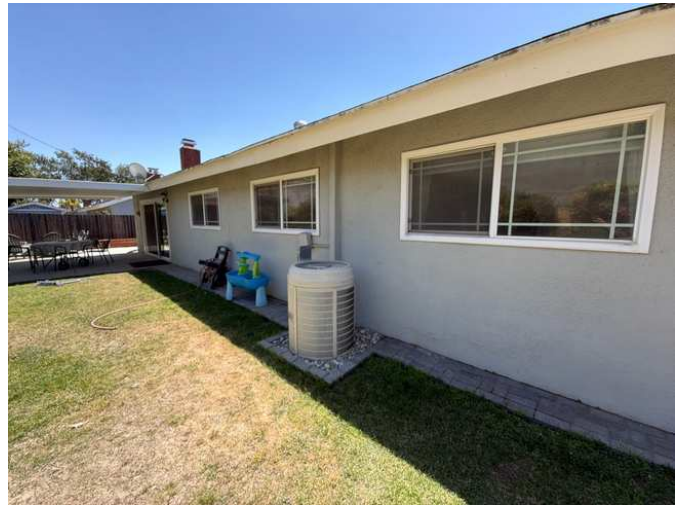
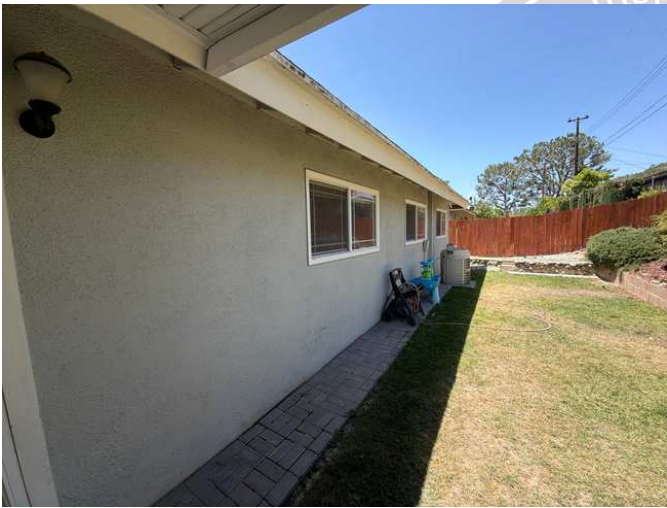
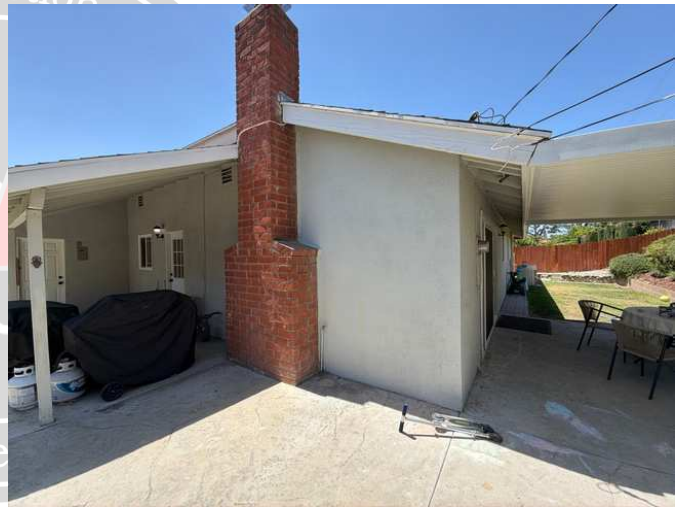
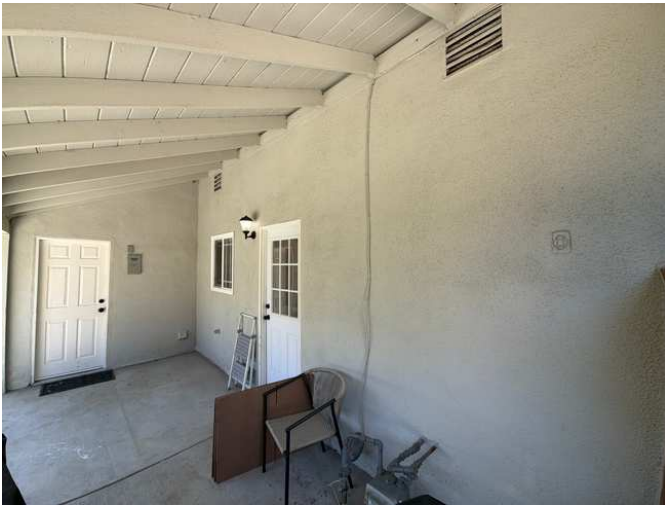
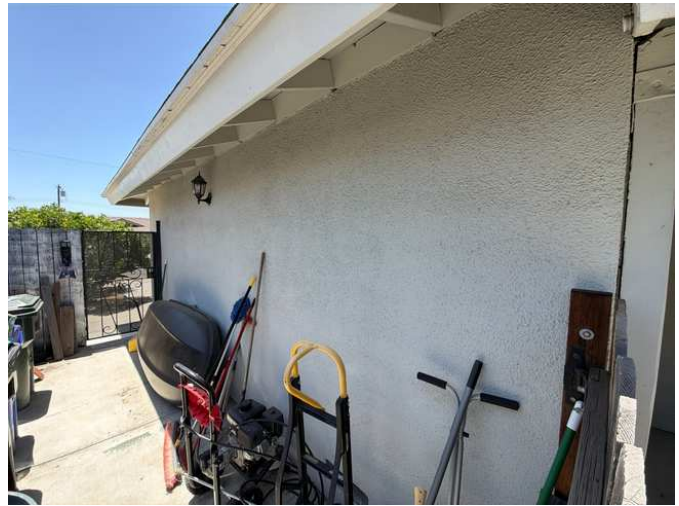
- ✓ **52:** The stucco was in satisfactory condition. Minor hairline cracks were noted. But are considered a normal part of the curing and settling.

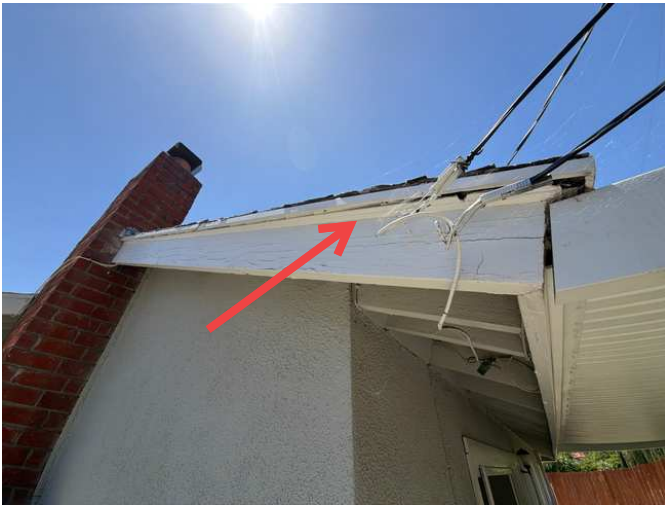
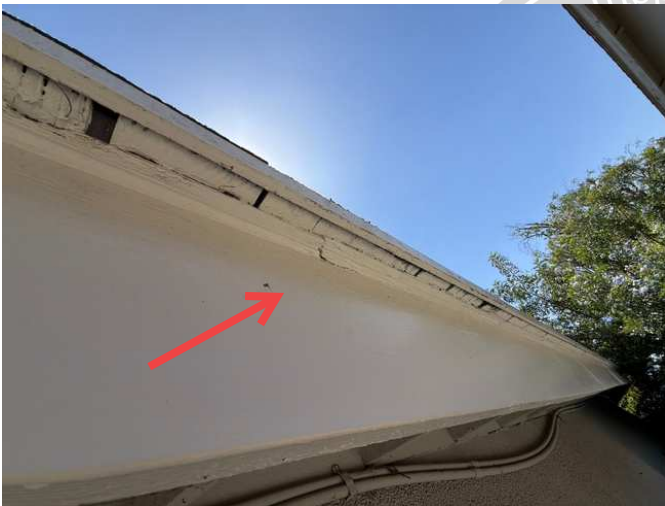
R53: Damaged Wood Trim Noted

Wood trim exhibited signs of WDO, peeling paint, fungi, splits. Consult with a qualified professional for further evaluation and repair.

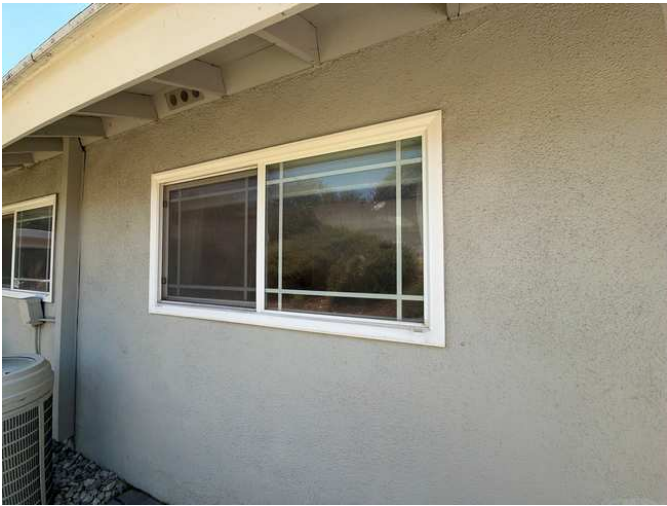
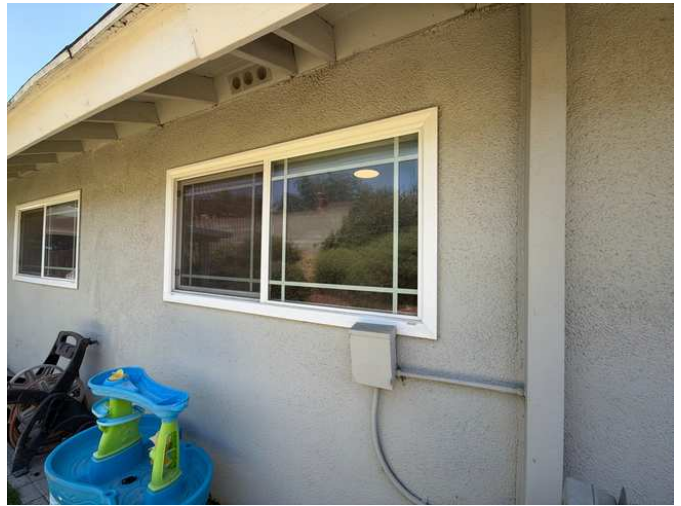
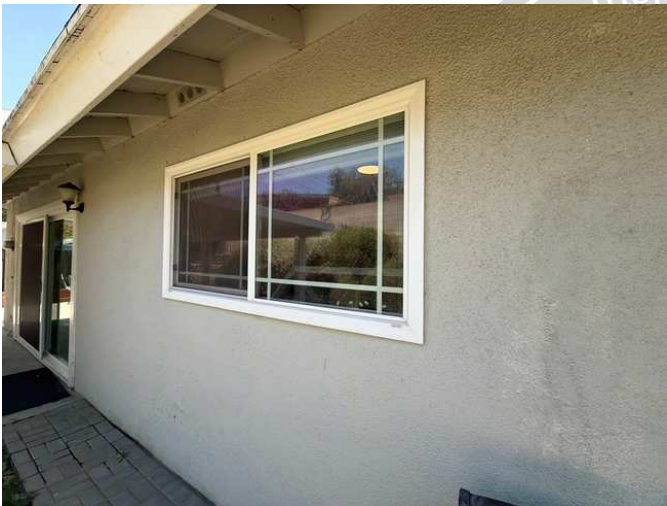
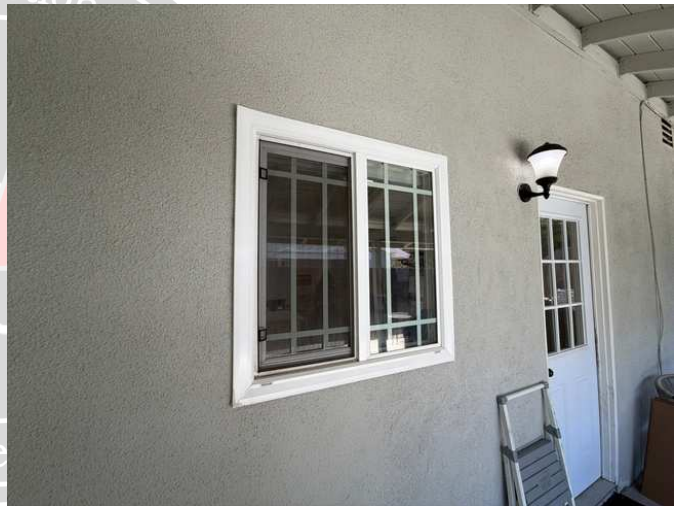
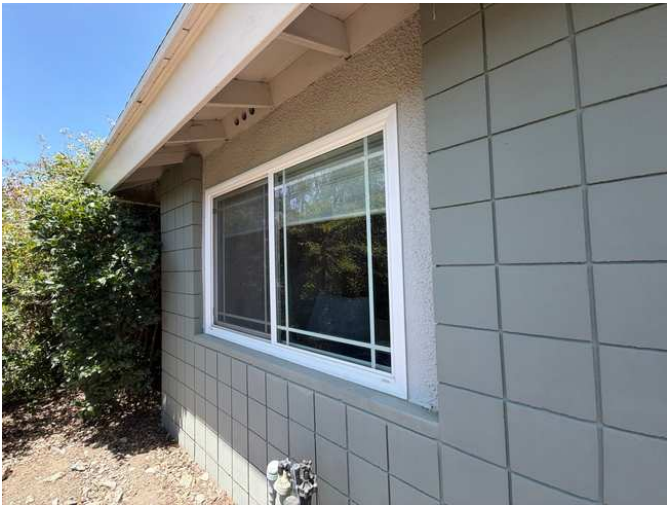
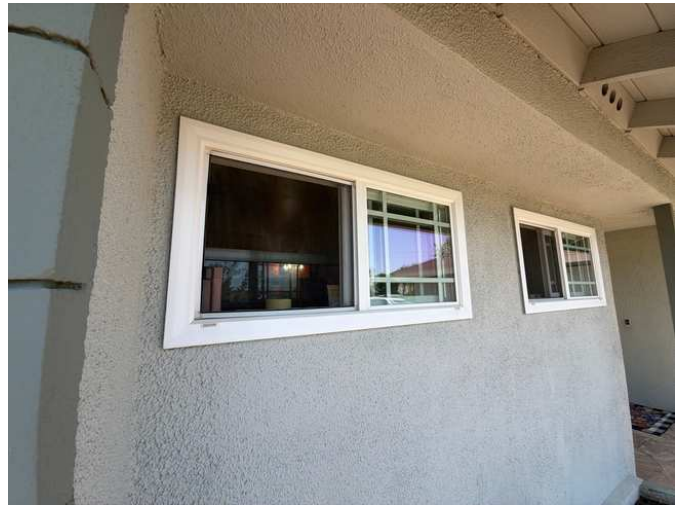
- ✓ **54:** Vinyl pane thermal windows were in satisfactory condition there were no cracked or broken window panes observed. Client should be aware that all vinyl windows are sealed using caulking and or other sealants that may break down overtime. Resealing vinyl windows is part of normal and regular home maintenance.

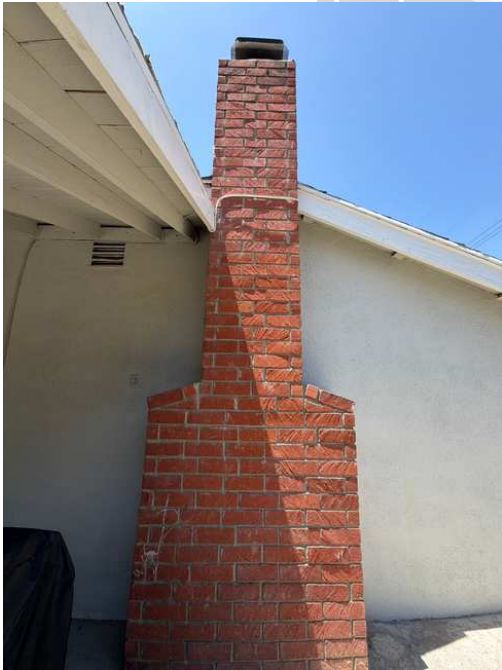
- **55:** Brick and mortar with a clay flue liner was utilized to construct the chimney.

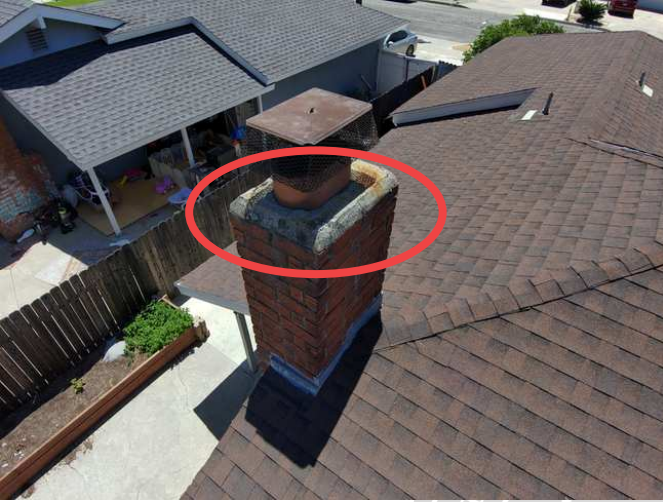
Evidence of weathering and cracks were noted at the chimney crown. Repairs are needed to help prevent water intrusion into the chimney cavity. Consult with a brickmason for evaluation and repairs. Chimney crown repair guide.

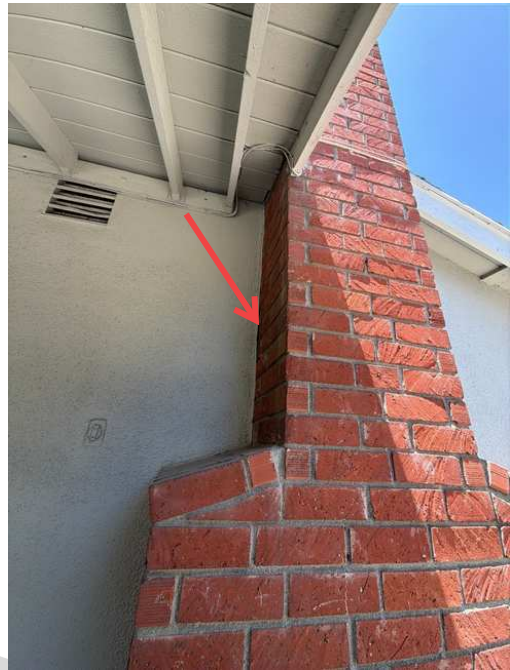
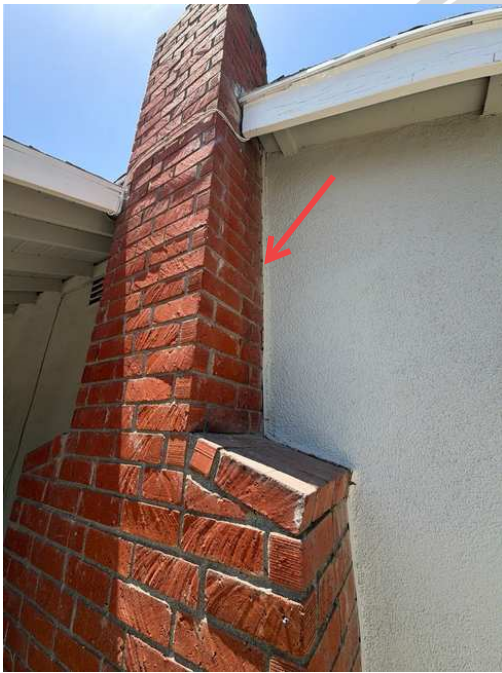
The chimney to wall flashing is showing signs of deferred maintenance. The sealant was dry and brittle. This can lead to water intrusion. Consult a general contractor for replacement.

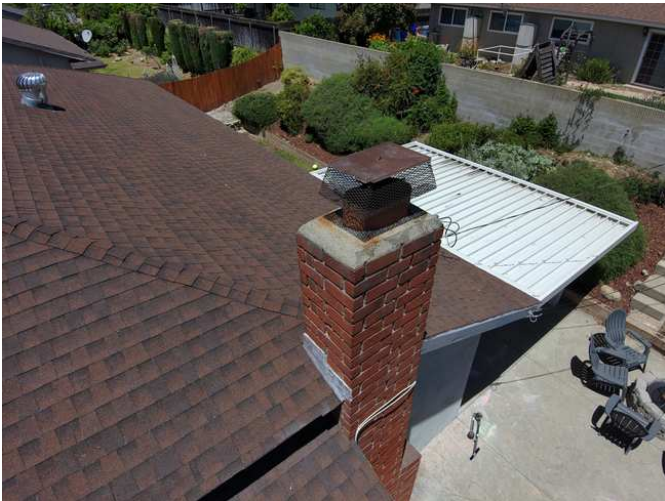
Storm Cap & Spark Arrestor

- ✓ **58:** Storm cap and spark arrestor were present.

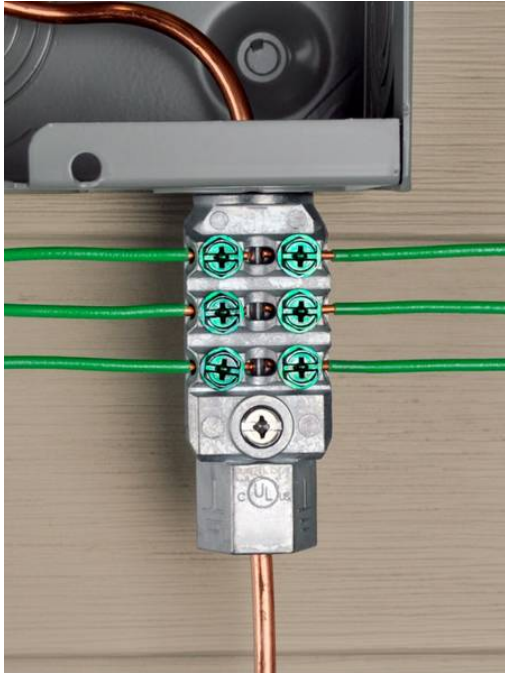
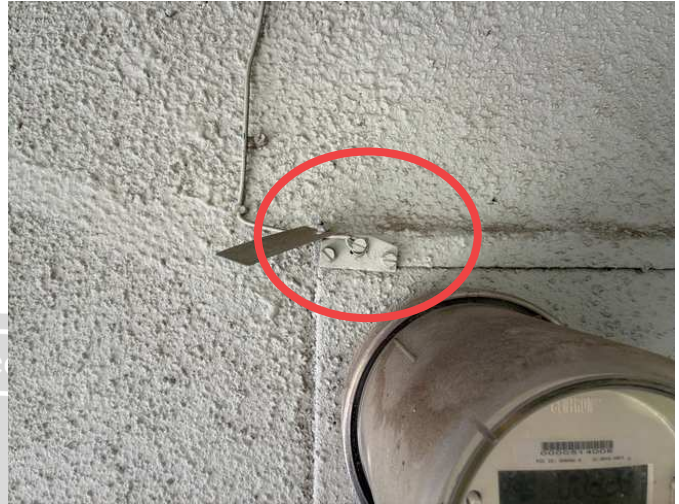
Missing intersystem bonding termination device. (IBT) Bonding of communication systems. A bonding termination device must be provided for communication systems in accordance with article 250.94 A and B of the national electrical code. It is suggested that a "Licensed Electrical Contractor" be contacted for further evaluation and installation.

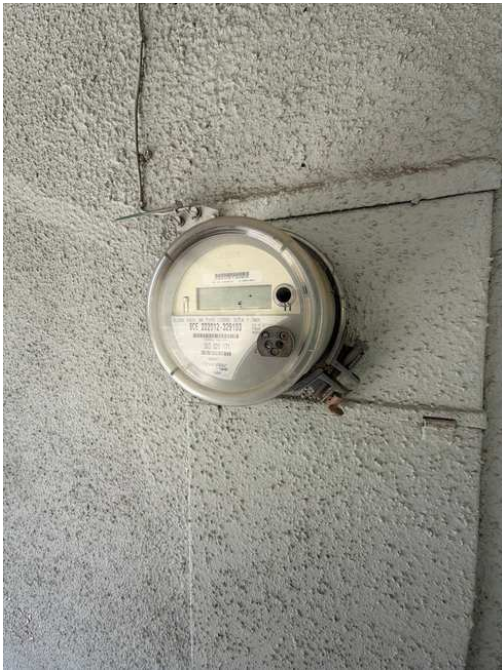
Electric Utility

- **60:** Electrical service was provided to the home by public utility.

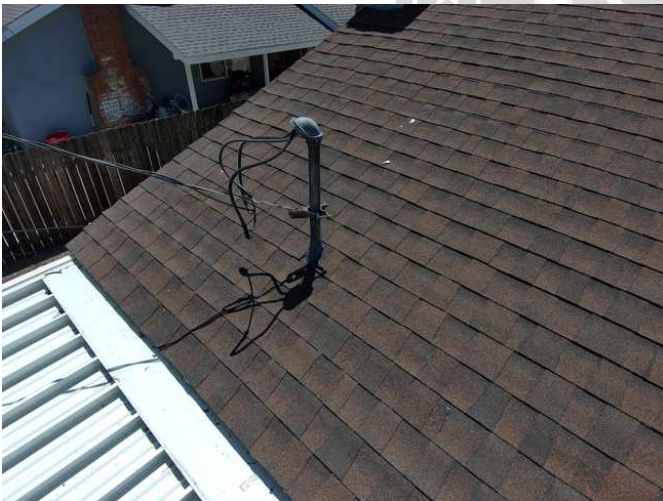
Electric Utility

✓ **61: Overhead Service**

Electrical service is provided to the home via overhead service conductors.

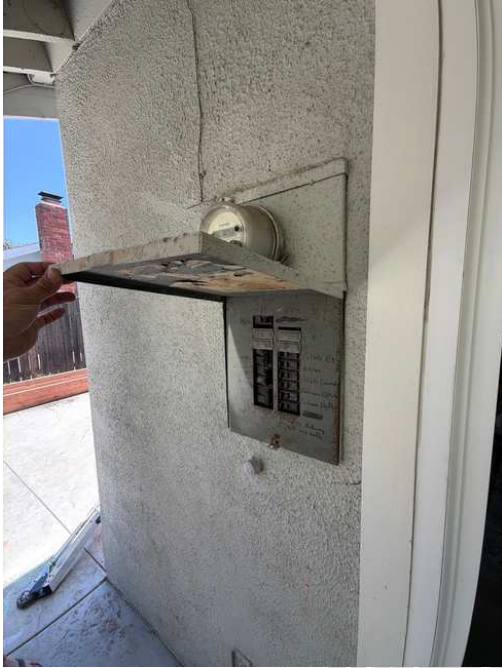
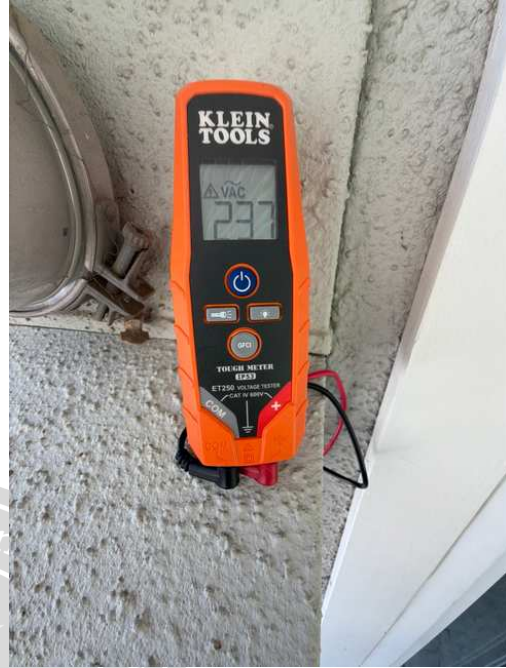
Manufacture

The main electrical panel is manufactured by General Electric and is rated for 125/250 Volts. The panel is in good condition. Voltage was tested and well within guidelines.

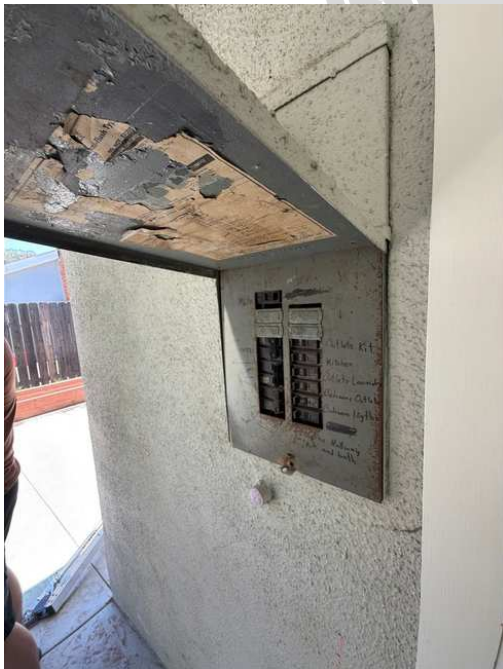
General Condition

The electrical panel is outdated and considered obsolete. It is for that reason we recommend electrical panel be upgraded to a 200 amp all in one meter and load center combo.

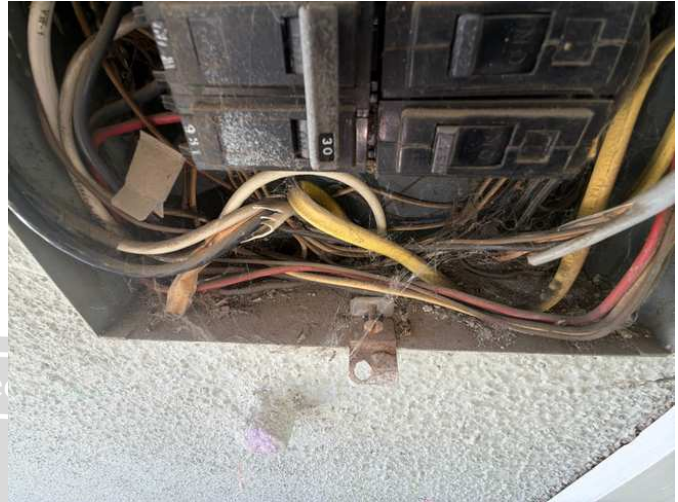
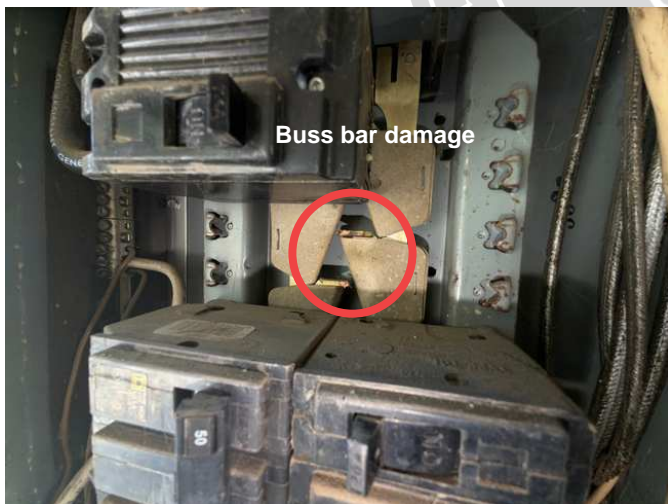
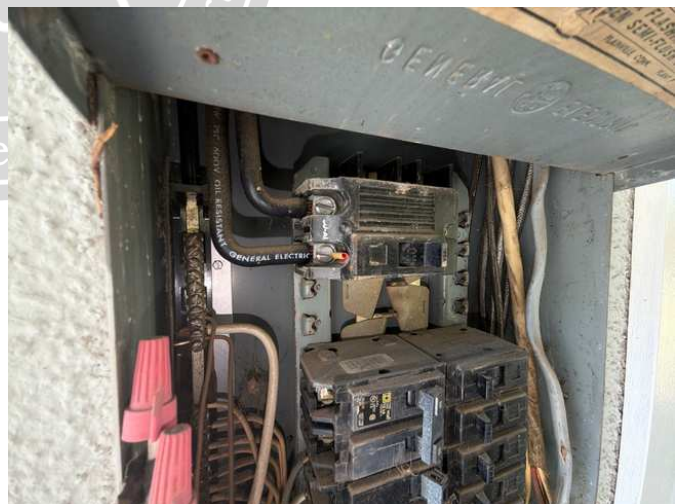
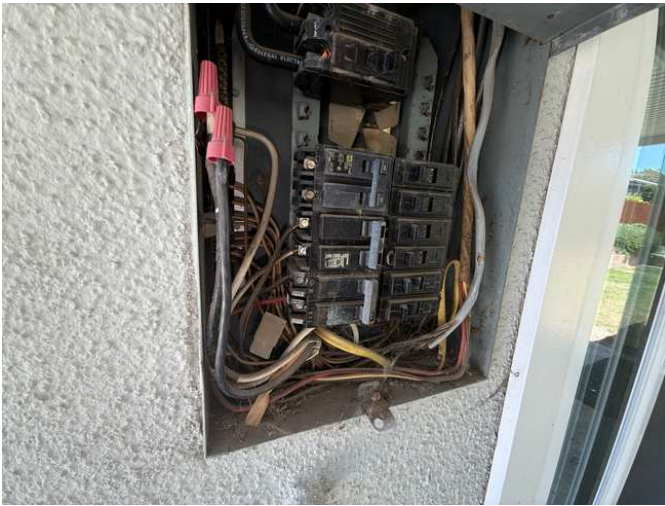
R65: Clean and Torque Service

Clean and torque service is recommended for the main electrical panel. Consult a licensed electrician for service. Signs of charring on the buss bars were observed.

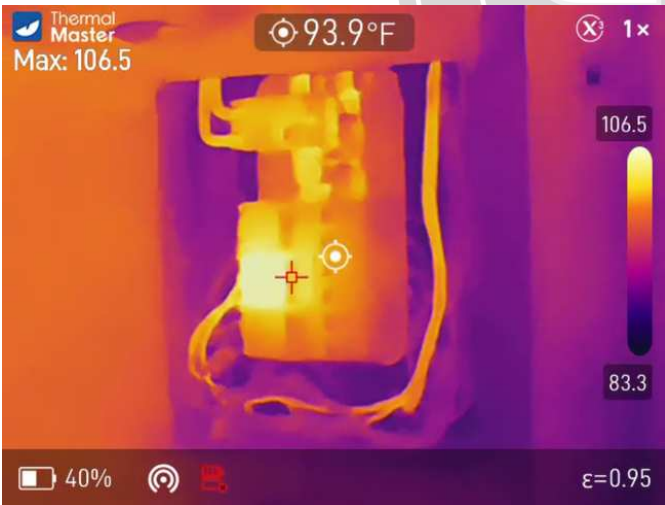
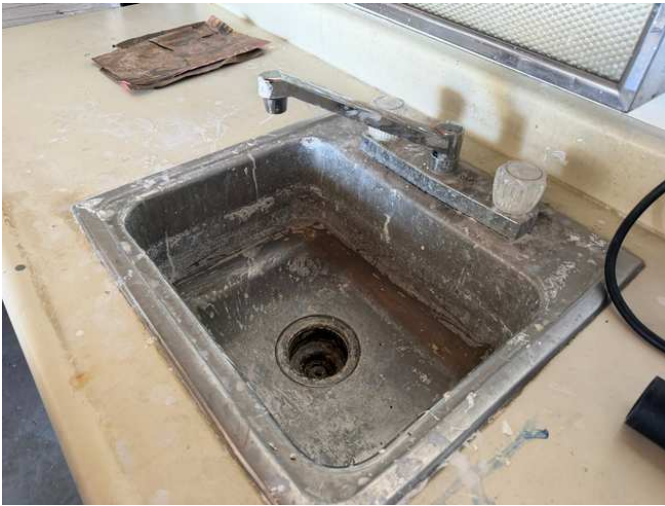
W67: Thermal Imaging

Thermal imaging was utilized to evaluate the panel components. Signs of overheating was observed. Consult with a qualified electrician for further evaluation and repair.

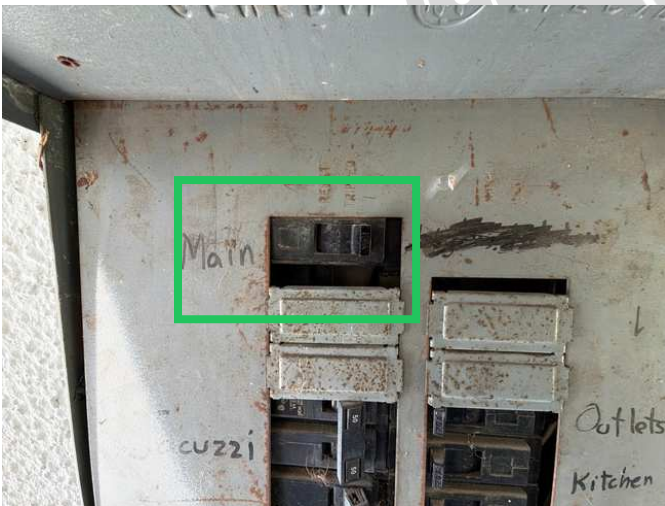
Amperage Rating

The main electrical panel is rated for 125/250 Volts 100Amps. The main service disconnect switch is located at the main electrical panel.

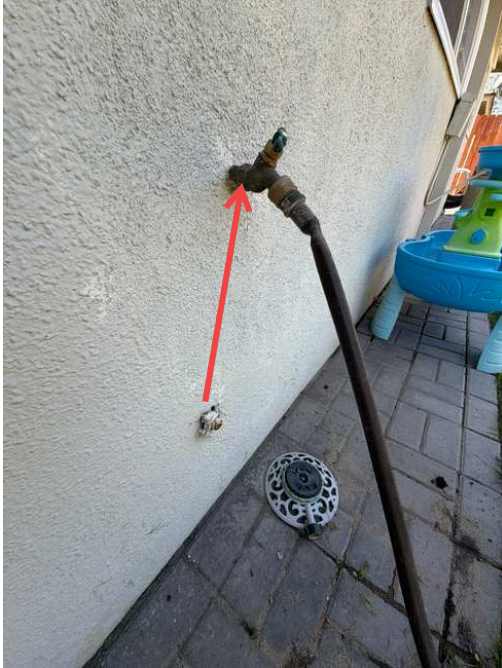
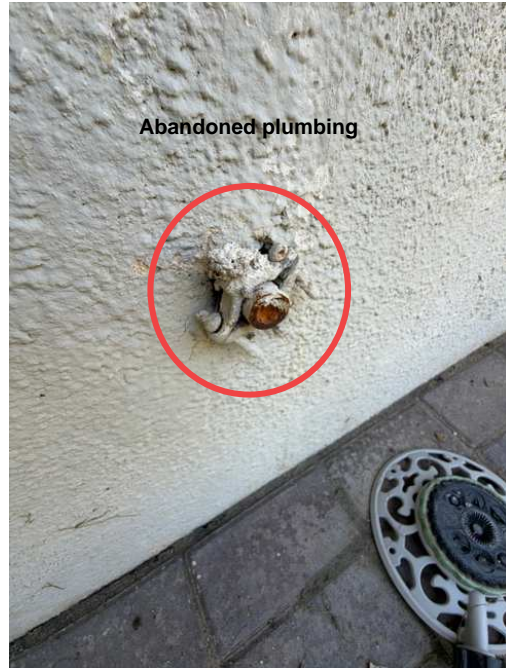
Wiring Methods

The cold water ground appears to be no longer properly connected to the home plumbing. It is suggested that a "Licensed Electrical Contractor" be contacted for further evaluation and repair.

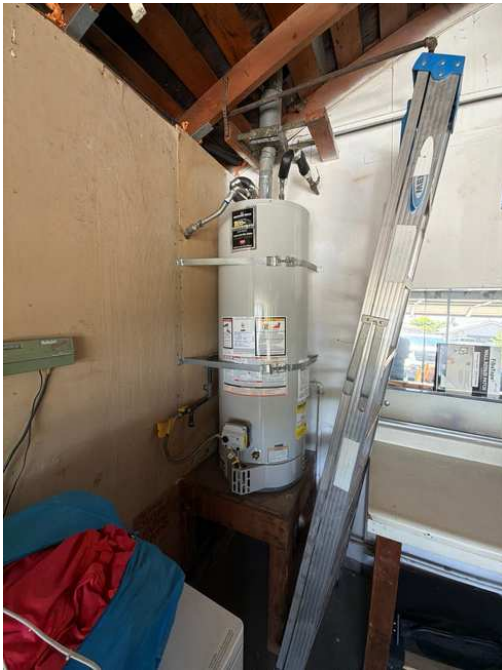
- **72:**
The hot water heater was located in the garage.

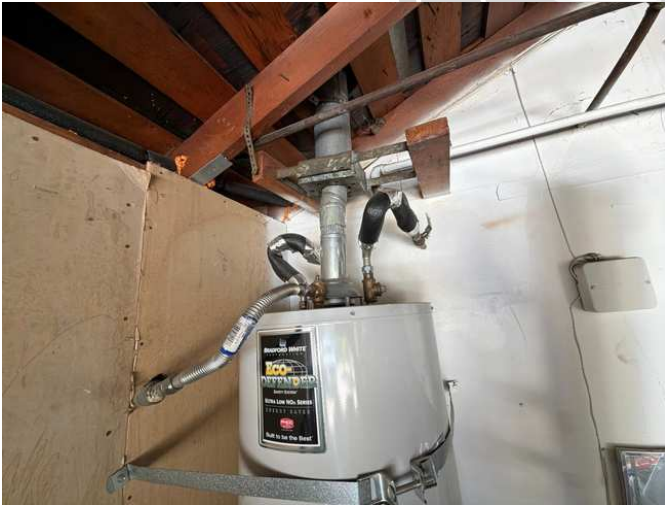
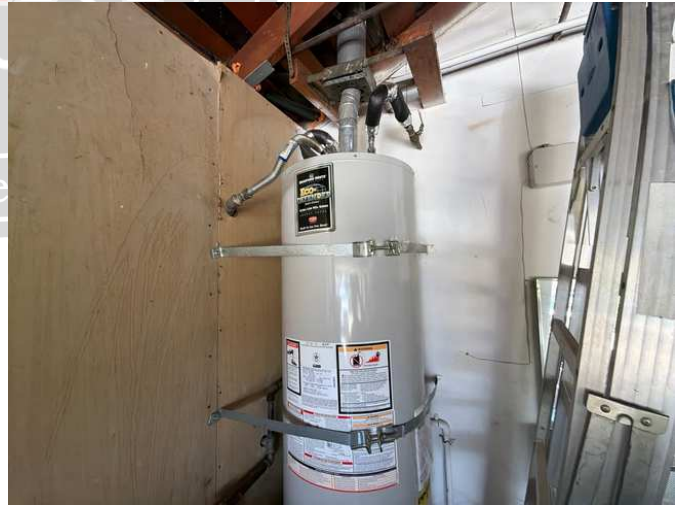
Type

- 73: Natural gas fired hot water storage tank.

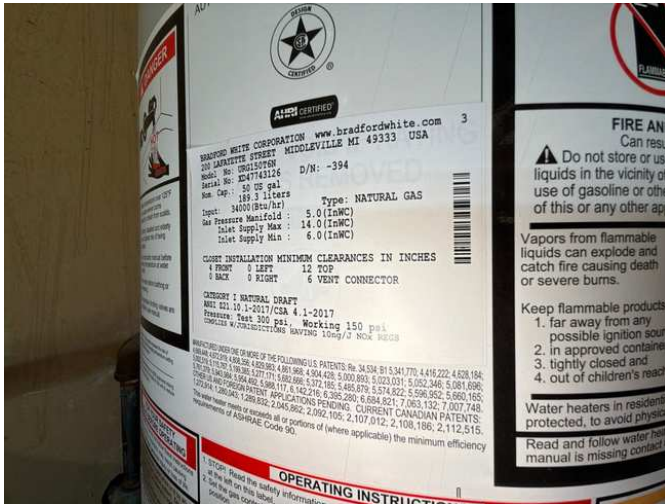
Capacity

✓ 75: Adequate Size

Based on national water heater charts the hot water heater for the home is adequate.

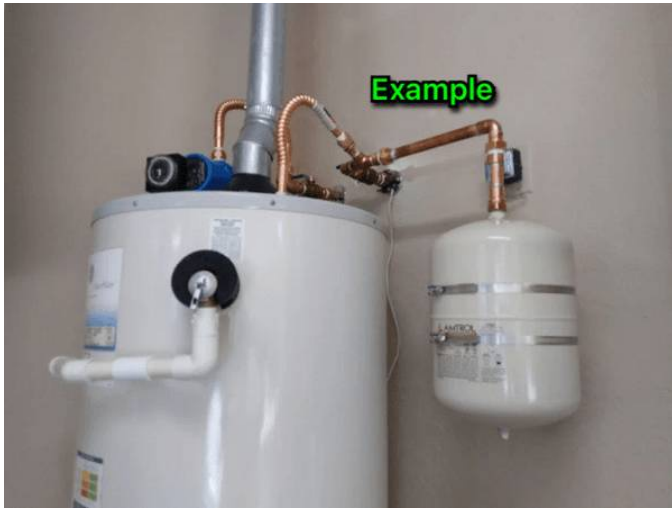
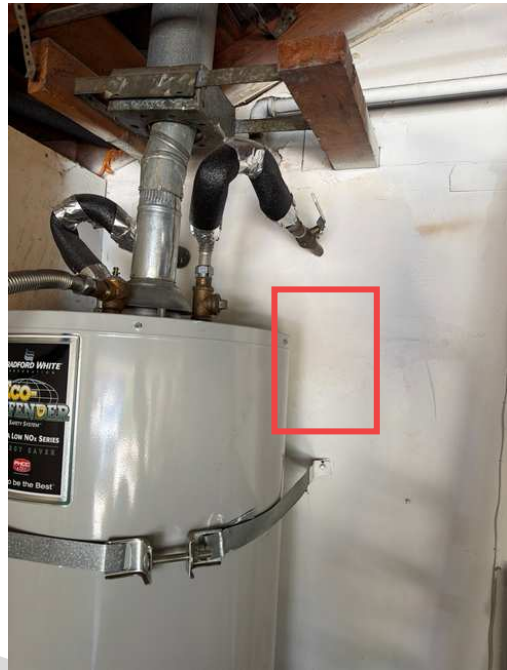
Expansion Tank

There was no expansion tank present. Expansion tanks help to balance water pressures that can cause damage to the plumbing system. Consult with a licensed plumbing contractor for cost of installation.

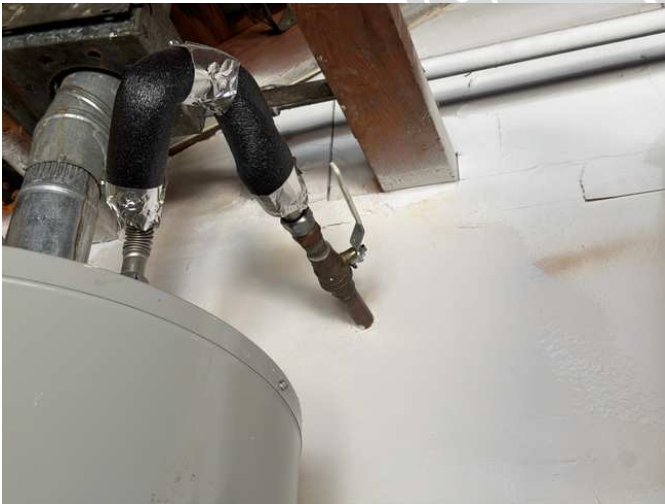
Shut Off Valve

The hot water heater shut off valve was in satisfactory condition. There were no signs of leaks rust or corrosion.

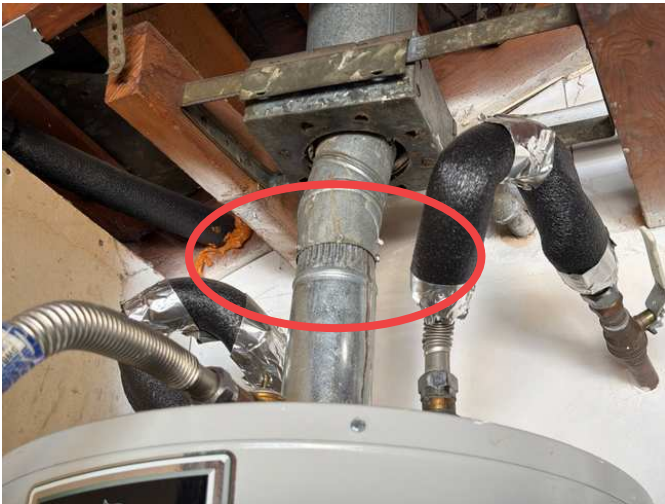
Vent Pipe

The fluted portion of the vent pipe should not be exposed more than a quarter of an inch according to local plumbing codes. The pipe is too short. A longer piece is needed. This will help prevent carbon monoxide leaks.

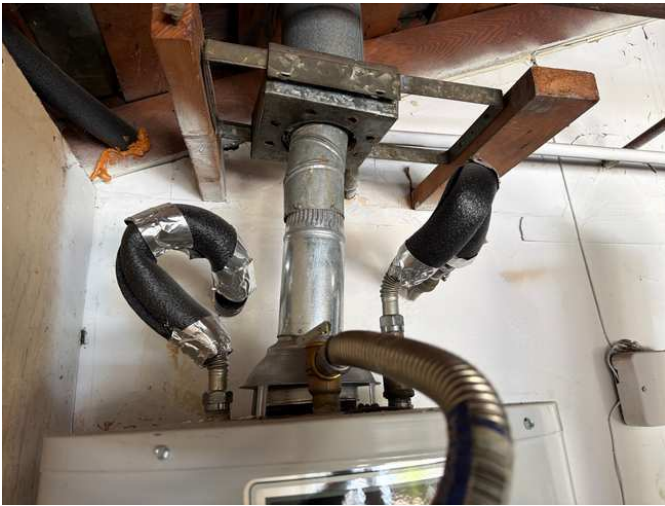
Supply Lines

The hot water heater supply lines were in satisfactory condition. There were no signs of leaks rust or corrosion.

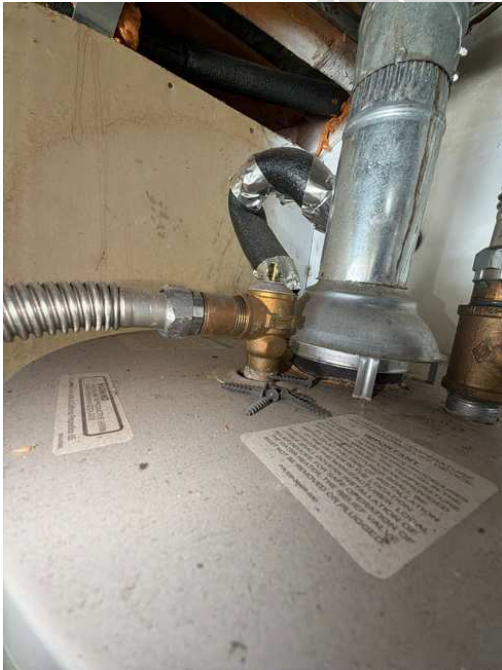
TPR Valve

The TPR valve was in satisfactory condition. There were no signs of leaks, rust or corrosion.

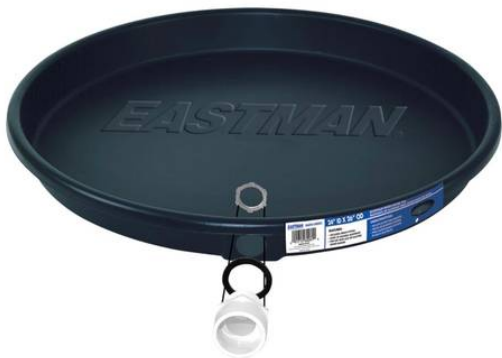
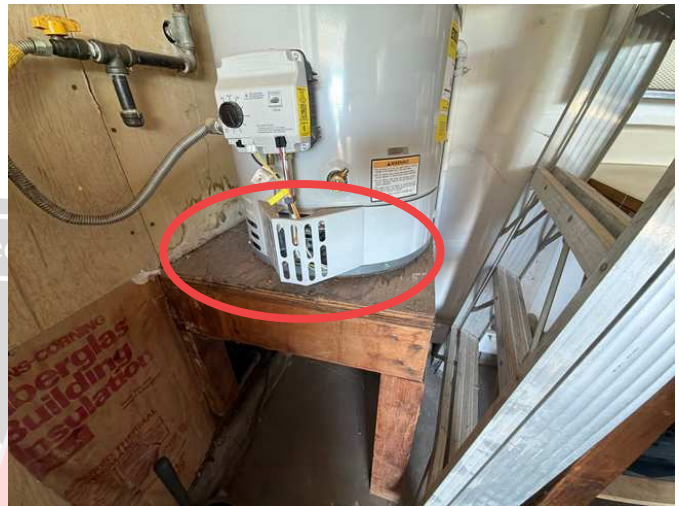
Drip Pan

Drip pans are recommended below all hot water heaters. This will help contain leaks and prevent water damage.

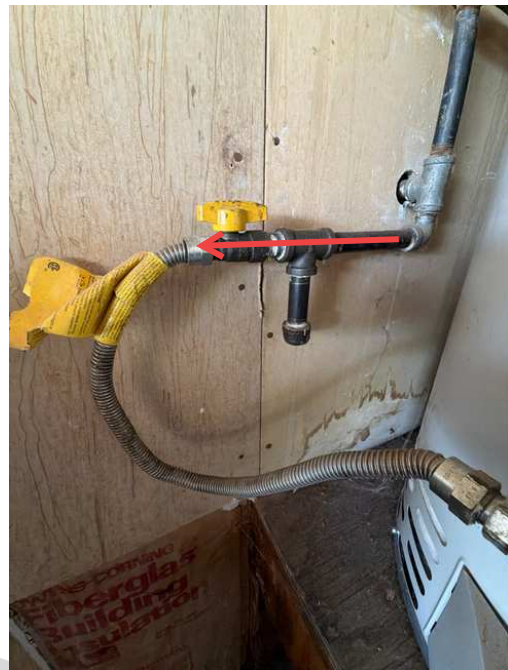
Gas Line

The sediment light was not installed in the right orientation. We recommend that a sediment leg be installed. This will help prevent sediment from clogging the gas valve or orifices.

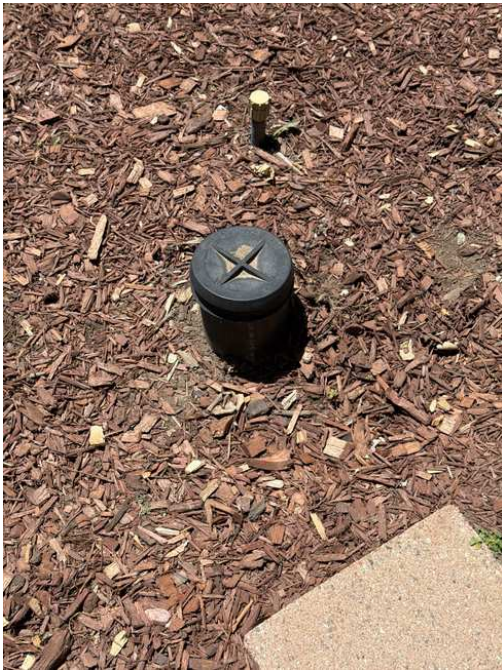
Sewer Connection

- **I85:**
Sewer is provided to the home via public utility.

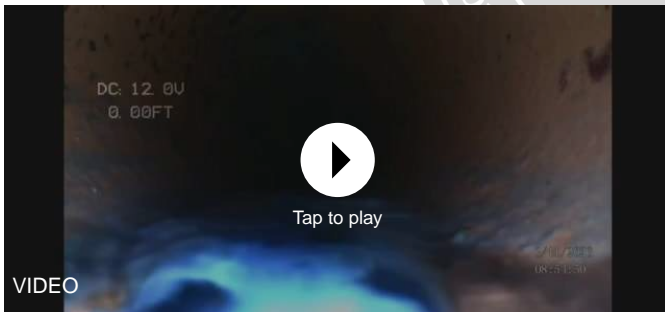
The sewer lateral was inspected using a high definition sewer line Camera. **The sewer line was accessed from the primary clean-out. The Sewer had significant root intrusion and significant signs of rust and corrosion. The sewer line is in need of upgrades.**

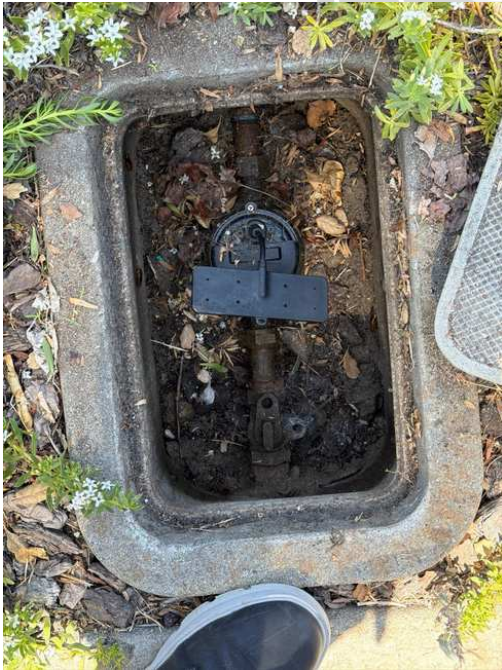
- **I90:** Public water service has been provided to the home via public utility.

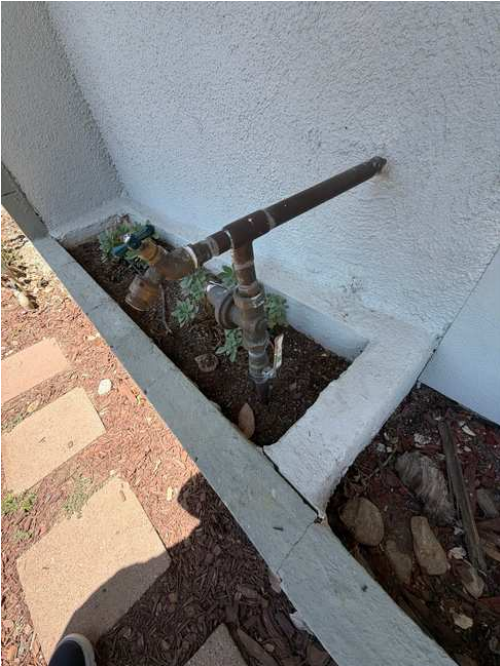
- **91:**
Copper was observed exiting the wall. Materials used underground are unknown.

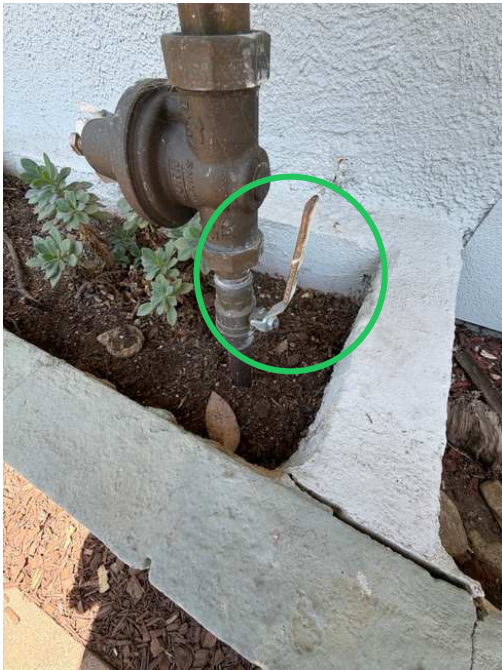
- ✓ **92:**
The main shutoff valve is located at the front of the home. The main water shutoff valve was in satisfactory condition.
