HOME INSPECTION REPORT

**Howard St
Upland, CA 91786**

Monday, May 18, 2026

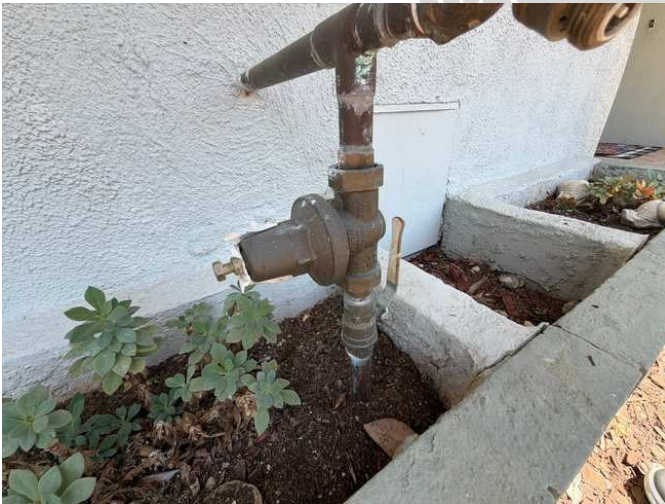
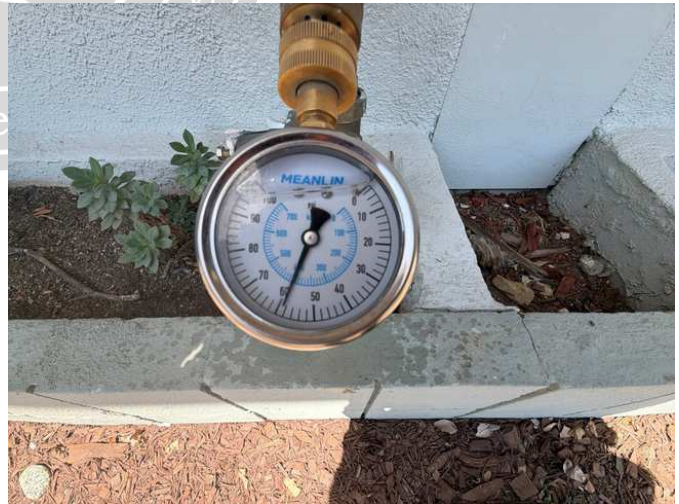
✓ 93:

The water pressure regulator (PRV) was tested and found to be in satisfactory condition.

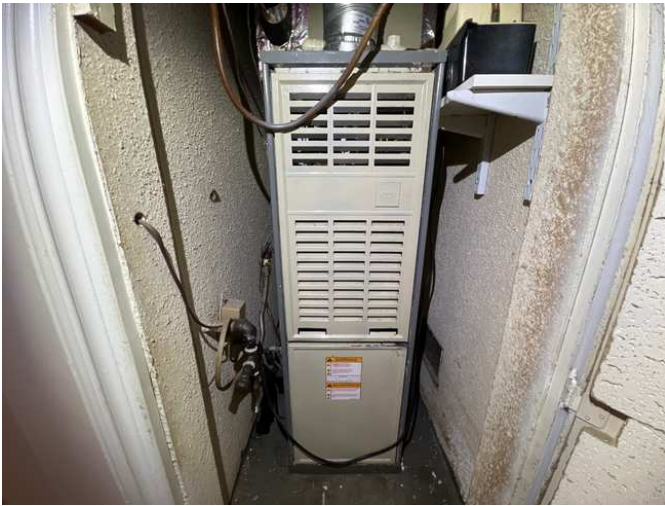
W101: Outdated

The furnace system is outdated and is considered to be inefficient. Client should consider the cost of upgrades. Consult with a licensed HVAC contractor for cost of upgrades prior to the close of escrow.

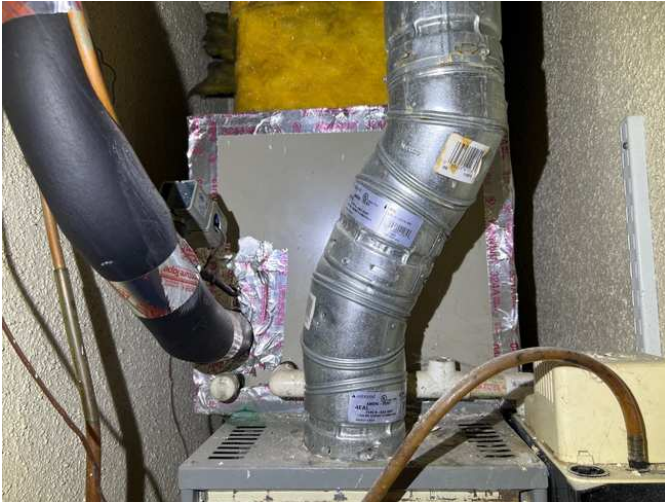
✓ **103:**

Heater vent was in satisfactory condition and directly vented through the roof.

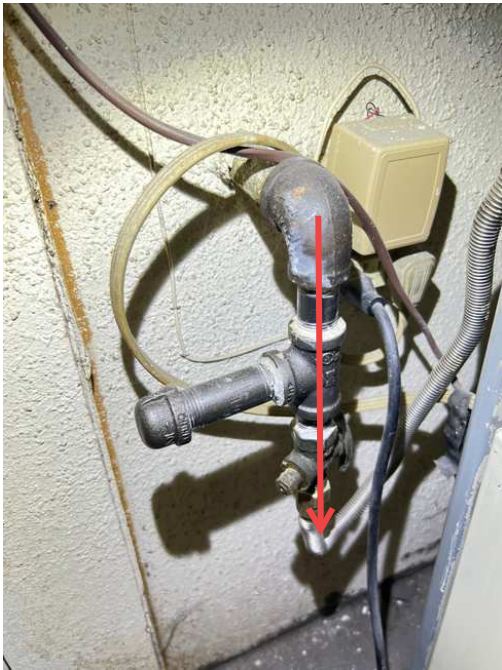
Sediment trap at the gas line was improperly installed at the time of inspection. Recommend further evaluation and correction by a qualified plumbing contractor.

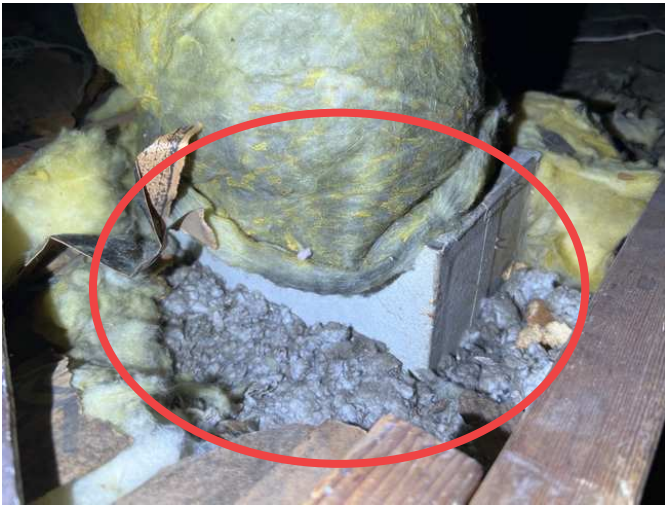
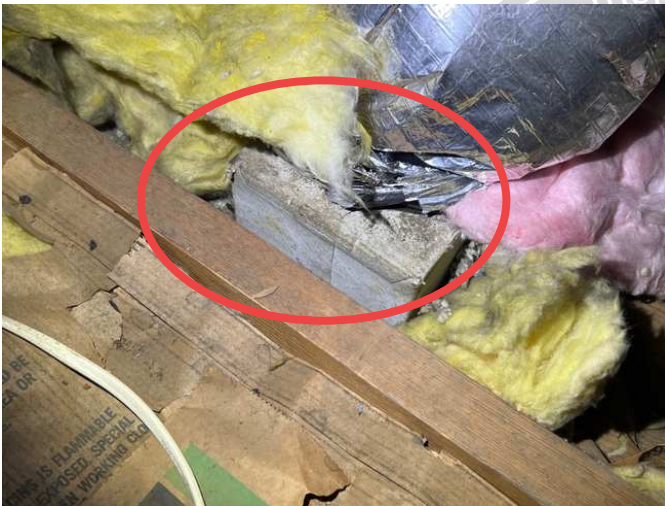
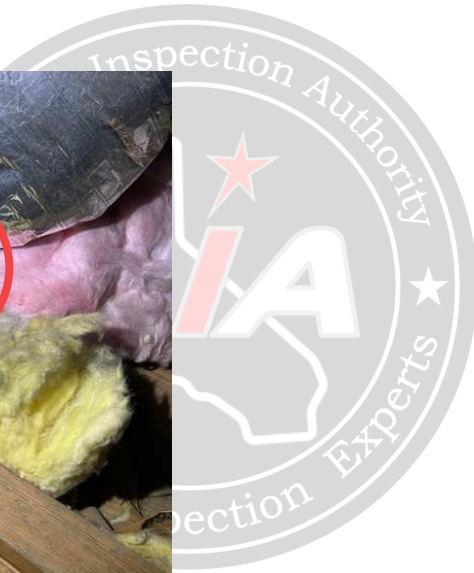
Asbestos like materials were noted at register heads. These materials were commonly used during the time of construction. It is highly recommended that the air distribution lines be tested for asbestos content prior to the close of escrow. Client should consider the cost of upgrades. Consult with a licensed HVAC contractor for full evaluation and cost of encapsulation or other resolution.

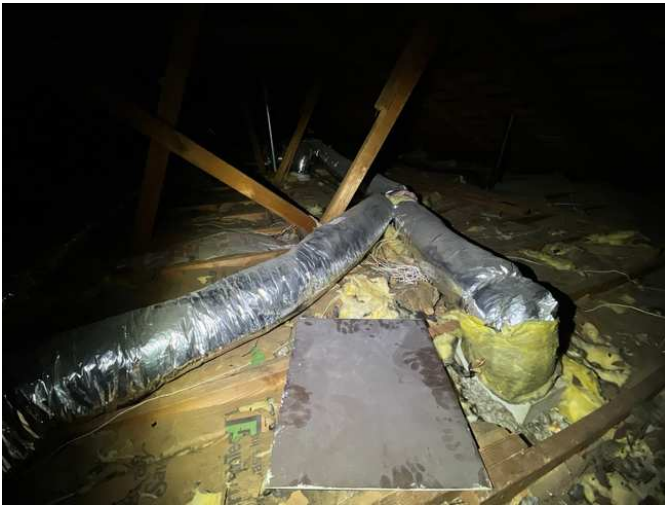
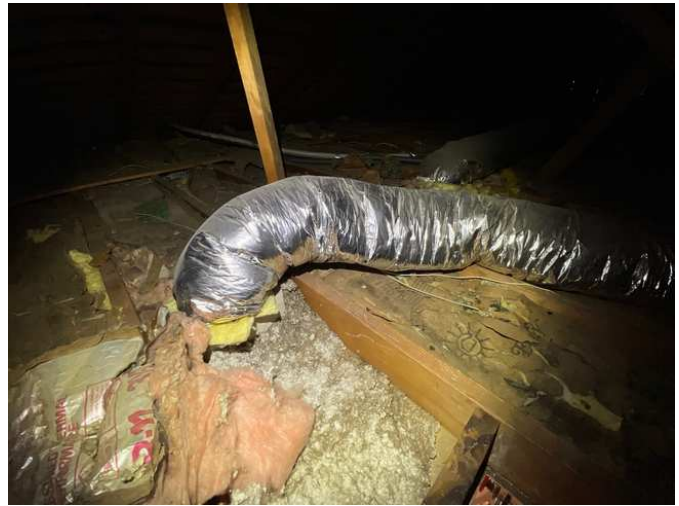
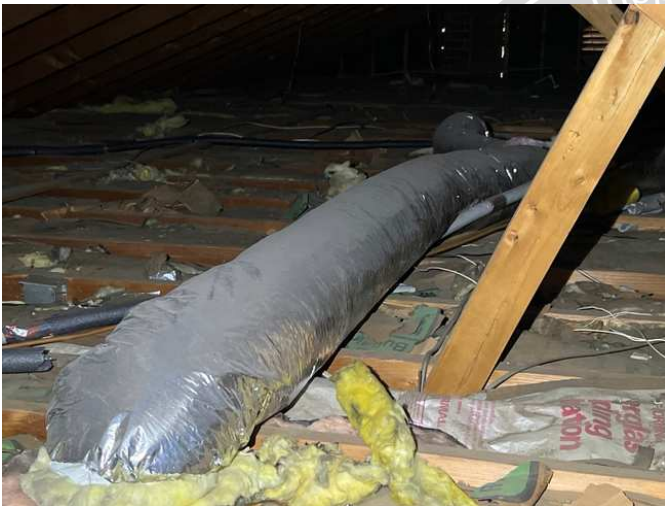
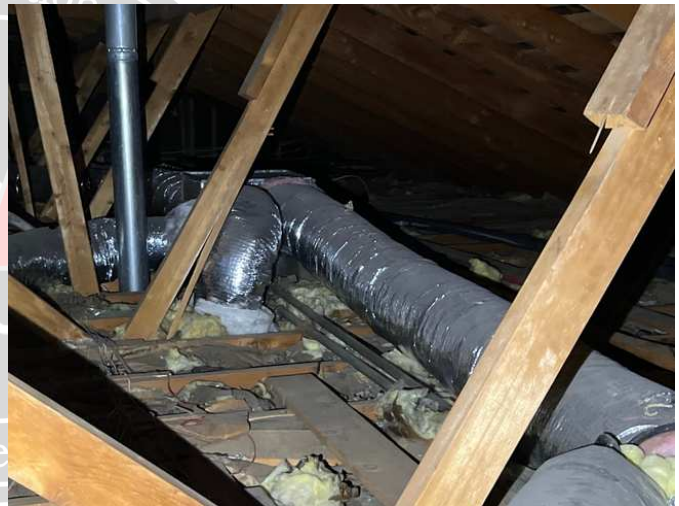
106:

Flexible insulated duct work was utilized. The duct work was in satisfactory condition where visible.

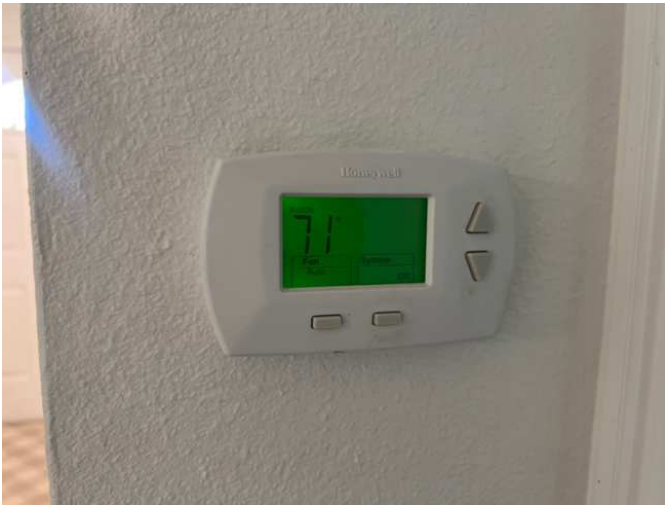
✓ **107:**

The thermostat was located in the hallway. The thermostat appears to be properly installed and the unit responded to the basic controls. This is a programmable device with many options for setback settings, timed events, etc. No attempt was made to test all functions of the thermostat. To do so would be time consuming and outside of the scope of a general home inspection.

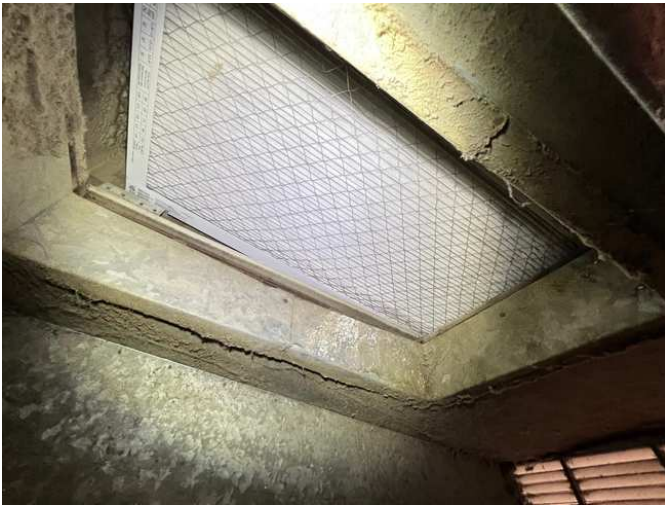
✓ **108: Filter Satisfactory**

The filter is in satisfactory condition. Filter should be replaced every 3 to 6 months as part of regular home maintenance.

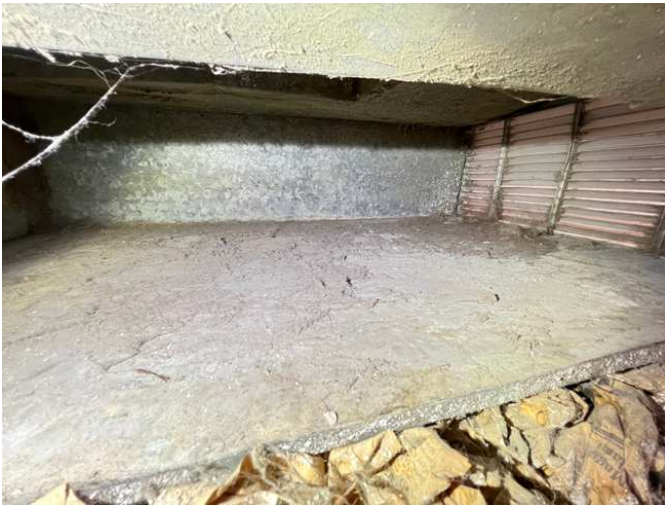
M109: Dirt And Debris

Dirt and debris is present in the lower plenum and/or return air cavity. Recommend this area be serviced prior to the closing of escrow.

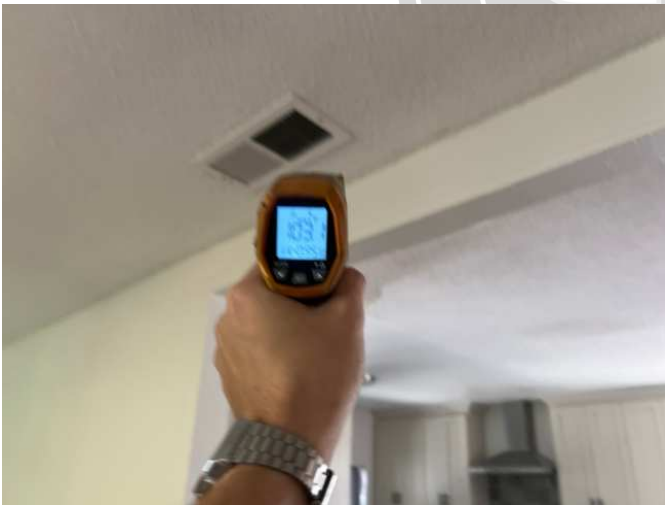
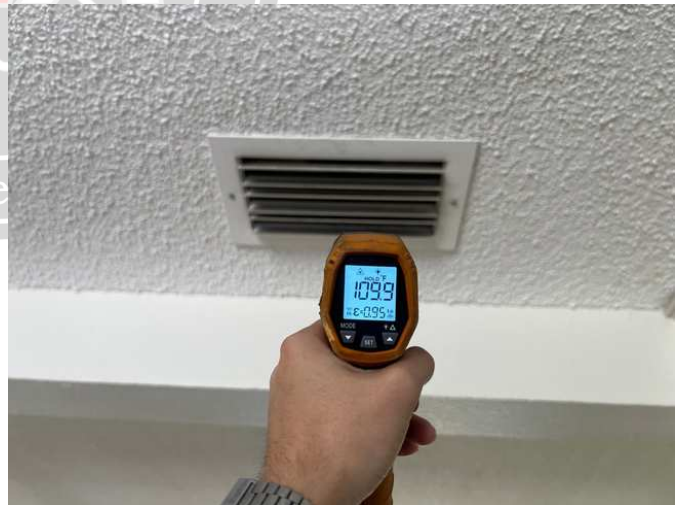
✓ **110:**

Output temperatures of the heating system were satisfactory on the day of inspection.

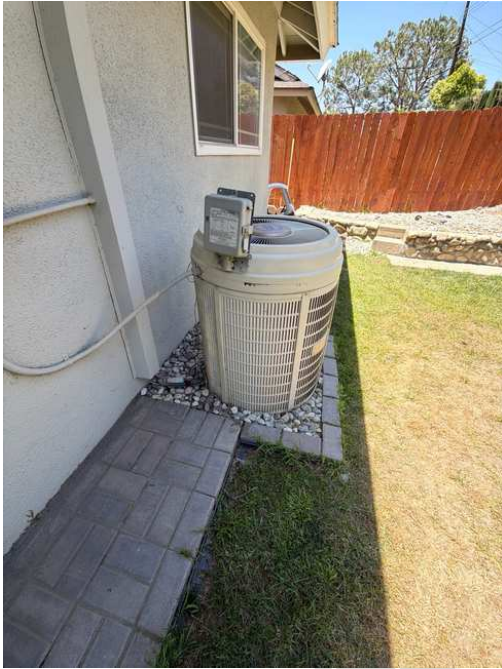
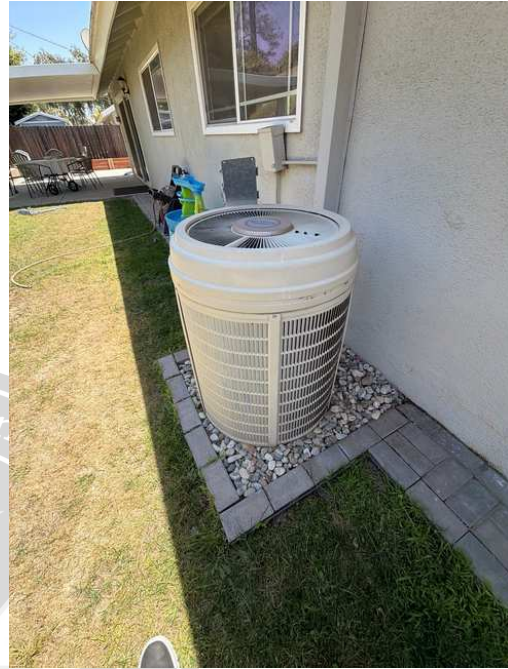
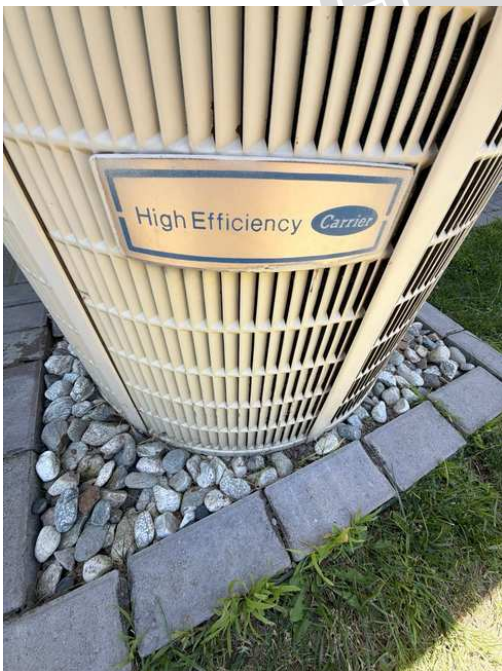
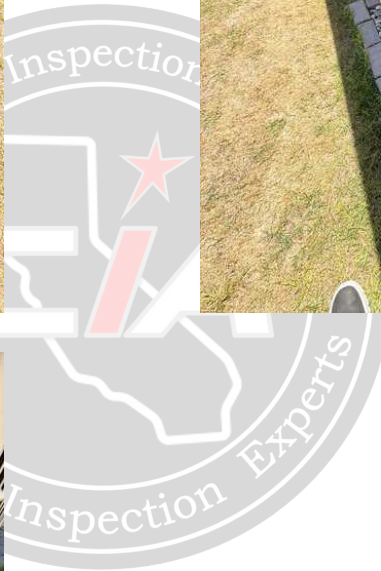
W112:

Air-conditioning system is at the end of its life expectancy. The life expectancy of an AC condenser is 15 to 20 years for well-maintained units. Client should consult with a licensed HVAC contractor for cost of upgrades.

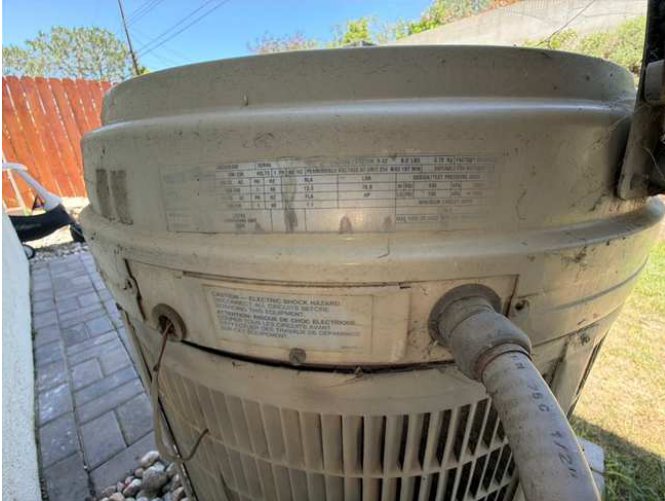
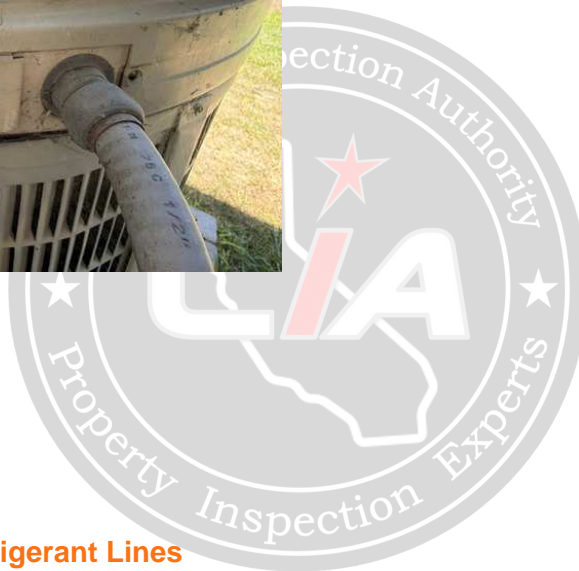
W113:

The EPA has mandated that all refrigerant manufactures cease in the distribution of R-22 refrigerant. This refrigerant has been connected with O-Zone deterioration and will no longer be manufactured. While stockpiles of R-22 refrigerant may still be available for a few years following its discontinuation. It should be noted that repairing and servicing R-22 equipment will skyrocket. And may become cost prohibitive making said equipment obsolete. If the inspector has marked your equipment as a potential unit for R-22 refrigerant. It is vital that you speak with an HVAC contractor prior to the close of escrow to determine if your equipment is suitable for upgrade or replacement. Any air conditioner manufactured up until 2015 may have been charged or supplied with R-22 refrigerant. Below is a list of the most recent replacements for R22 refrigerant. R-32 R452B R454A R-454B R454C R457A

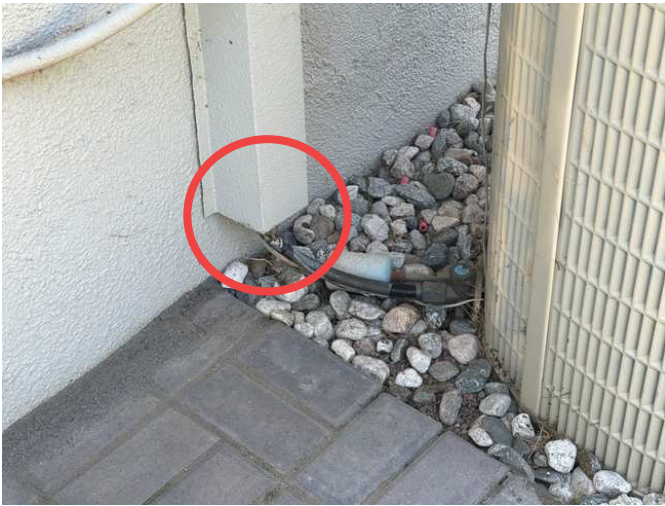
Refrigerant/suction lines should be properly sealed where the lines enter the structure. This will help prevent unwanted rodent entry points.

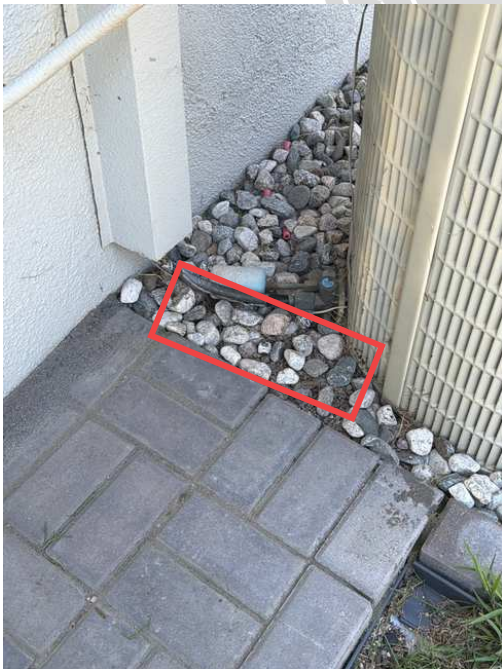
R116: Insulation

The refrigerant line insulation was damaged and or missing. Improvements are needed. Consult with a licensed HVAC contractor for resolution.

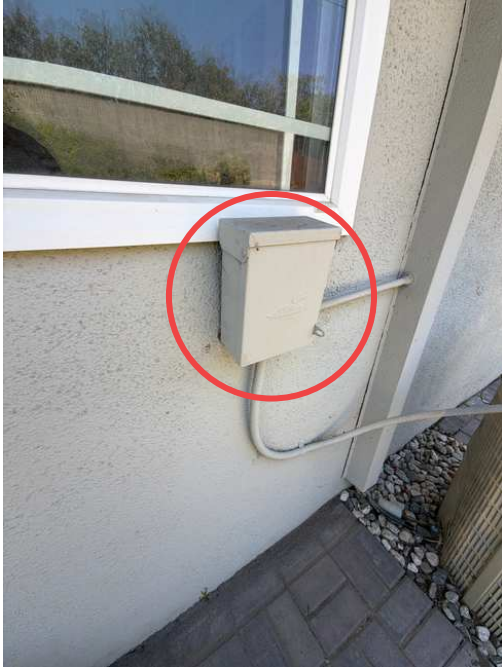
R117: Loose

Disconnect was loosely mounted to the wall. Improvements needed.

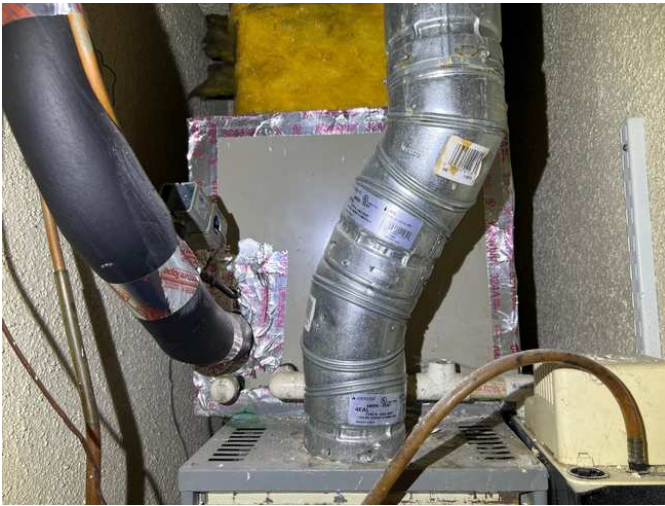
118: Evaporator Satisfactory

The evaporator was in satisfactory condition. There were no apparent signs of leaks on the day of inspection.

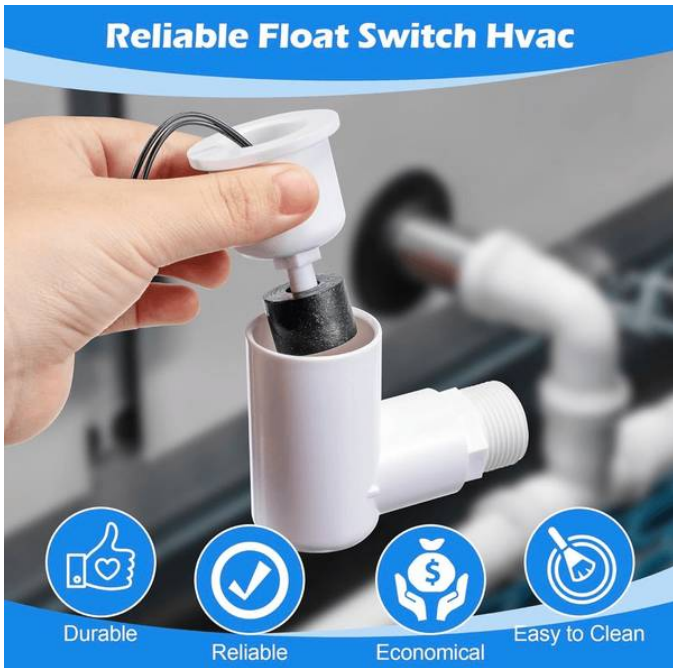
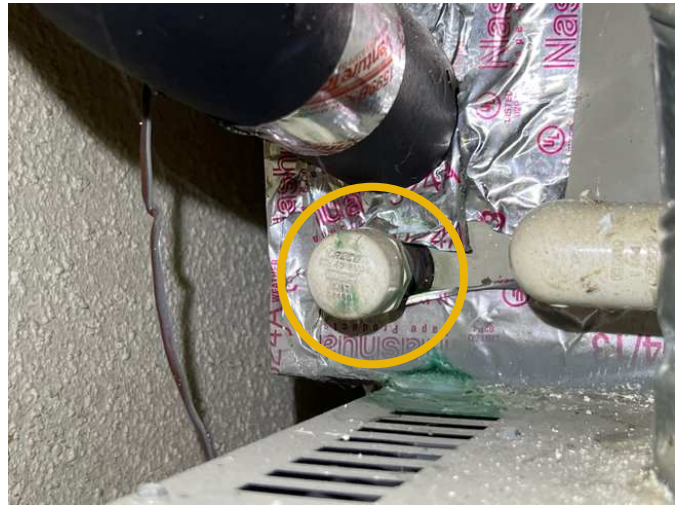
No condensation cut off switch present. Condensation cut off switches are a modern safety device to help prevent water damage in the event of a clog in the condensation lines. Client is encouraged to speak with a licensed HVAC contractor for installation.

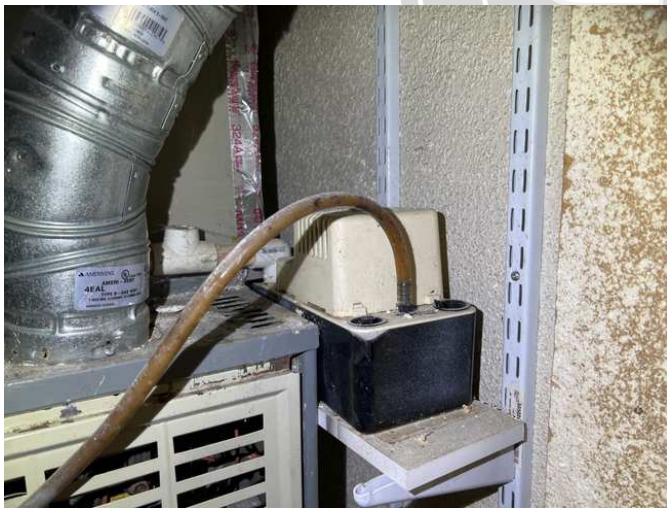
✓ **120: Ejection Pump**

An ejection pump has been installed to help mitigate condensation water. These pumps have been known to fail. Sometimes these failures can cause water damage within the home. Buyer beware.

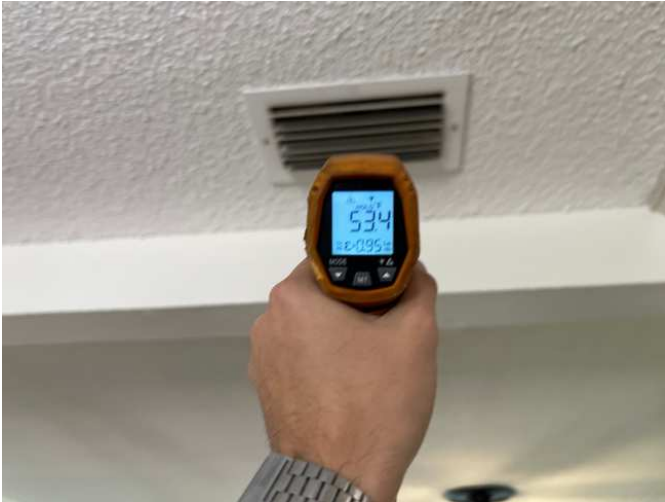
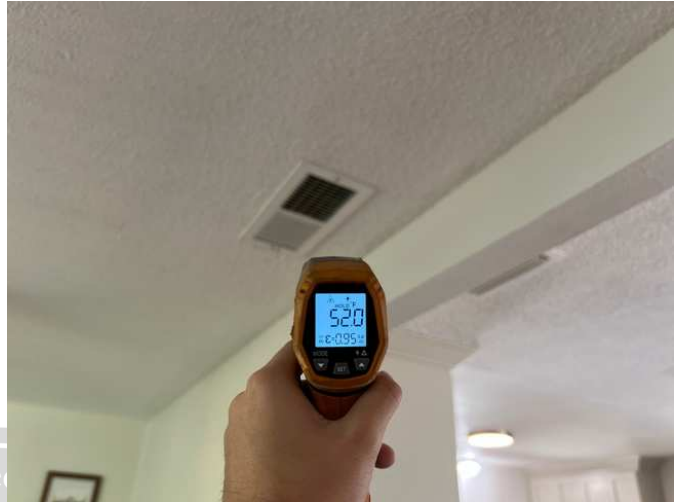
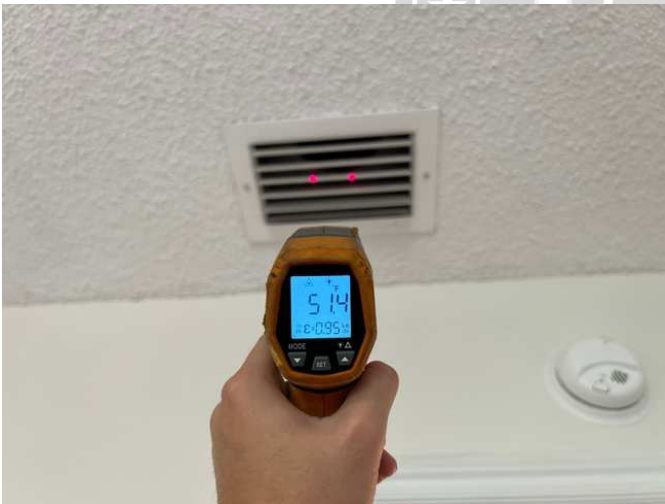
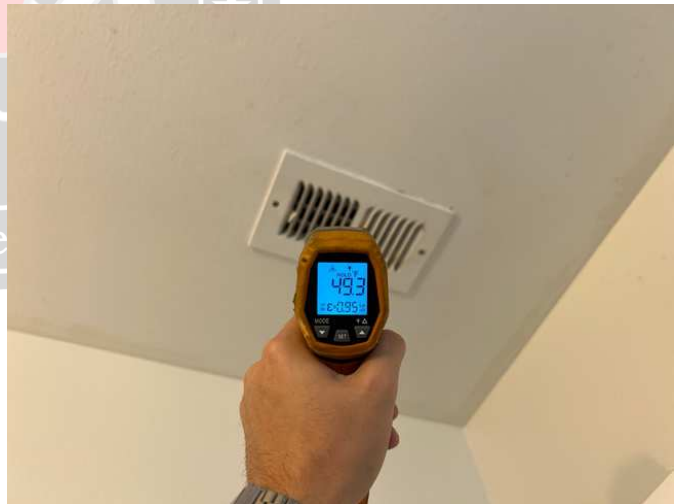
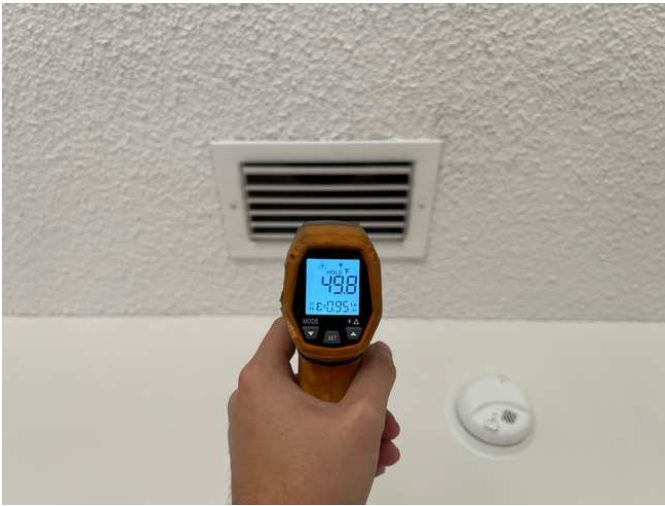
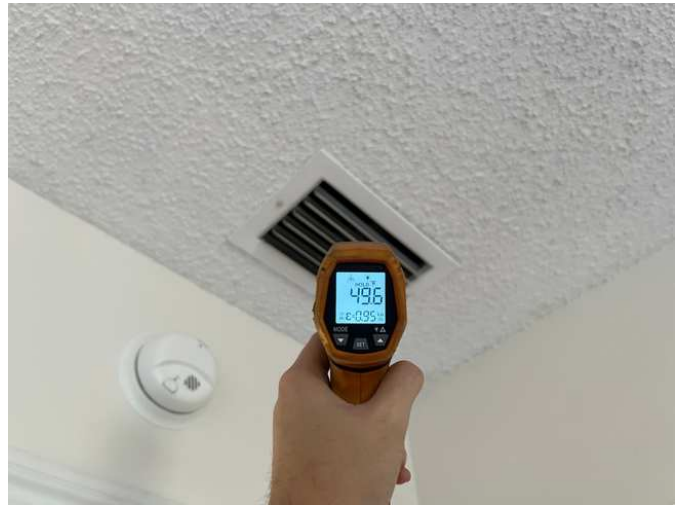
✓ **121:**

Output temperatures as tested on the day of inspection were satisfactory.

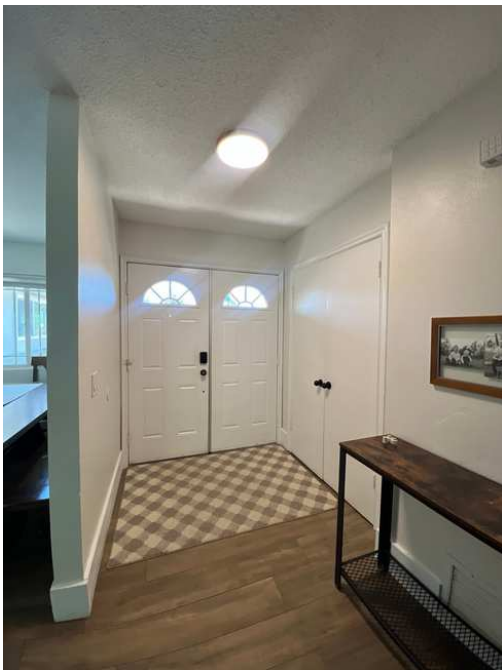
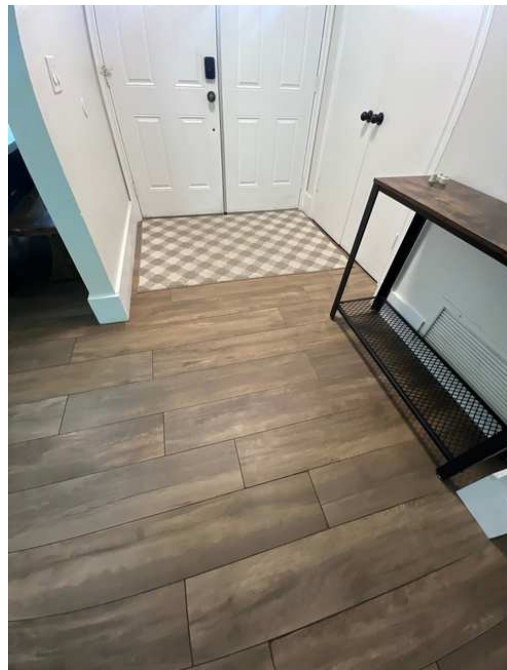
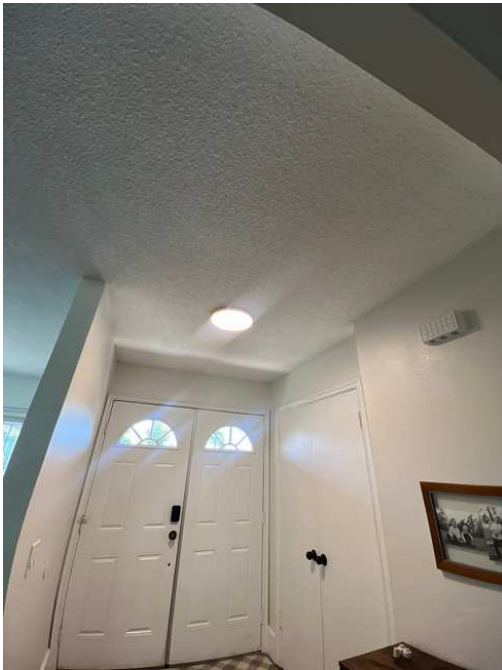
- ✓ **122:**
Foyer and hallway condition were satisfactory.

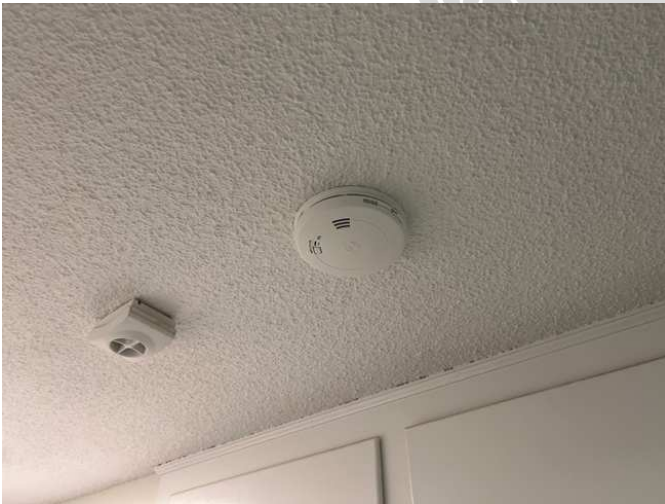
- ✓ **123:** Detectors were present, tested, and functional.

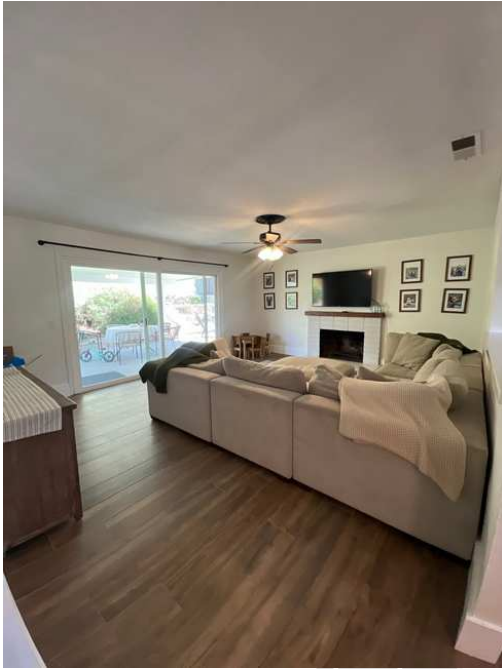
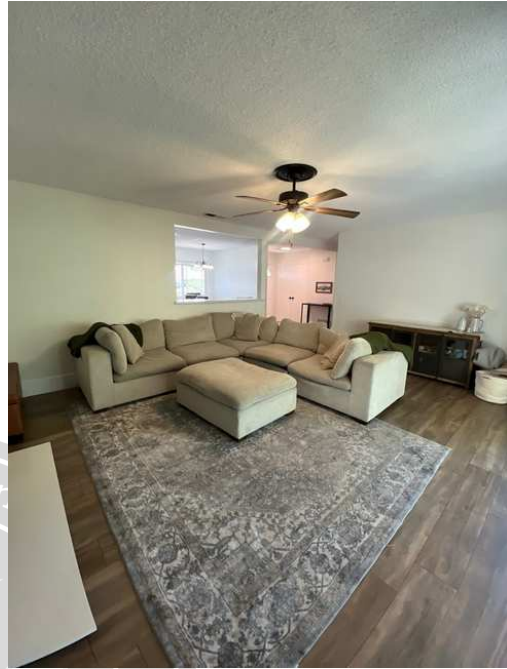
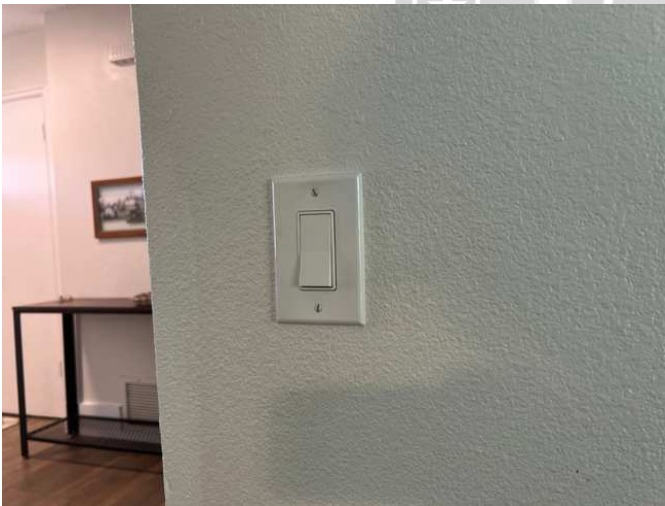
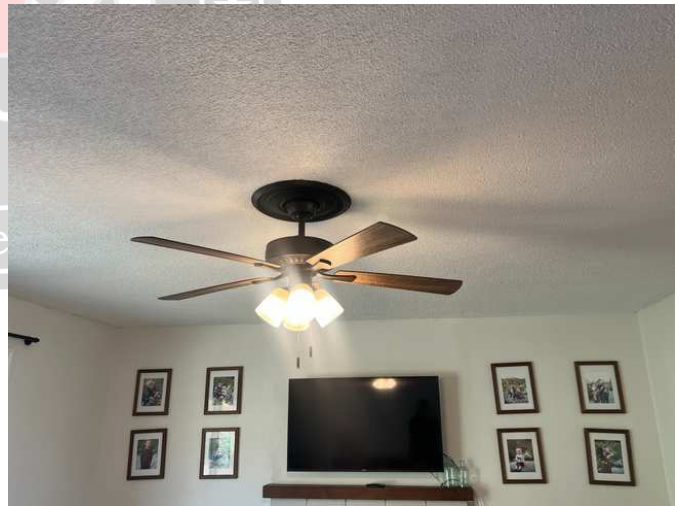
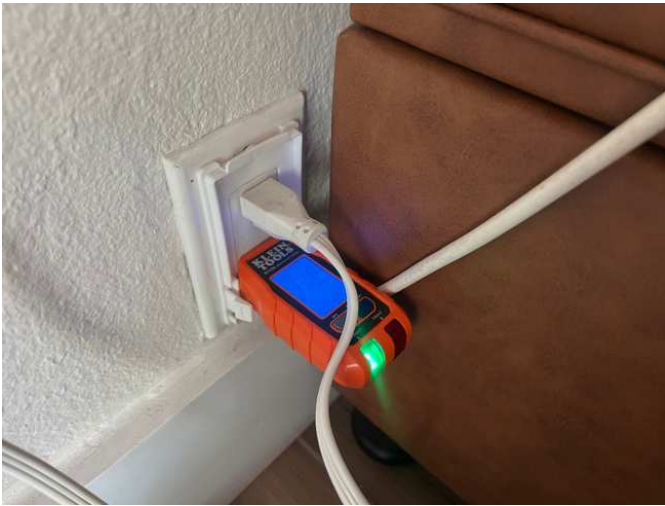
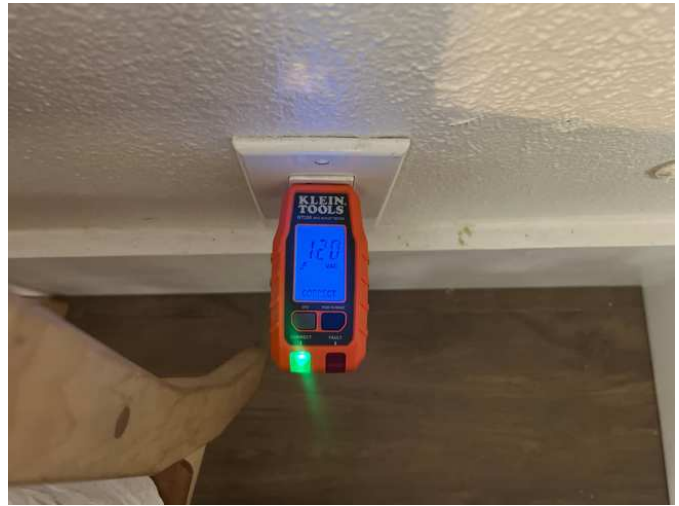
- ✓ **124:**
The room was in satisfactory condition overall.

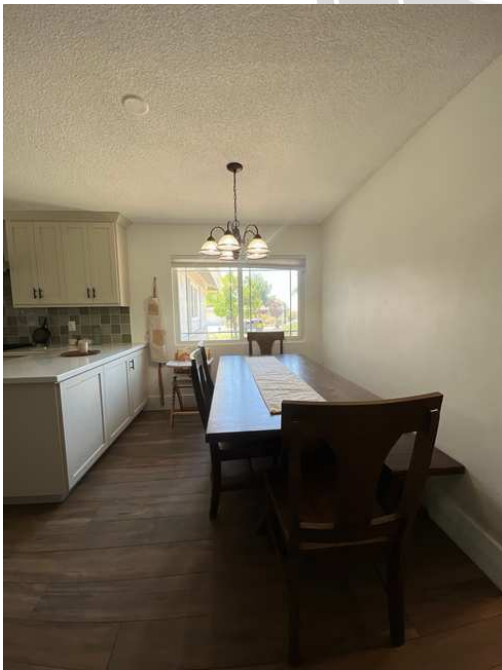
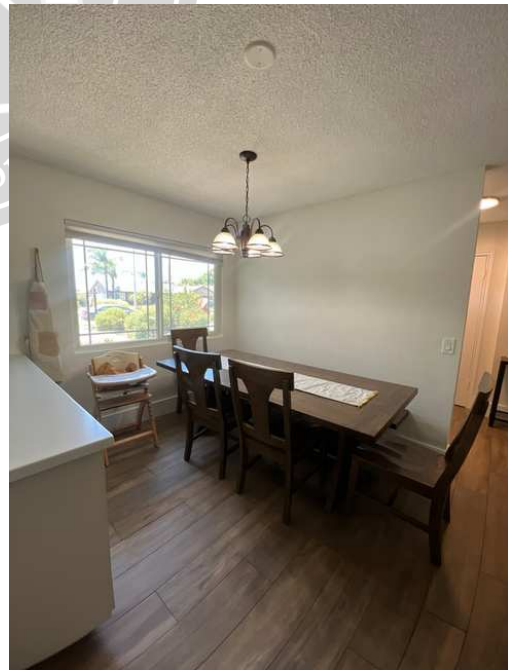
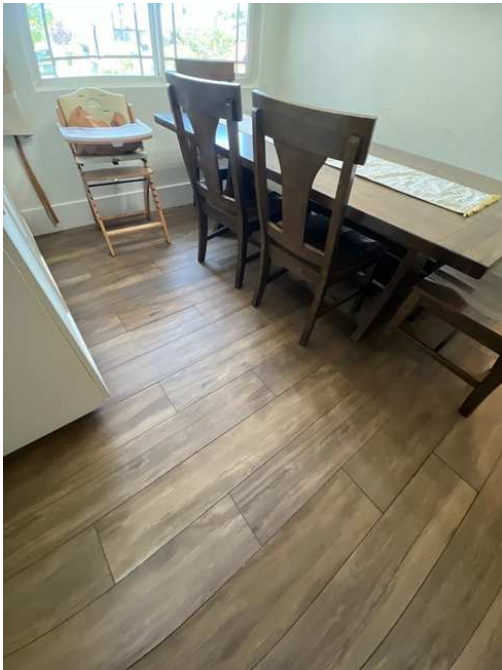
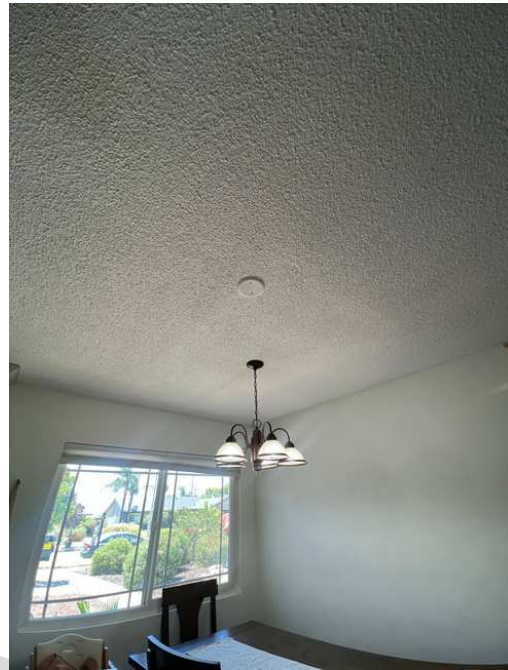
- ✓ **125:** The room was in satisfactory condition overall.

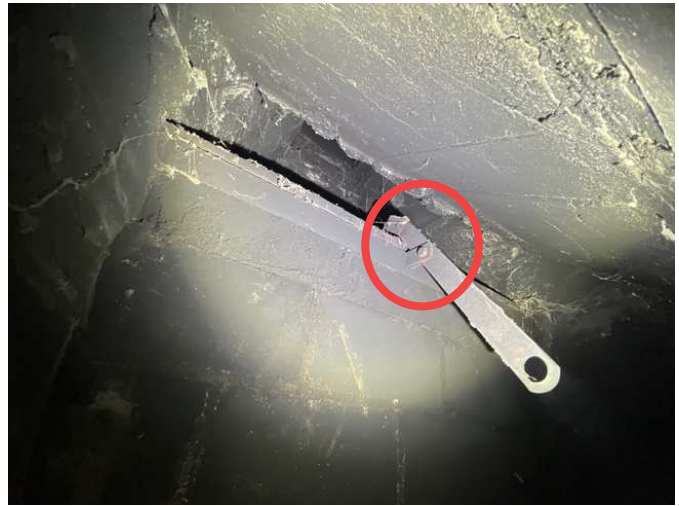
The damper door stopper was missing. Damper door stoppers are required to help prevent accidental closing of the damper door while the gas log lighter is in use.

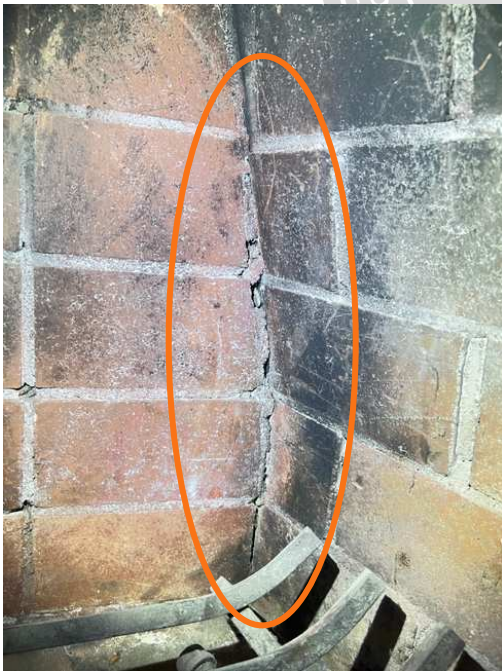
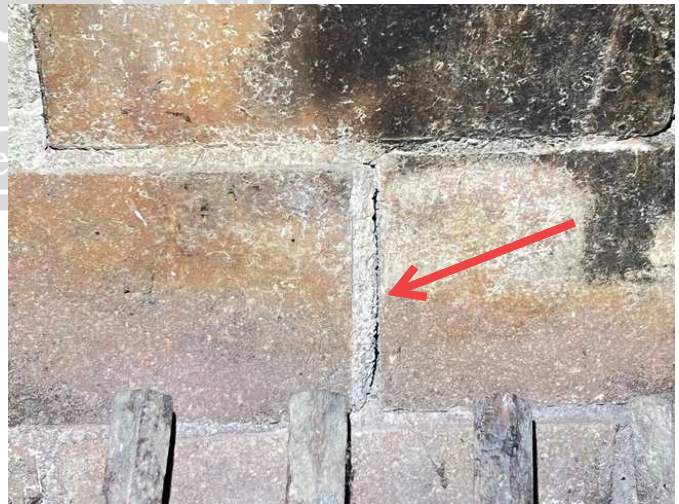
Deteriorated and missing mortar was noted within the firebox. Recommend further evaluation and repair/repointing by a qualified chimney or masonry contractor.

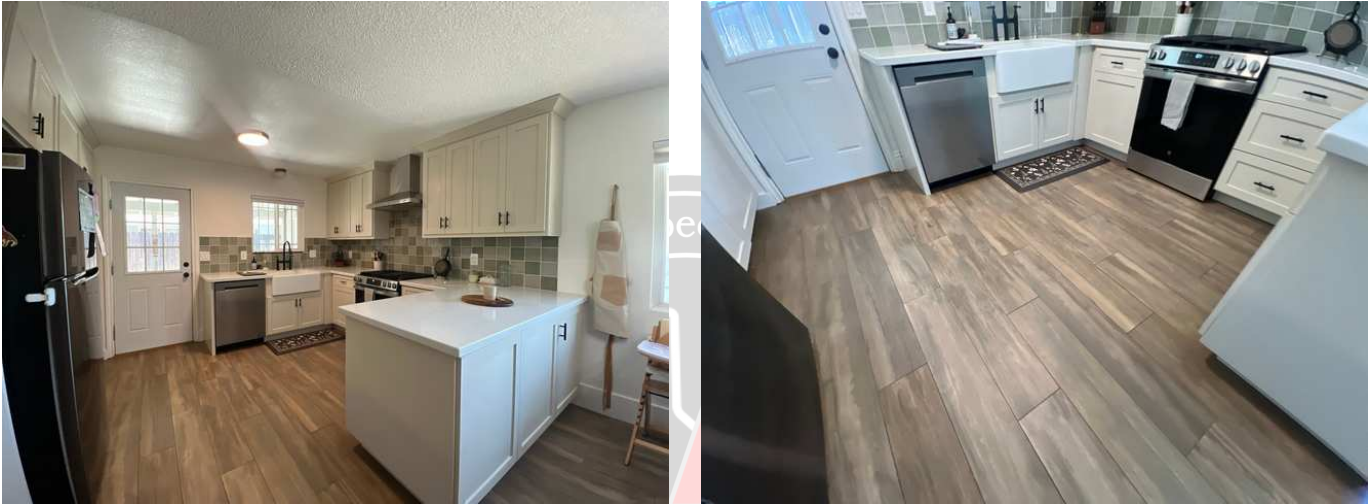
- ✓ **130:** Floor, walls and ceiling in the kitchen area were in satisfactory condition overall.

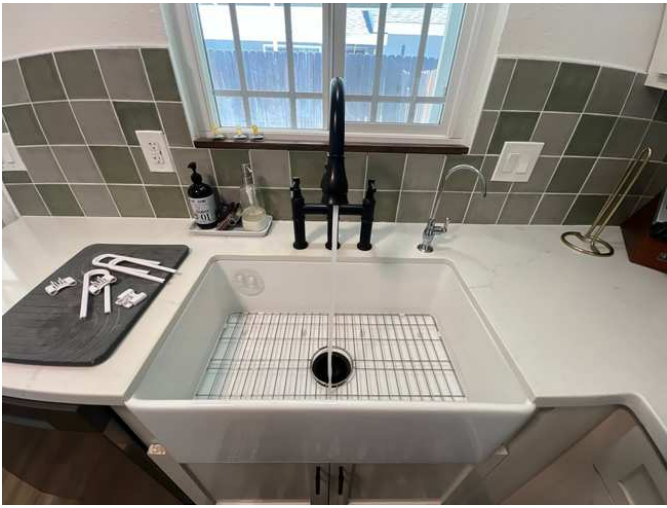
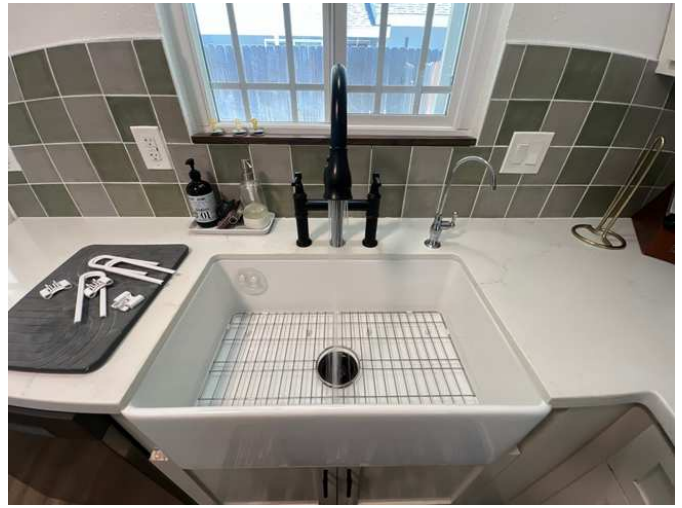
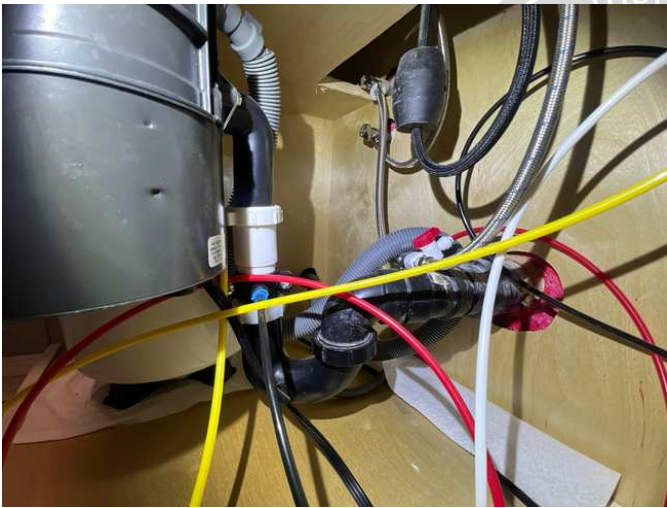
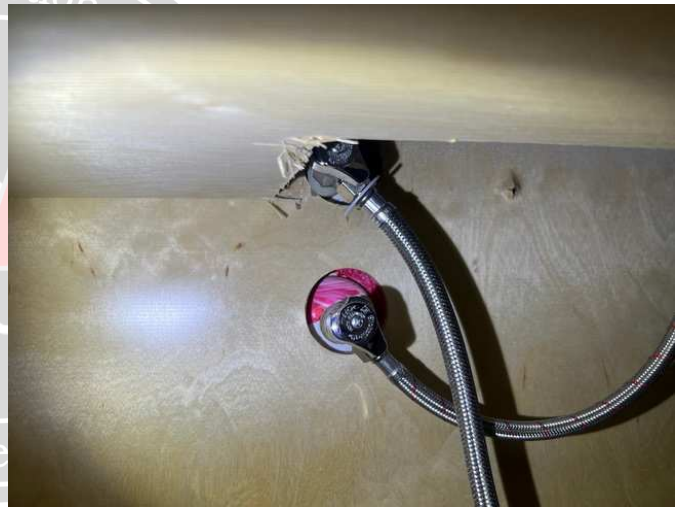
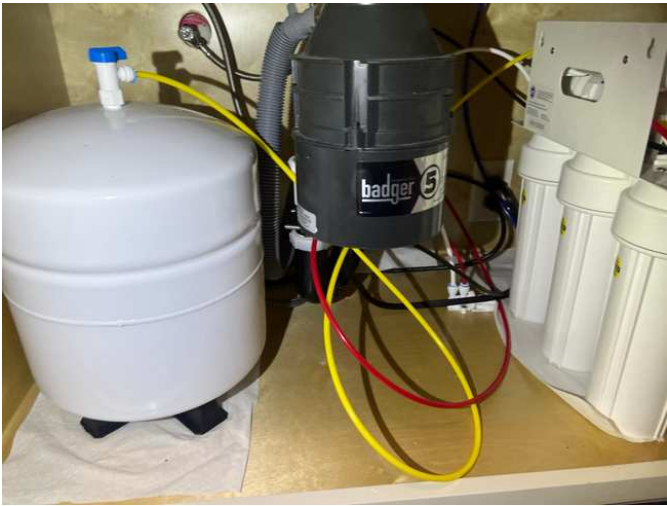
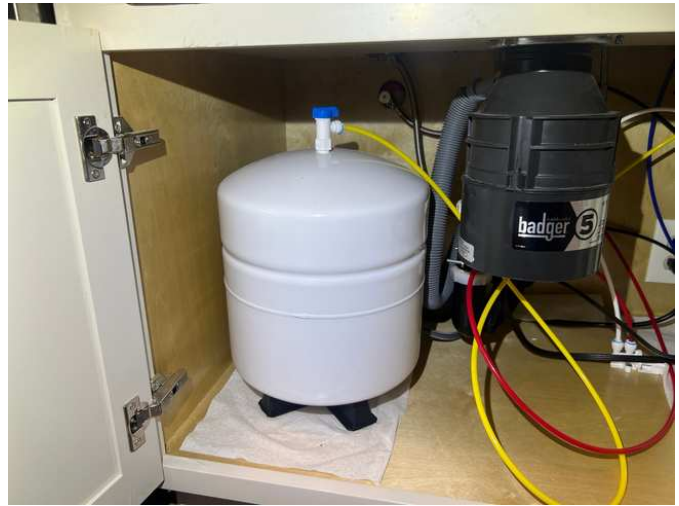
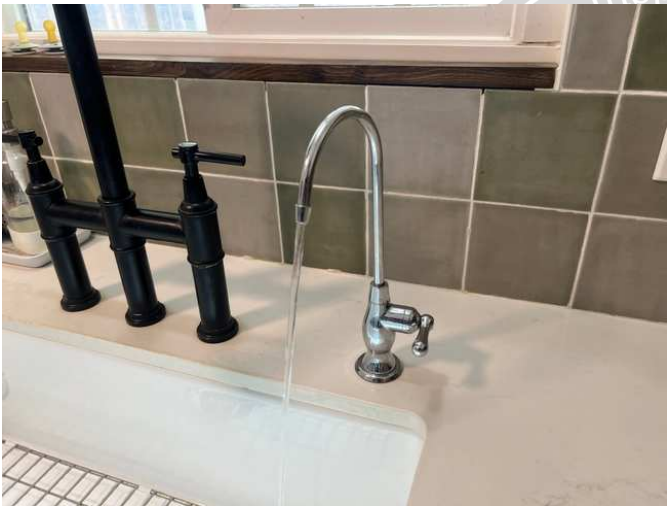
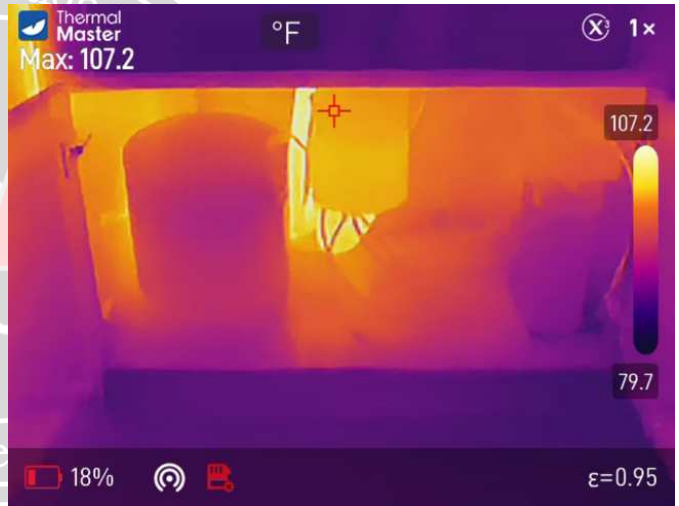
- ✓ **131:** The kitchen sink was in satisfactory condition. Faucet was functional.

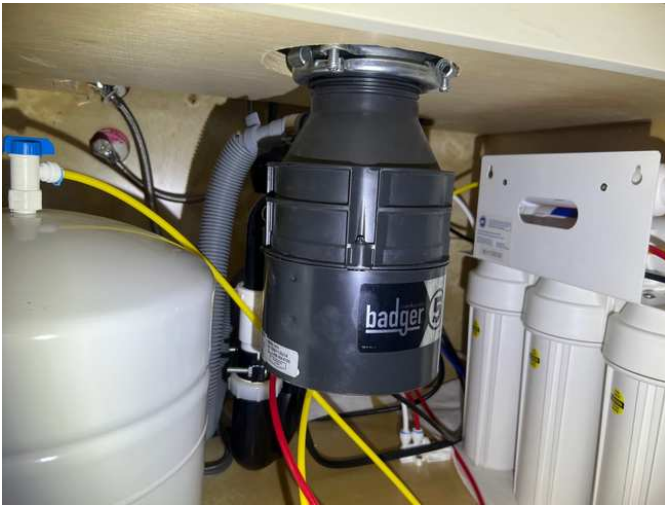
- ✓ **132:** The garbage disposal was in satisfactory condition.
