HOME INSPECTION REPORT

**Howard St
Upland, CA 91786**

Monday, May 18, 2026

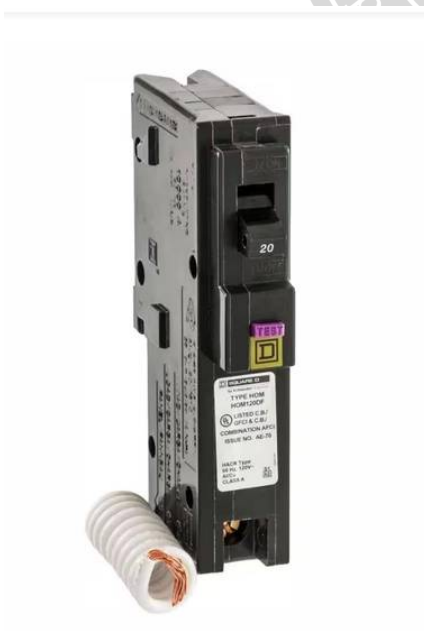
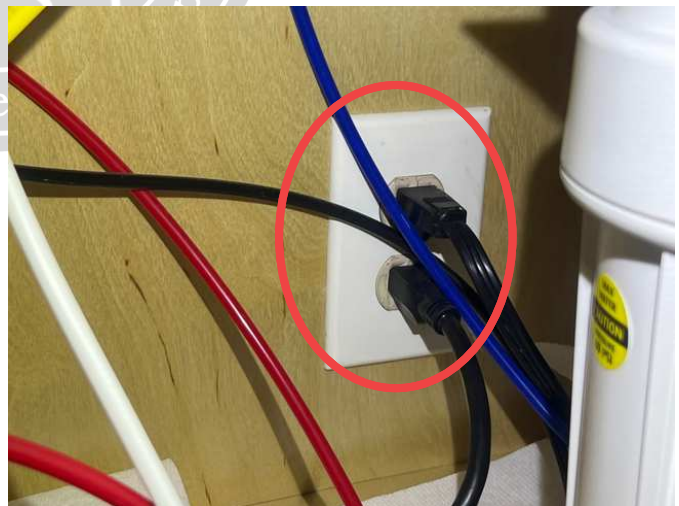
GFCI power outlet detects ground faults and shuts off power to prevent serious electric shock.

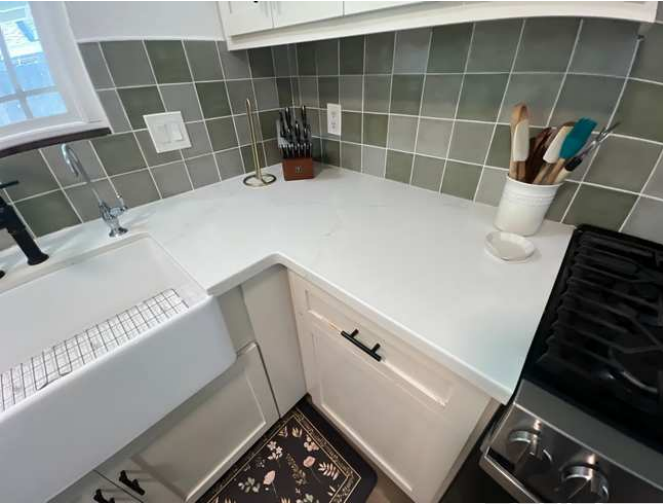
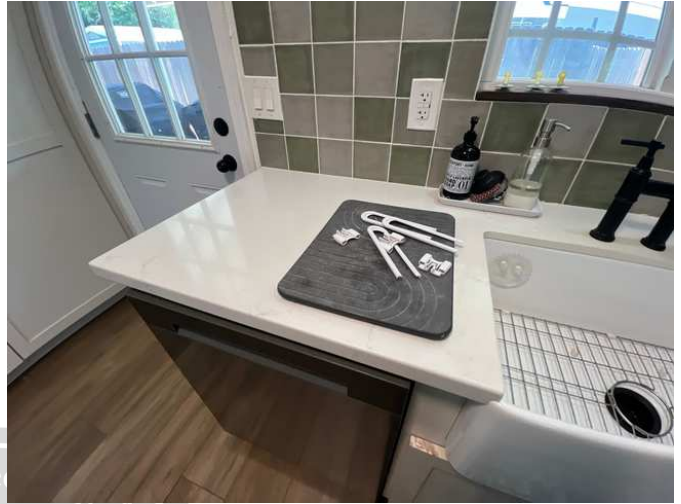
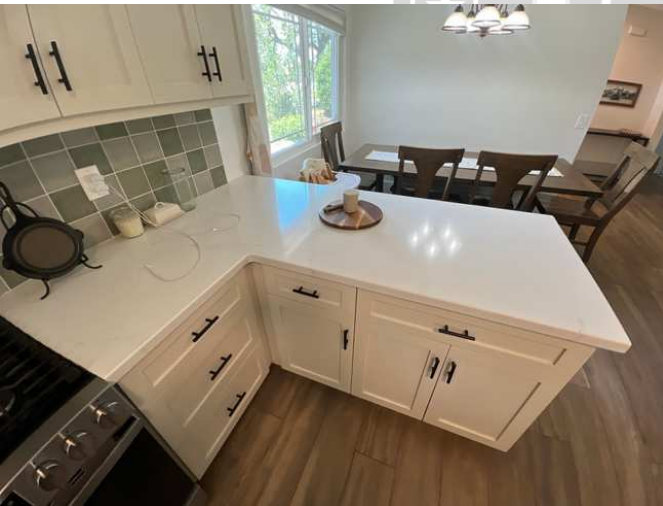
Quartz countertops were in satisfactory condition and professionally finish the edges and seams.

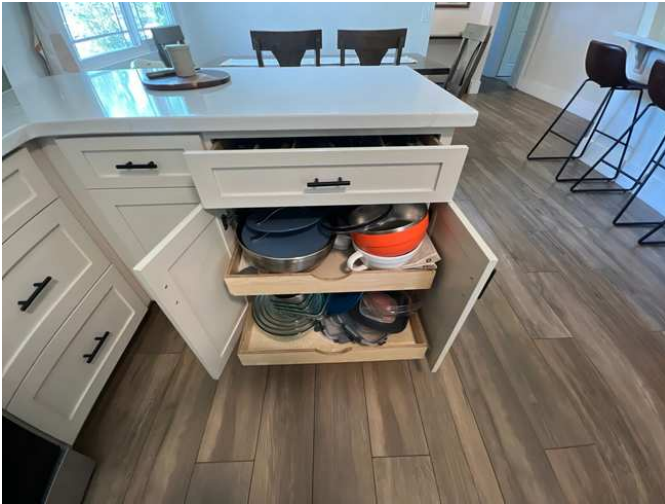
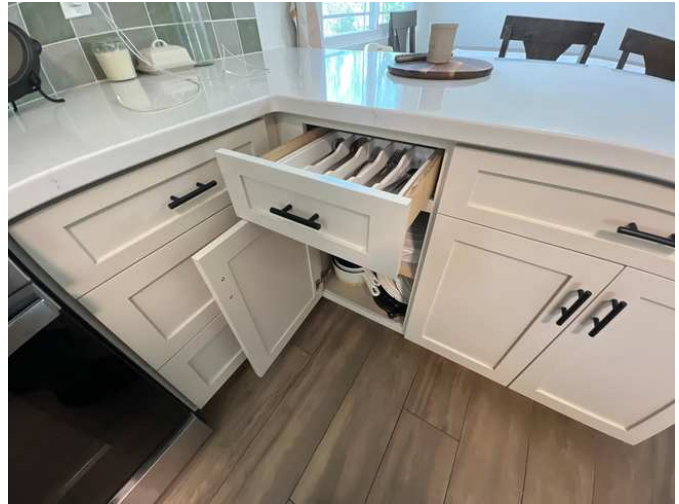
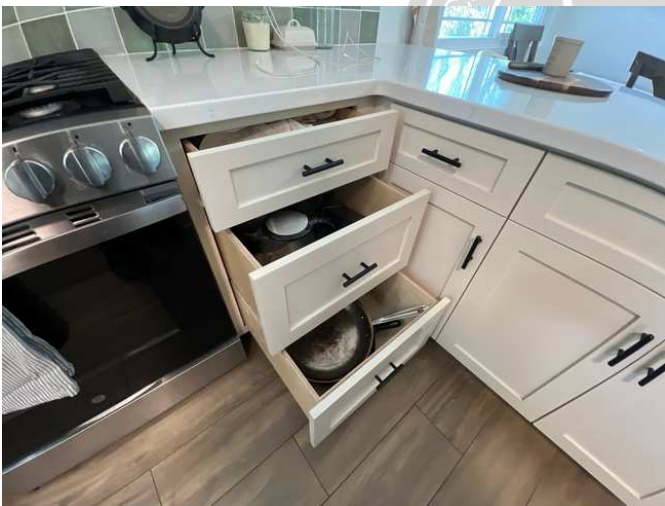
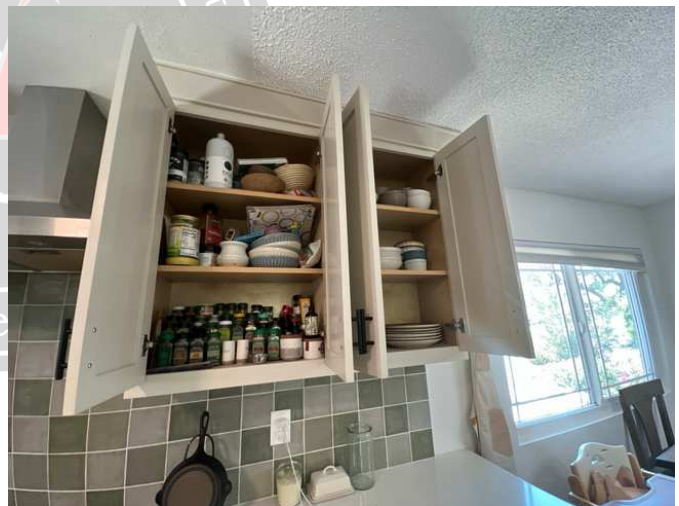
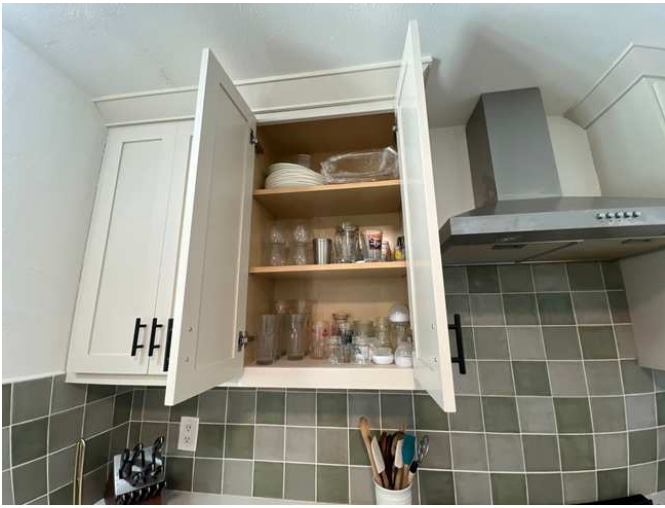
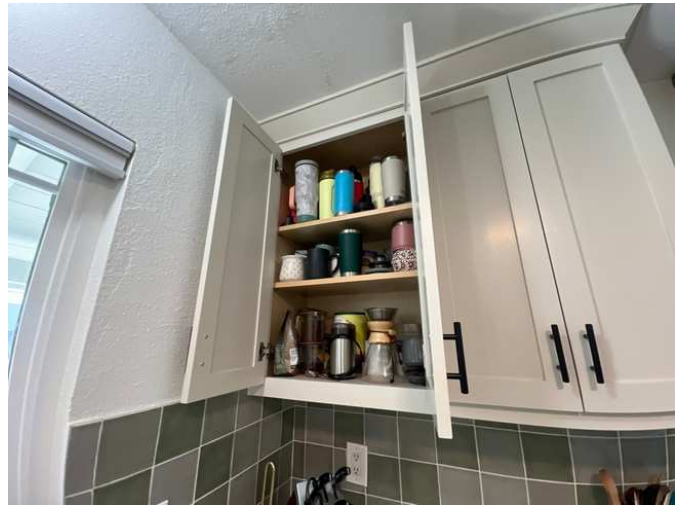
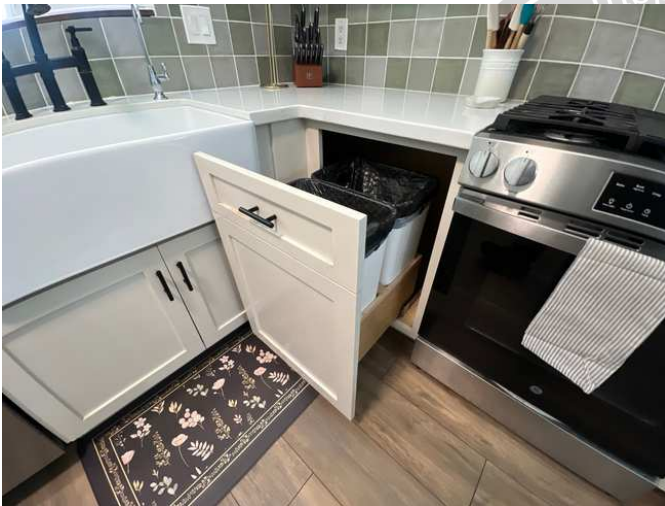
Cabinets are showing signs of normal wear and tear. All doors and drawers function normally.

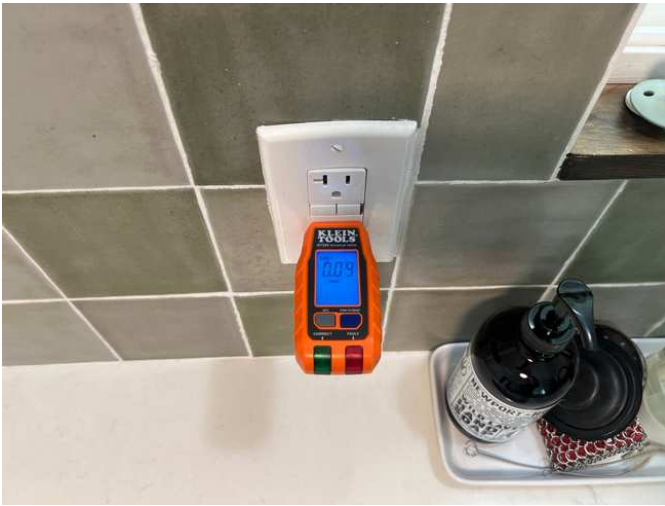
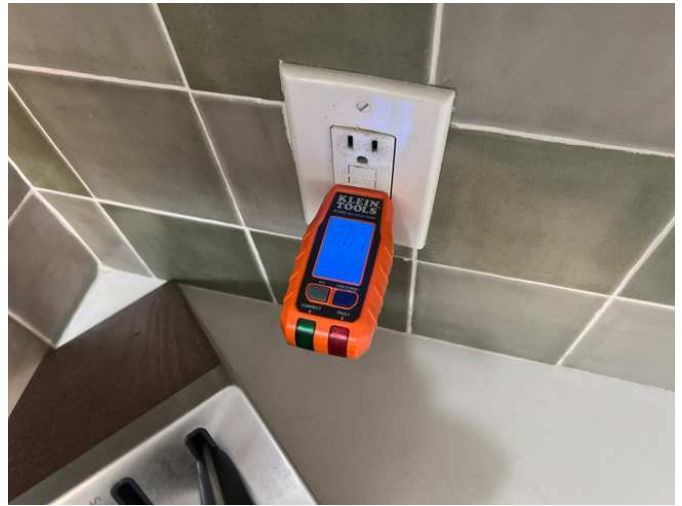
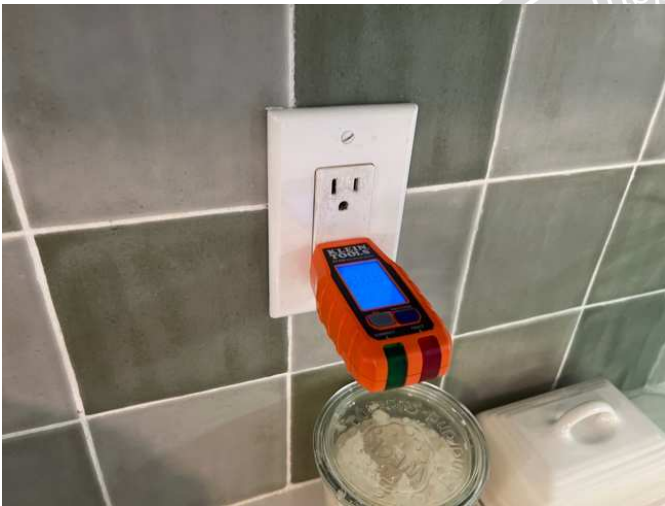
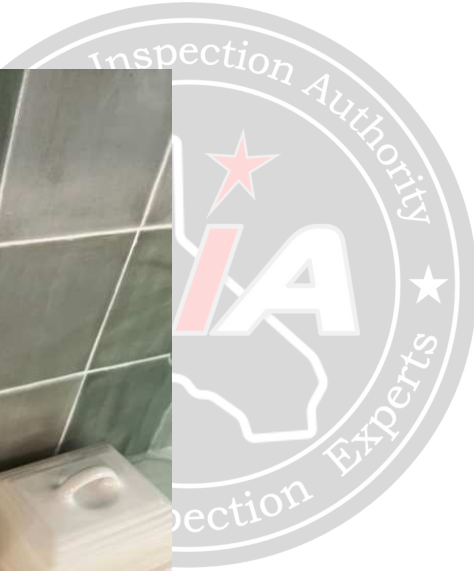
- ✓ **136:** All GFCI receptacles were in satisfactory condition.

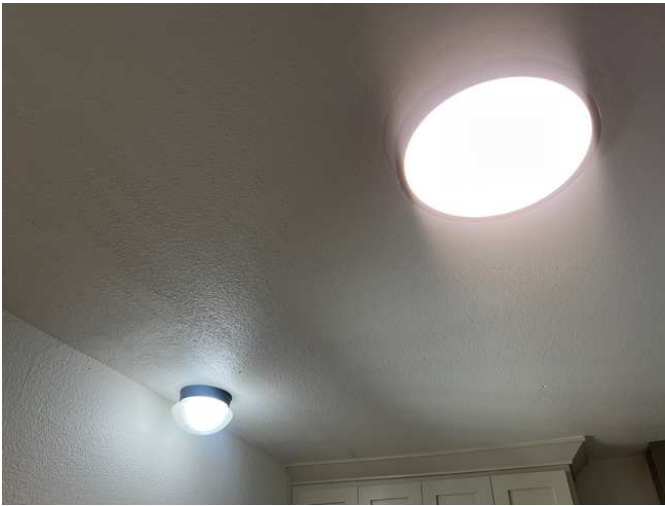
- ✓ **137:** Kitchen lighting was satisfactory.

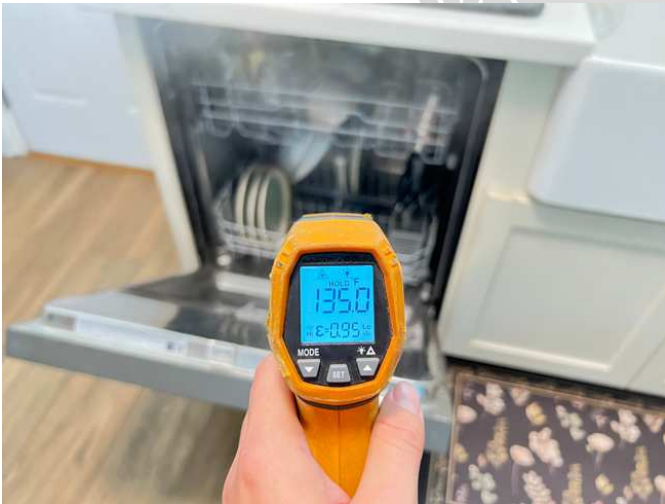
The dishwasher was functional. The dishwasher was run through a full "NORMAL wash "cycle only. There were no defects or deficiencies to report. No representation is expressed or implied as to the effectiveness of the dishwashers cleaning capacity.

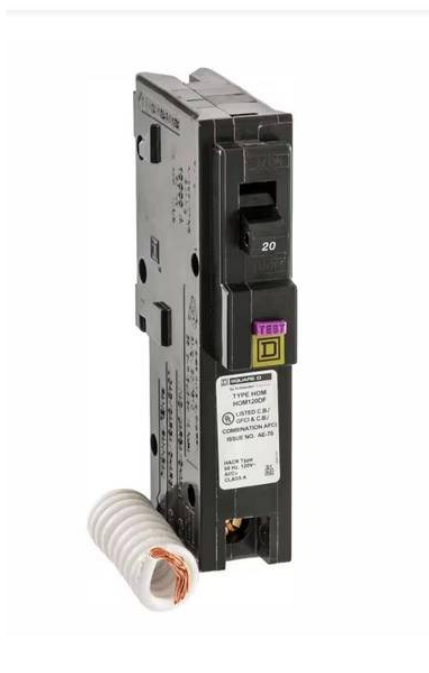
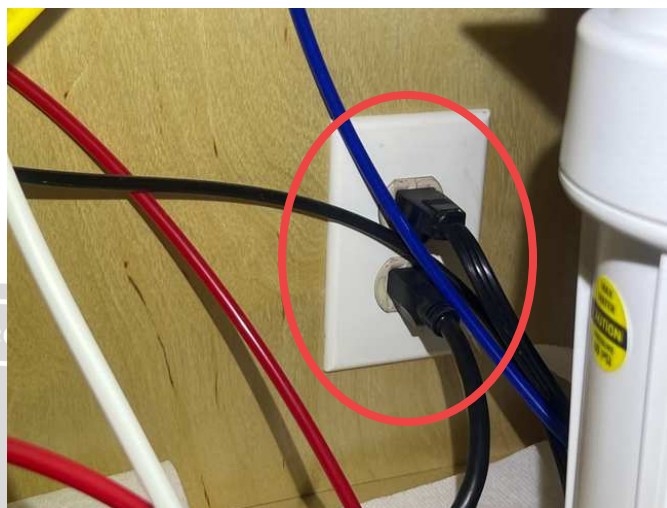
Garbage and dishwasher circuit must be AFCI and GFCI protected for occupant safety. Consult with a licensed electrician for further evaluation and repair.

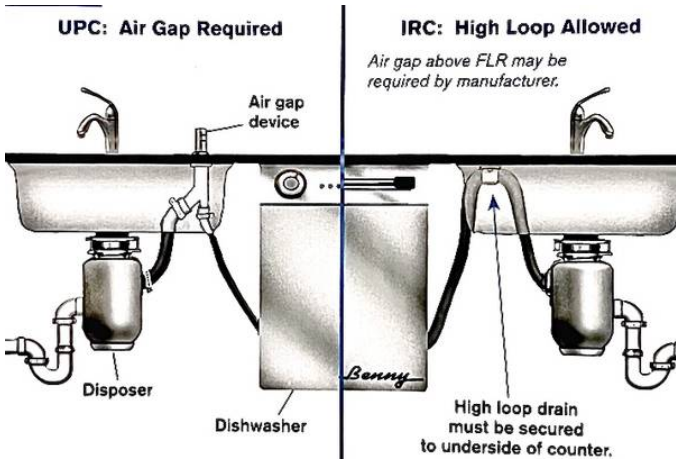
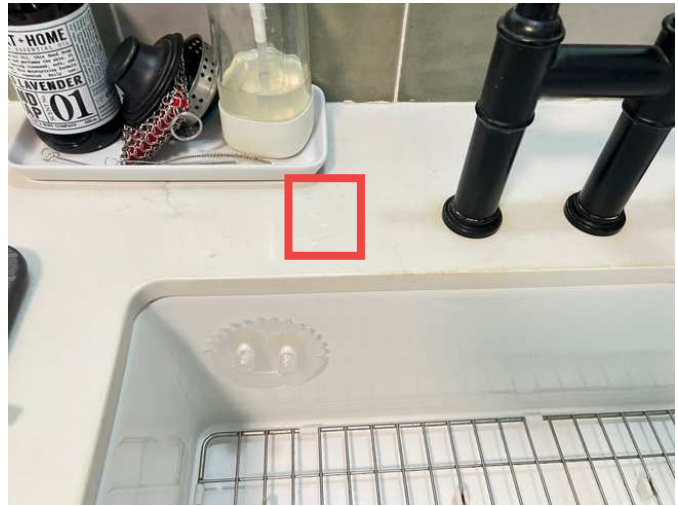
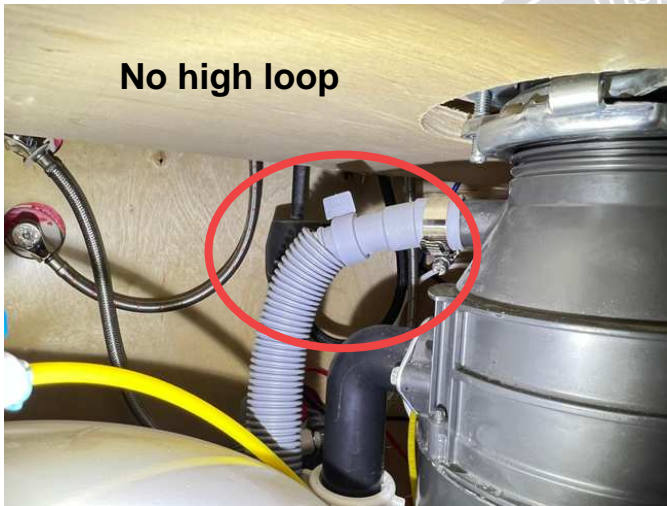
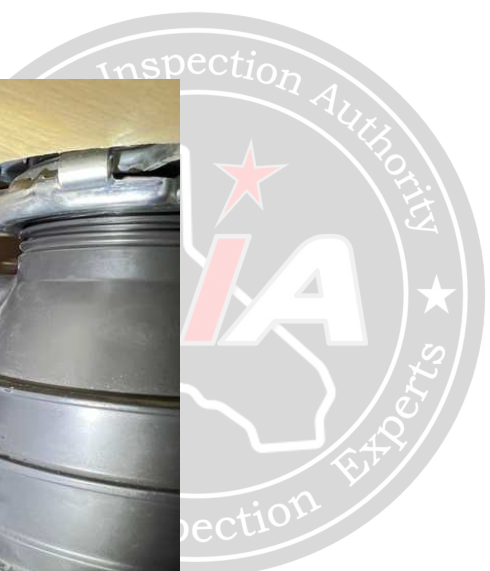
R140: Missing Air Gap

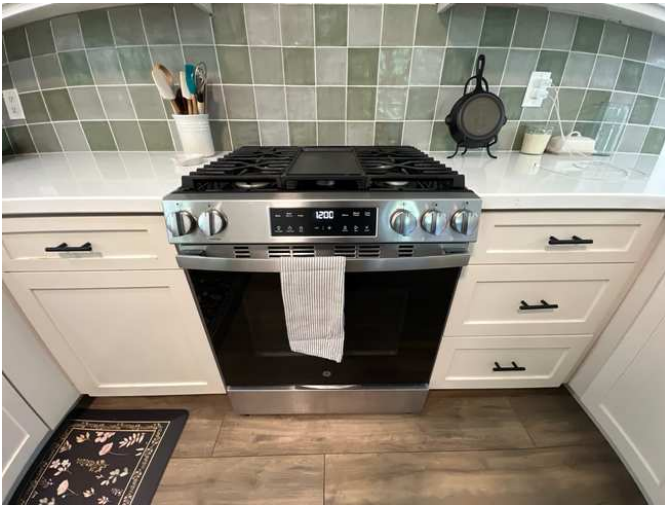
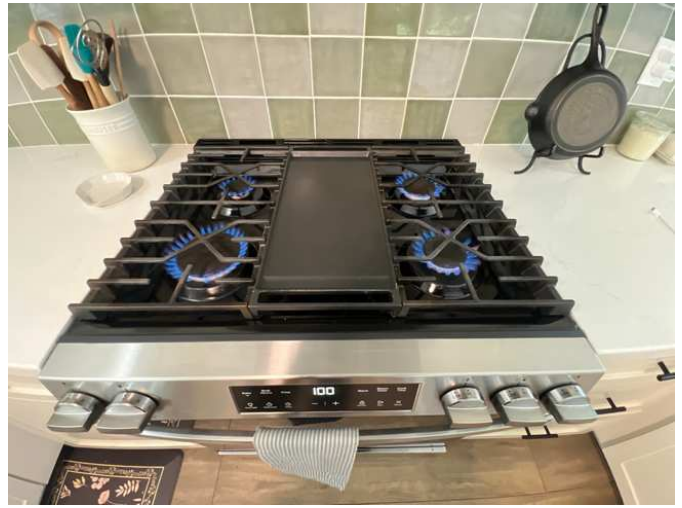
The range was thoroughly tested. Temperatures were satisfactory. The unit was found to be functional.

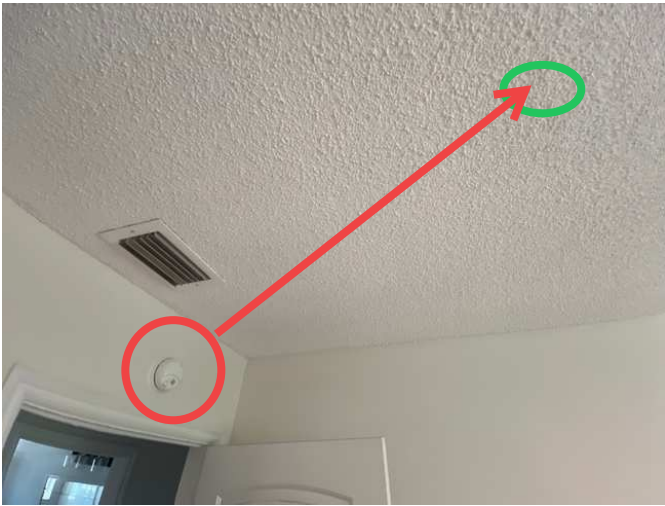
Smoke detector is located near HVAC register. May cause false alarms. Relocate recommended.

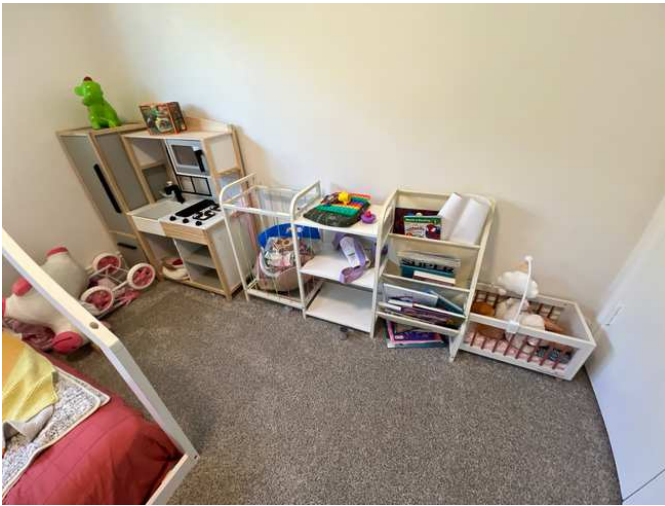
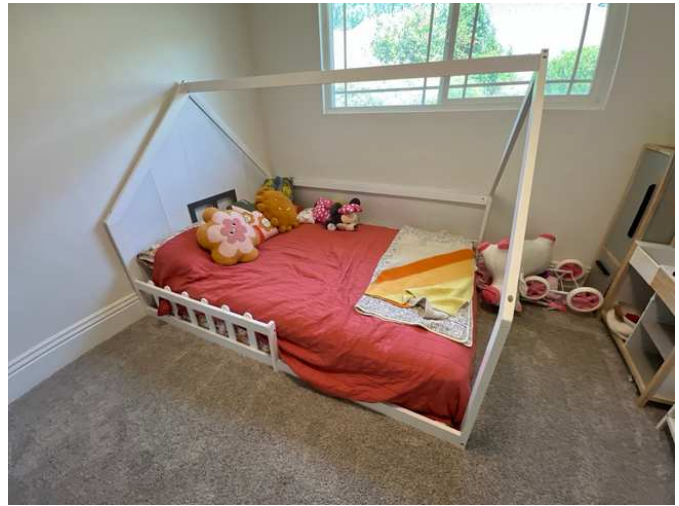
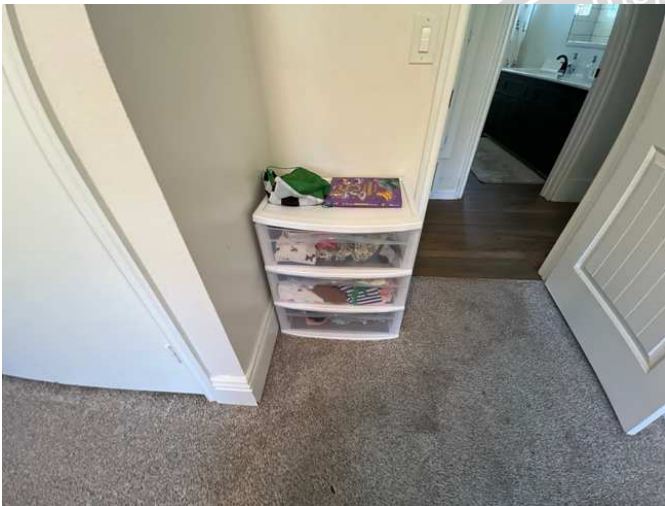
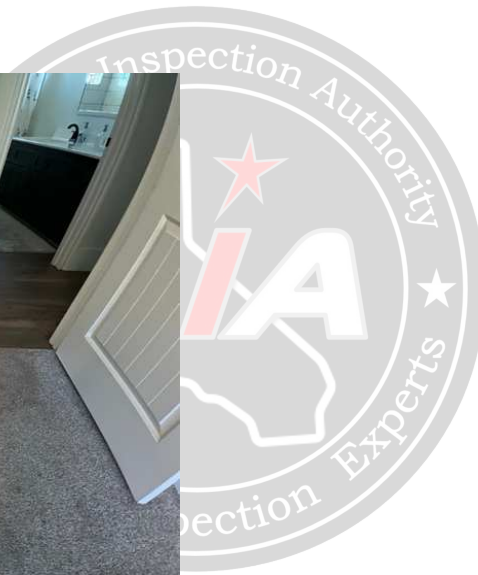
W146: Obstructed

Outlet/switch is obstructed. Clear for access.

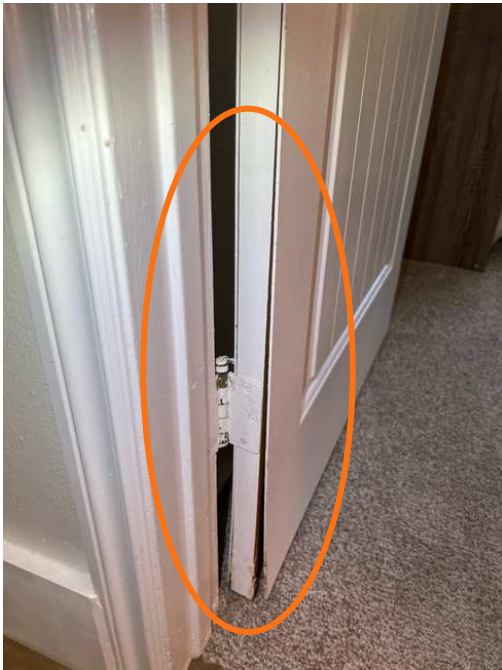
R148: Damage/Replacement

Door is damaged and needs replacement.

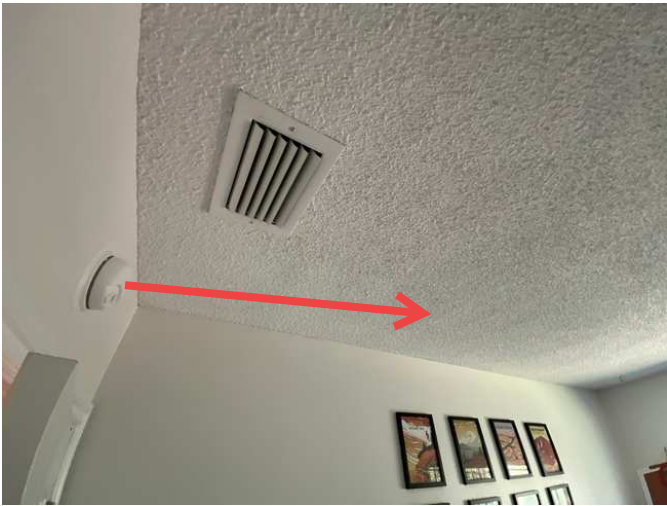
Smoke detector is located near HVAC register. May cause false alarms. Relocate recommended.

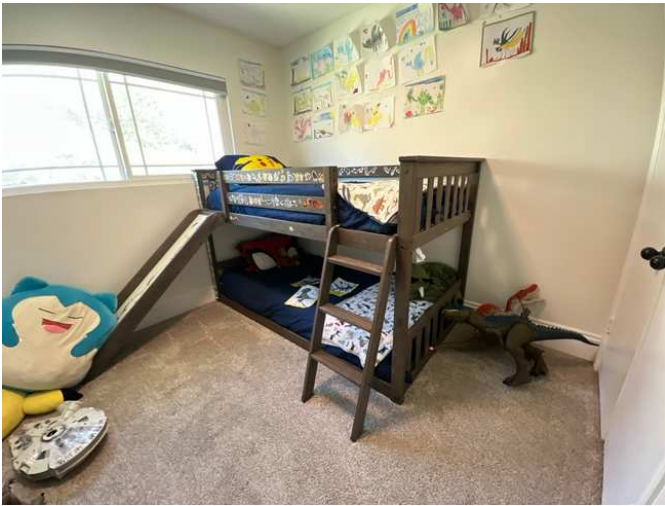
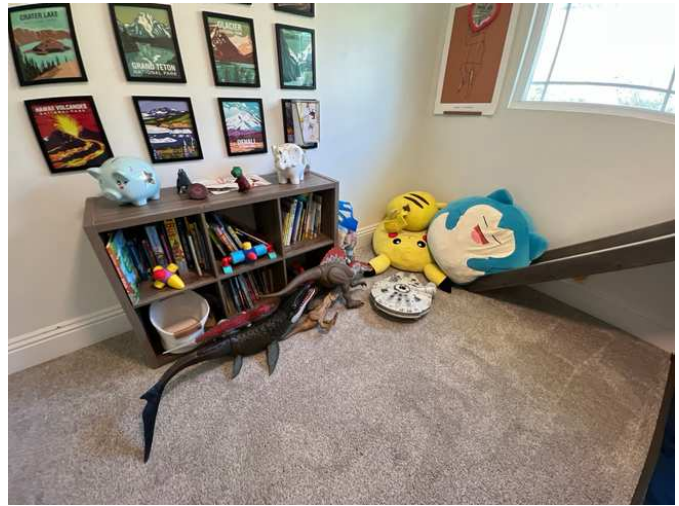
W151: Obstructed

Outlet/switch is obstructed. Clear for access.

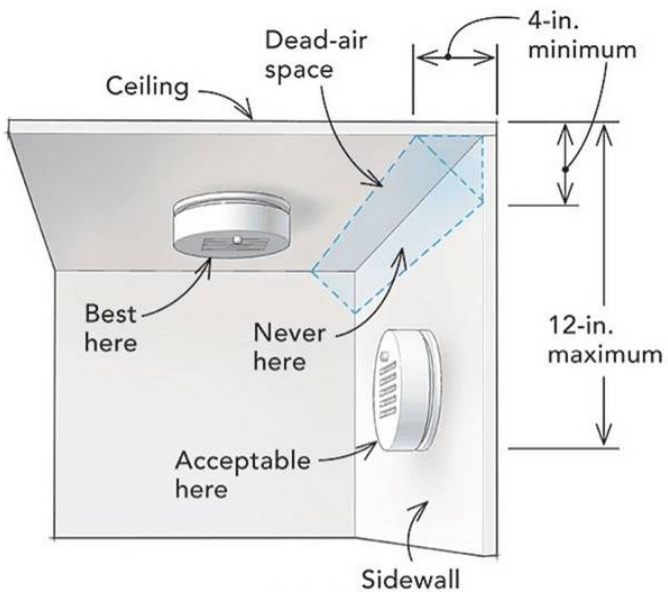
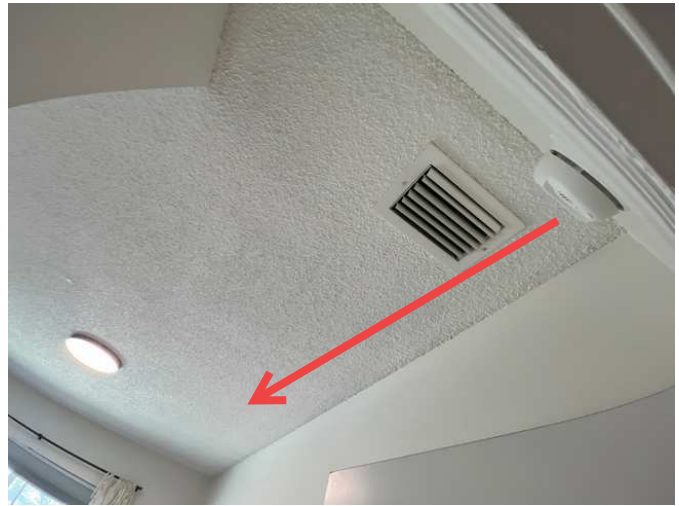
Smoke detector is located near HVAC register. May cause false alarms. Relocate recommended.

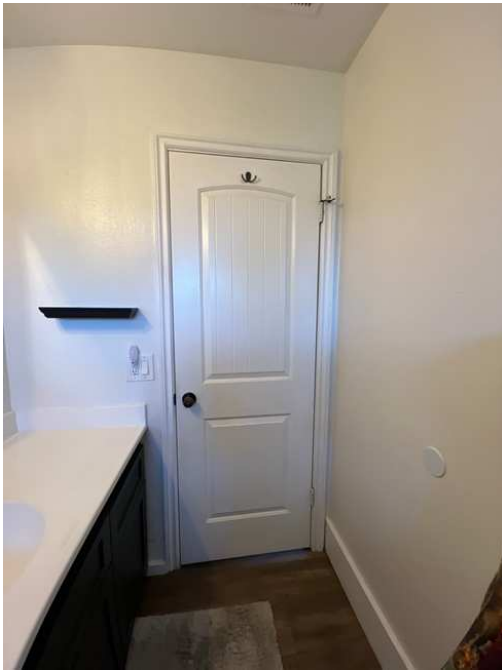
- ✓ **159:** The door was in satisfactory condition.

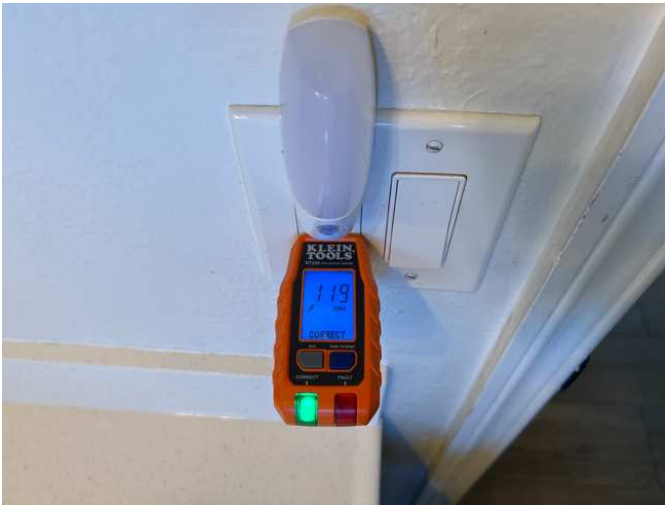
- ✓ **161:** GFCI receptacle was present and functional.

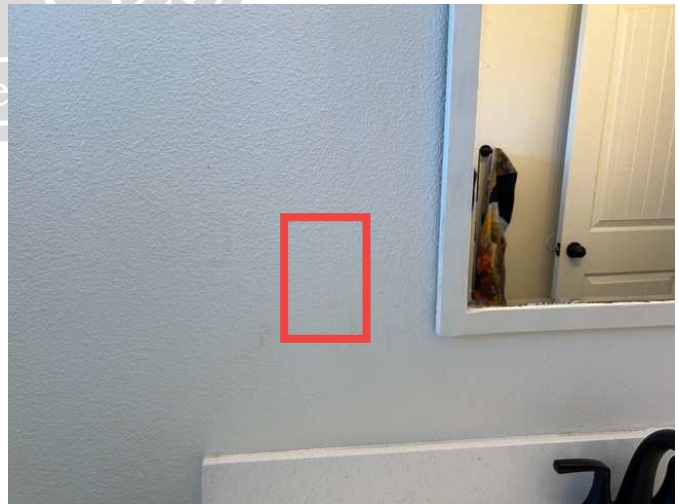
GFCI Outlets

⚠ S162: Missing Receptacle

According to the national electrical code in building standards, a receptacle is required within 36 inches of any sink basin. It is suggested that a "Licensed Electrical Contractor" be contacted for further evaluation and repair.

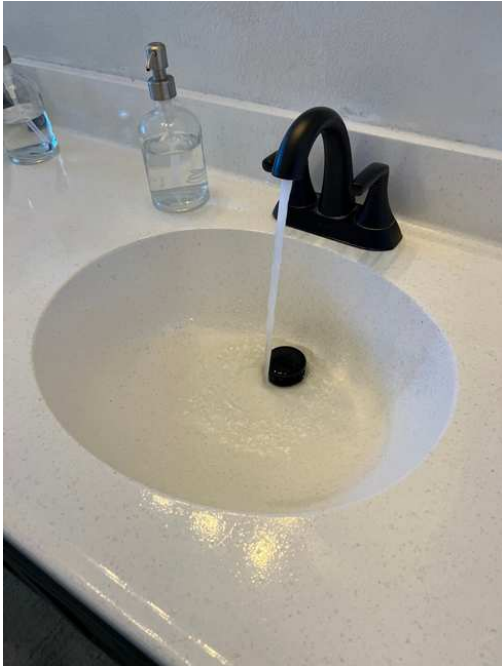
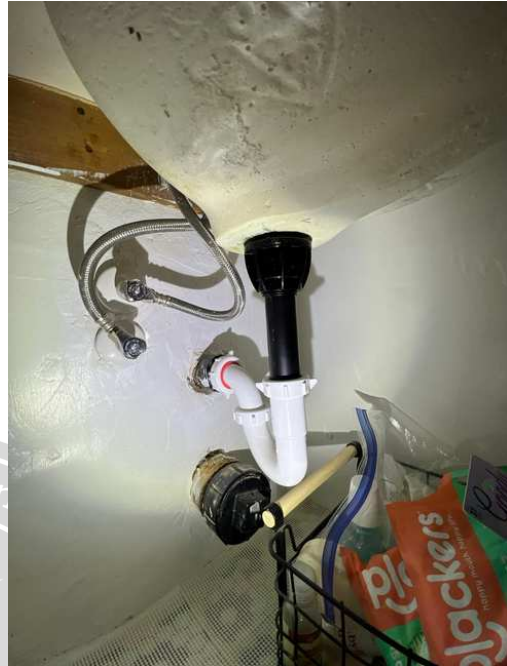
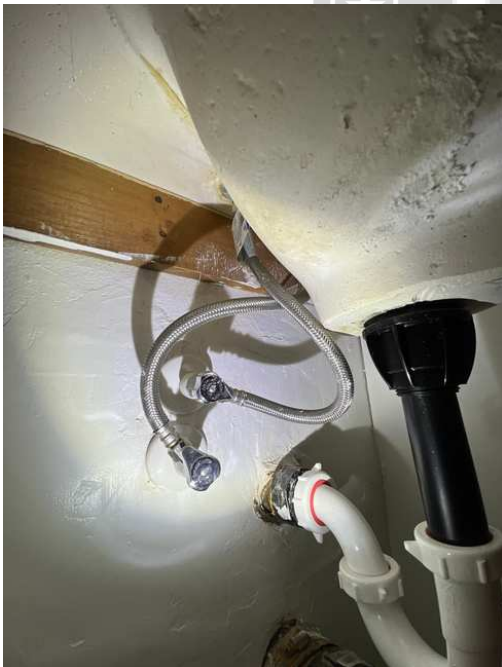
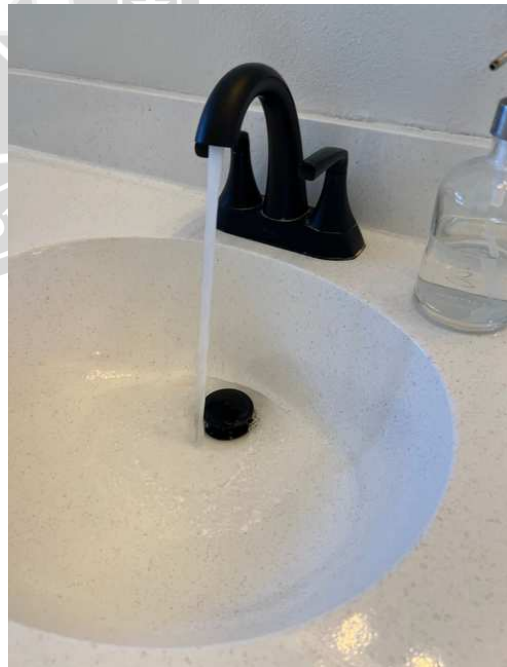
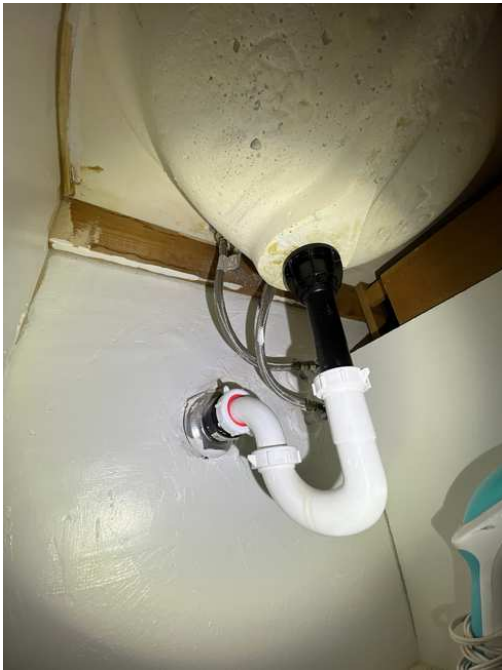
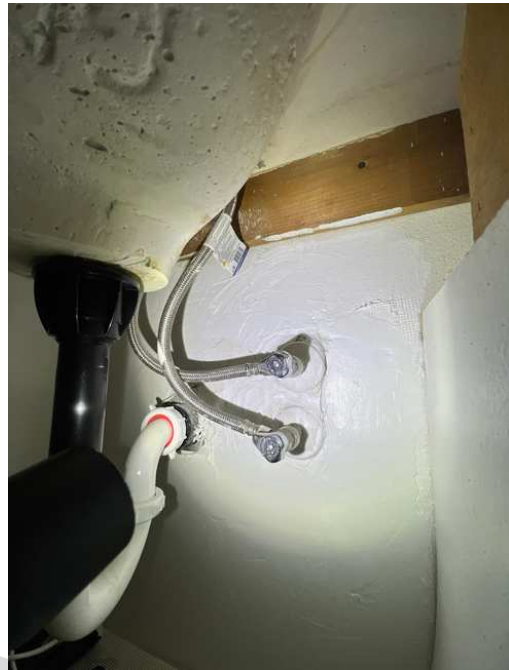
✓ **163:**

Sink and faucet were functional. Hot and cold water were present. And the drain was free flowing.

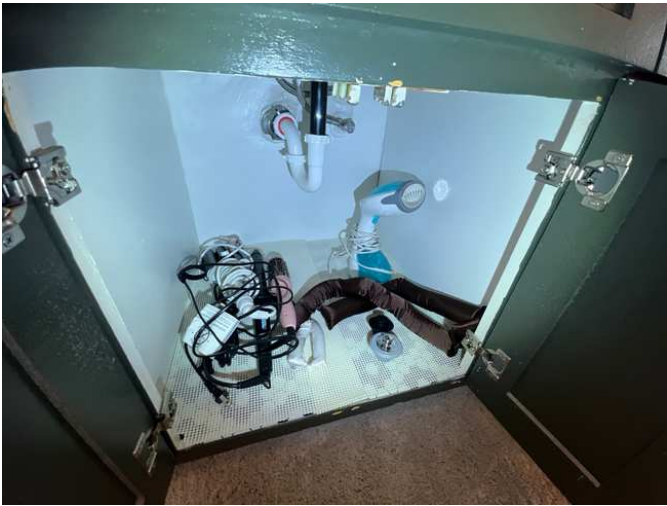
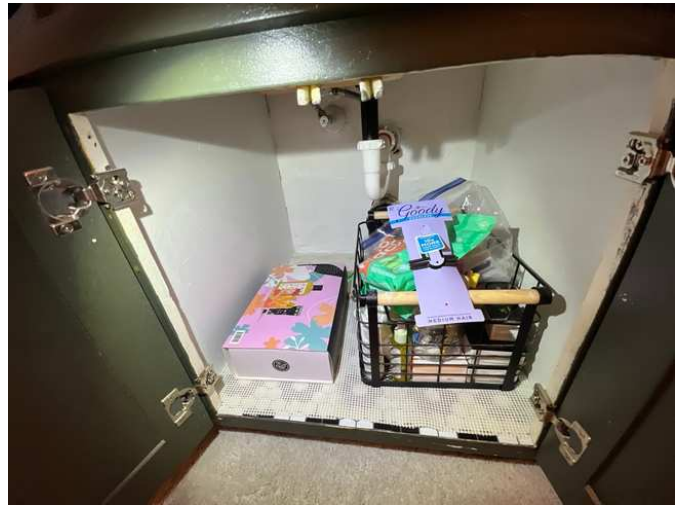
W164:

Personal items and storage below the sink prohibited a complete visual assessment. Defects or deficiencies may exist that were obstructed.

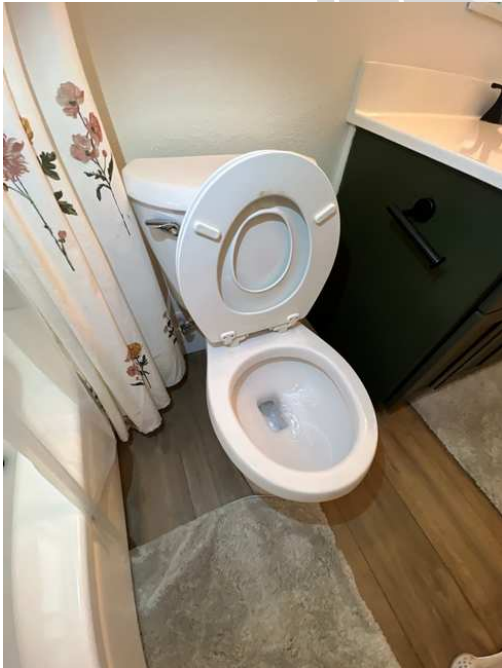
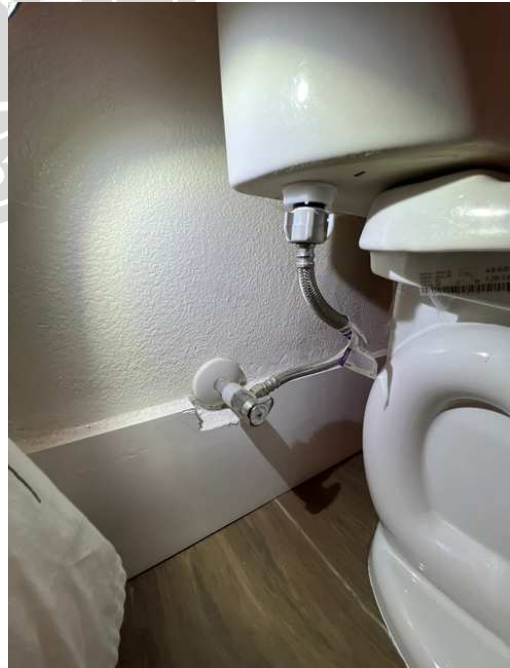
- ✓ **165:** The toilet was functional and in satisfactory condition.

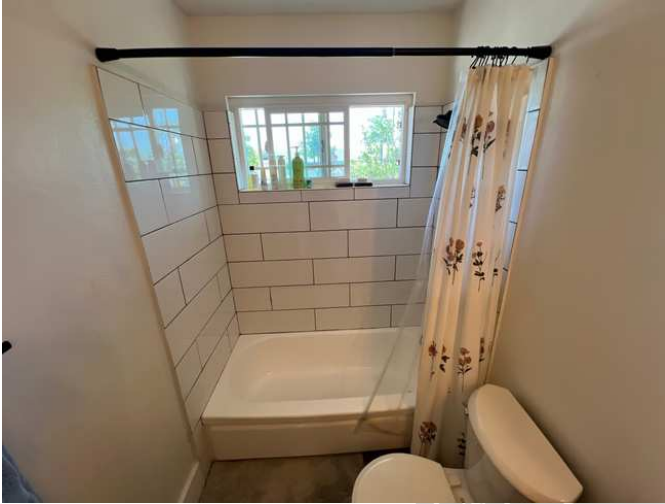
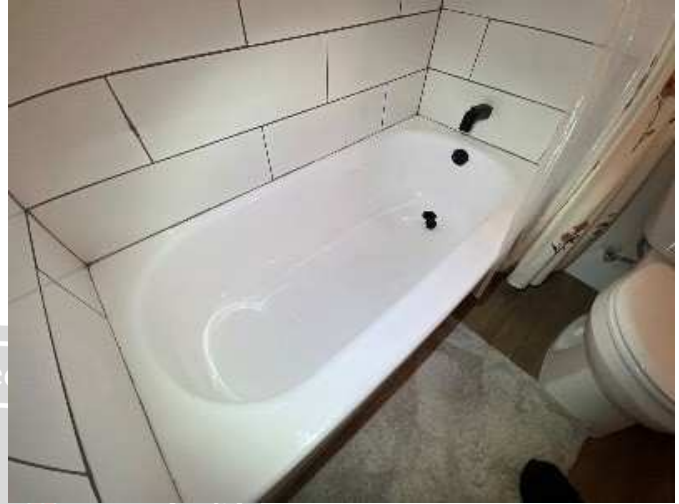
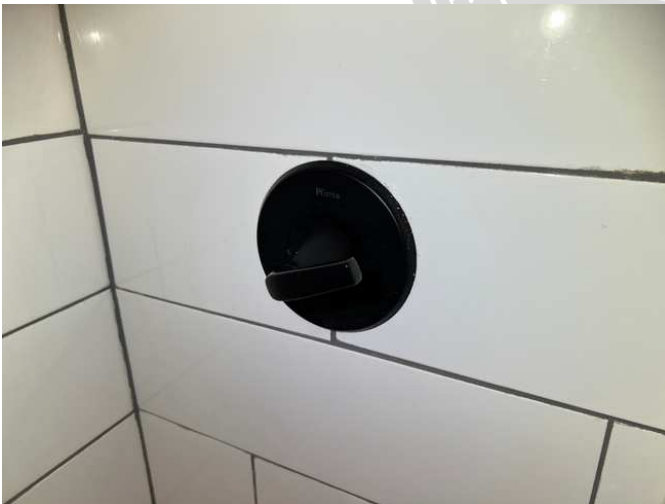
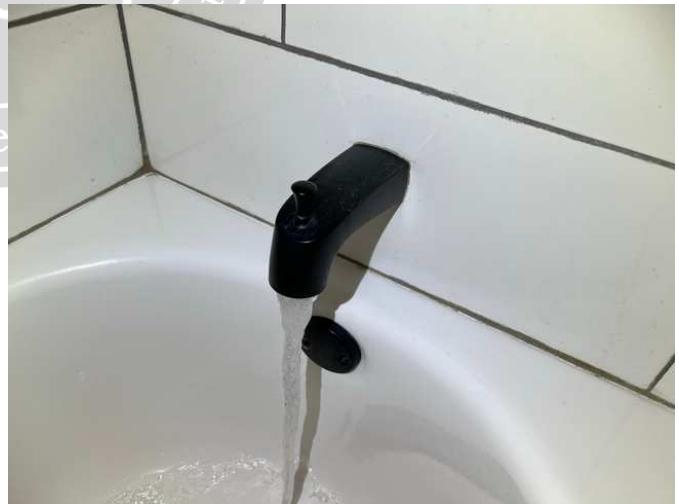
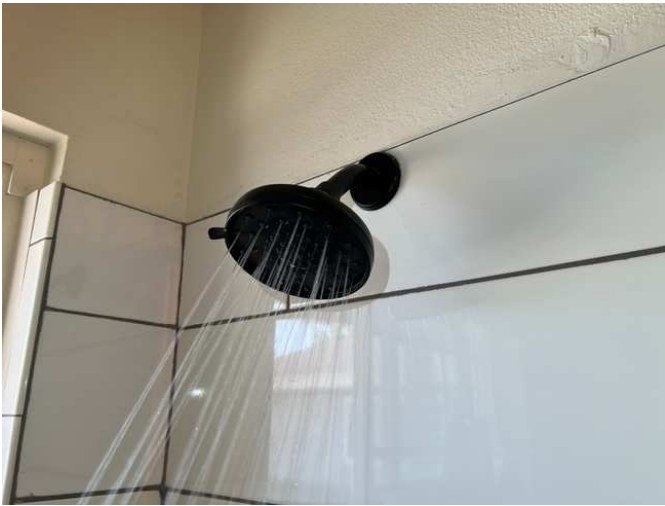
✓ **166:**

Tub and shower are showing signs of normal wear and tear. It should be noted that the tub overflow drain was not tested by filling the tub water above it to see if it leaks. Seals tend to dry out and can leak over time. It is recommended that the seals be checked and or replaced to prevent leakage as part of regular home maintenance.

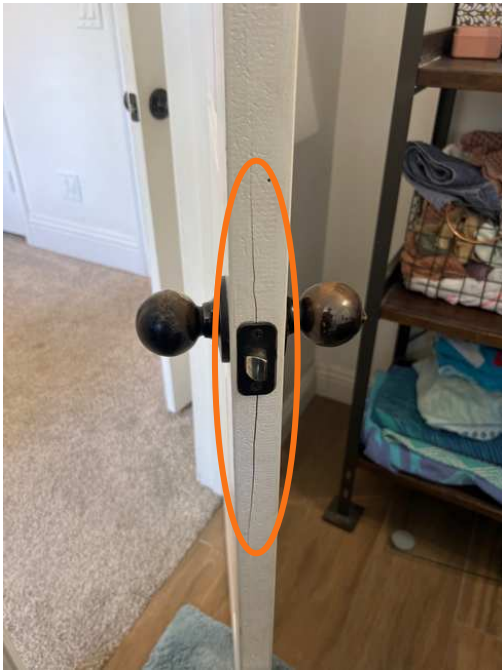
R167:

Crack was noted in the door buyer beware

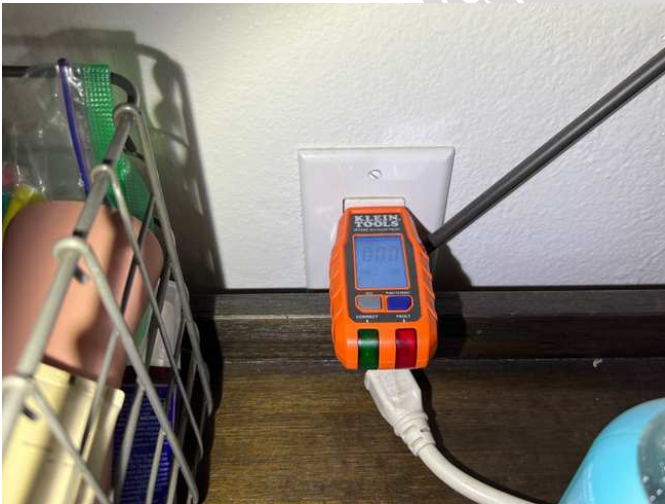
✓ **169: GFCI Protected**

Bathroom receptacle was GFCI protected from another location.

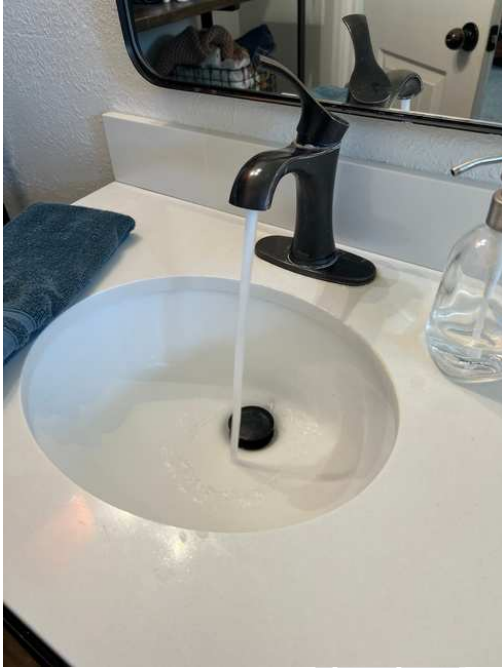
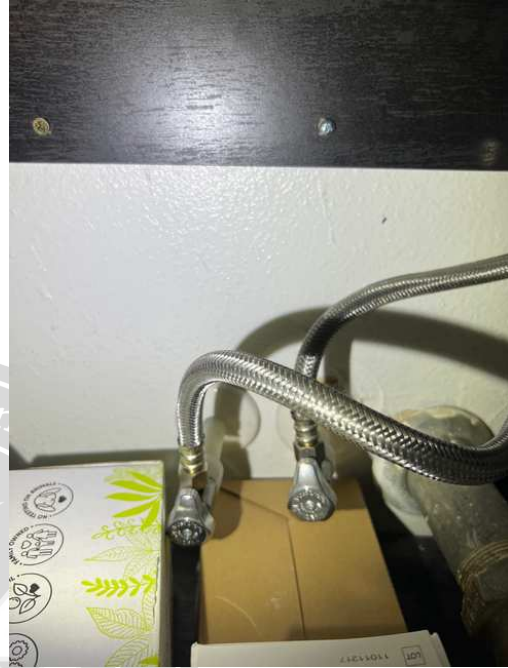
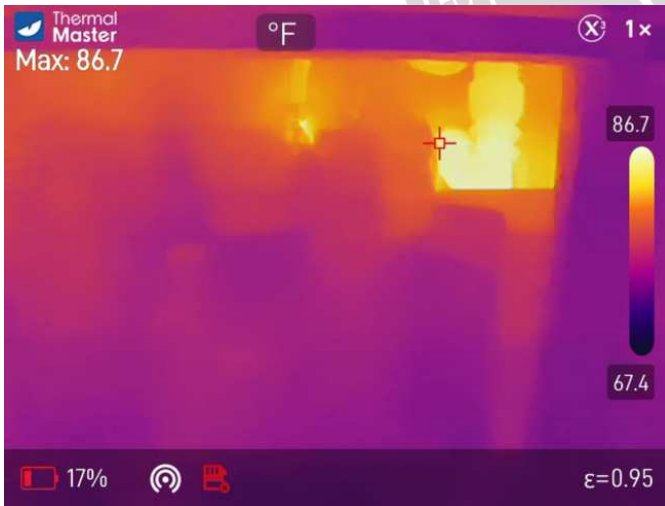
✓ **170: Satisfactory**

Sink and faucet were functional. Hot and cold water were present. And the drain was free flowing.

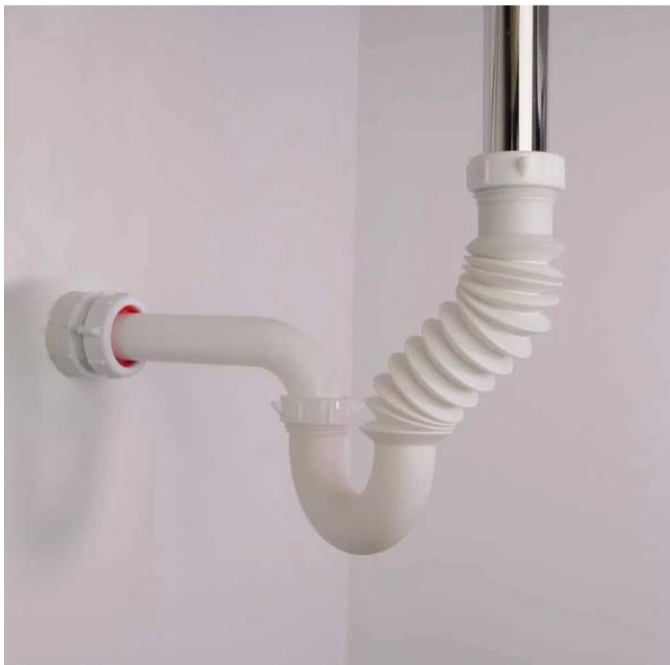
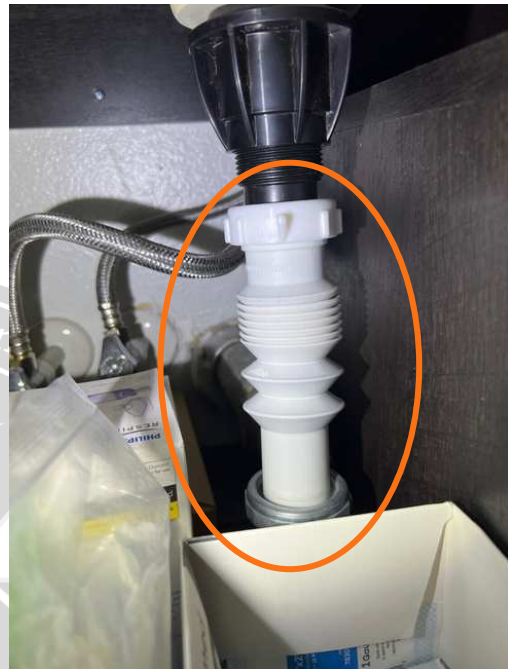
R171: Drain, Flexible Trap Assembly

While flexible trap assemblies may be functional they are not approved by the uniform plumbing code for permanent use. Flexible trap assemblies can harbor bacteria and emit a foul odor. It is for that reason we recommend the client consult with a plumbing contractor to replace flexible trap components located below the sink.

AI Estimated Cost: \$188 - \$375 *

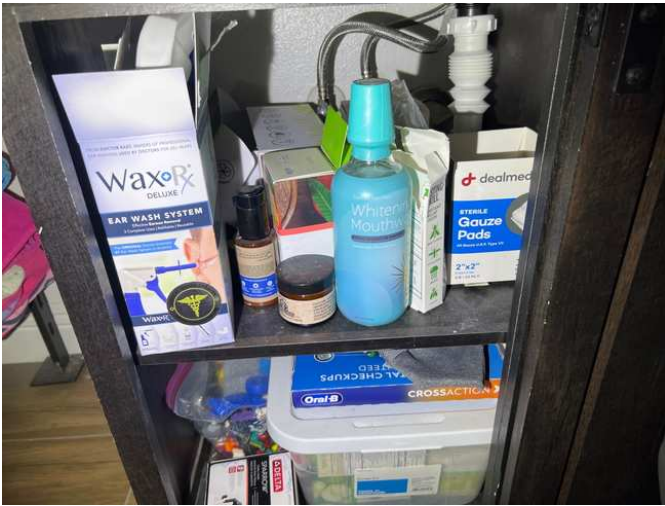
W172:

Personal items and storage below the sink prohibited a complete visual assessment. Defects or deficiencies may exist that were obstructed.

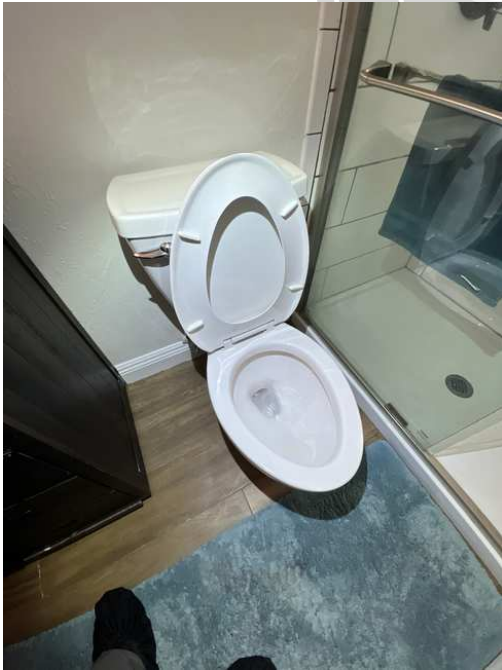
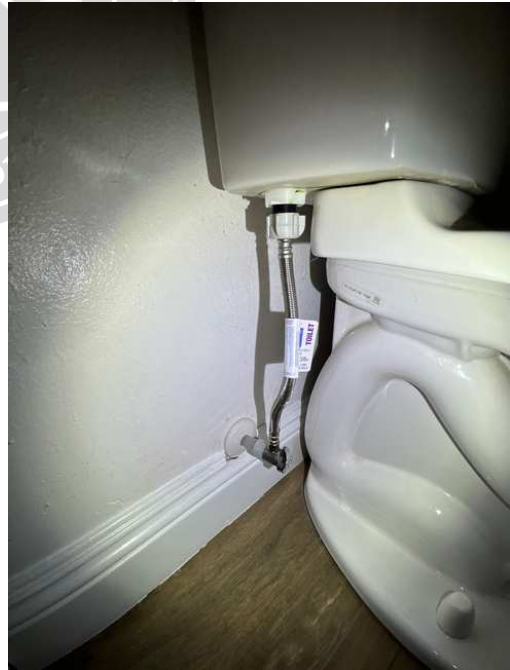
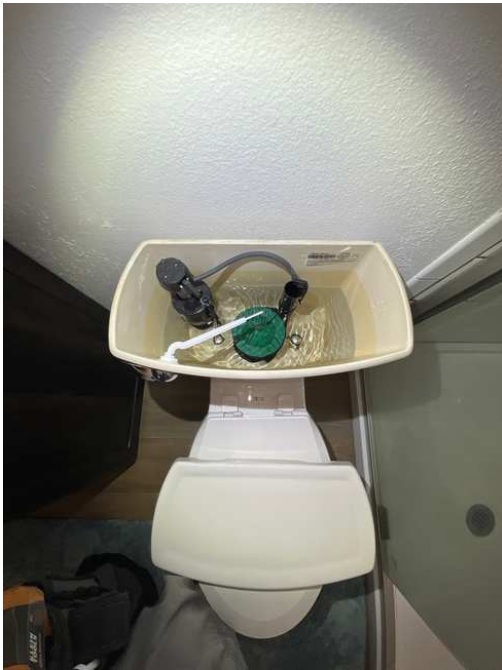
173:

The toilet was functional and in satisfactory condition.
