HOME INSPECTION REPORT

**Howard St
Upland, CA 91786**

Monday, May 18, 2026

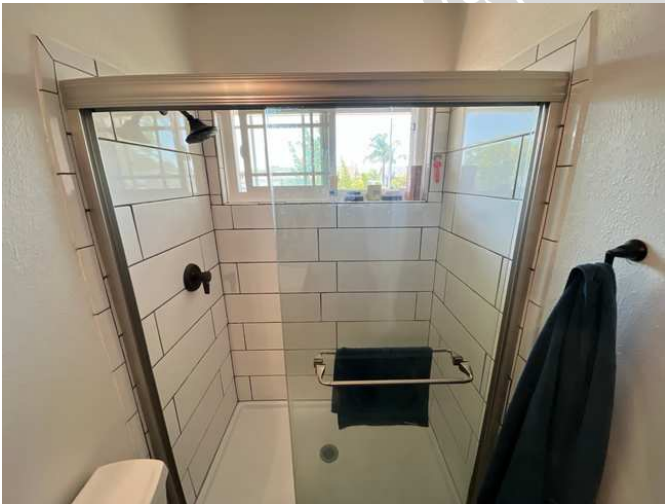
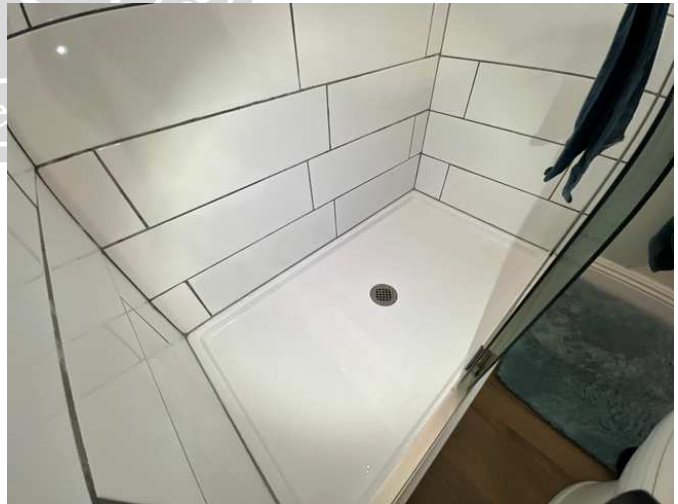
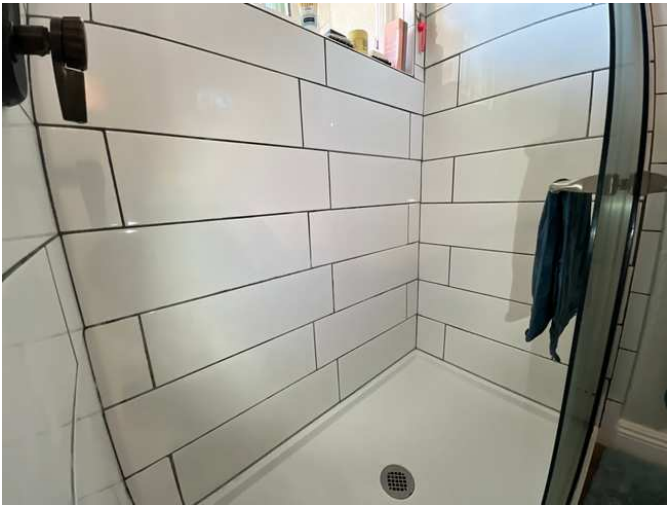
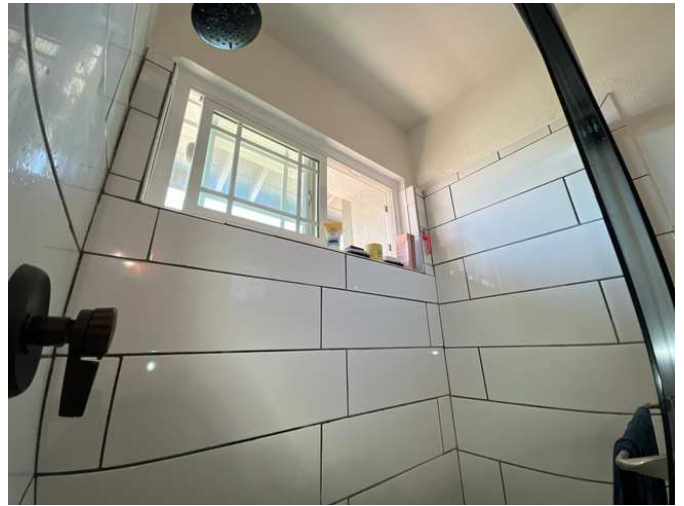
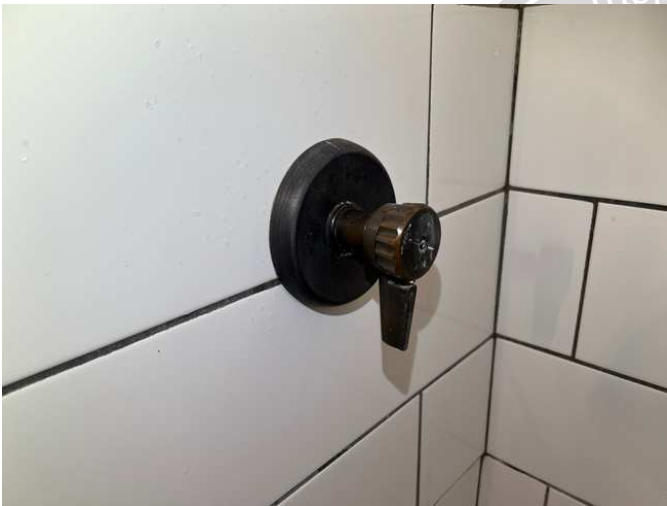
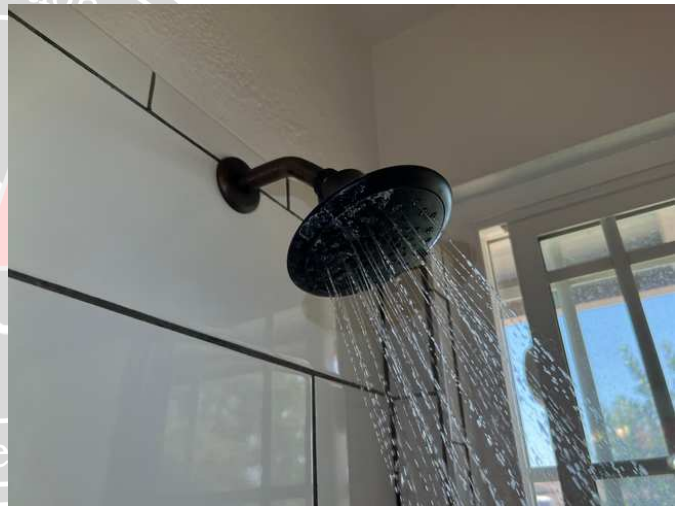
✓ **174: Shower Only**

The shower is showing signs of normal wear and tear.

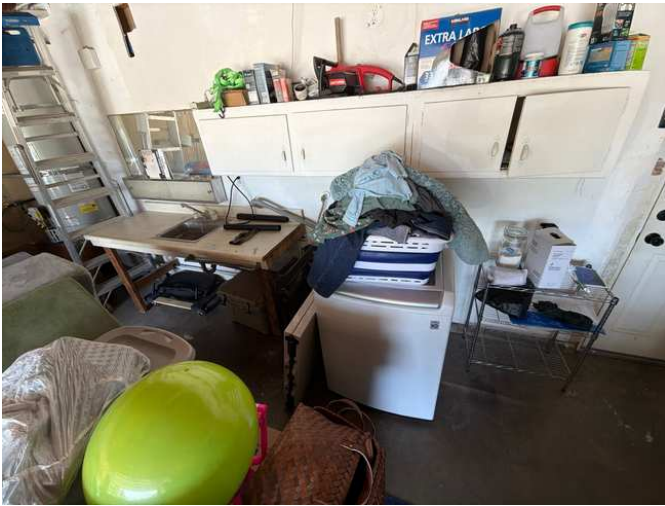
W175: Garage location

The laundry is located in the garage area. The laundry was likely relocated to the garage without permits.

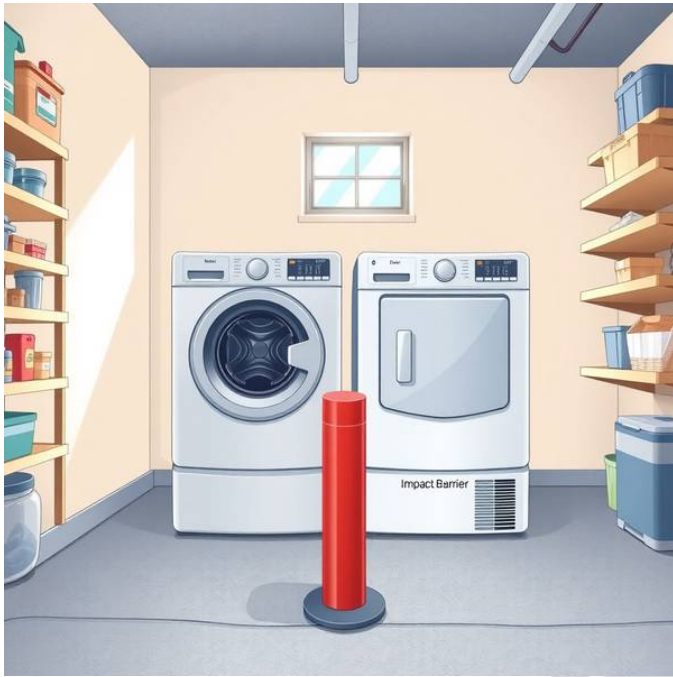
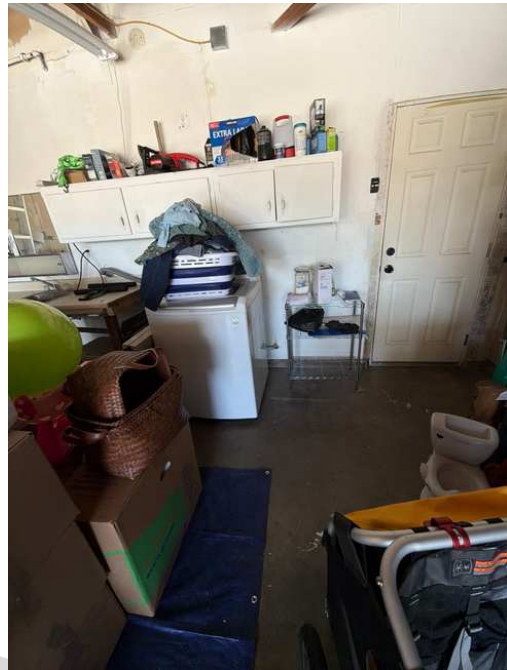
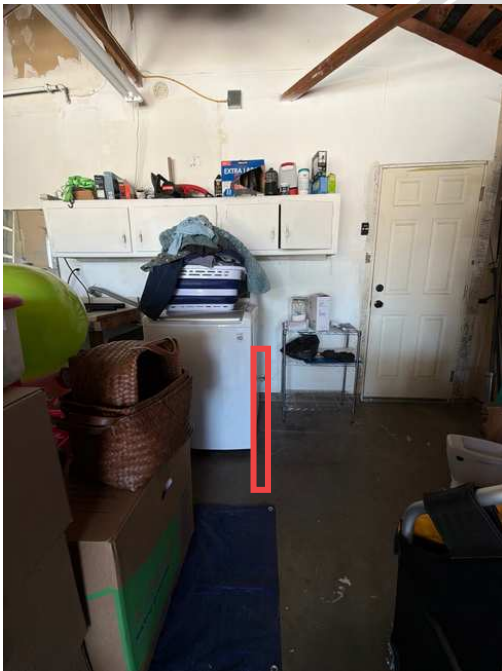
S176: Missing Impact Barrier

Parking bollards are steel tubes embedded in concrete to help prevent vehicles from running into laundry equipment. These actions can cause the gas line to become severed leading to gas fires. Parking bollards are needed for safety.

AI Estimated Cost: \$1,000 - \$1,875 *

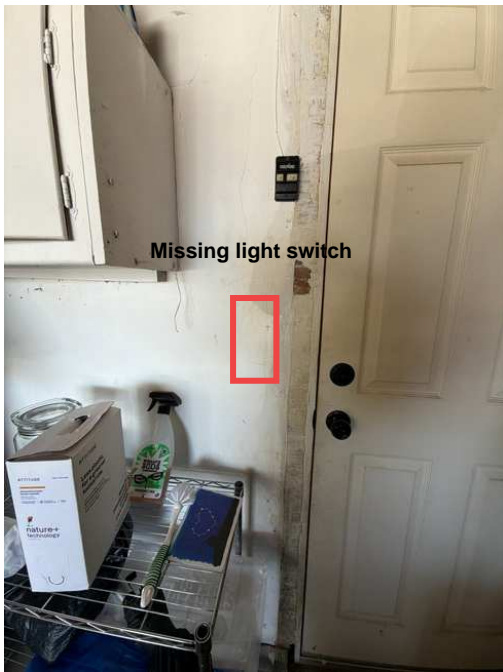
There are two primary entries for the garage. The main garage door and the main door. There was no light switch located at the main door. A three-way switch between the main garage door and the main door is needed for occupant safety.

AI Estimated Cost: \$250 - \$500 *

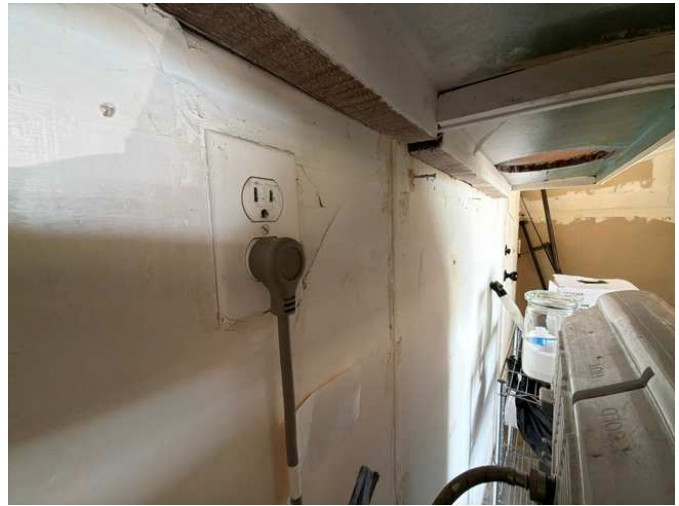
According to the national electrical code all laundry room receptacles must be AFCI and GFCI protected for occupant safety. Upgrades are needed. Safety hazard. Please click here for a complete cost guide to GFCI outlet installation.

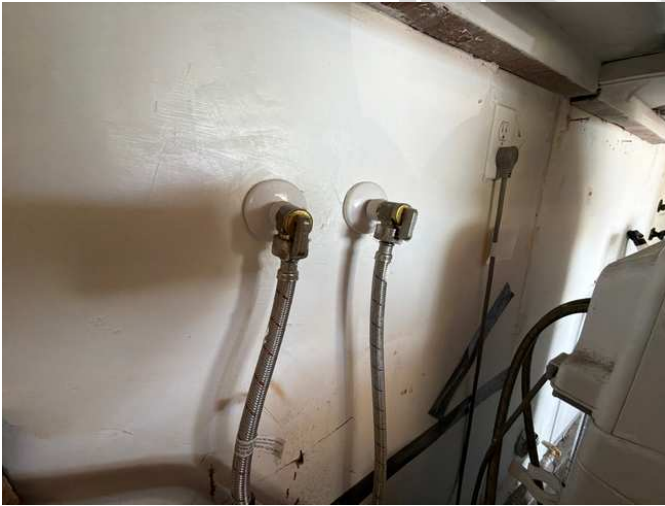
179:

Laundry connections were in satisfactory condition.

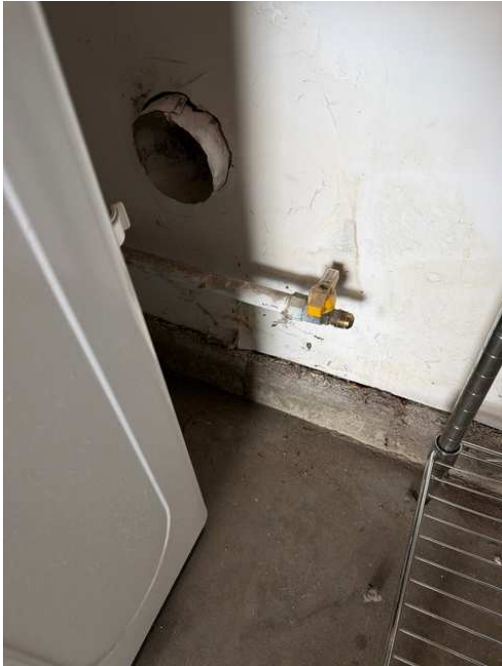
- ✓ **180:** The gas line and dryer connection was satisfactory.

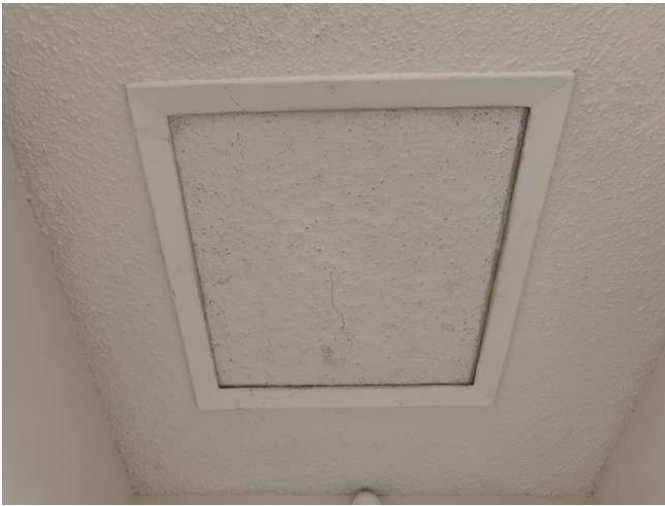
- ✓ **181:** The attic access hatch is of sufficient size for easy access into the attic area.

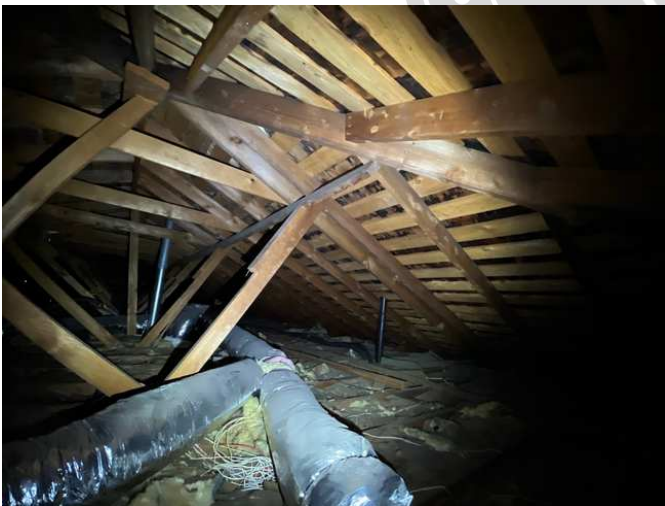
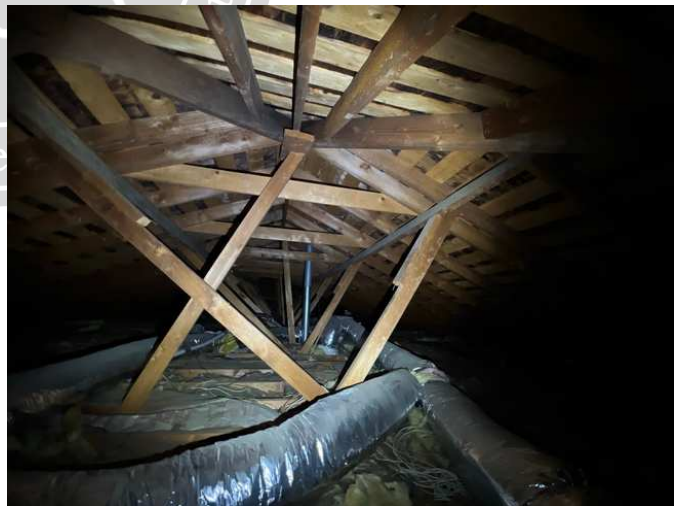
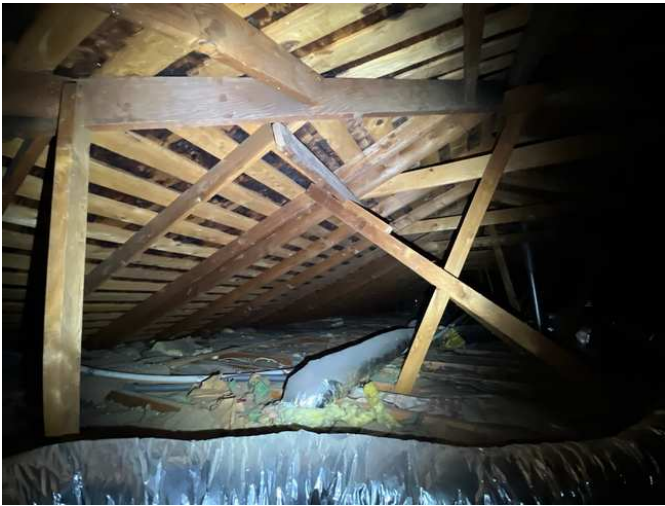
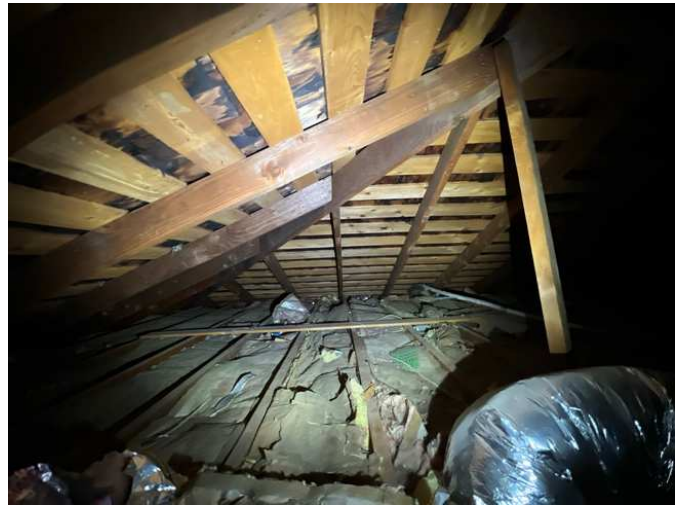
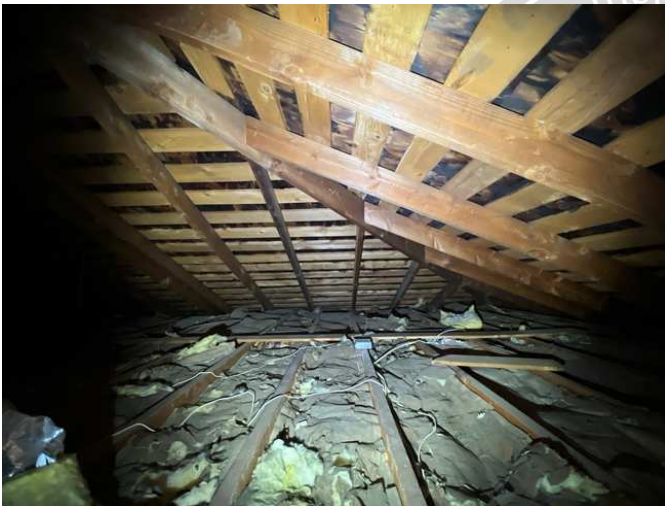
✓ **182:**

The roof rafters were in good condition. Midspan bracing and collar ties were satisfactory. There were no apparent signs of alterations or damage to the wood frame members.

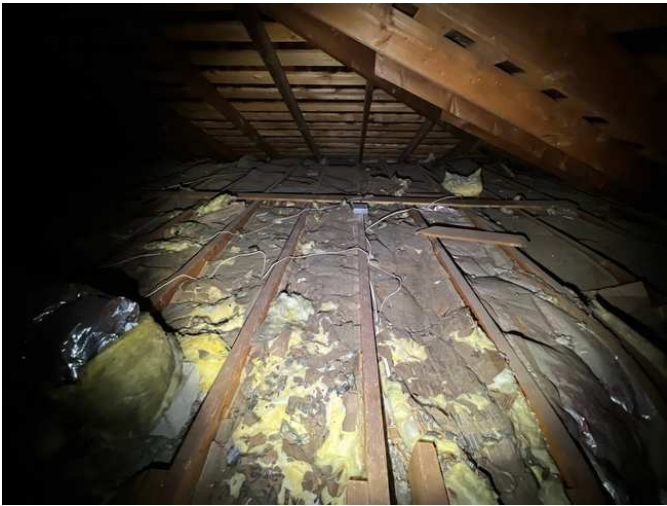
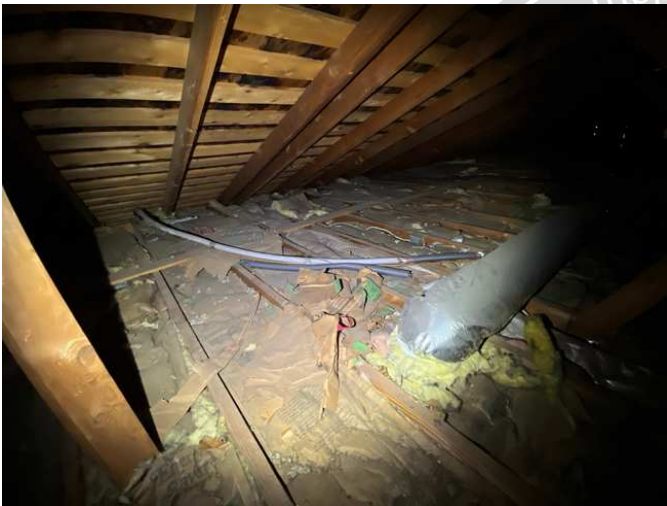
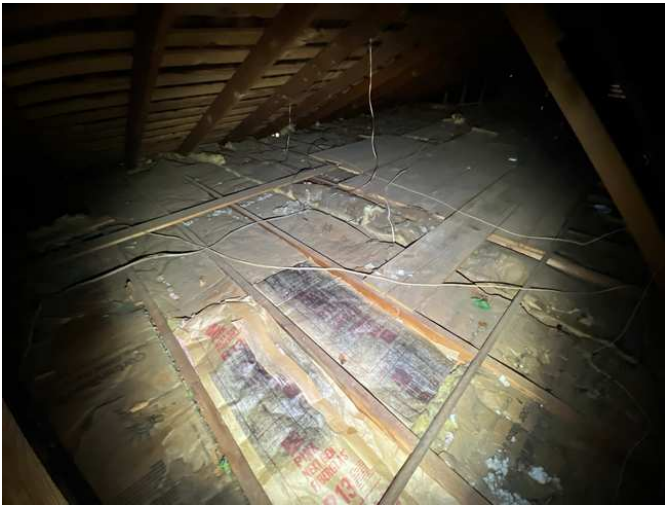
M183:

We recommend an additional 8 to 10 inches of insulation for energy savings and comfort.

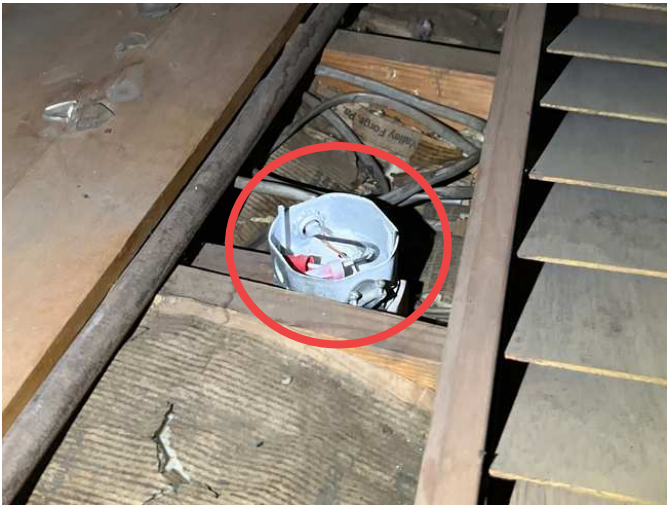
Junction box is missing a cover plate install cover plates as needed
