# HOME INSPECTION REPORT

PROFESSIONAL PROPERTY EVALUATION

Tuesday, July 7, 2026

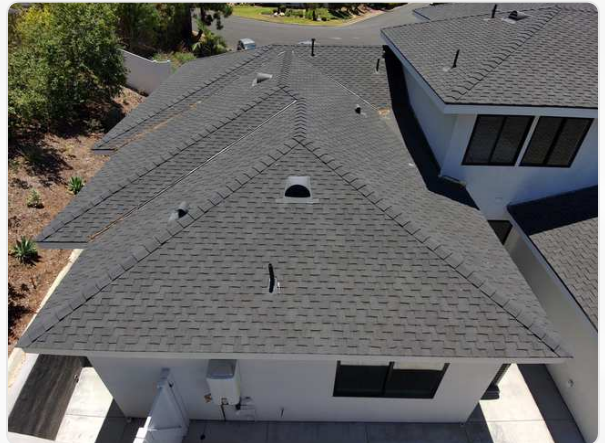
**SATISFACTORY 2**

**Roof Condition** — The tile roof system was in satisfactory condition overall. The home inspector can in no way offer an opinion as to whether the roof leaks today unless it is moderately raining at the time of inspection. If the client needs this determination, they should consult with a licensed roofing contractor to perform a wet test on the roof system to determine if it is water tight.

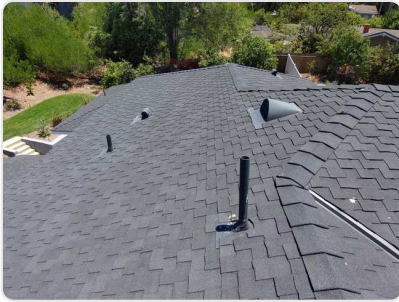
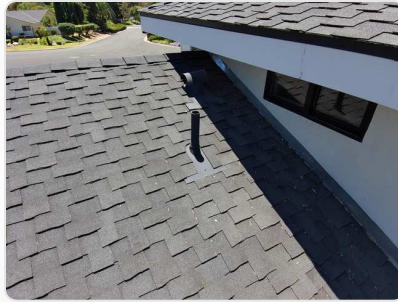
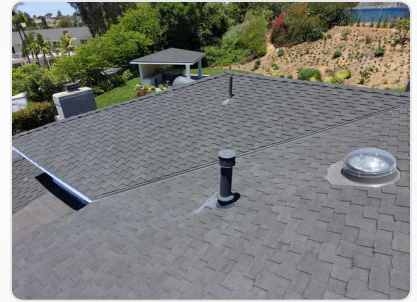
**Flashing Conditions** — Roof penetrations were in good condition. There were no apparent signs of water infiltration. Roof penetrations should be resealed every 5 to 8 years as part of regular home maintenance. And prevent water intrusion.

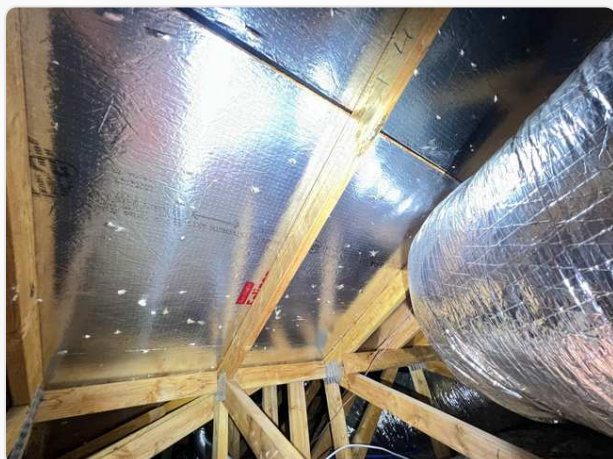
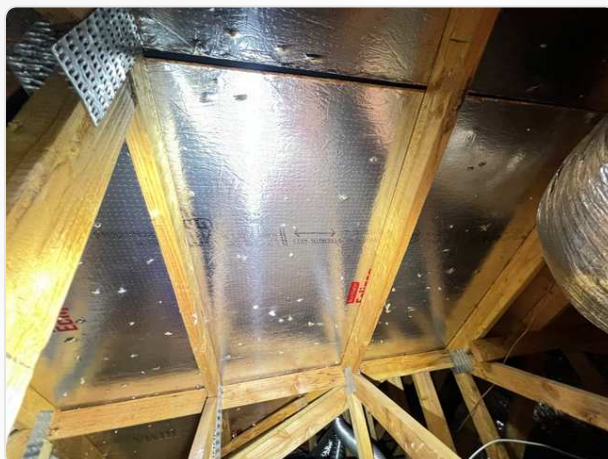
**SATISFACTORY** 4: Roof Deck  
**Satisfactory**

Roof Decking — The visible portions of the attic roof decking were in satisfactory condition.

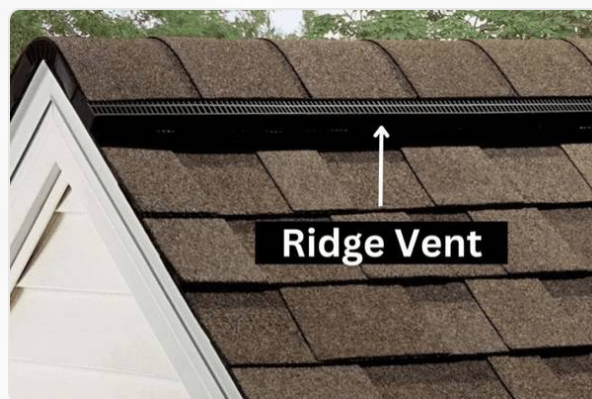
**WARNING** **W5: Missing Ridge Vent**

Ventilation — Manufactures of composition shingles recommend continuous roof vent systems to maintain the manufactures warranty. Dormer vents were utilized. A lack of ventilation will result in early deterioration of the shingles. Upgrades recommended.

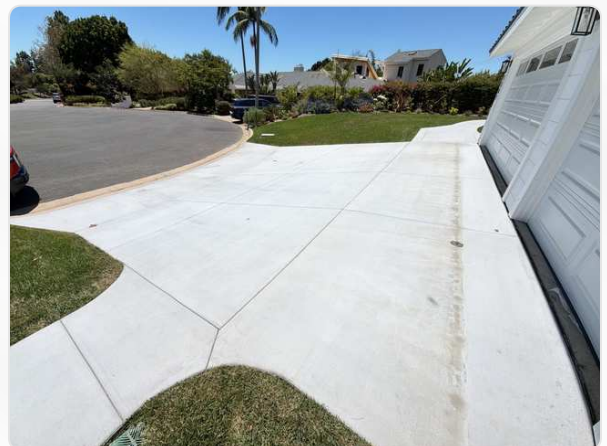
### SATISFACTORY 8

Driveway Observations — The driveway appeared to be in satisfactory and usable condition at the time of the inspection.

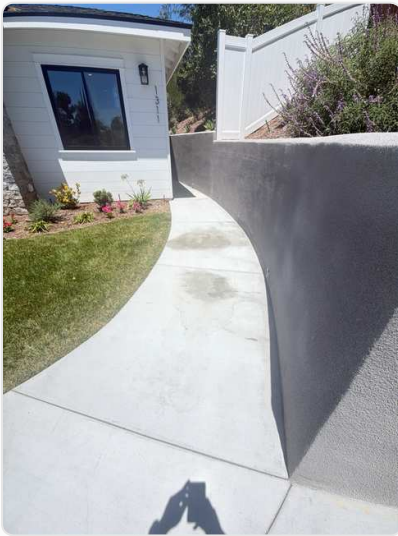
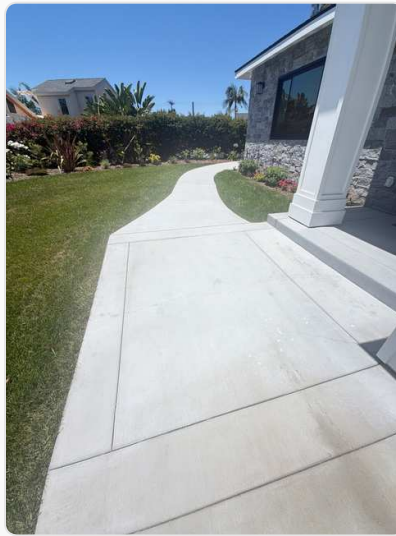
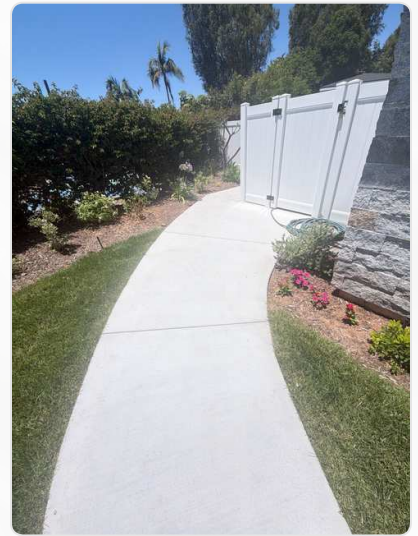
**SATISFACTORY 10**

Sidewalk Observations — The visible areas of the sidewalk appeared to be in serviceable condition at the time of the inspection.

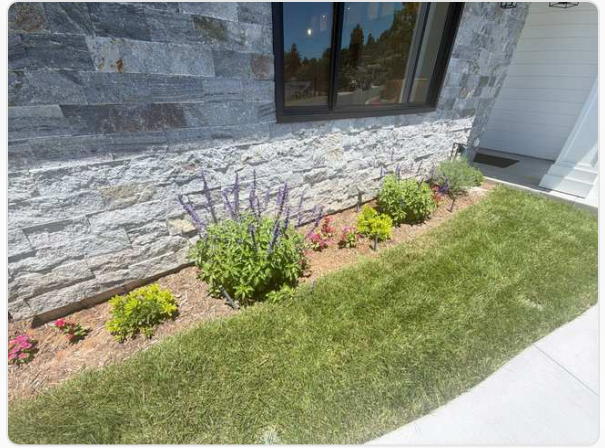
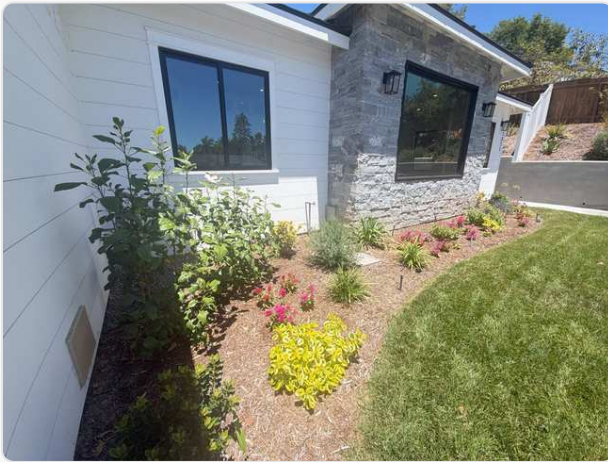
**WARNING****W12: Planters Warning**

Yard Conditions — Caution should be exercised not to over water planters at the front of the home. There was no evidence of water proofing against the foundation at the planters. Excessive watering can lead to water intrusion and deterioration of the foundation walls.

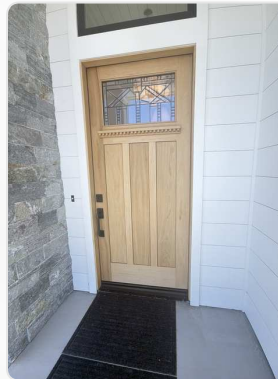
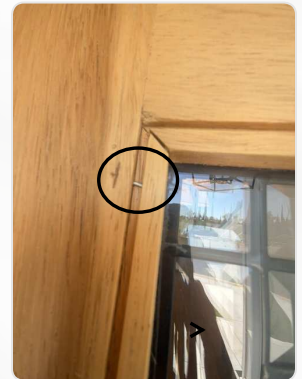
**SATISFACTORY 13**

Porch — Front porch was in satisfactory condition.

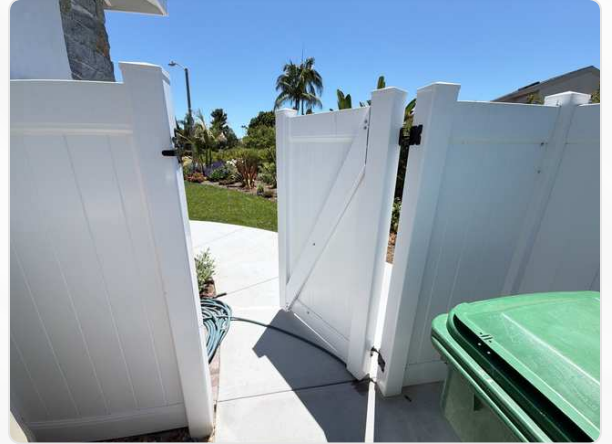
### SATISFACTORY 18

Gates — Gates were in satisfactory condition.

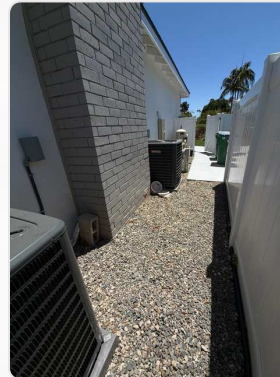
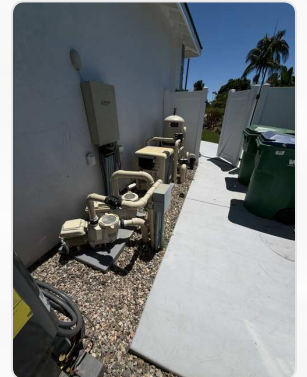
### SATISFACTORY 19: Satisfactory

Yard Conditions — Drainage at the front of the home is satisfactory.

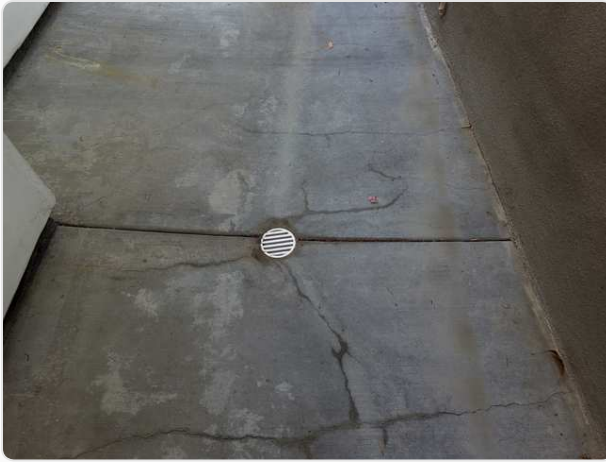
**WARNING** W20: Storm Drain  
**Warning**

Yard Conditions — It is vital to maintain clear storm drains. This will help prevent flooding during long sustained rains.

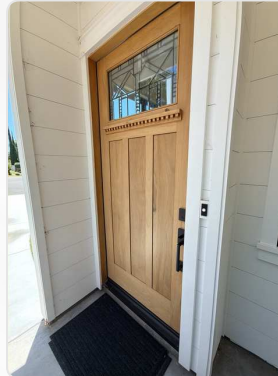
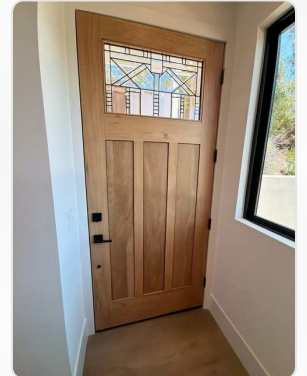
**SATISFACTORY** 21: Satisfactory

Entry Door — The side ADU main entry door was functional. There were no signs of water infiltration.

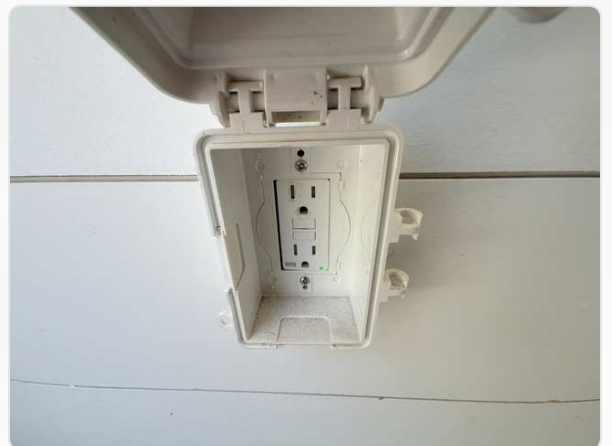
**SATISFACTORY** 22: GFCI's  
**Satisfactory**

Receptacle Conditions — The receptacle photographed was tested and found to be GFCI protected. The inspector will make an attempt to verify that all outlets are GFCI protected. However, some receptacles such as those hidden in flower planters or those that are outside view may-not be tested.

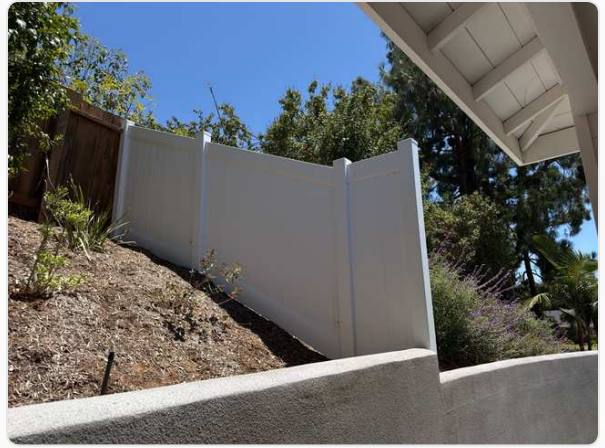
**SATISFACTORY 25: Appeared Serviceable**

Retaining Wall Conditions — The visible and accessible portions of the retaining walls appeared to be in serviceable condition at the time of the inspection.

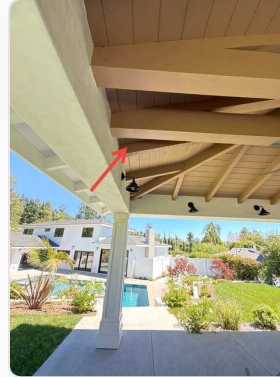
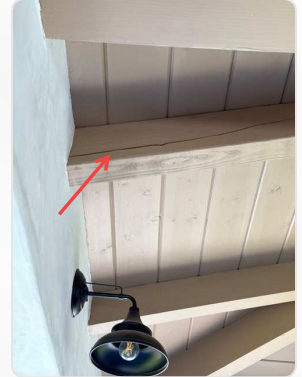
### REPAIR R26

Yard Conditions — One of the wooden support timbers for the roof over the barbecue was split. Client may wish to discuss this condition with a qualified individual for repair or replacement.

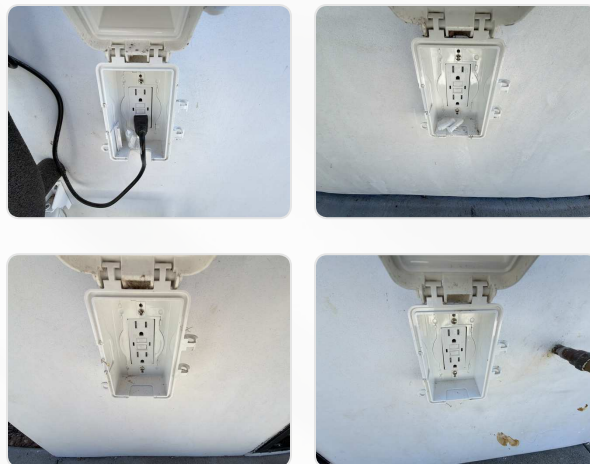
**SATISFACTORY 28**

**Receptacle Conditions** — The receptacles photographed were tested and found to be GFCI protected. The inspector will make an attempt to verify that all outlets are GFCI protected. However, some receptacles such as those hidden in flower planters or those that are outside view may-not be tested.

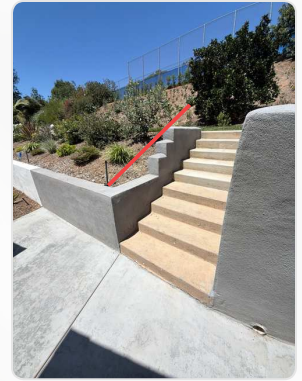
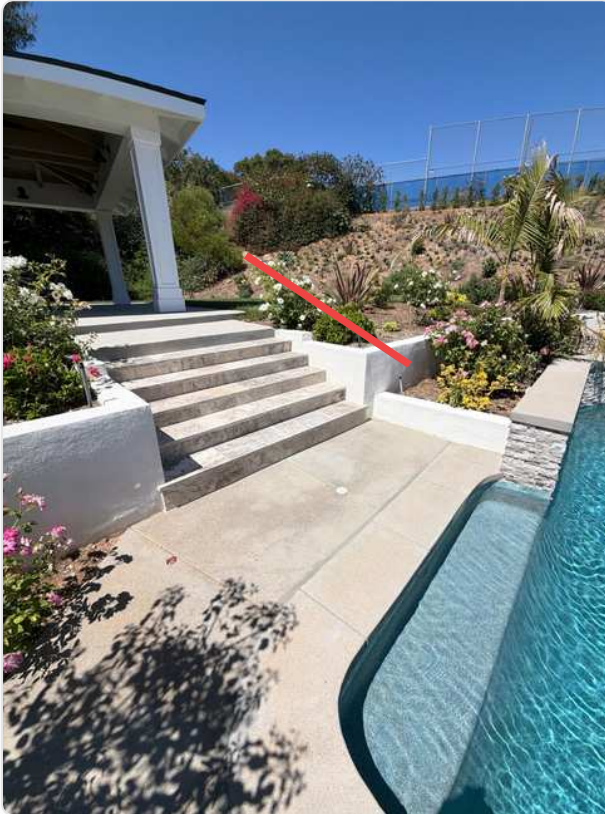
**SAFETY** **S33: Handrail  
Damaged/Missing**

Exterior Steps — The handrail had damaged/missing components. Consult with a general contractor for repairs. Safety concern.

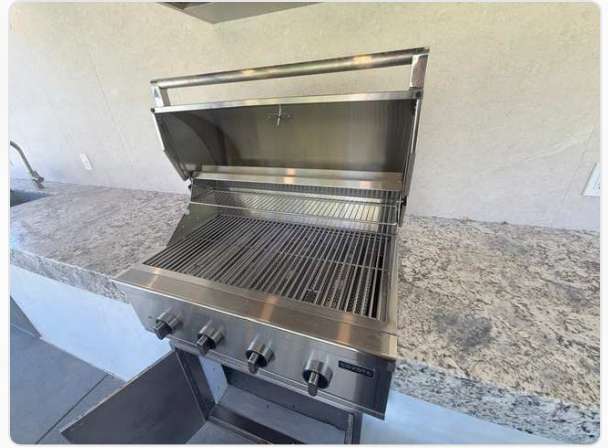
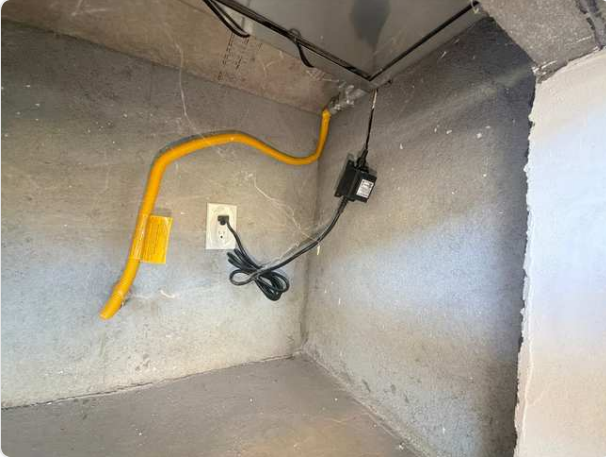
**SATISFACTORY 34: Not Inspected**

Barbecue — Barbecue is in new condition and appear serviceable. Barbecues are excluded from the home inspection process. Furthermore barbecues are excluded from the industry standards of practice of which your home inspection was performed. The barbecue may have been tested for gas leaks as a courtesy to the client only.

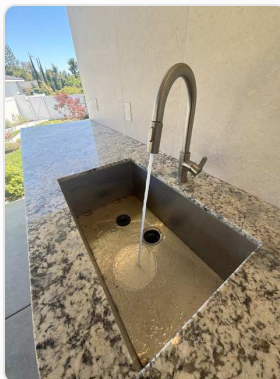
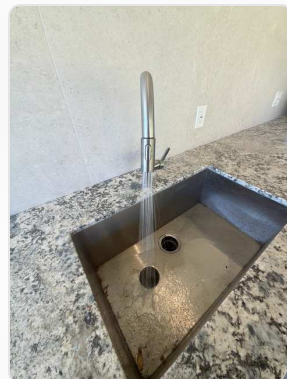
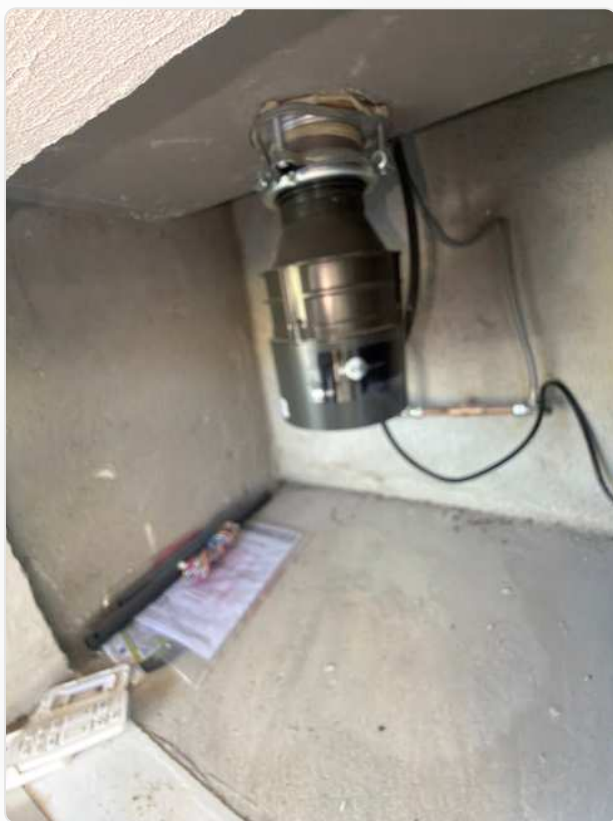
**SATISFACTORY****36: Satisfactory**

Outdoor Sink — The outdoor sink was in satisfactory condition. Faucet was functional.

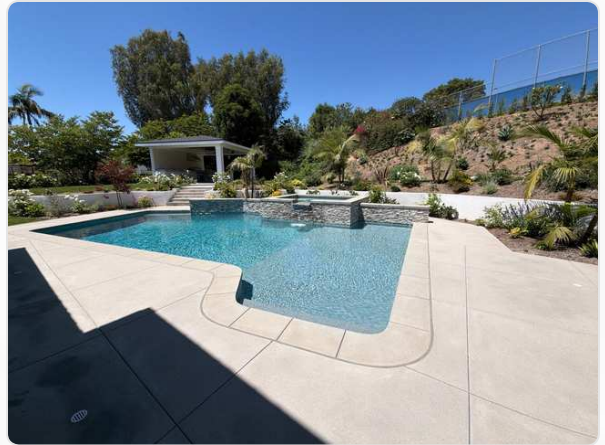
Pool Barrier Conditions — A properly installed child barrier fence is highly recommended for pool safety. Client should consult with a pool contractor for cost of installation.

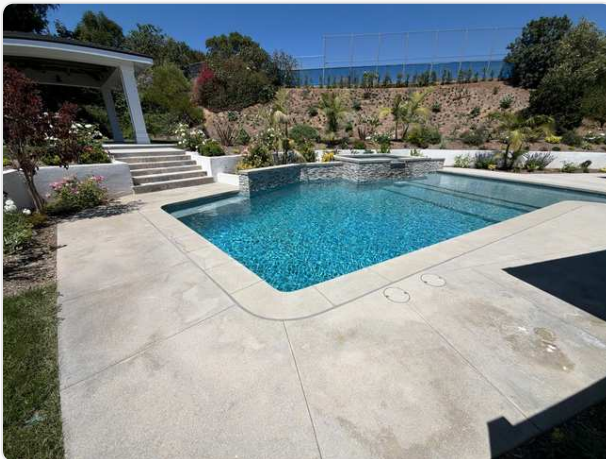
**SATISFACTORY 39**

Concrete Decking — The concrete decking surrounding the swimming pool was in satisfactory condition. Minor hairline cracks were noted but are considered normal.

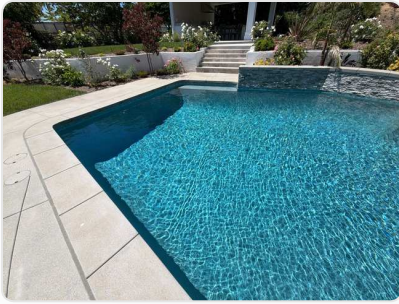
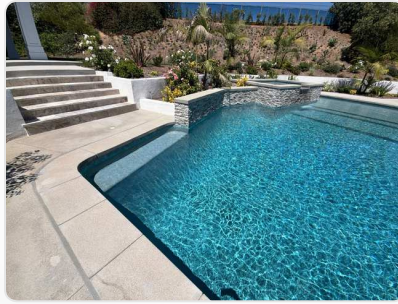
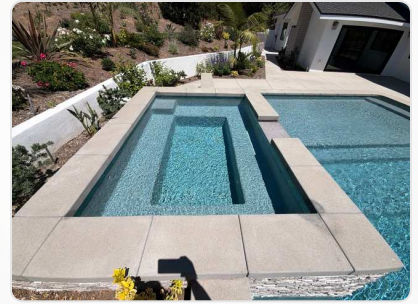
**SATISFACTORY 40**

Pool General Conditions — Pebble-Tec liner was in satisfactory condition.

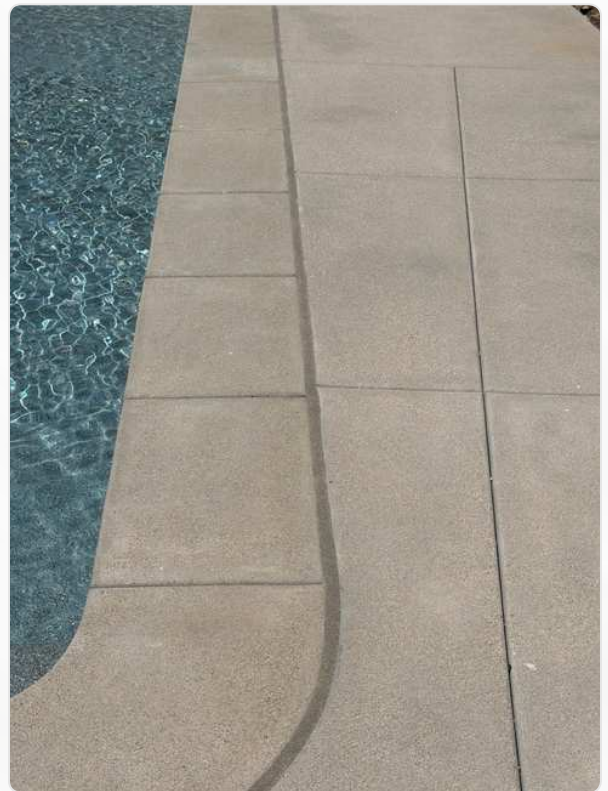
**SATISFACTORY** **41: Elastomeric Seal Satisfactory**

Elastomeric Seal — The elastomeric seal was in satisfactory condition.

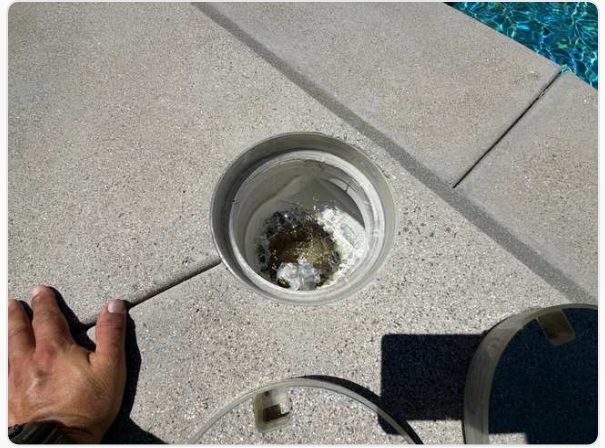
**SATISFACTORY 43**

Skimmer — The skimmer was in satisfactory condition. The cover was intact.

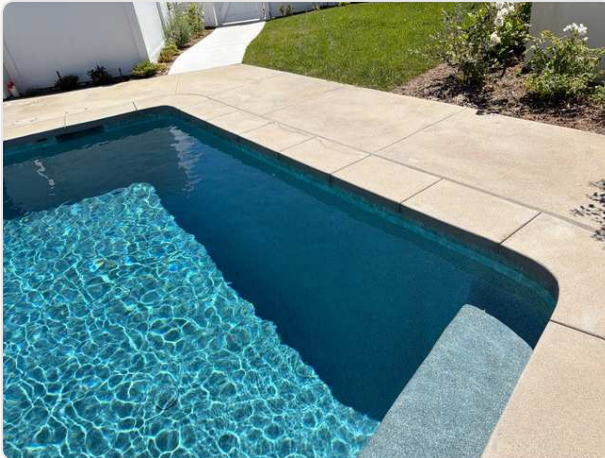
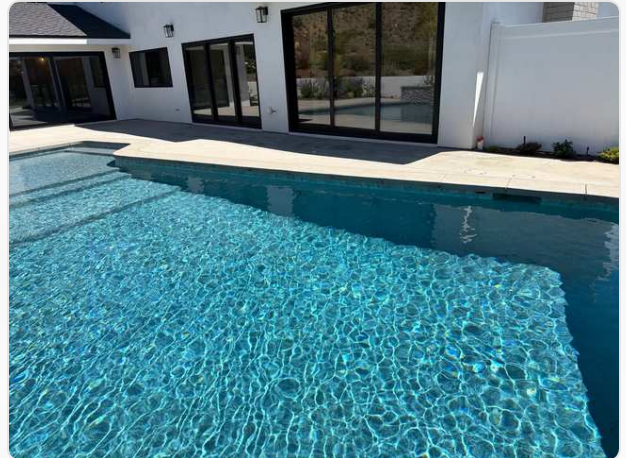
**SATISFACTORY 44**

Water Line Tile Condition — The pool tile surrounding the waterline was in satisfactory condition.

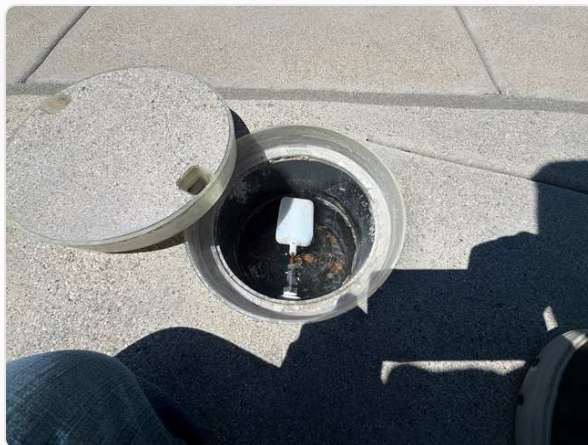
**SATISFACTORY 46**

Fill Valve — The pool fill valve was present and functional. Backflow preventer present and functional.

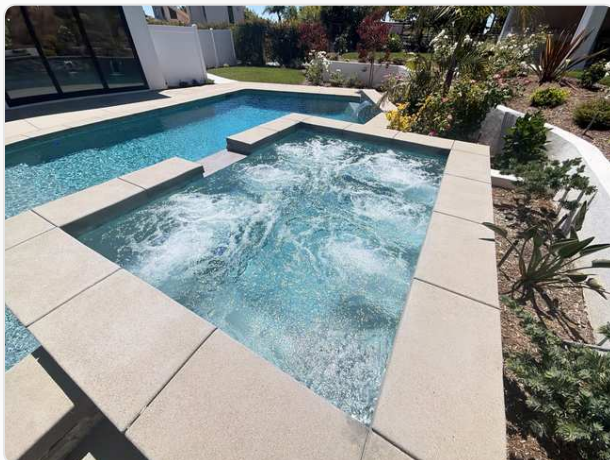
**SATISFACTORY 47**

Water Features

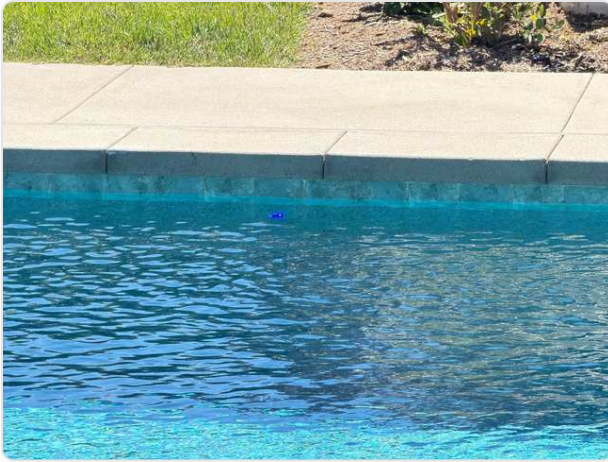
**SATISFACTORY 48**

Pool/Spa Lighting — Underwater lights were tested and found to be functional on the day of inspection.

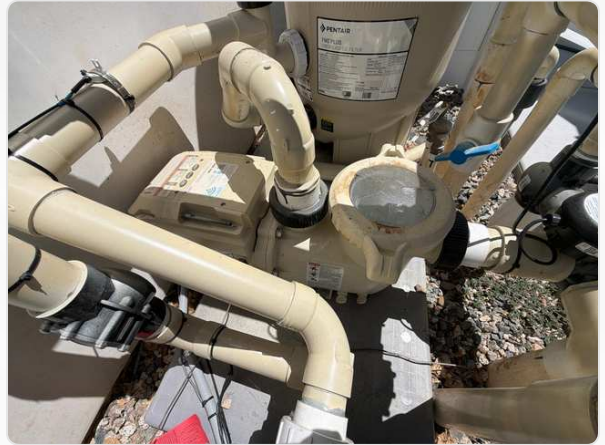
**NOTE 49**

Pump 1 — Pump is an energy compliant, variable speed pump.

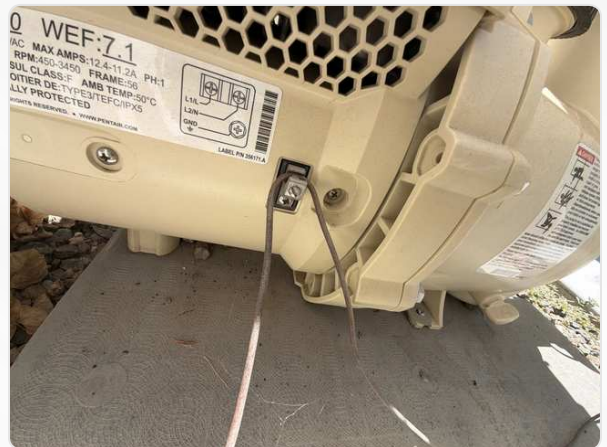
**SATISFACTORY 50: Bonding Ground Present**

Pump 1 — Bonding ground was present and tight.

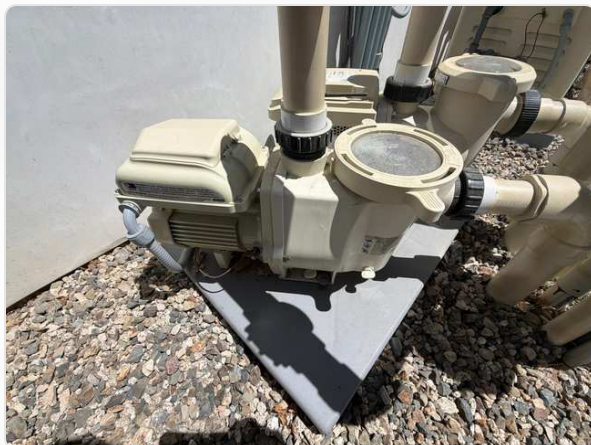
**NOTE 51**

Pump 3 — Pump is an energy compliant, variable speed pump.

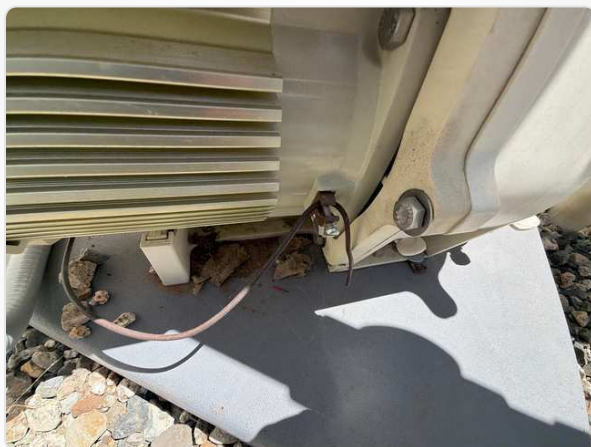
**SATISFACTORY 52**

Pump 3 — Bonding ground was present and tight.

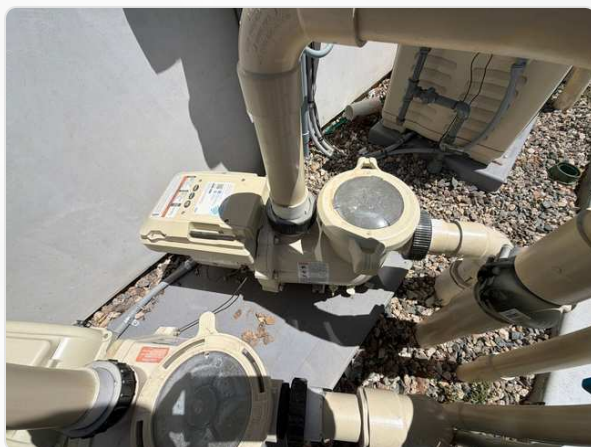
**NOTE 53**

Pump 2 — Pump is an energy compliant, variable speed pump.

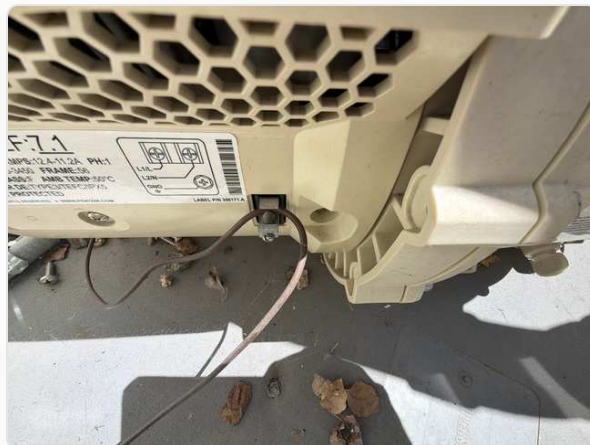
**SATISFACTORY** **54: Bonding  
Ground Present**

Pump 2 — Bonding ground was present and tight.

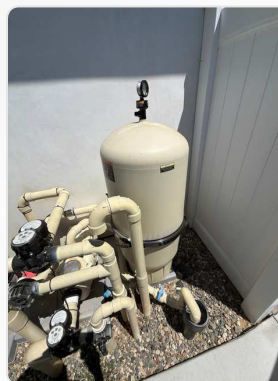
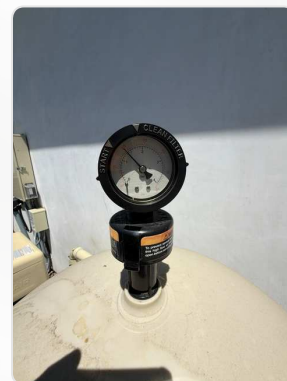
**SATISFACTORY** **55**

Filter — The filter was in satisfactory condition. There were no apparent signs of leaks. Pressure gauge and bleeder valve were functional.

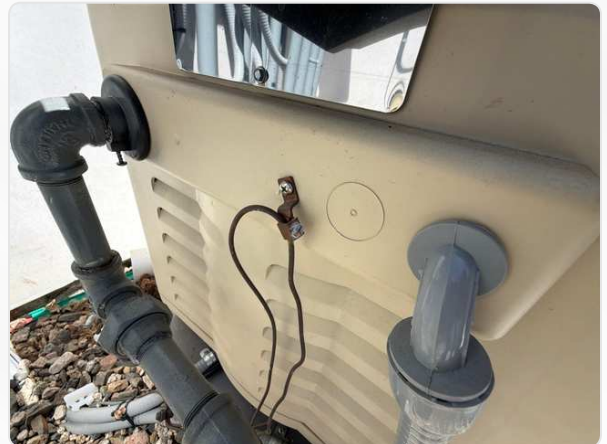
**SATISFACTORY 58: Bonding Ground Present**

Heater — Bonding ground was present and tight.

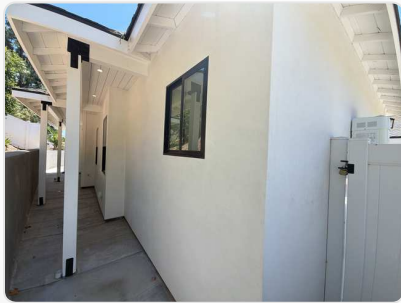
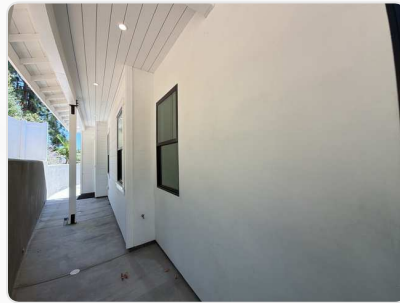
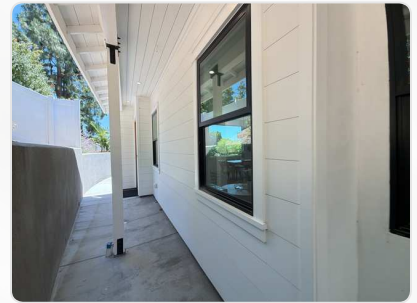
Exterior Wall Conditions — Exterior wall surfaces are comprised of siding, stone, veneer, and stucco. Wall conditions appear to be normal and in good overall condition.

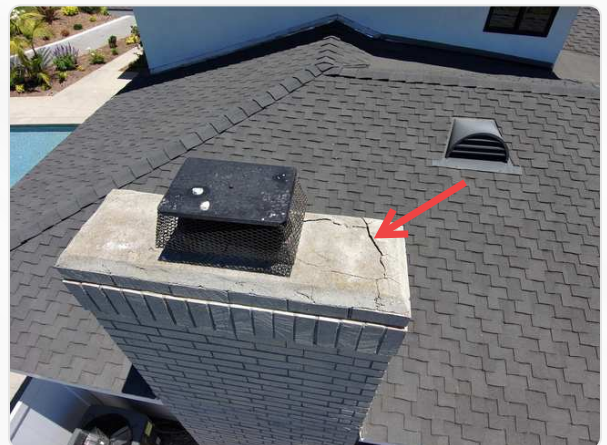
**REPAIR****R67: Mortar Cap/Crown**

Chimney Conditions — Evidence of weathering and cracks were noted at the chimney crown. Repairs are needed to help prevent water intrusion into the chimney cavity. Consult with a brickmason for evaluation and repairs.

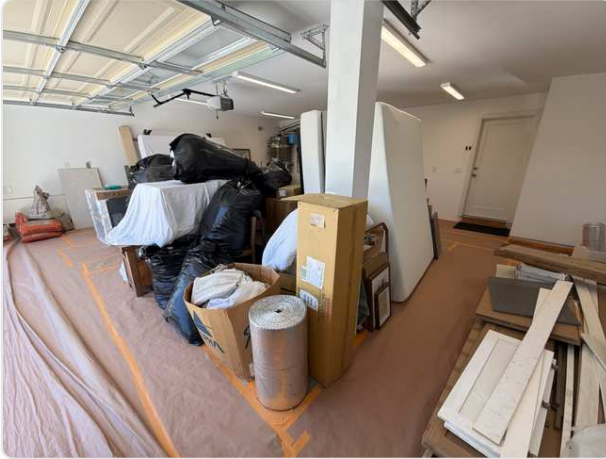
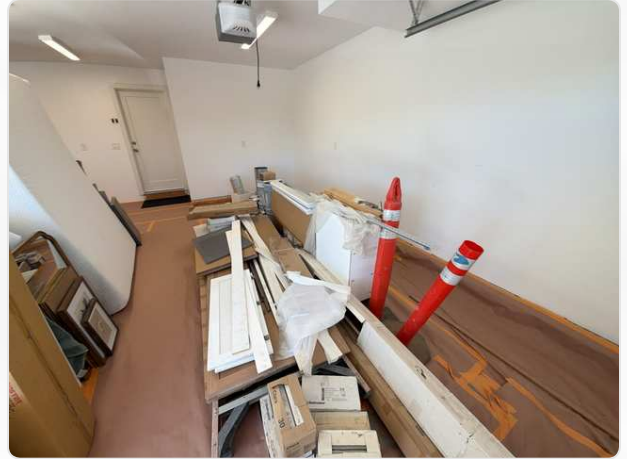
**WARNING W74: Could Not Be Inspected**

Slab — The slab could not be inspected because it was covered by floor covering. Floor covering may cover significant defects and deficiencies that may adversely affect your decision to purchase the property. It is strongly suggested that any floor coverings be removed and the slab be evaluated prior to the close of escrow.

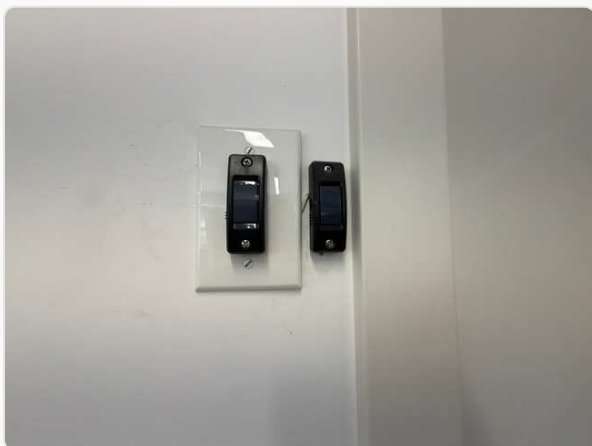
**NOTE 80**

Opener and Safety Sensors — Garage door opener and safety sensors were new condition, but could not be tested because they were not plugged in on the day of inspection.

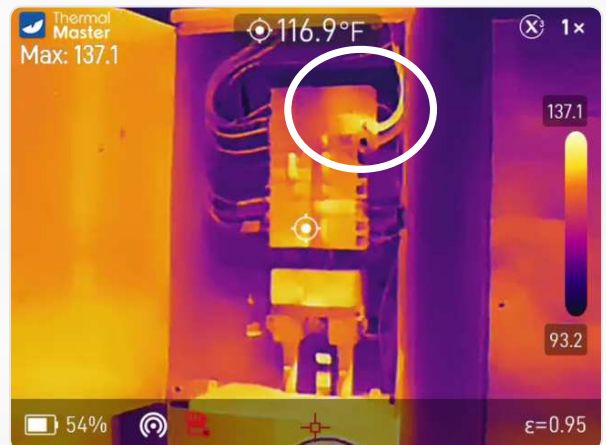
**FURTHER EVALUATION E84**

**General Condition** — Thermal imaging inspection of the main electrical panel revealed abnormal temperature patterns or hotspots indicative of loose connections, overloaded circuits, or deteriorated components at the time of scanning. Consult with a qualified individual for further evaluation and resolution.

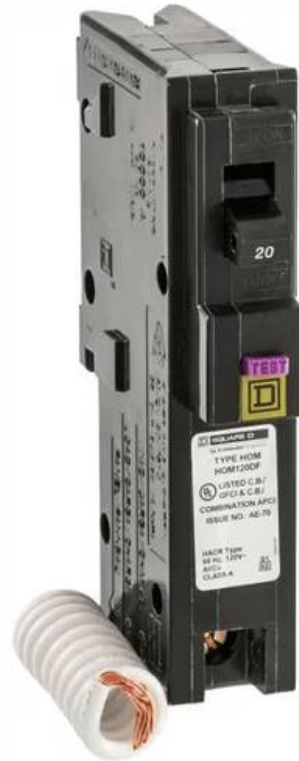
### **WARNING** W86: Missing AFCI Circuit Breakers

AFCI Circuit Breakers — In 2020 the National Electrical Code (NEC) 210.12 required that all 120v 15 and 20 amp branch circuits feeding convenience outlets and devices be protected by an AFCI circuit breaker. Including but not limited to kitchen, family rooms, dining room, living room, parlors, libraries, dens, bedrooms, Sun rooms and patios, recreation rooms, closets, hallways, laundry areas and or similar rooms. The National Fire Protection Authority (NFPA) recognizes that AFCI circuit breaker's can greatly reduce the risk of fire at receptacles throughout the dwelling caused by arc fault conditions. It is for that reason we at California Inspection Authority recommend the client consult with a licensed electrical contractor for installation of such safety devices.

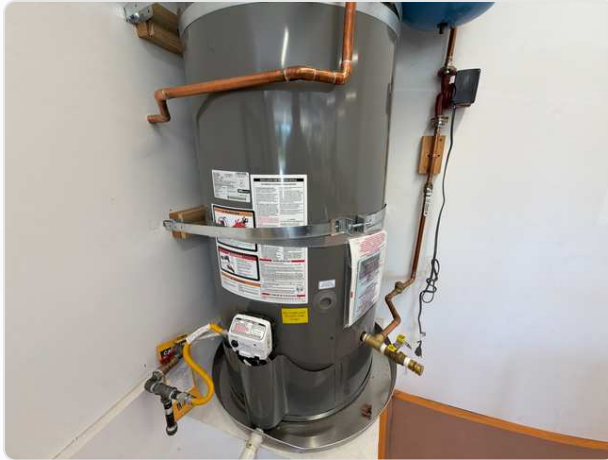
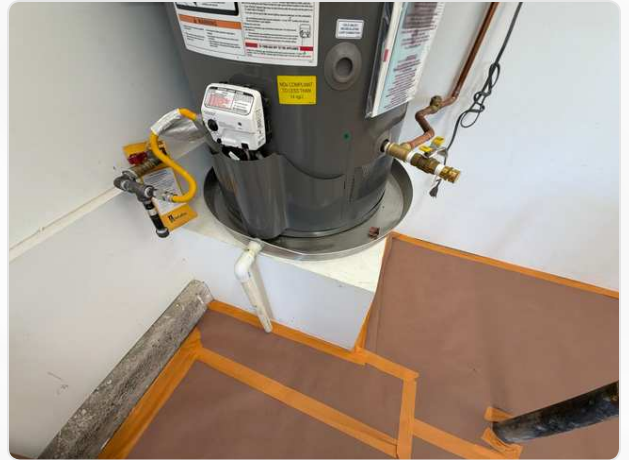
**SATISFACTORY 109**

Water Heater General Conditions — Hot water heater was in satisfactory condition.

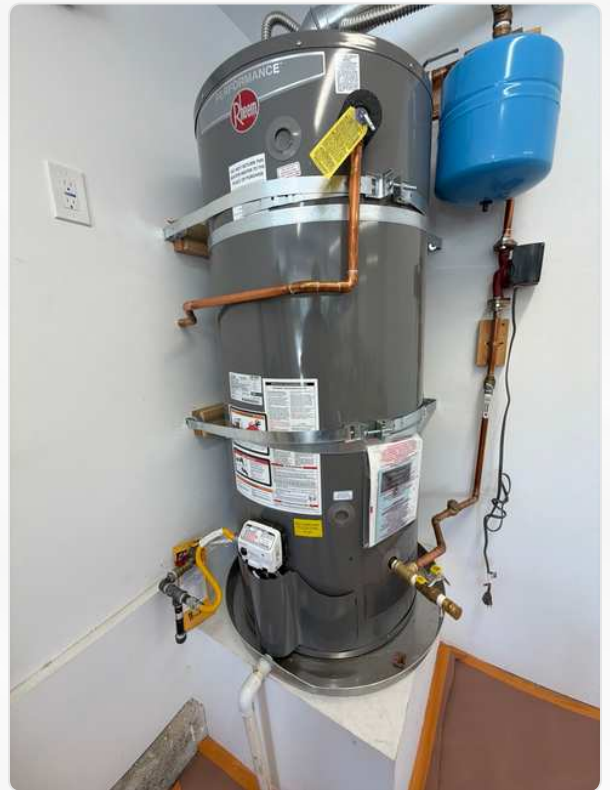
**SATISFACTORY 110: Adequate Size**

Capacity — Based on national water heater charts the hot water heater for the home is adequate.

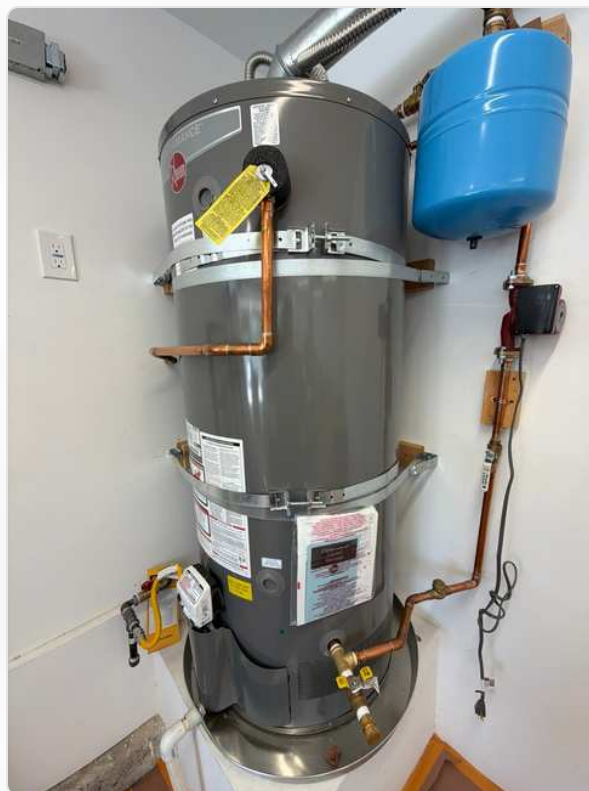
**SATISFACTORY 115**

TPR Valve — The TPR valve was in satisfactory condition. There were no signs of leaks, rust or corrosion.

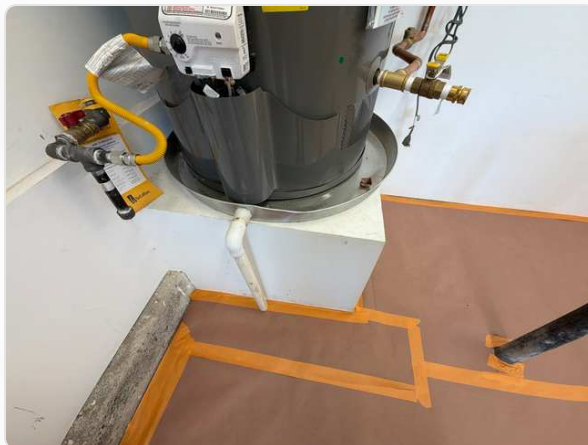
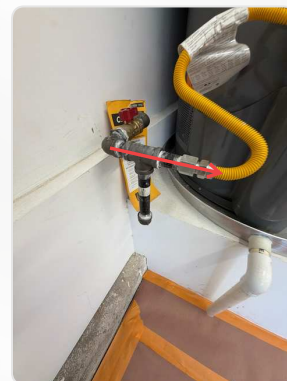
**WARNING W117: Sediment Leg**

Gas Line — Gas line, sediment leg, and or drip leg was not installed in the correct orientation. Referred to diagram.

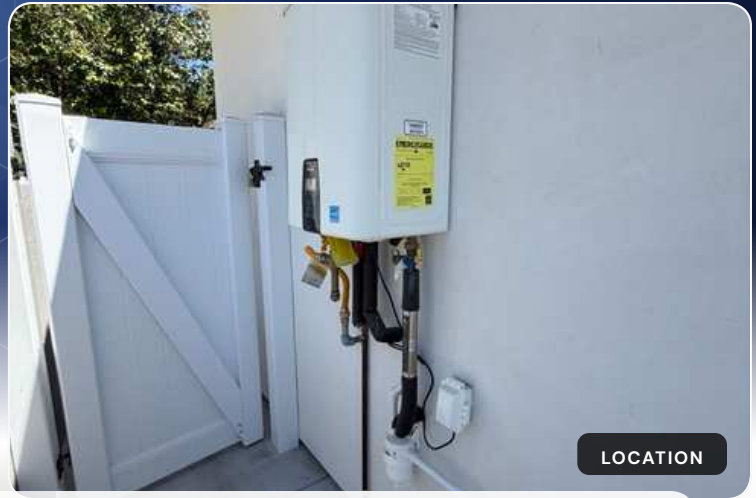
#### SATISFACTORY 118

Location — Tankless hot water heater is located at the rear of the property behind the ADU

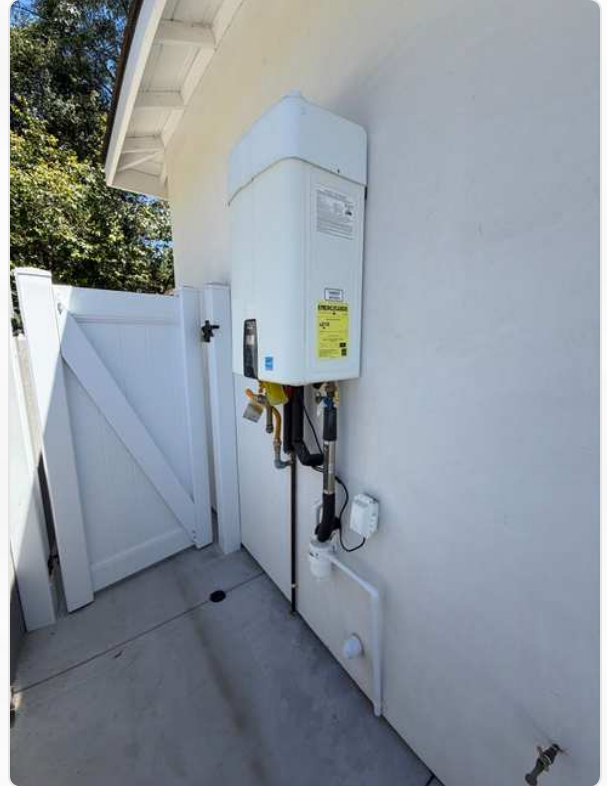
#### SATISFACTORY 119

Water Heater General Conditions — Hot water heater was in satisfactory condition.

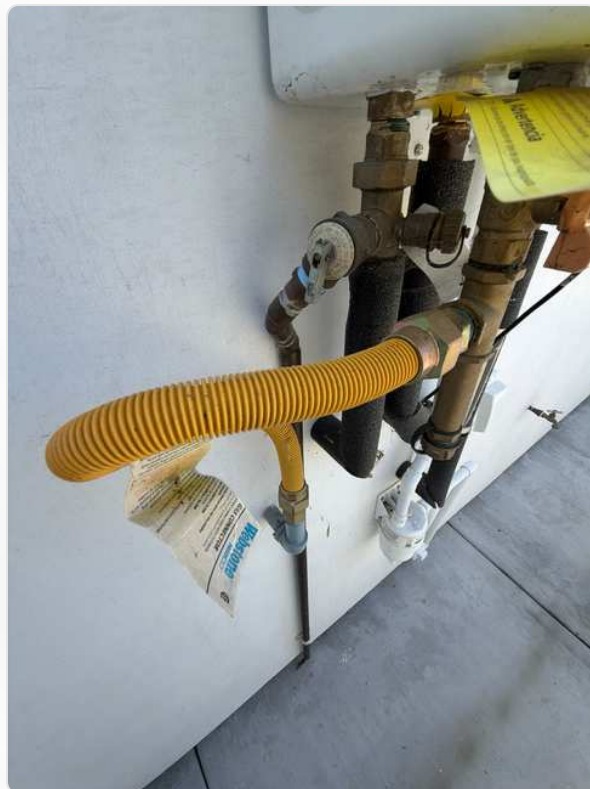
**SATISFACTORY 122: Satisfactory**

Gas Line — The gas line was in satisfactory condition. No gas leaks were detected.

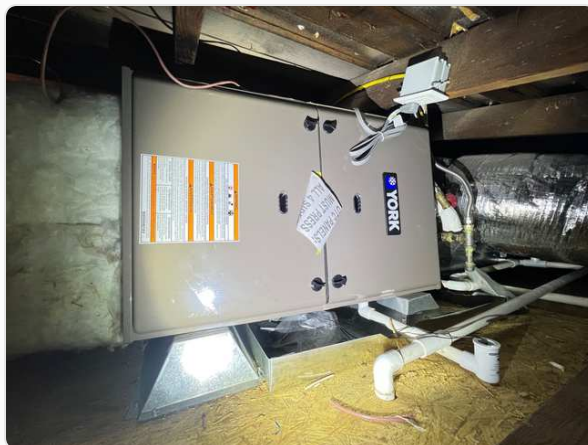
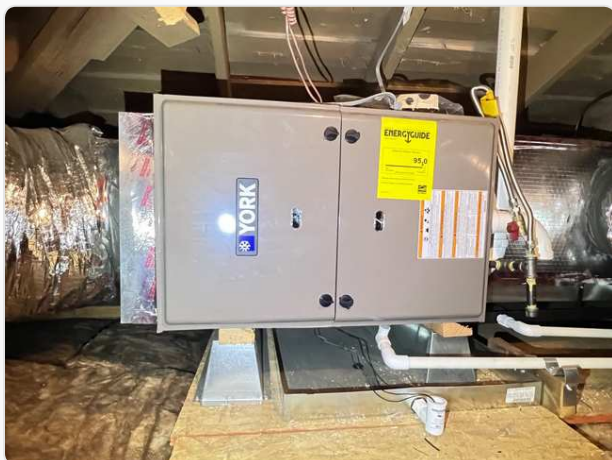
**REPAIR R126**

**Heating System Condition —** The horizontal gas furnace was observed to be elevated using wood blocking placed on top of the metal furnace stand supports. While the furnace is supported, the use of combustible wood spacers is not considered an appropriate support method for this type of installation. If additional elevation was required, properly sized code-compliant metal furnace stands or supports should have been used. Recommend consultation with the builder or a qualified HVAC contractor to evaluate the installation and provide proper support as necessary.

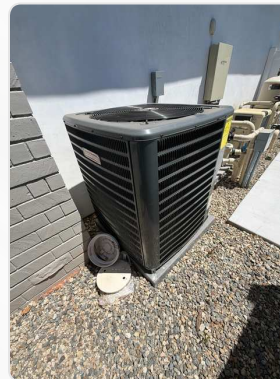
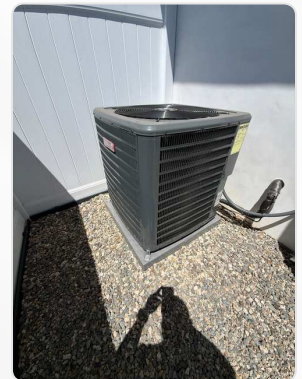
**SATISFACTORY** **133**

Condenser Conditions — A/C condenser responded normally to testing.

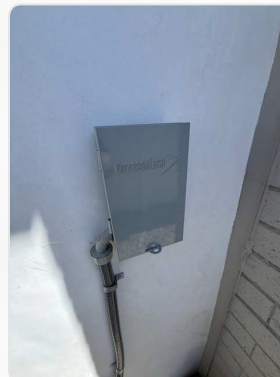
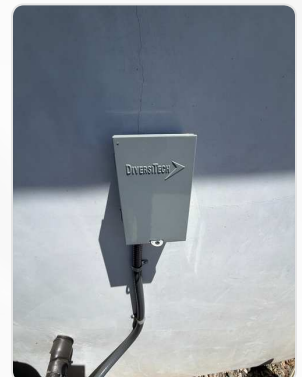
## MAINTENANCE M134: Caulking Needed

Service Disconnect — The service disconnect should be properly sealed to the structure.

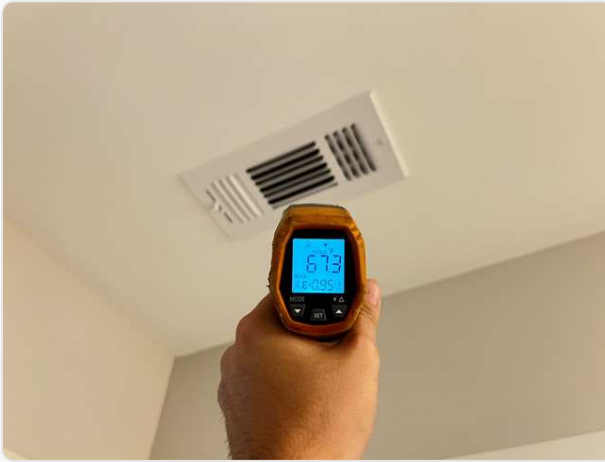
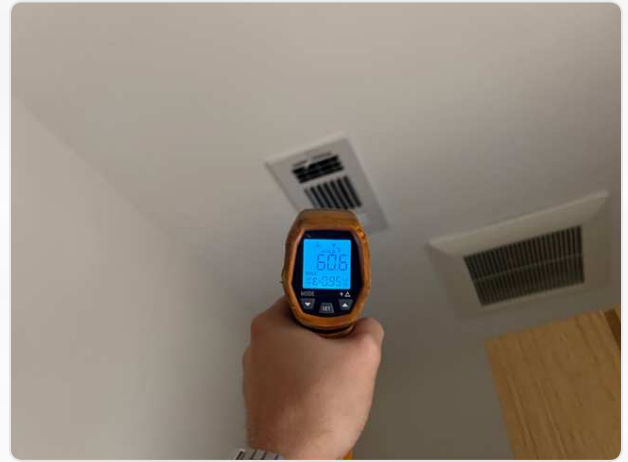
**SATISFACTORY****137: Satisfactory**

Output Temperature — Output temperatures as tested on the day of inspection were satisfactory.

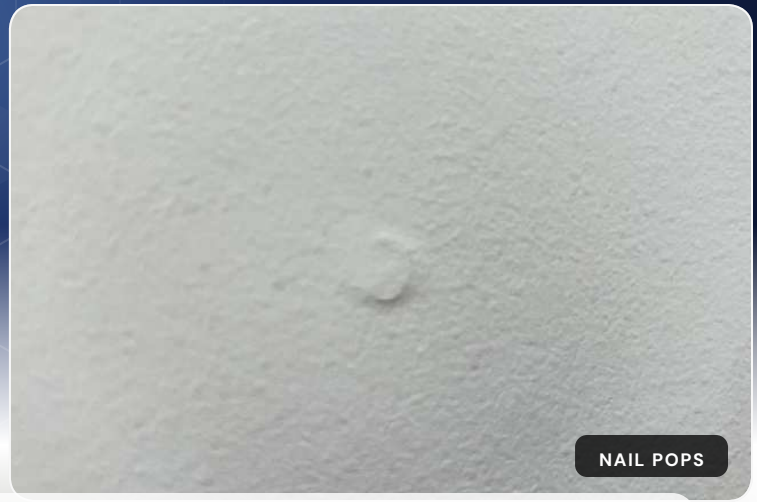
NAIL POPS

Nail Pops — One or more nail pops was observed. Client should consult with the builder for a complete audit and resolution.

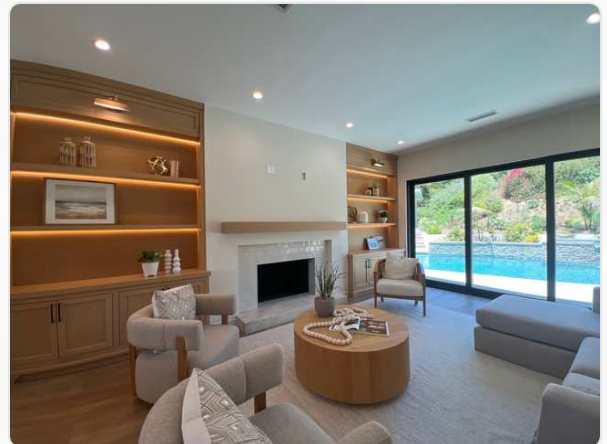
**SATISFACTORY****147: Satisfactory**

General Conditions — The fireplace was in satisfactory condition. Our inspection does not include actual operation of the fireplace and we cannot offer opinions regarding its performance. We suggest inquiries of the owner or occupant in this regard. Fireplaces should have annual maintenance performed. The client is advised to have the fireplace service by a qualified chimney specialist.

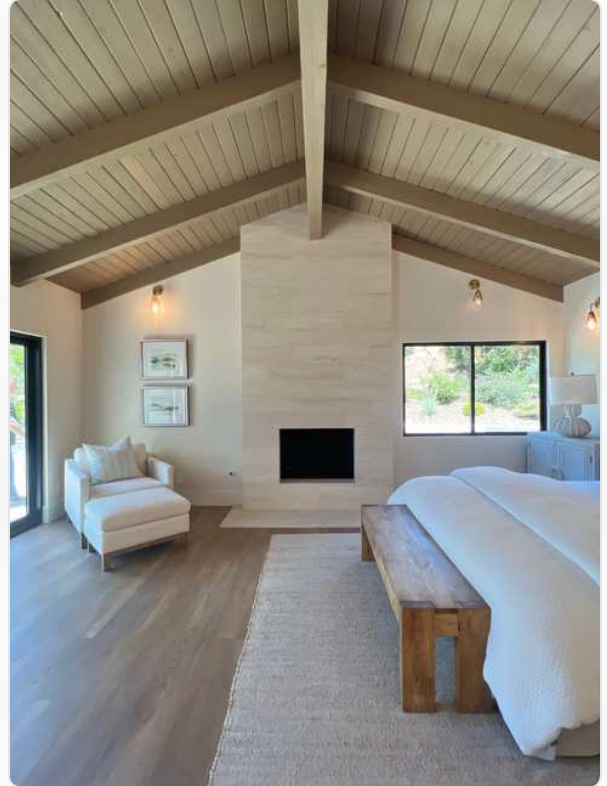
**SATISFACTORY****149: Satisfactory**

General Conditions — The fireplace was in satisfactory condition. Our inspection does not include actual operation of the fireplace and we cannot offer opinions regarding its performance. We suggest inquiries of the owner or occupant in this regard. Fireplaces should have annual maintenance performed. The client is advised to have the fireplace service by a qualified chimney specialist.
