# HOME INSPECTION REPORT

PROFESSIONAL PROPERTY EVALUATION

Tuesday, July 7, 2026

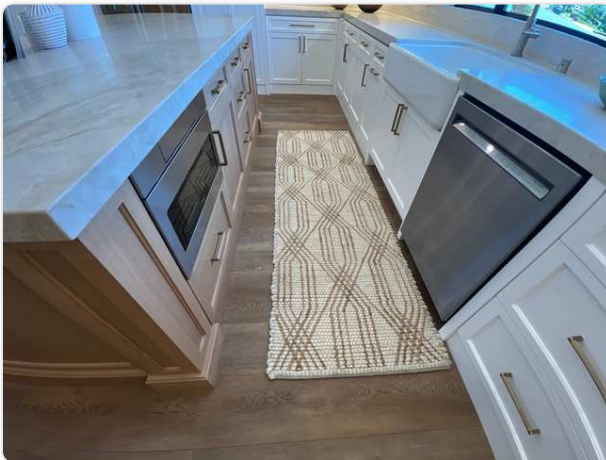
**REPAIR R151**

General Conditions — The toe kick beneath the kitchen sink cabinet was not properly secured at the time of the inspection. The toe kick detached during the inspection and was reinstalled by the inspector in its original location. Recommend consultation with the builder to properly secure the toe kick using appropriate fastening methods.

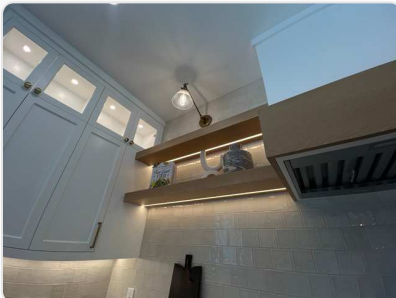
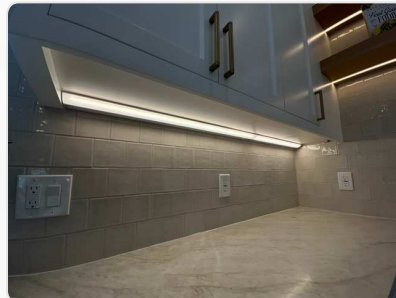
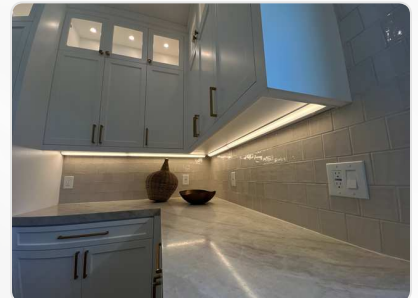
**SATISFACTORY 158**

Lighting Conditions — Kitchen lighting was satisfactory.

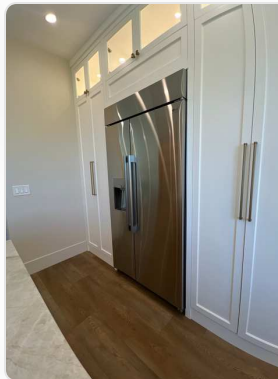
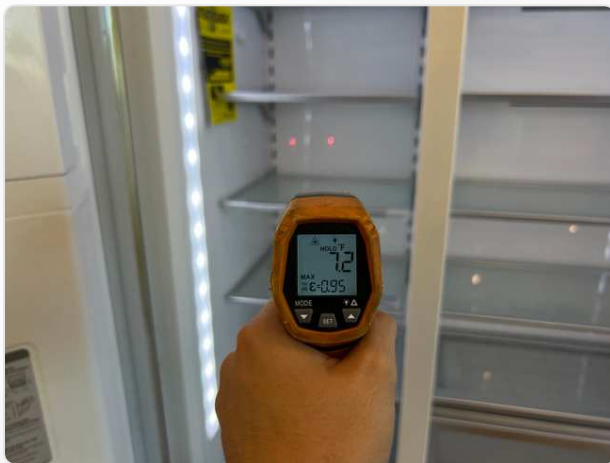
**SATISFACTORY 159: Satisfactory**

Refrigerator — The refrigerator was in satisfactory condition.

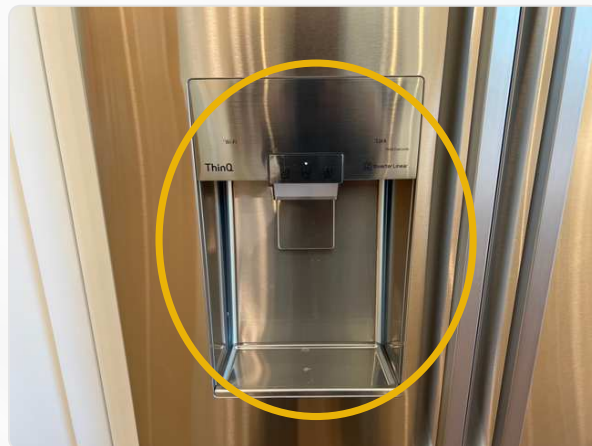
**WARNING W160: Icemaker Disclaimer**

Refrigerator — It should be noted that the refrigerator was equipped with an ice/water dispenser. These components are not tested during a general home inspection. Client should inquire with the seller regarding its functionality prior to the close of escrow to satisfy any concerns.

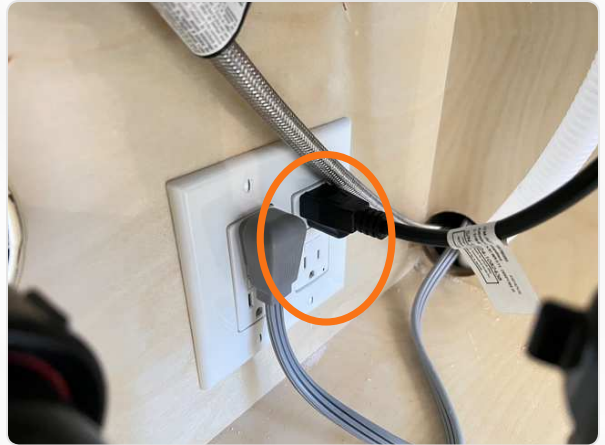
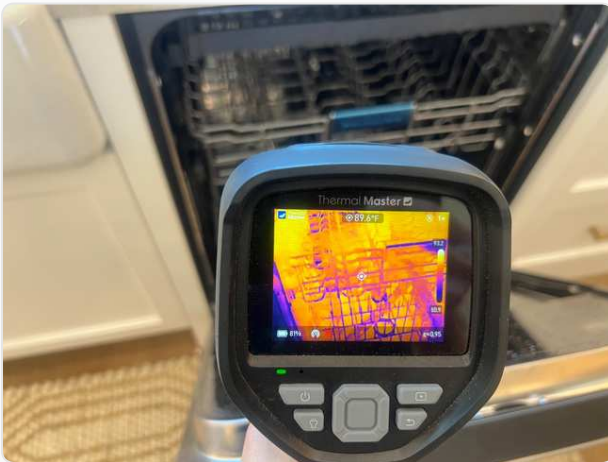
**REPAIR R161**

Dishwasher(s) — The dishwasher was successfully tested on the day of the inspection by temporarily utilizing the garbage disposal receptacle. However, the dedicated receptacle intended to supply power to the dishwasher was found to be non-functional. Recommend consultation with a qualified electrician for further evaluation and repair of the dedicated dishwasher receptacle to ensure proper operation.

AI Est. \$316 - \$518 \*

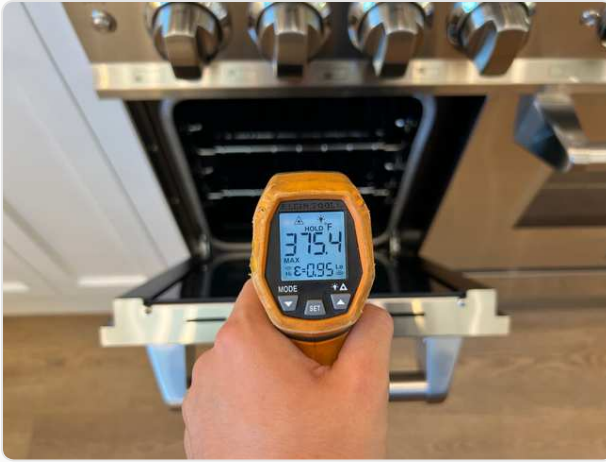
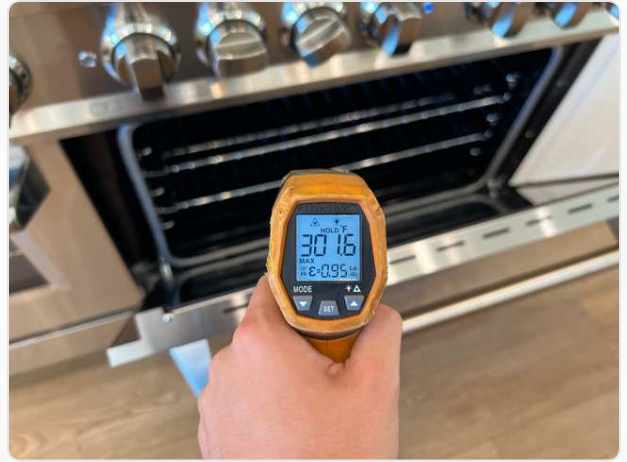
**SATISFACTORY 162: Satisfactory**

Range — The range was thoroughly tested. Temperatures were satisfactory. The unit was found to be functional.

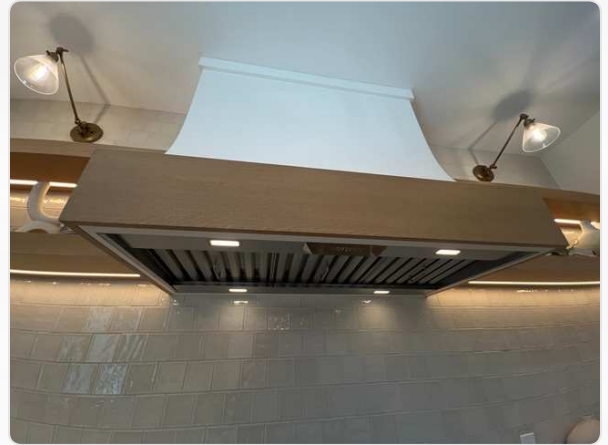
**SATISFACTORY 163: Satisfactory**

Vent Hood — The vent hood was in satisfactory condition.

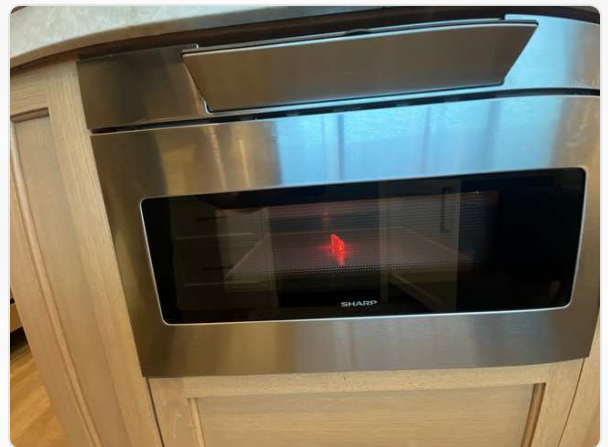
**SATISFACTORY 164: Satisfactory**

Built In Microwave — The built-in microwave was tested and found to be in satisfactory condition on the day of inspection.

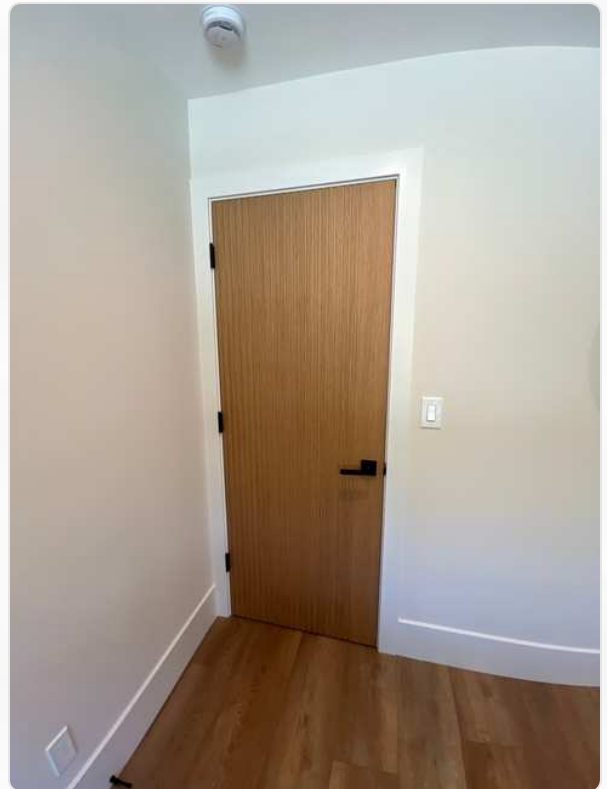
## SATISFACTORY 165

Privacy Door — The door was in satisfactory condition.

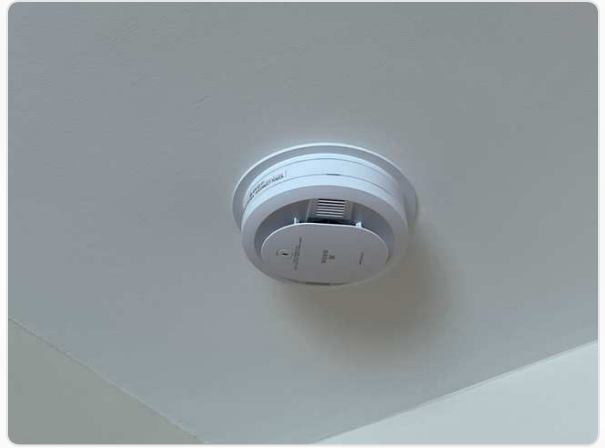
**SATISFACTORY 166**

Smoke Detector — Smoke detector present and functional.

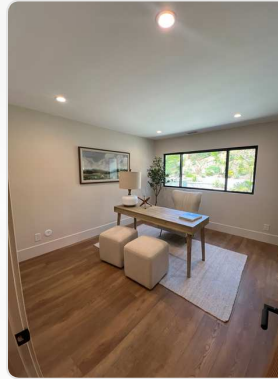
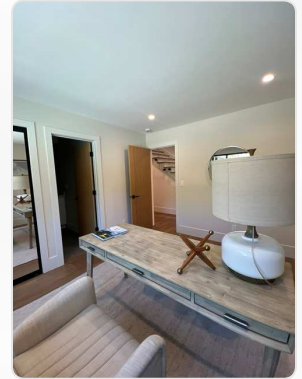
**SATISFACTORY 167**

General Condition — Bedroom was satisfactory.

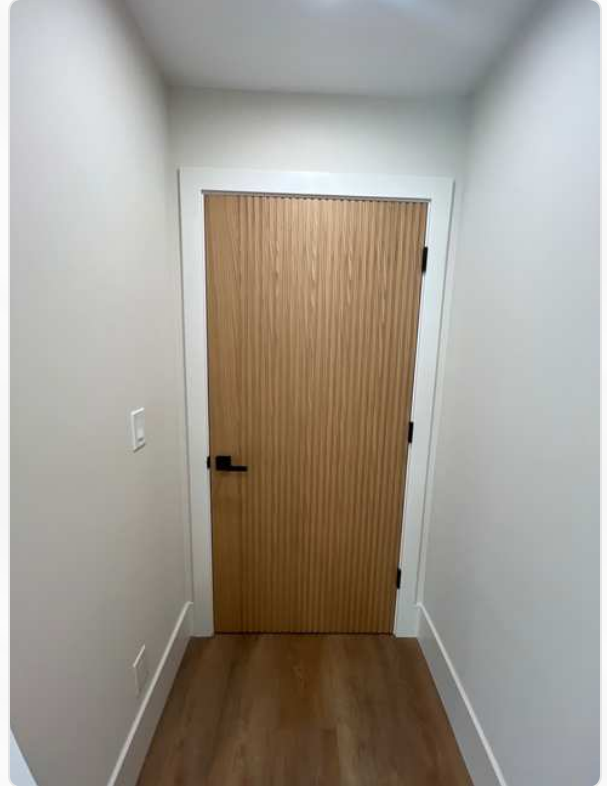
### SATISFACTORY 168

Privacy Door — The door was in satisfactory condition.

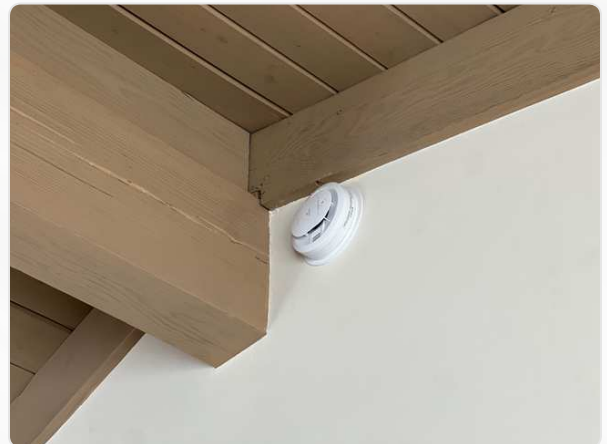
### SATISFACTORY 169

Smoke Detector — Smoke detector present and functional.

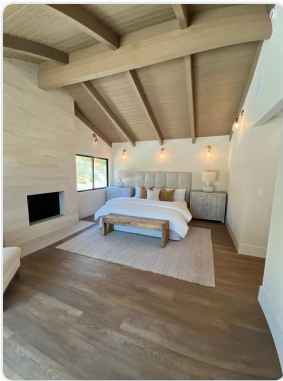
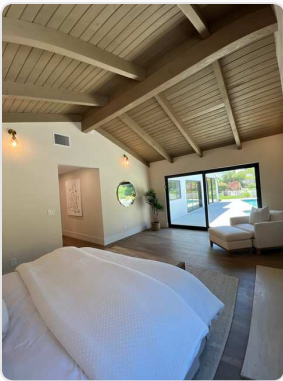
**SATISFACTORY 170**

General Condition — Bedroom was satisfactory.

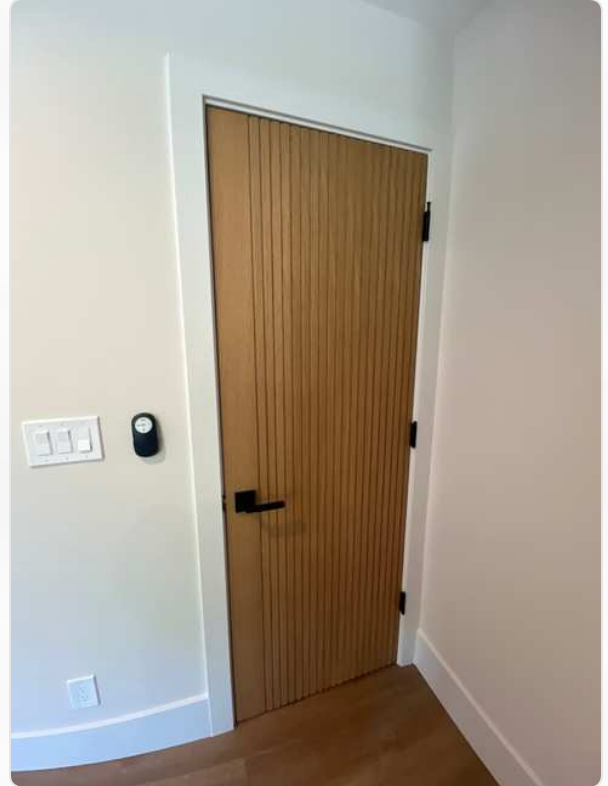
## SATISFACTORY 171

Privacy Door — The door was in satisfactory condition.

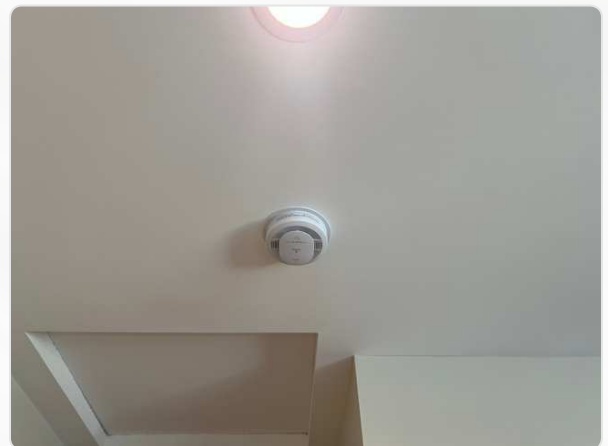
## SATISFACTORY 172

Smoke Detector — Smoke detector present and functional.

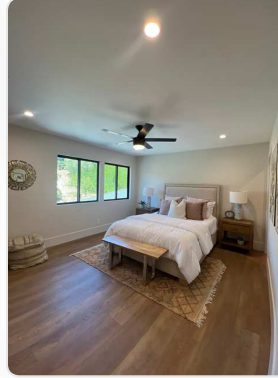
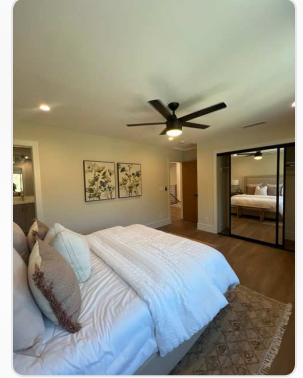
**SATISFACTORY 173**

General Condition — Bedroom was satisfactory.

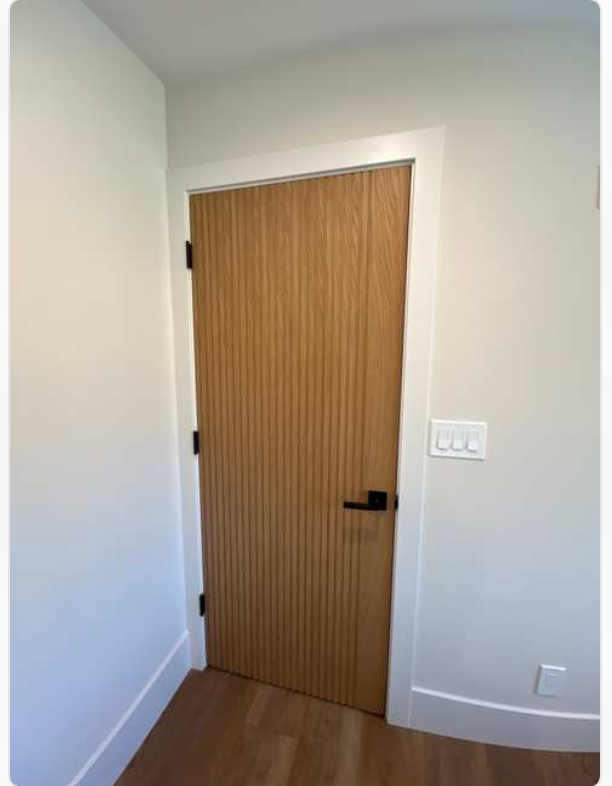
## SATISFACTORY 174

Privacy Door — The door was in satisfactory condition.

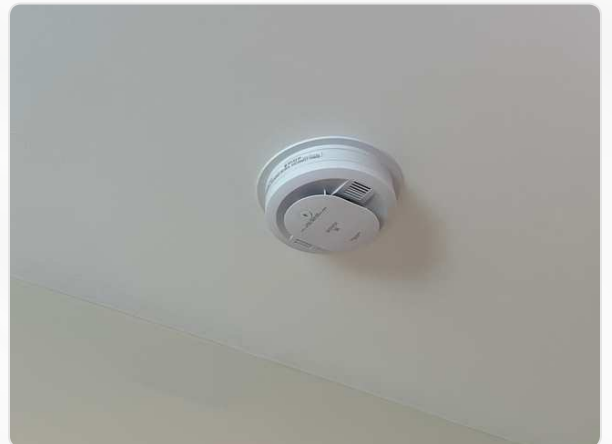
## SATISFACTORY 175

Smoke Detector — Smoke detector present and functional.

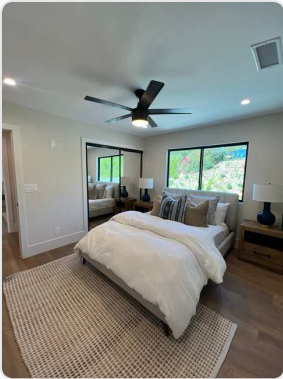
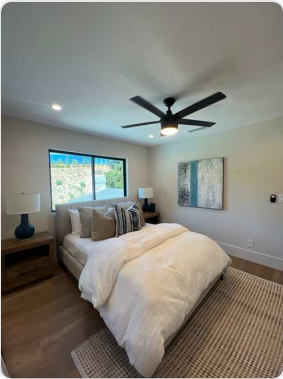
**SATISFACTORY 176**

General Condition — Bedroom was satisfactory.

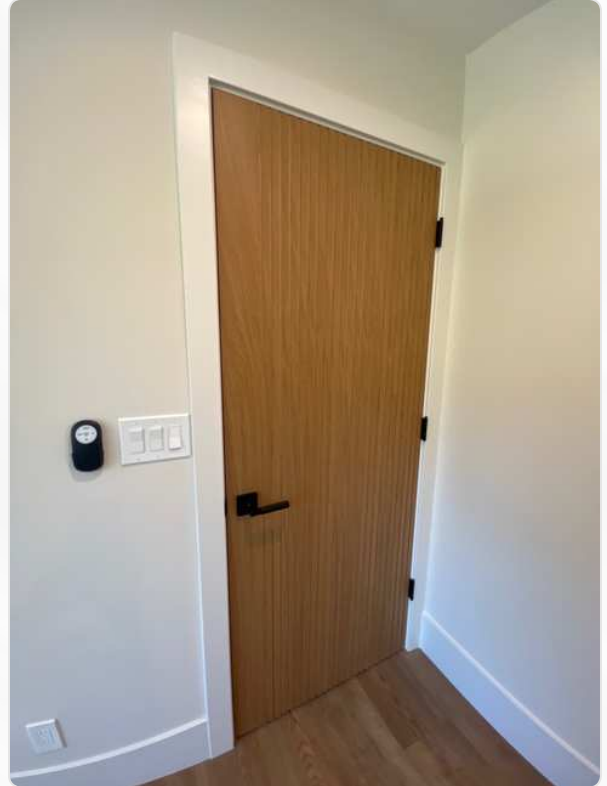
### SATISFACTORY 177

Privacy Door — The door was in satisfactory condition.

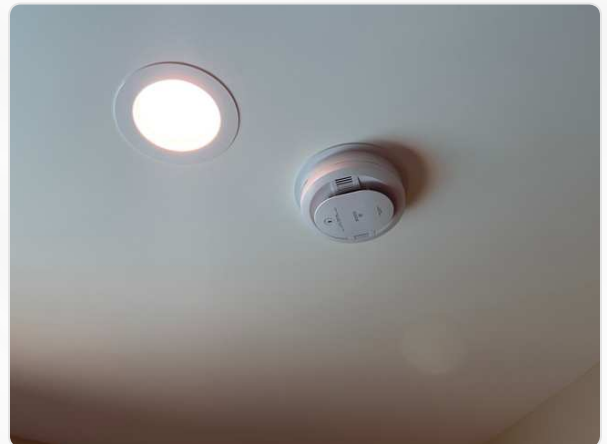
### SATISFACTORY 178

Smoke Detector — Smoke detector present and functional.

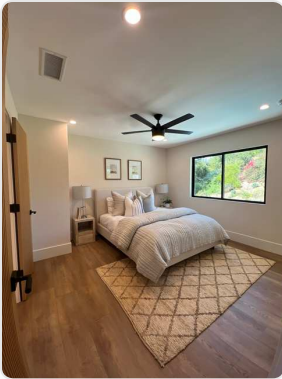
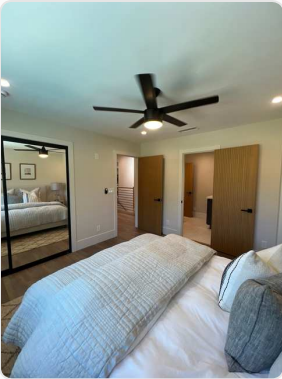
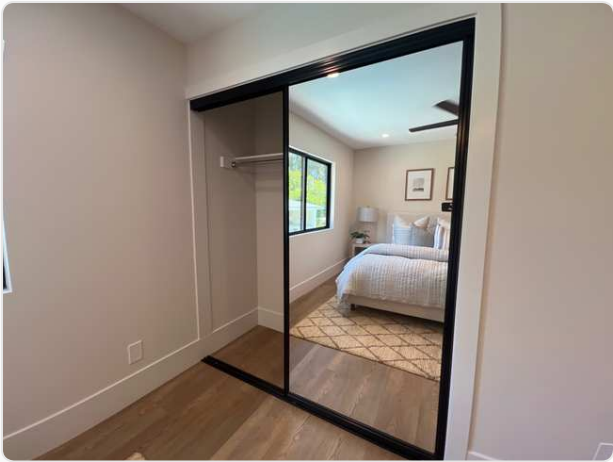
**SATISFACTORY 179**

General Condition — Bedroom was satisfactory.

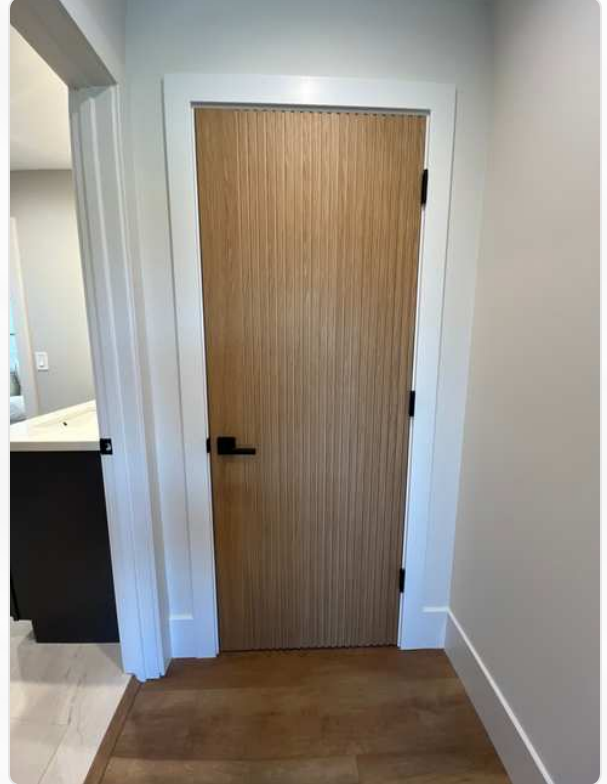
### SATISFACTORY 180

Privacy Door — The door was in satisfactory condition.

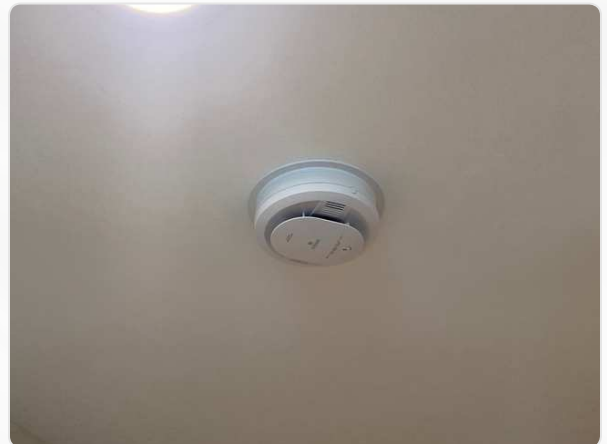
### SATISFACTORY 181

Smoke Detector — Smoke detector present and functional.

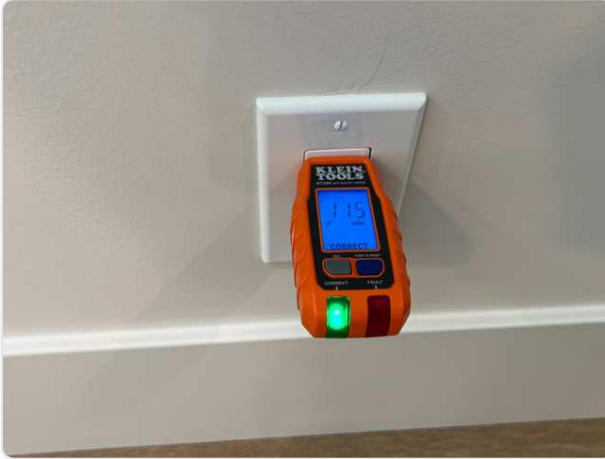
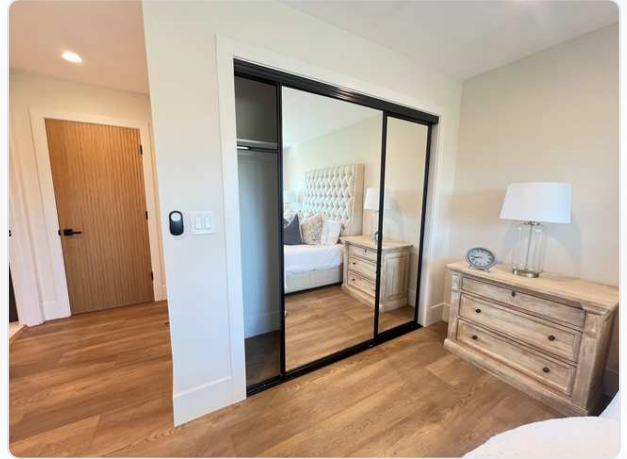
**SATISFACTORY 182**

General Condition — Bedroom was satisfactory.

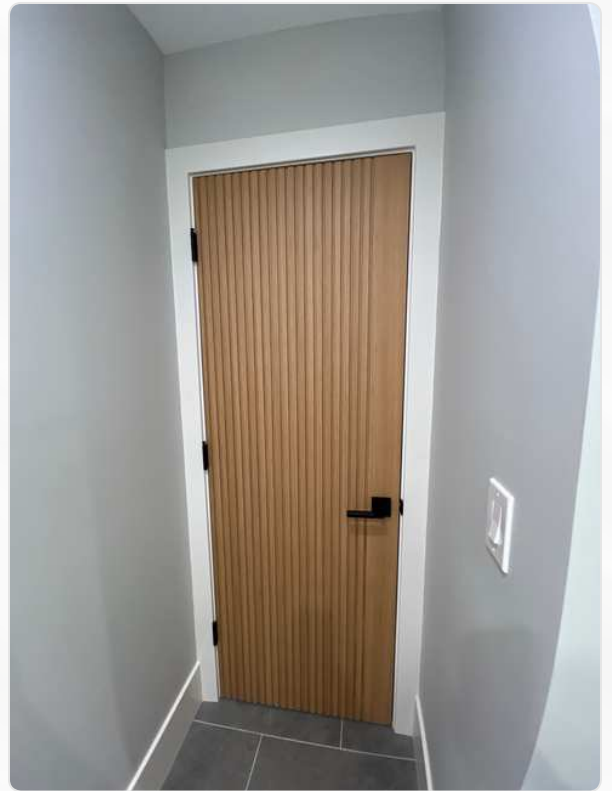
**SATISFACTORY 183**

Privacy Door — The door was in satisfactory condition.

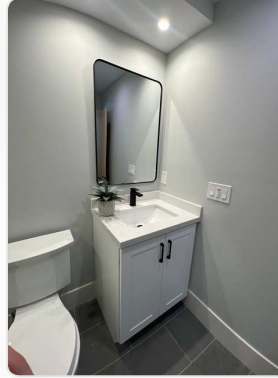
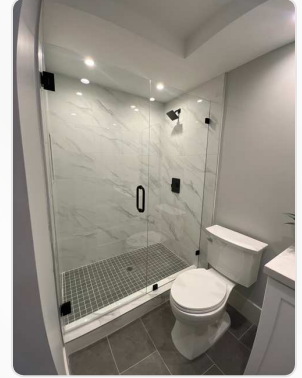
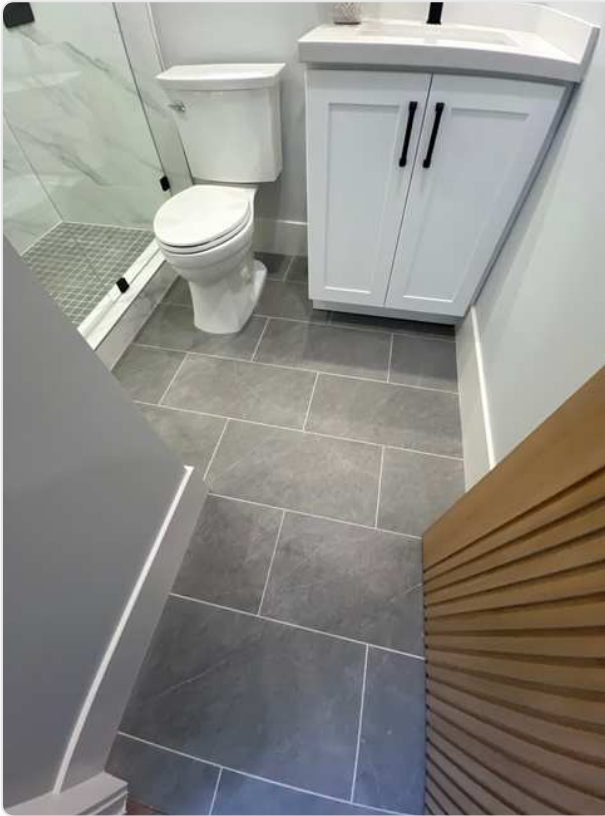
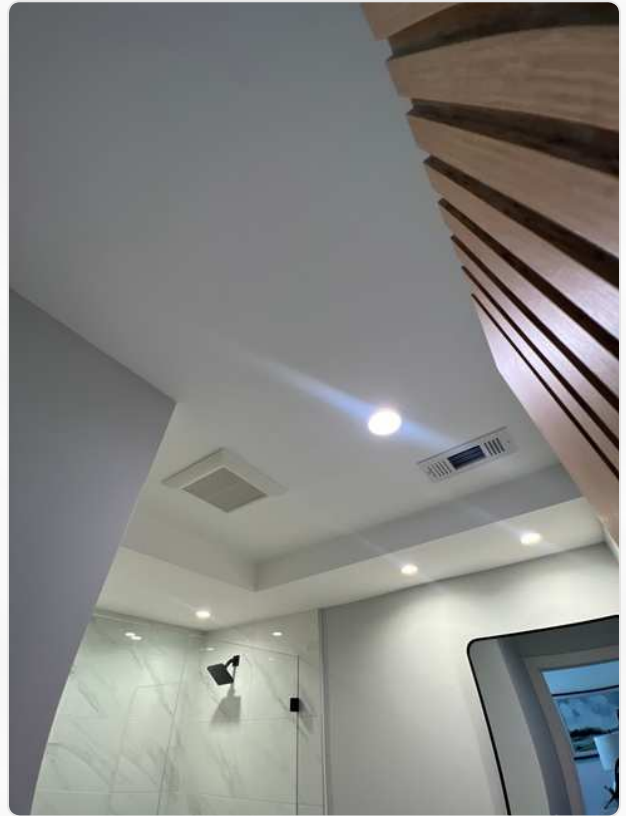
**SATISFACTORY 184**

Overall Conditions — The floor, walls and ceiling were in satisfactory condition. There were no significant deficiencies noted.

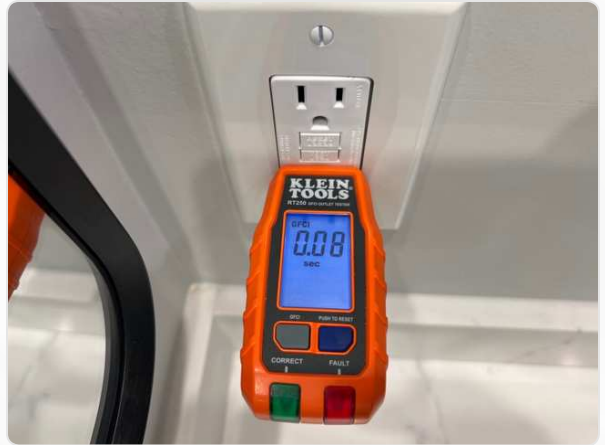
**SATISFACTORY 185**

GFCI Outlets — GFCI receptacle was present and functional.

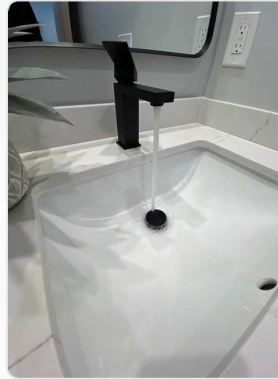
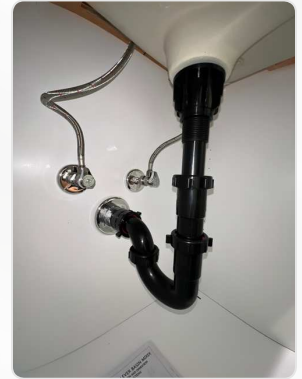
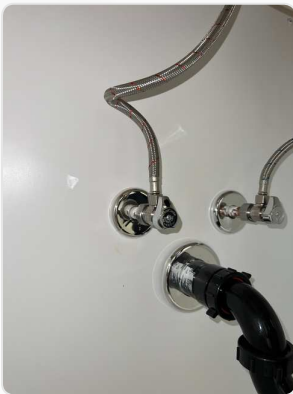
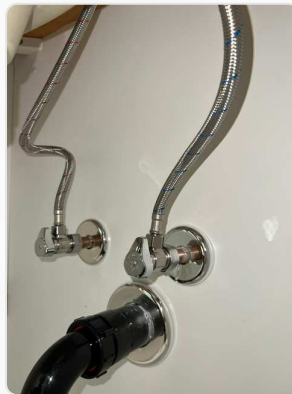
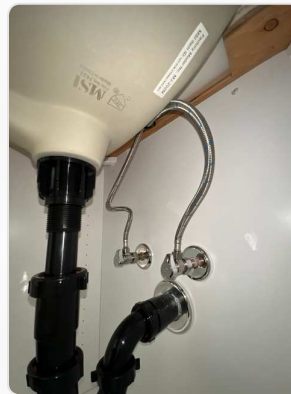
**SATISFACTORY 186**

Sink and Plumbing — Sink and faucet were functional. Hot and cold water were present. And the drain was free flowing.

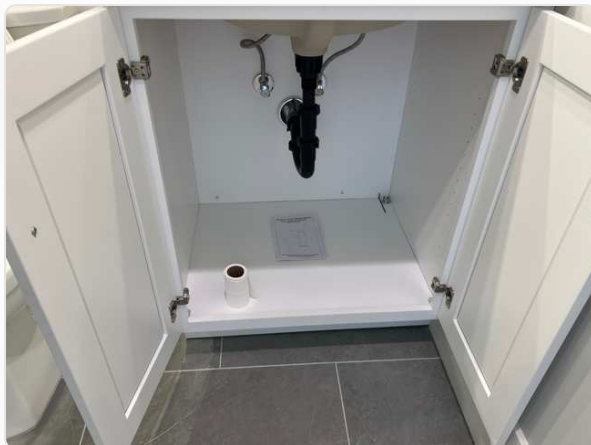
**SATISFACTORY 187**

Cabinet Conditions — Bathroom cabinets are in new condition.

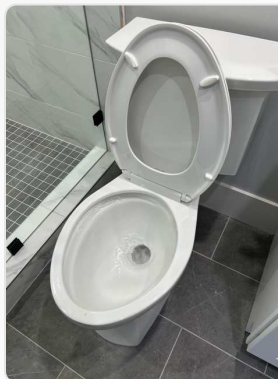
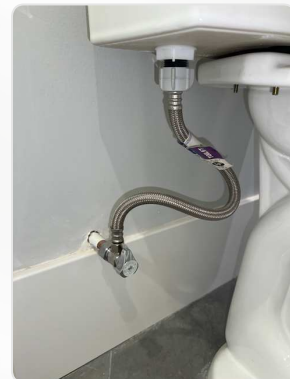
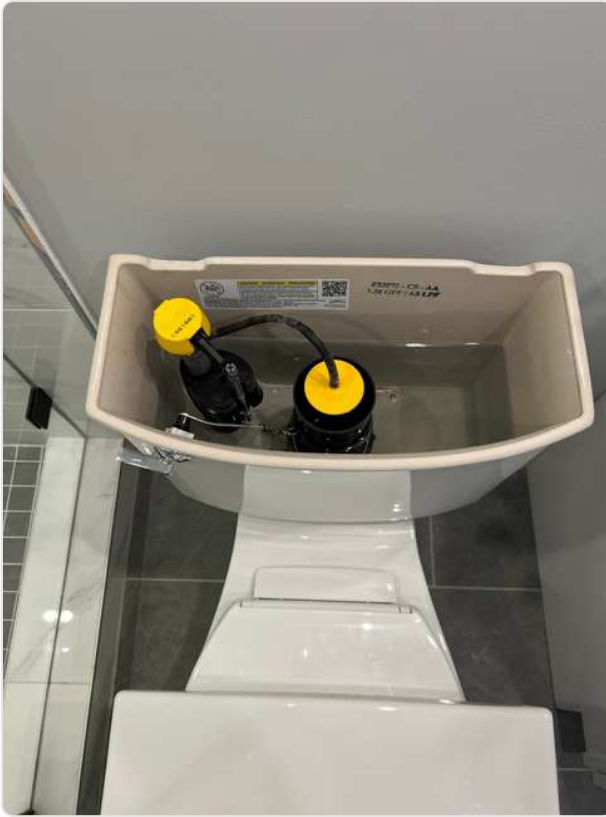
**SATISFACTORY 188**

Toilet — The toilet was functional and in satisfactory condition.

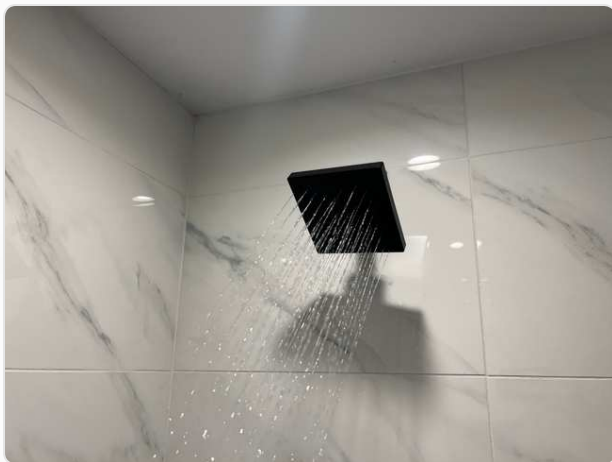
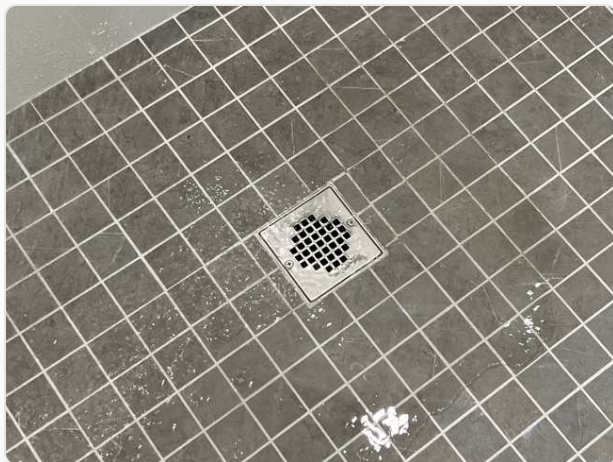
**SATISFACTORY 189**

Tub and Showers — The shower was in new condition. Hot and cold running water was present. The drain was free flowing.

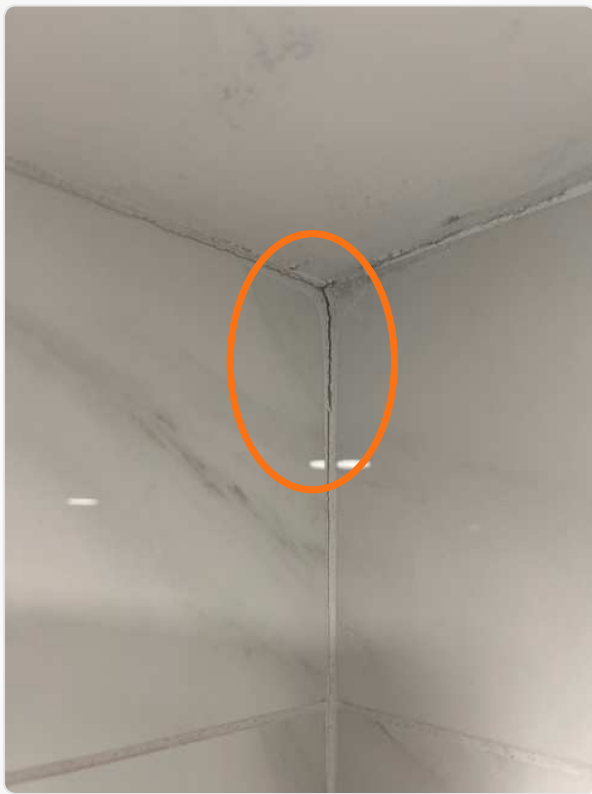
**REPAIR** **R190: Deficient Tile Grout**

Tub and Showers — Deficient and or missing tile grout was noted. This condition can lead to water infiltration and concealed mold. Repairs needed.

AI Est. \$460 - \$920 \*

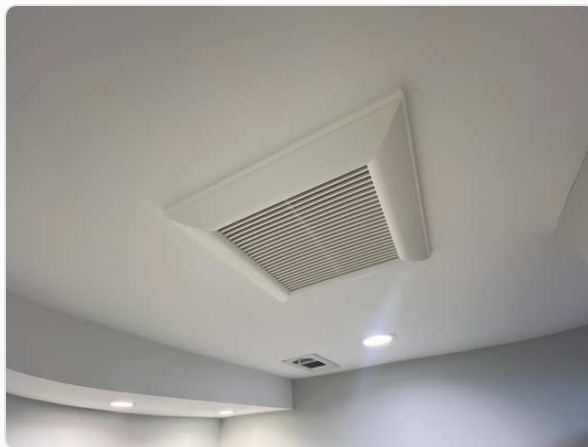
**SATISFACTORY 191**

Ventilator Conditions — The bathroom ventilator was tested and found to be functional on the day of inspection.

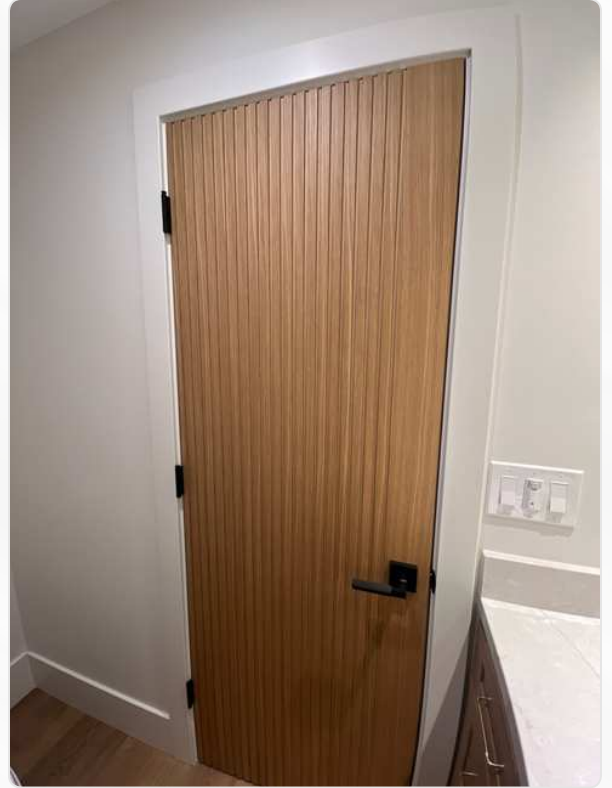
### SATISFACTORY 192

Privacy Door — The door was in satisfactory condition.

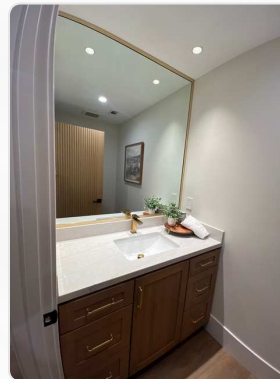
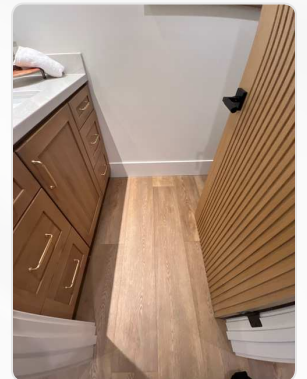
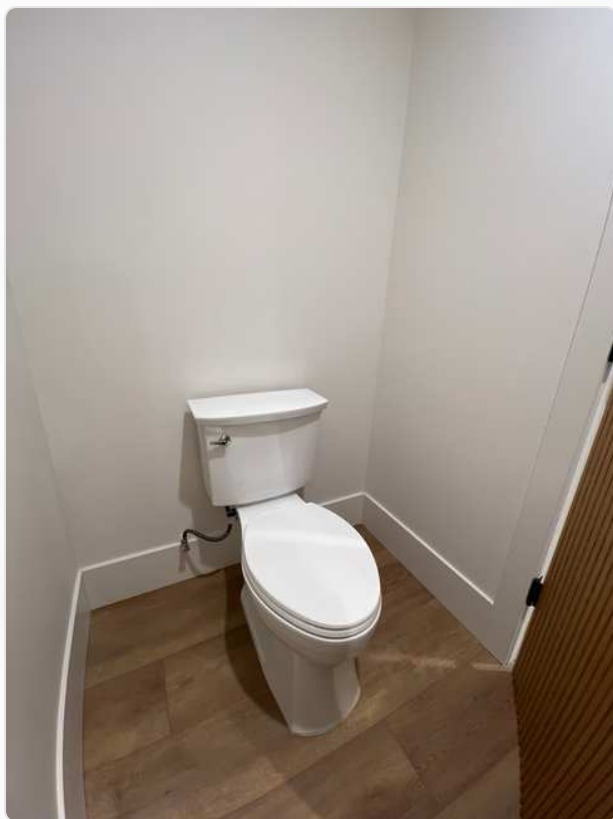
### SATISFACTORY 193

Overall Conditions — The floor, walls and ceiling were in satisfactory condition. There were no significant deficiencies noted.

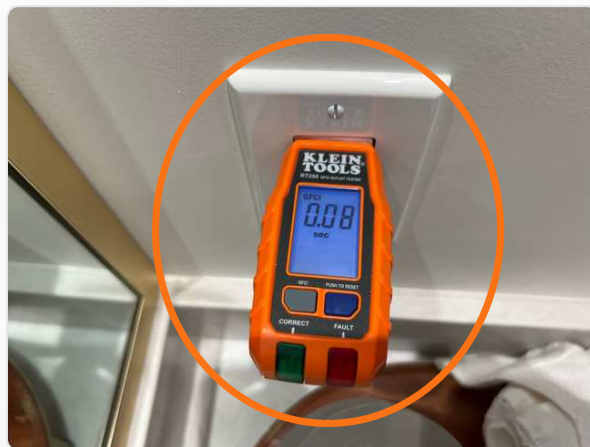
**SATISFACTORY** 194: GFCI  
**Satisfactory**

GFCI Outlets — GFCI receptacle was present and functional.

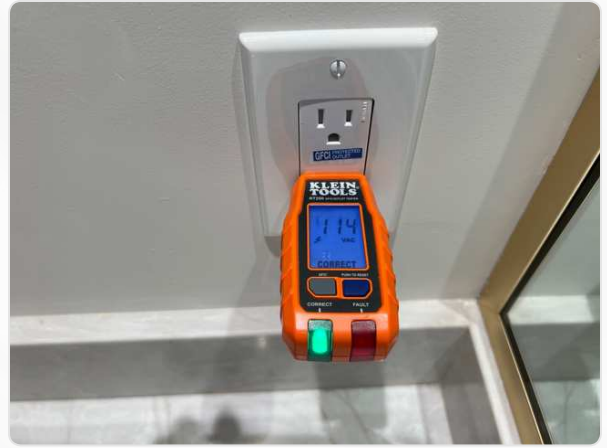
**195: GFCI Protected**

GFCI Outlets — Bathroom receptacle was GFCI protected from another location.

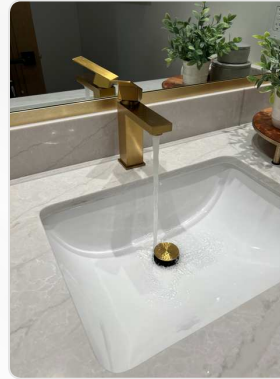
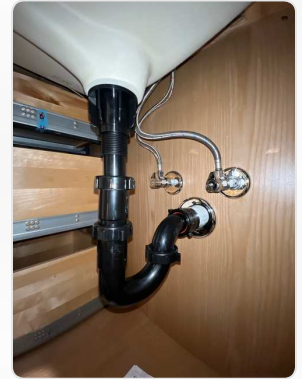
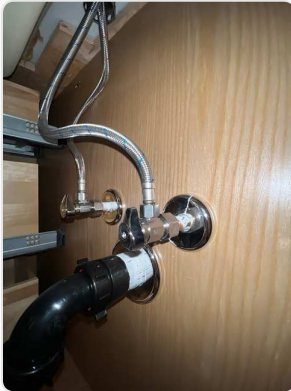
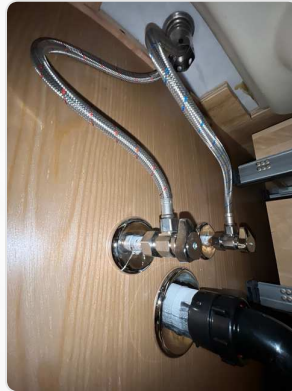
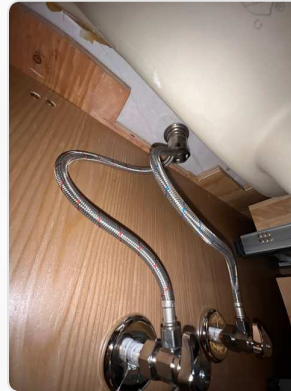
**196**

Sink and Plumbing — Sink and faucet were functional. Hot and cold water were present. And the drain was free flowing.

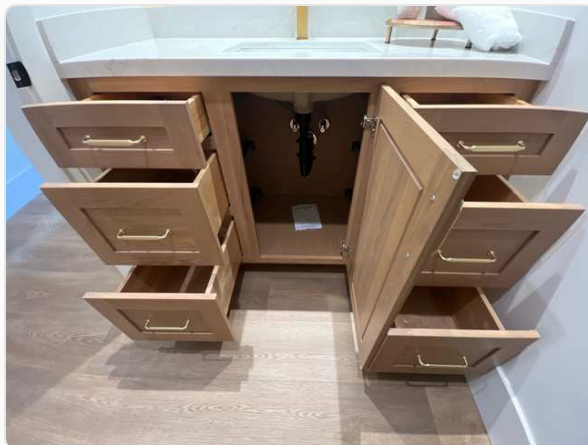
**SATISFACTORY 197**

Cabinet Conditions — Bathroom cabinets are in new condition.

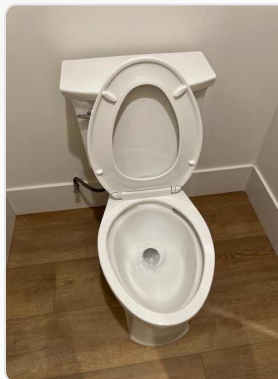
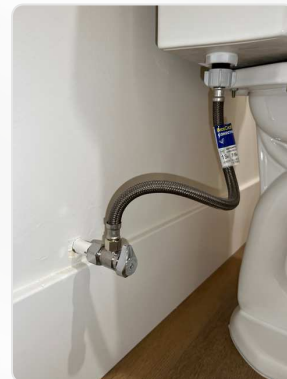
**SATISFACTORY 198**

Toilet — The toilet was functional and in satisfactory condition.

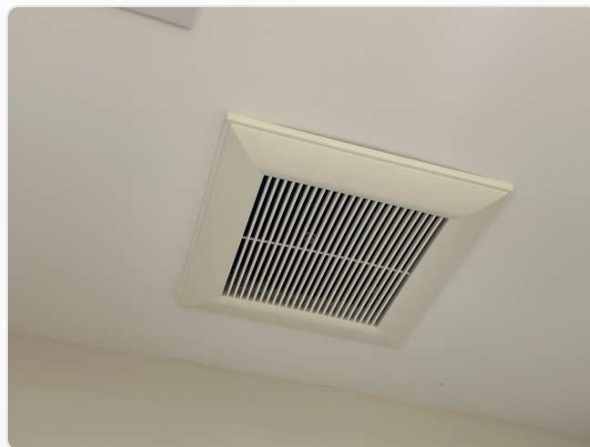
**REPAIR R199: Noisy**

Ventilator Conditions — The bathroom ventilator was noisy. This may be an indication that the fan motor and blade housing needs cleaning and or replacement.

AI Est. \$288 - \$690 \*

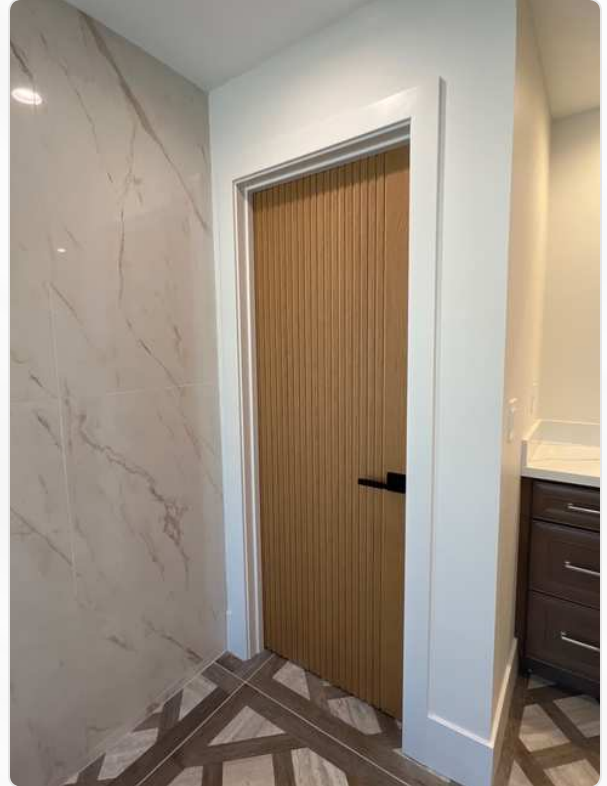
## SATISFACTORY 200

Privacy Door — The door was in satisfactory condition.

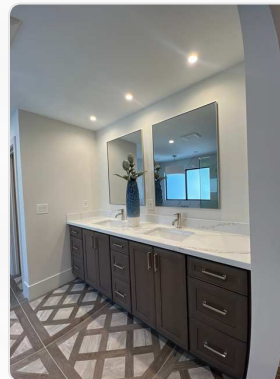
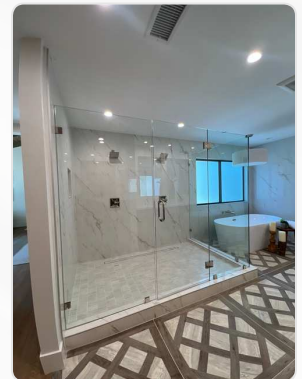
## SATISFACTORY 201

Overall Conditions — The floor, walls and ceiling were in satisfactory condition. There were no significant deficiencies noted.

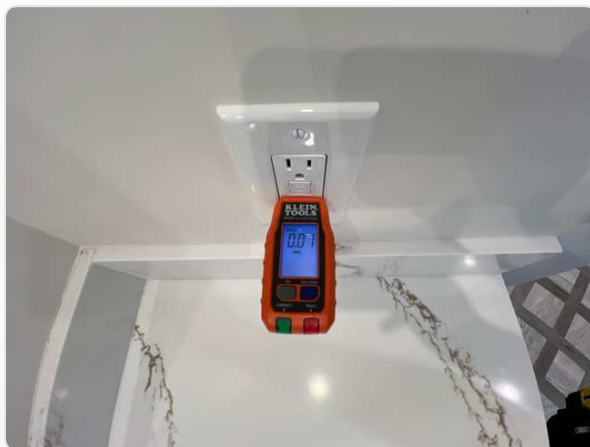
**SATISFACTORY** 202: GFCI  
**Satisfactory**

GFCI Outlets — GFCI receptacle was present and functional.

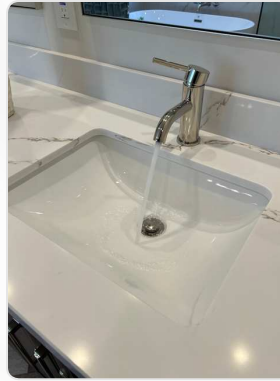
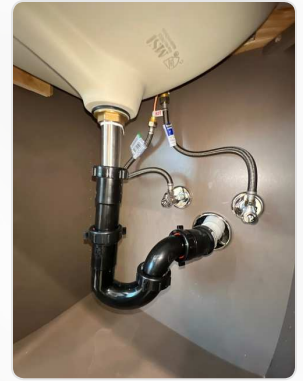
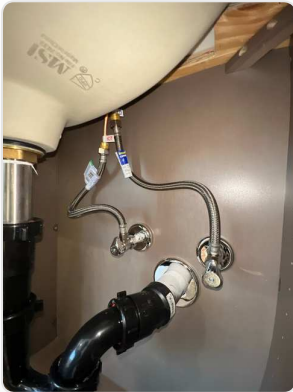
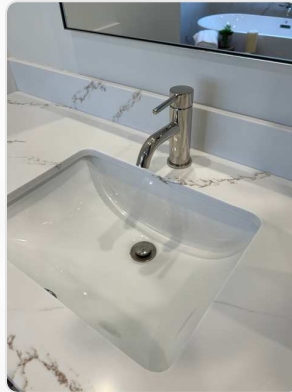
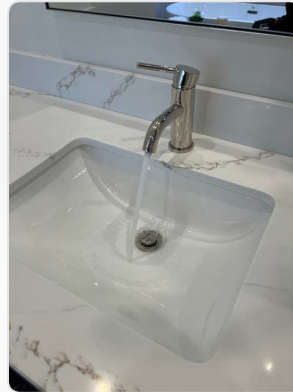
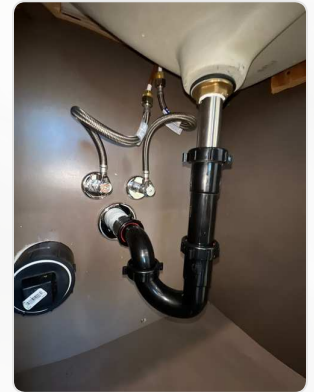
**SATISFACTORY 204**

Sink and Plumbing — Sink and faucet were functional. Hot and cold water were present. And the drain was free flowing.

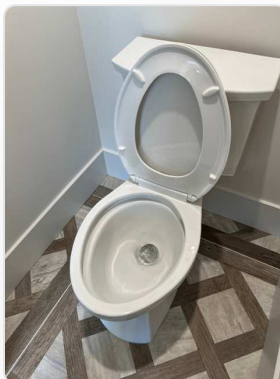
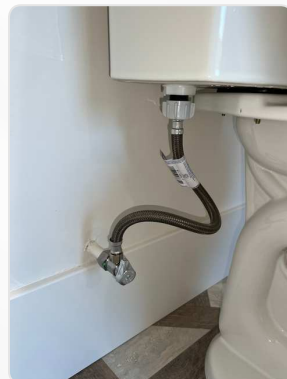
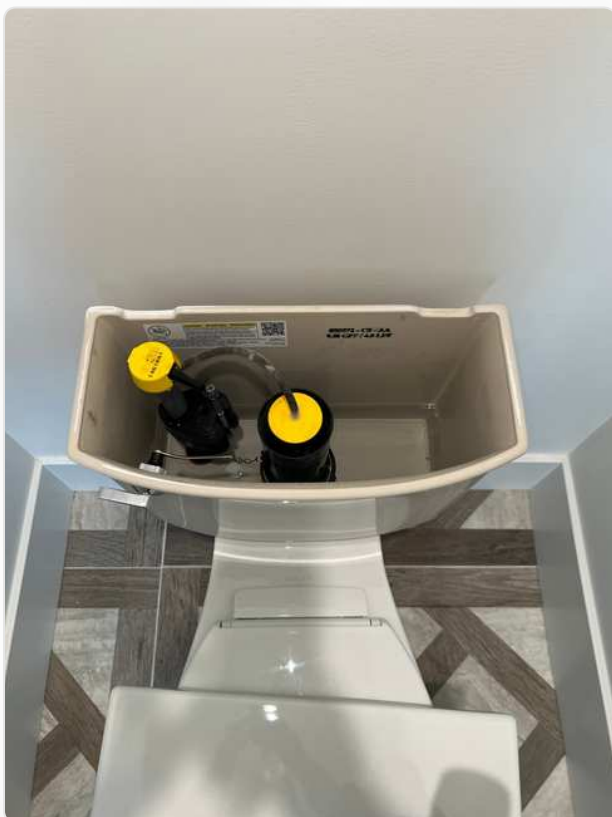
**SATISFACTORY 206**

Toilet — The toilet was functional and in satisfactory condition.

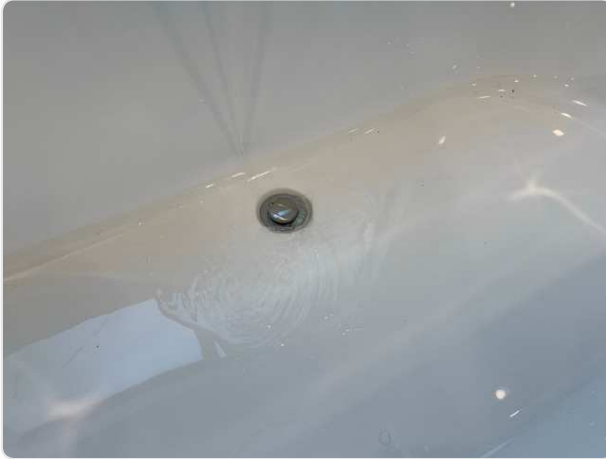
**SATISFACTORY 207**

Tub and Showers — The tub was in new condition. Hot and cold running water was present. The drain was free flowing.

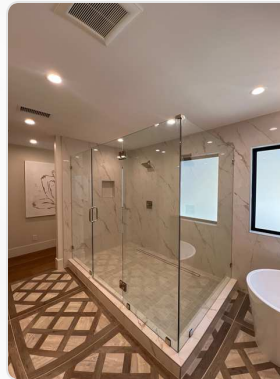
**SATISFACTORY 208**

Tub and Showers — The shower was in new condition. Hot and cold running water was present. The drain was free flowing.

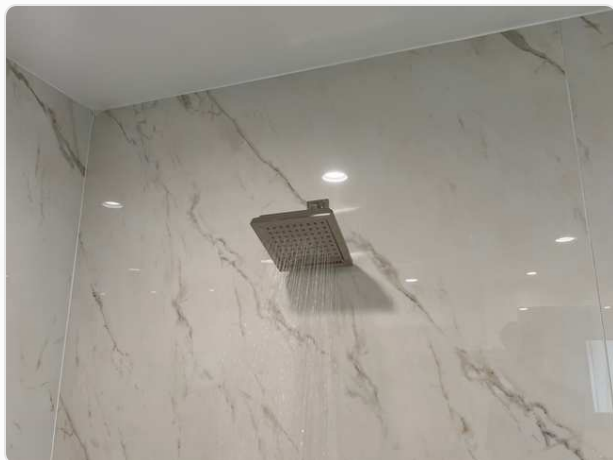
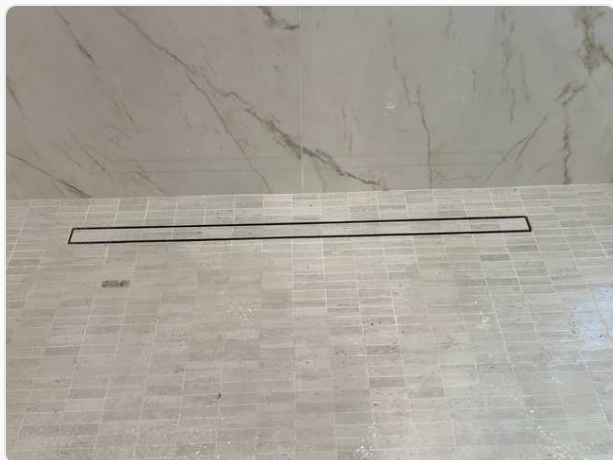
**SAFETY S209**

Tub and Showers — Per the National Electrical Code NEC section 410.10 D. Code violation. Pendant lights, chandeliers, or any cord chain or cable suspended fixture within a zone measuring 3 feet horizontally and 8 feet vertically from the top of the tub rim or shower stall threshold.

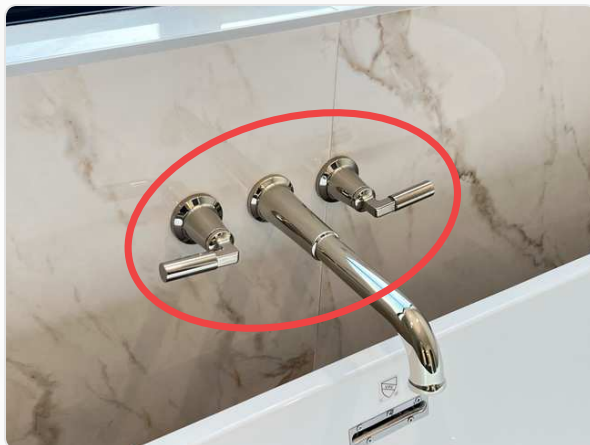
**SAFETY****S210: Missing Temperature Control Valve**

Temperature Control Valve — <https://amzn.to/4cqV3ux> (The whole house temperature control valve designed to maintain a stable, safe, and energy-efficient temperature throughout the home.)

AI Est. \$345 - \$690 \*

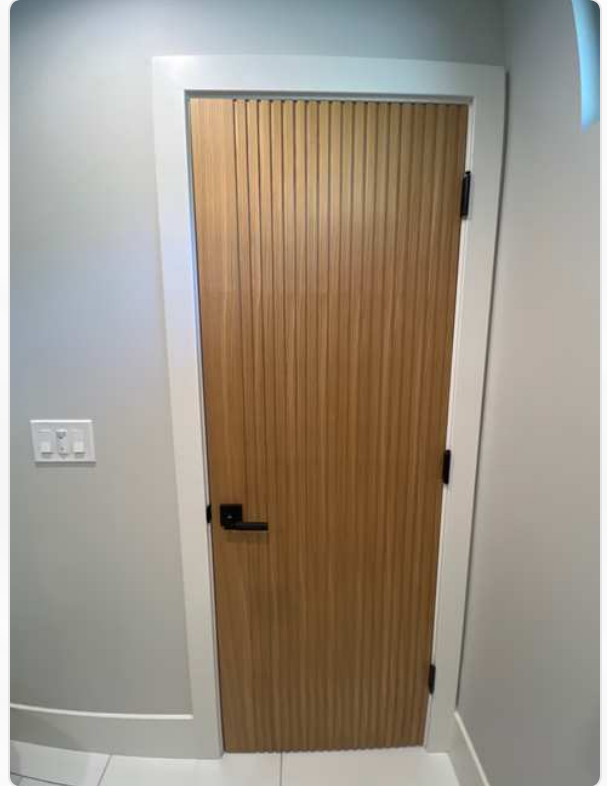
### SATISFACTORY 212

Privacy Door — The door was in satisfactory condition.
