# HOME INSPECTION REPORT

PROFESSIONAL PROPERTY EVALUATION

Tuesday, July 7, 2026

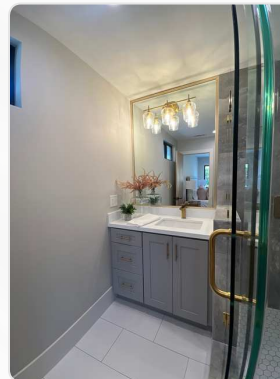
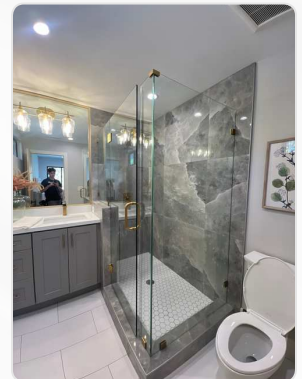
### SATISFACTORY 213

Overall Conditions — The floor, walls and ceiling were in satisfactory condition. There were no significant deficiencies noted.

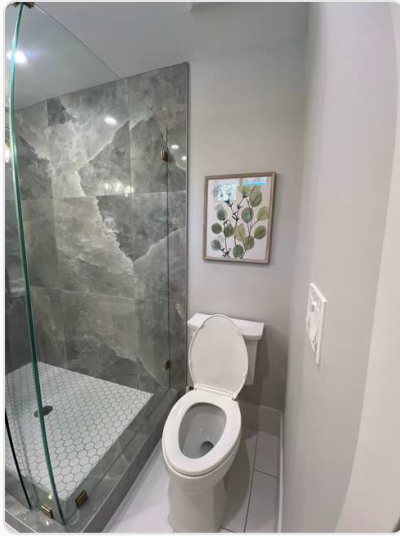
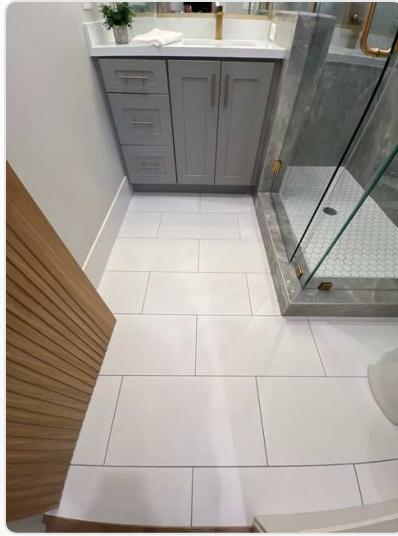
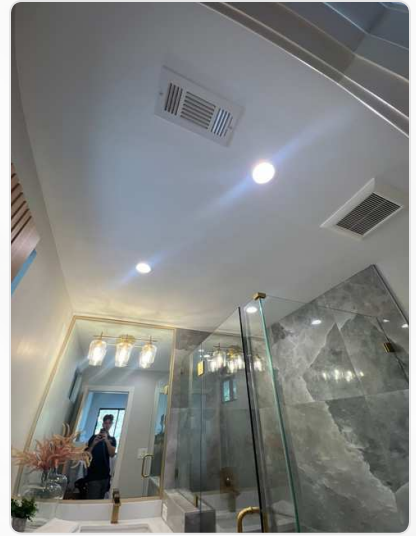
**SATISFACTORY 214: GFCI****Satisfactory**

GFCI Outlets — GFCI receptacle was present and functional.

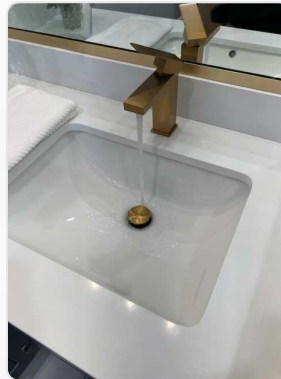
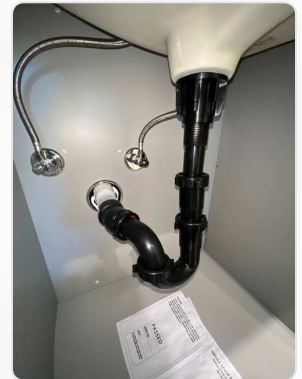
**SATISFACTORY 215**

Sink and Plumbing — Sink and faucet were functional. Hot and cold water were present. And the drain was free flowing.

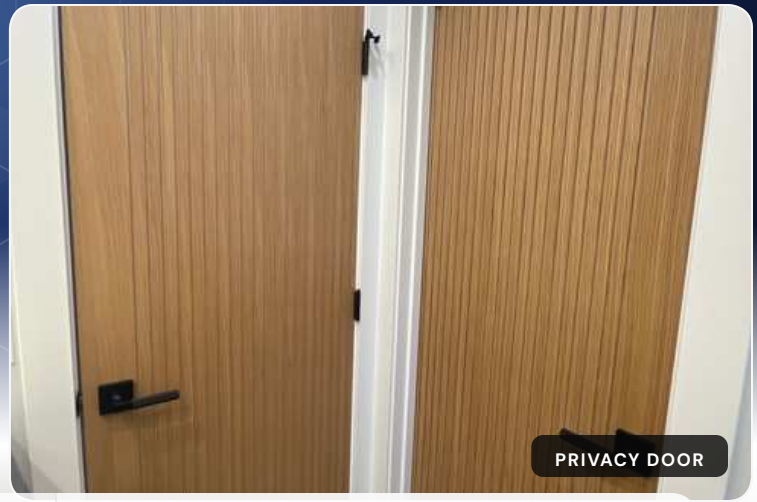
### SATISFACTORY 221

Privacy Door — The door was in satisfactory condition.

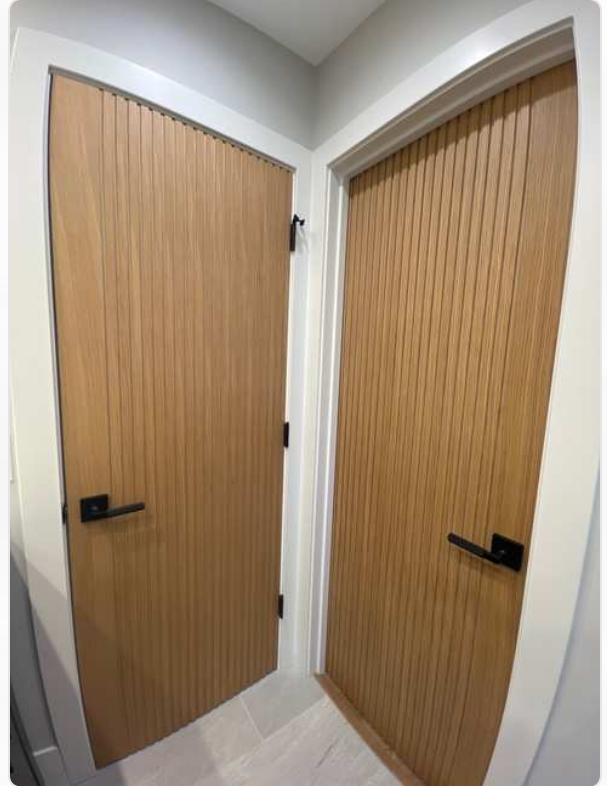
### SATISFACTORY 222

Overall Conditions — The floor, walls and ceiling were in satisfactory condition. There were no significant deficiencies noted.

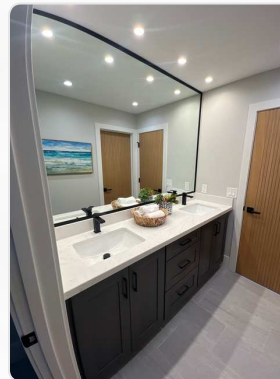
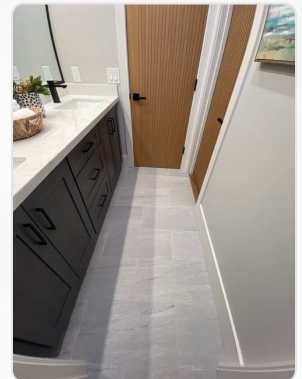
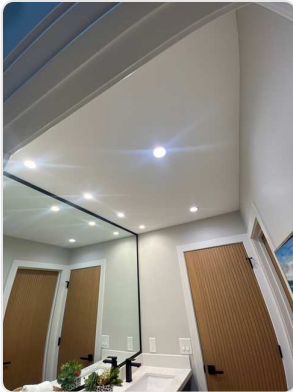
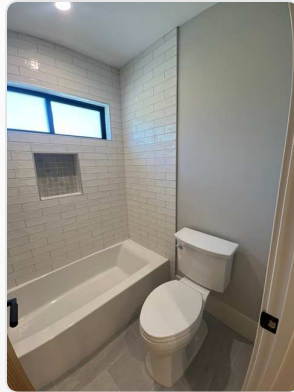
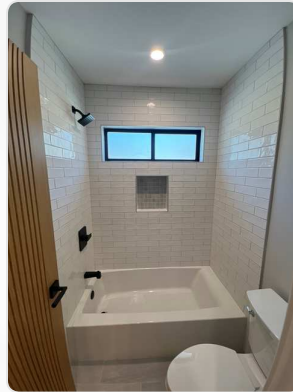
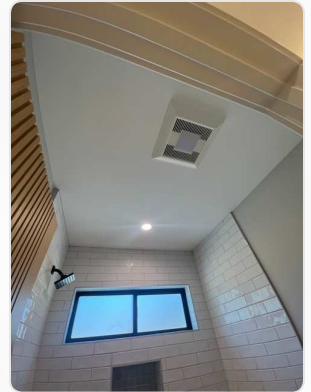
**REPAIR R223**

Overall Conditions — No HVAC supply air register was present in Bathroom #4 at the time of the inspection. The absence of a supply register may result in reduced comfort and inadequate temperature conditioning within the bathroom. Recommend consultation with a qualified HVAC contractor to determine whether a supply air register should be installed.

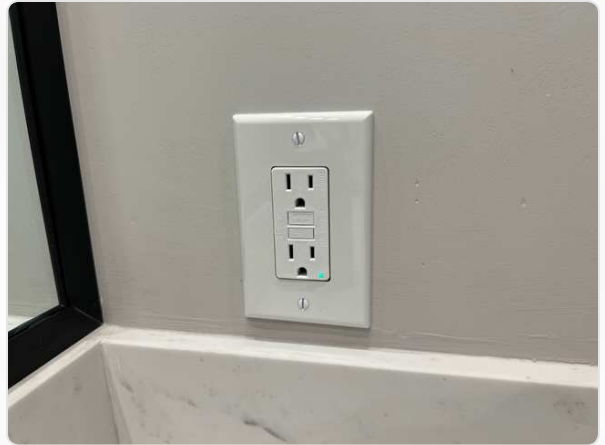
**SATISFACTORY 225: GFCI****Protected**

GFCI Outlets — Bathroom receptacle was GFCI protected from another location.

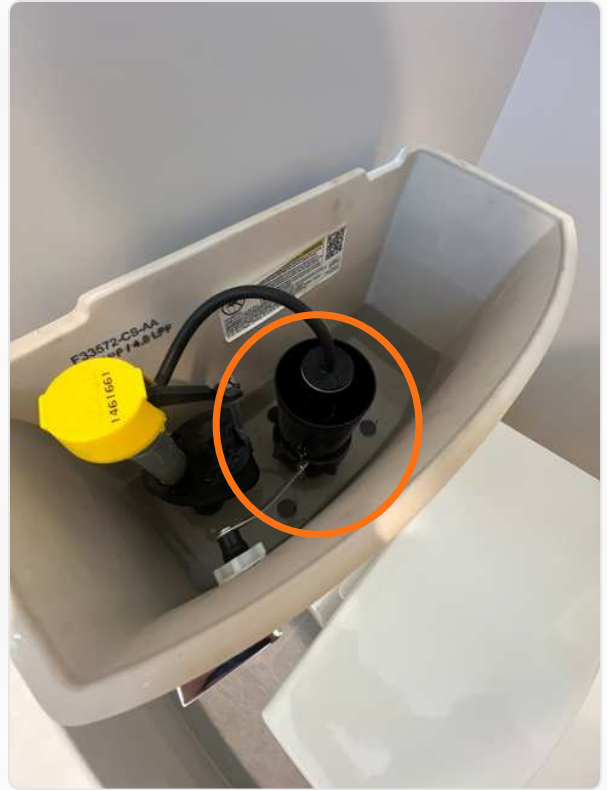
**REPAIR****R228: Leaks At Tank**

Toilet — Water leaks were noted at the tank. Service and repair needed.

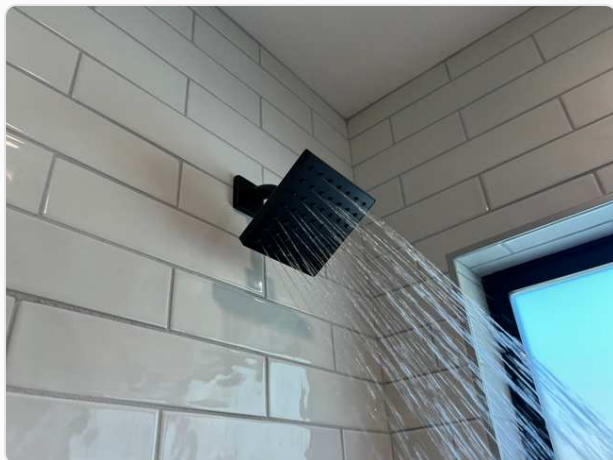
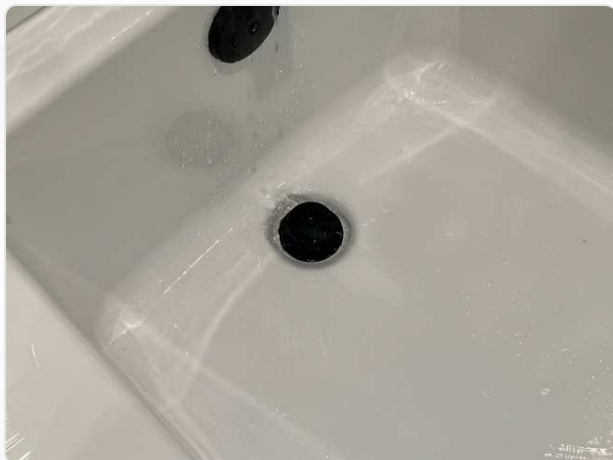
**SATISFACTORY****229**

Tub and Showers — The shower was in new condition. Hot and cold running water was present. The drain was free flowing.

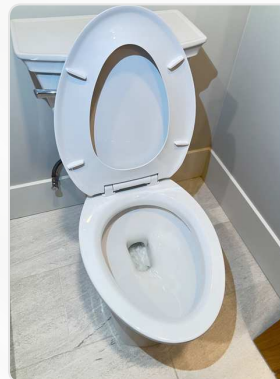
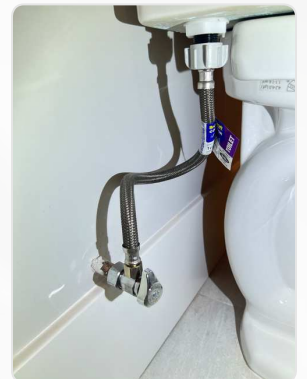
### 236: Satisfactory

Toilet — The toilet was functional and in satisfactory condition.

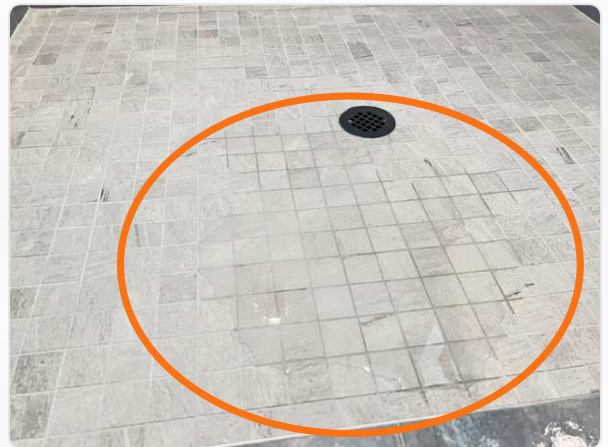
**REPAIR R237**

Tub and Showers — Improper slope was noted in the shower pan of Bathroom #6. Water was observed to collect rather than drain completely toward the shower drain, resulting in standing water. Recommend consultation with the builder to correct the shower pan slope and provide proper drainage to the drain.

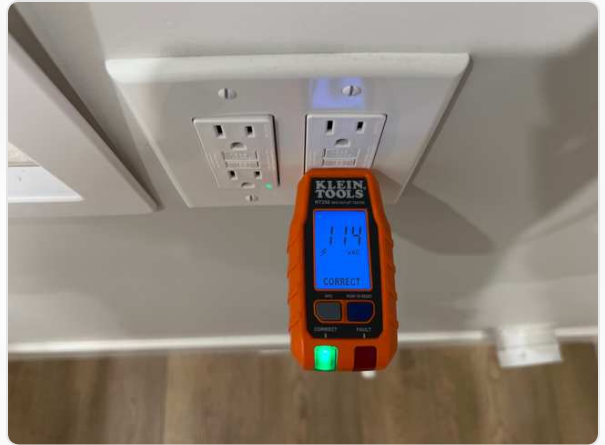
**SAFETY****S252: GFCI Missing**

Electrical — According to the national electrical code all laundry room receptacles must be AFCI and GFCI protected for occupant safety. Upgrades are needed. Safety hazard. Please click [here](#) for a complete cost guide to GFCI outlet installation.

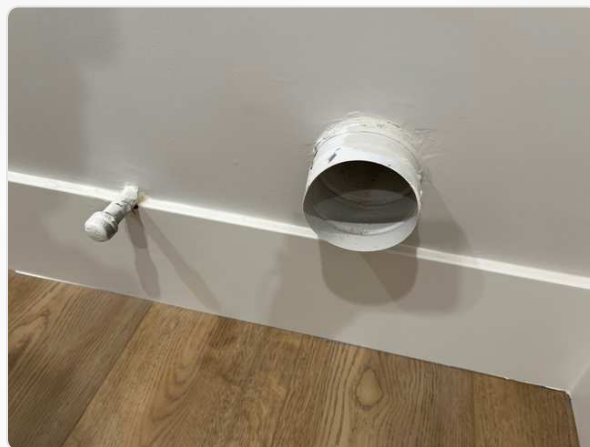
**WARNING****W255: Drip Pan Recommended**

Drip Pan — A drip pan with an appropriate floor drain connection is recommended for all second-floor laundry locations. This will help prevent significant water damage during leaks. Consult with a general contractor for cost of installation.

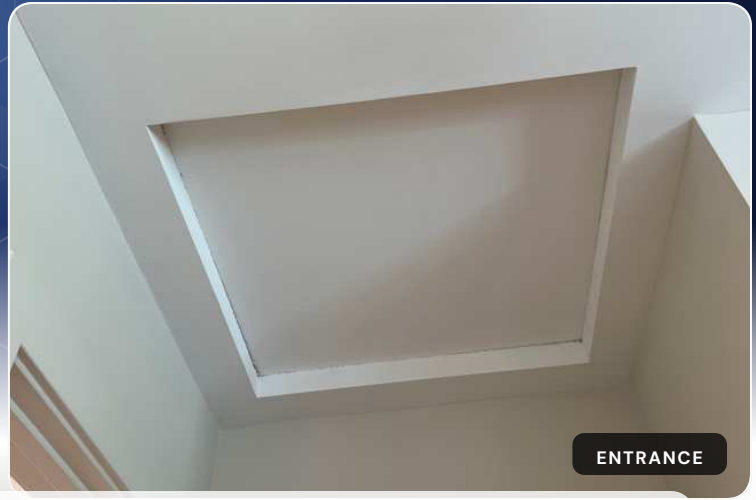
ENTRANCE

Entrance — The attic access hatch is of sufficient size for easy access into the attic area.

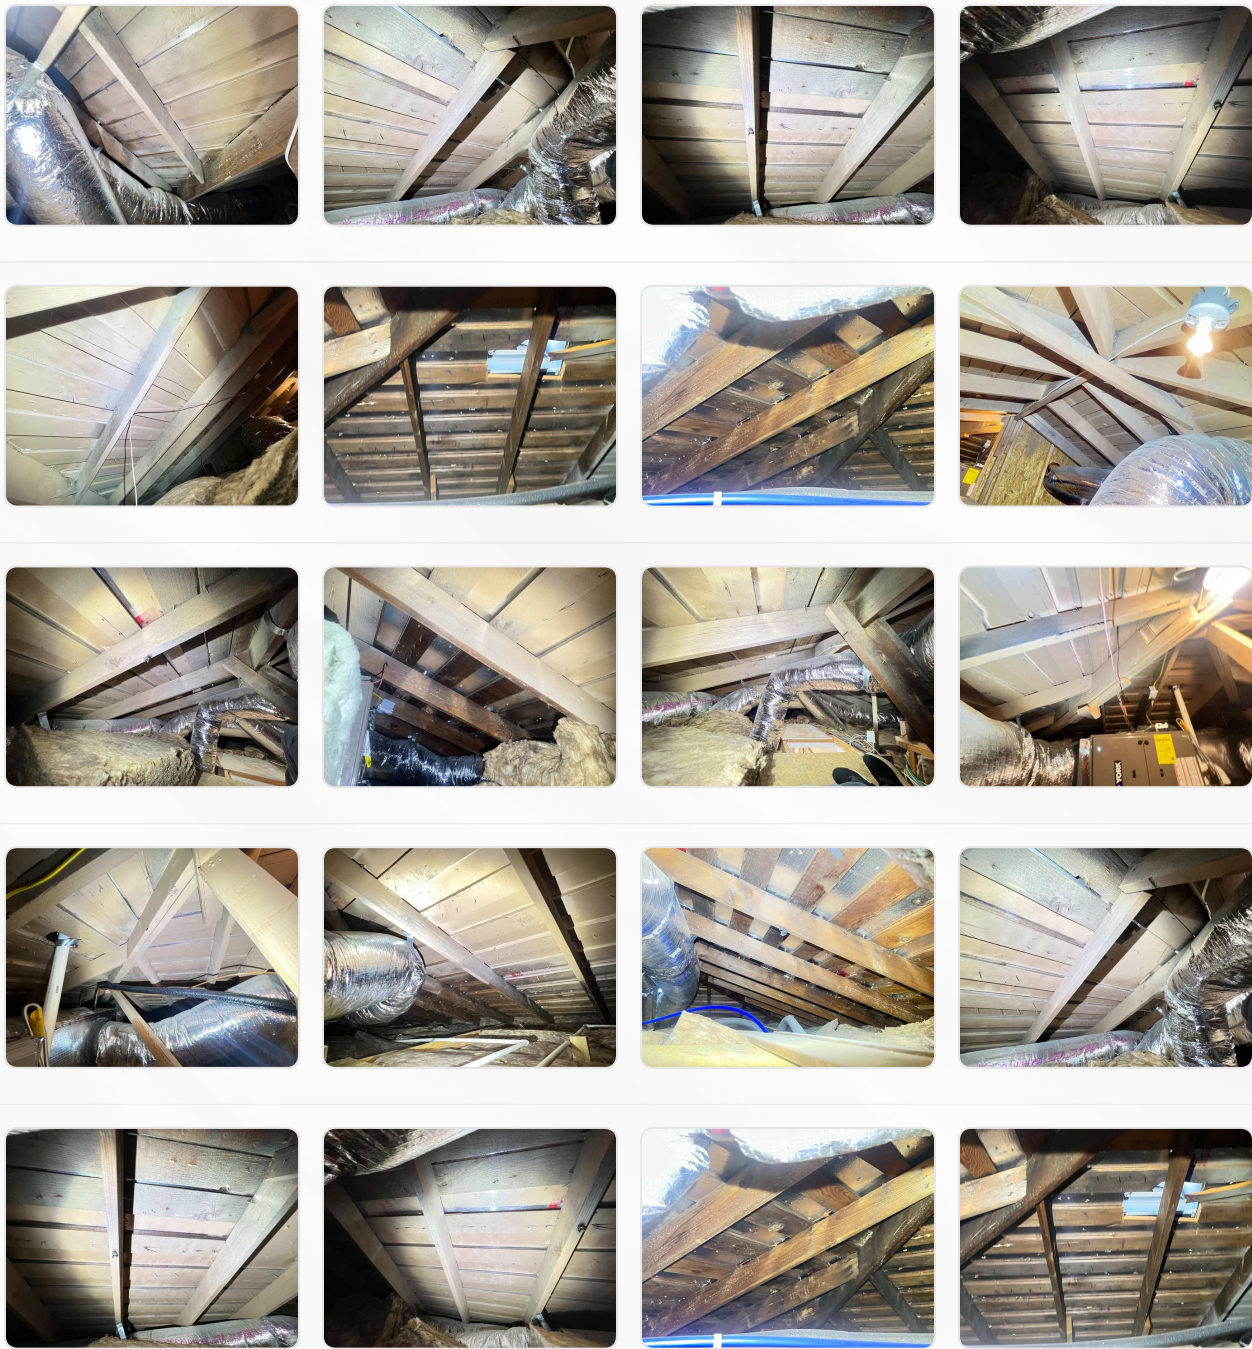
**SATISFACTORY** **261: Fiberglass Batt**  
**Satisfactory**

Insulation — Fiberglass batt insulation was utilized throughout the attic area. The installation was satisfactory.

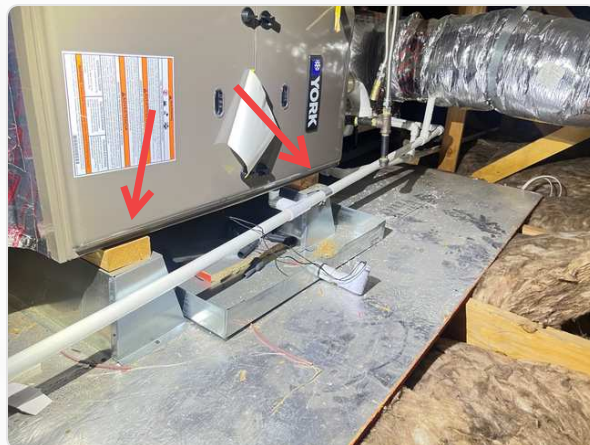
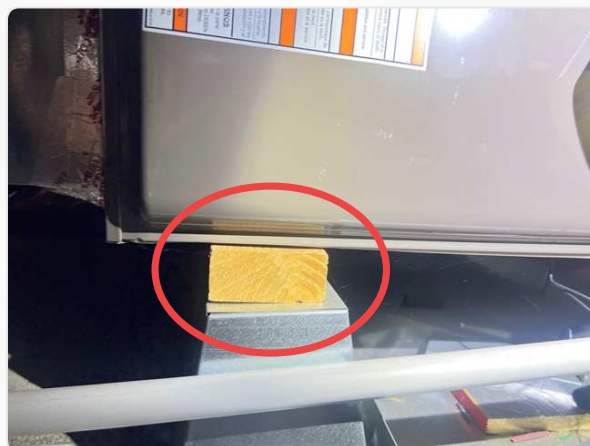
Heating System Condition — The horizontal gas furnace was observed to be elevated using wood blocking placed on top of the metal furnace stand supports. While the furnace is supported, the use of combustible wood spacers is not considered an appropriate support method for this type of installation. If additional elevation was required, properly sized code-compliant metal furnace stands or supports should have been used. Recommend consultation with the builder or a qualified HVAC contractor to evaluate the installation and provide proper support as necessary.

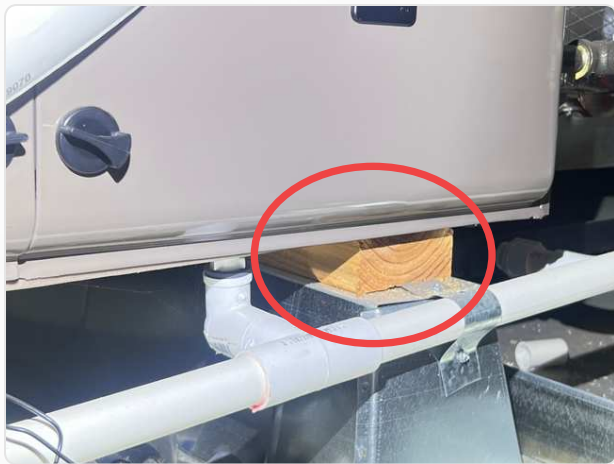
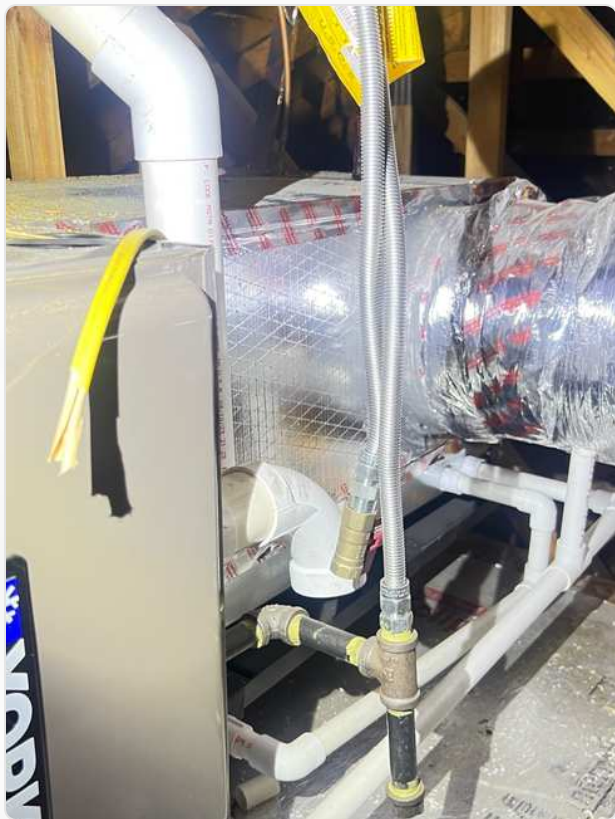
**SATISFACTORY 266**

Venting — Heater vent was in satisfactory condition and directly vented through the roof.

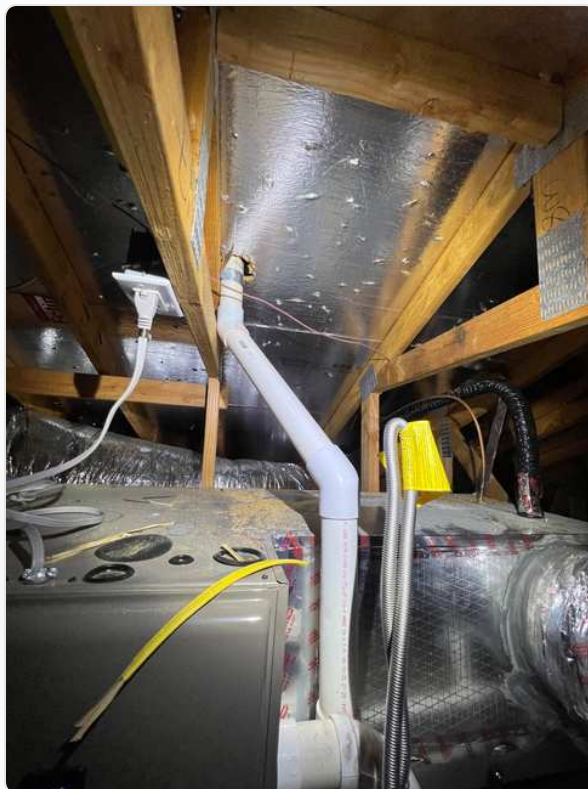
**REPAIR R267**

Gas Line — The gas supply line for the ADU furnace unit was not connected to the gas supply at the time of the inspection. As a result, the furnace could not be operated or evaluated for proper function. Recommend consultation with the builder to complete the gas connection and verify proper operation of ADU furnace unit prior to occupancy.

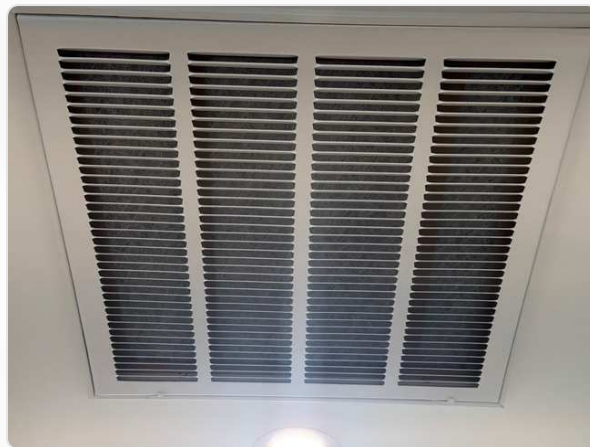
**WARNING W271**

Output Temperatures — The ambient temperatures on the day of inspection were too hot to test the furnace unit safely. Testing the furnace system during high ambient temperatures may cause significant damage to the unit. The unit should only be tested during cooler temperatures. We recommend that the client return in the early morning hours for testing prior to the close of escrow to satisfy any concerns.

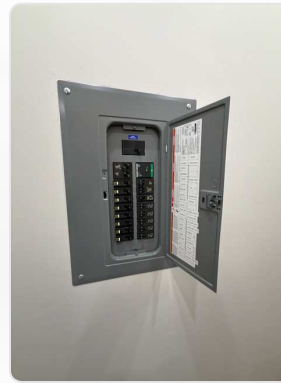
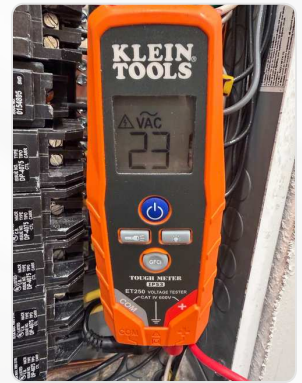
### SATISFACTORY 277

General Condition — The panel was in satisfactory condition overall.

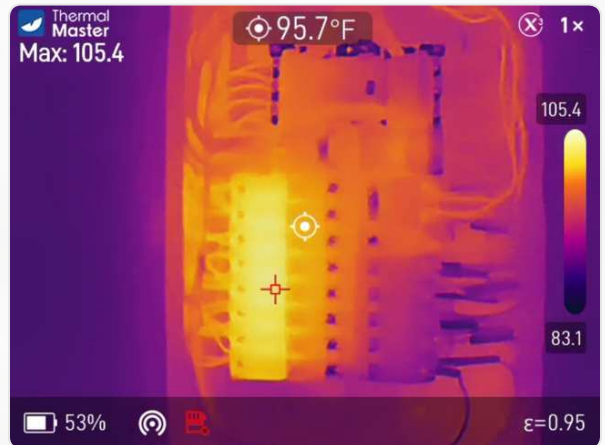
**NOTE 280**

Amperage Rating — The electrical panel is rated for 125/250 Volts 100Amps. The service disconnect switch is located at the main electrical panel at the exterior of the home.

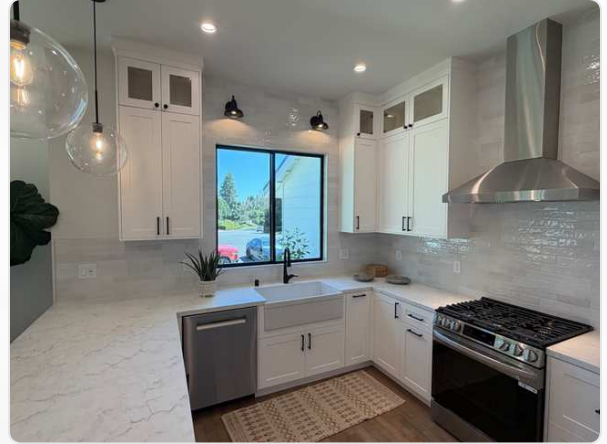
## SATISFACTORY 290

Kitchen Sink — The kitchen sink was in satisfactory condition. Faucet was functional.

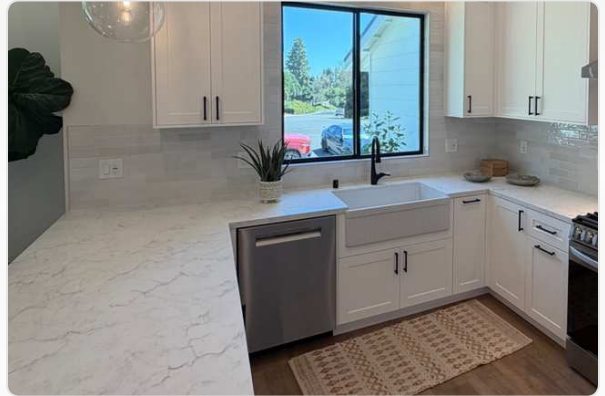
**SATISFACTORY 293: Like New Condition**

Kitchen Cabinets — Kitchen cabinets are in new condition. All doors and drawers function normally.

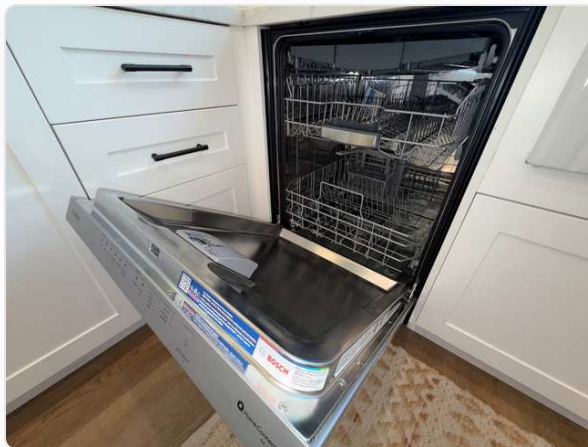
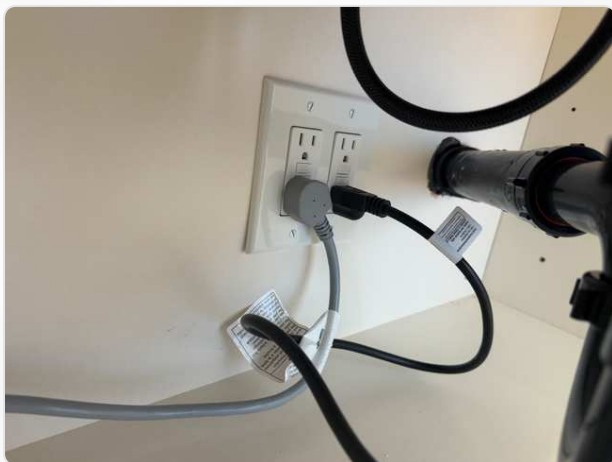
**SATISFACTORY****297: Satisfactory**

Dishwasher(s) — The dishwasher was run through a full "NORMAL wash "cycle only. There were no defects or deficiencies to report. No representation is expressed or implied as to the effectiveness of the dishwashers cleaning capacity.

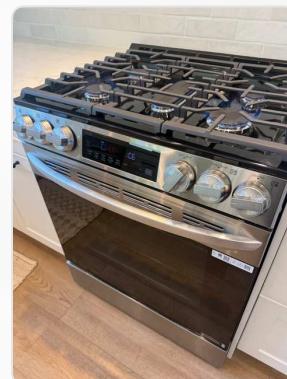
**SATISFACTORY****298**

Range — The range was thoroughly tested. Temperatures were satisfactory. The unit was found to be functional.

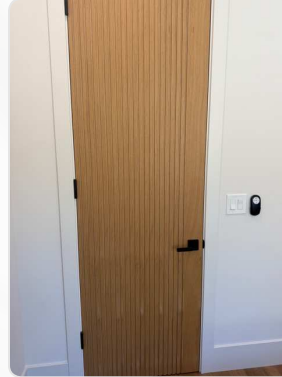
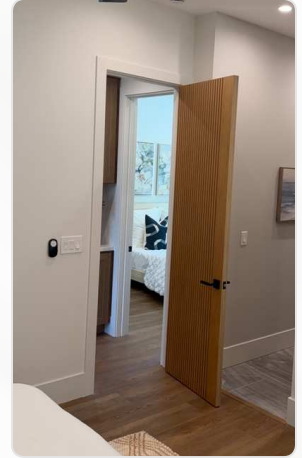
### SATISFACTORY 300

Privacy Door — The door was in satisfactory condition.

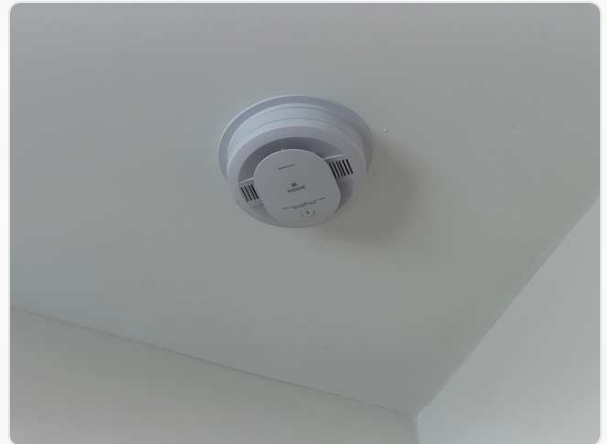
### SATISFACTORY 301

Smoke Detector — Smoke detector present and functional.

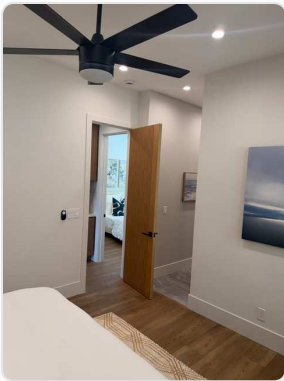
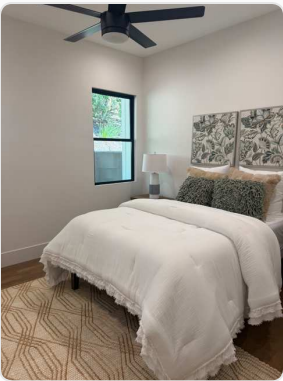
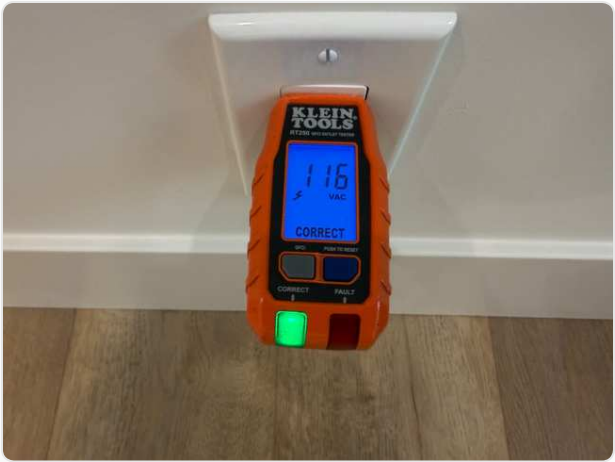
**SATISFACTORY 302**

General Condition — Bedroom was satisfactory.

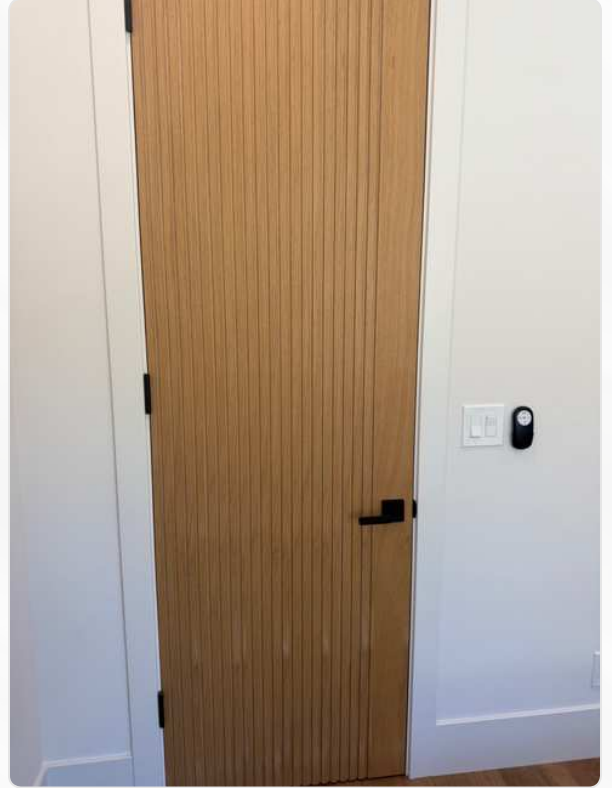
### SATISFACTORY 303

Privacy Door — The door was in satisfactory condition.

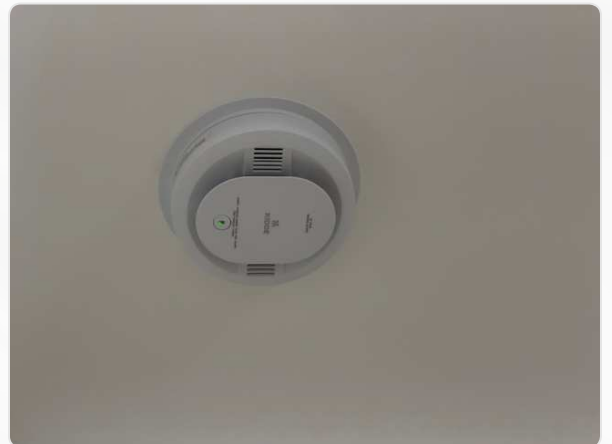
### NOTE 304

Smoke Detector — Smoke detector present and functional.

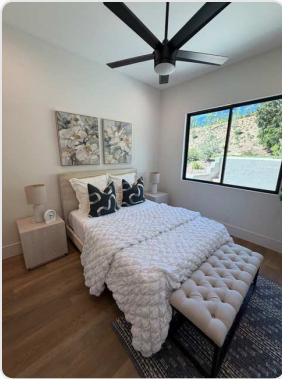
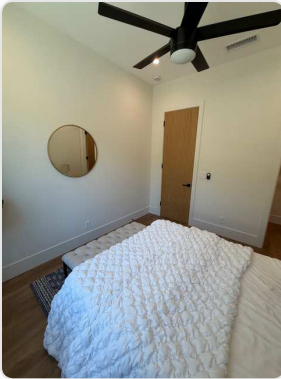
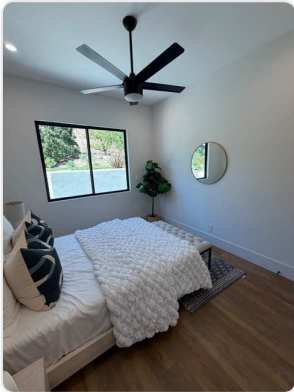
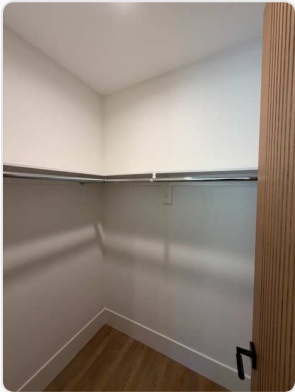
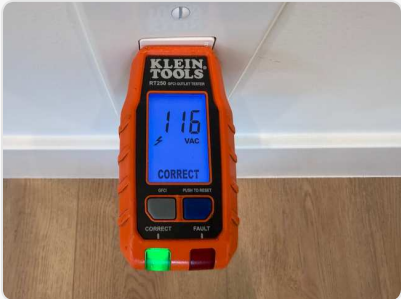
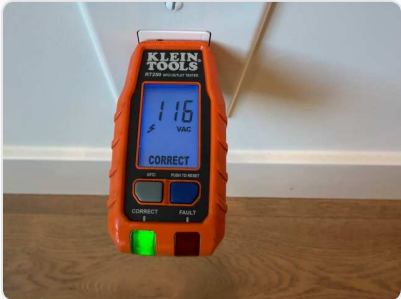
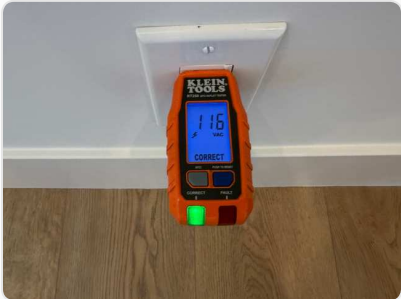
**SATISFACTORY 305**

General Condition — Bedroom was satisfactory.

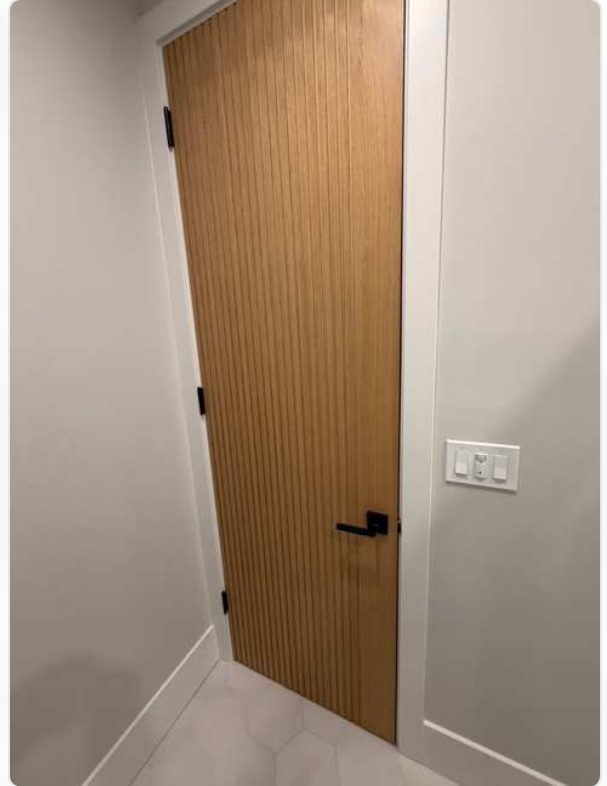
### SATISFACTORY 306

Privacy Door — The door was in satisfactory condition.

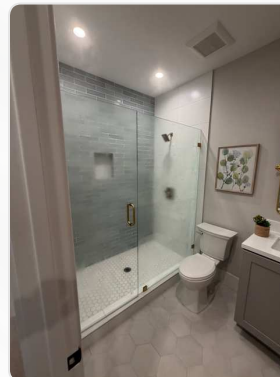
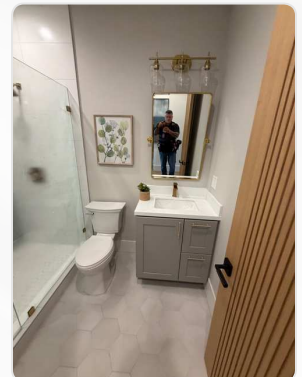
### NOTE 307

Overall Conditions — The floor, walls and ceiling were in satisfactory condition. There were no significant deficiencies noted.

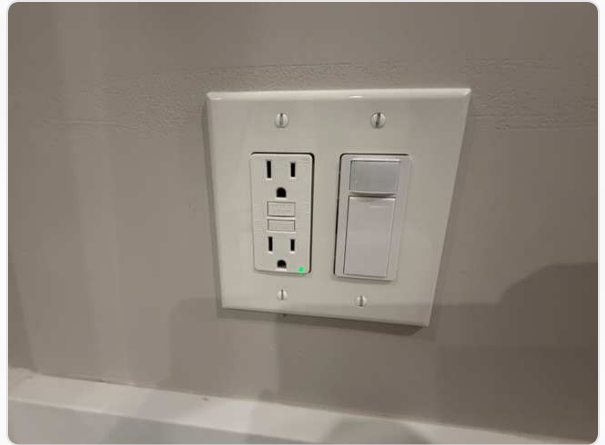
**NOTE 308**

GFCI Outlets — GFCI receptacle was present and functional.

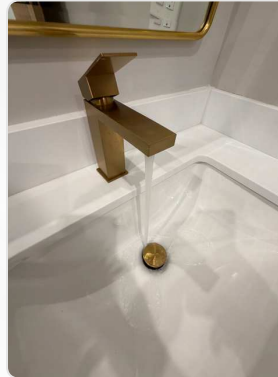
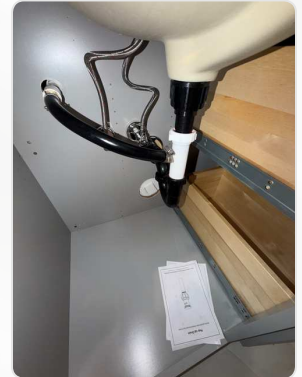
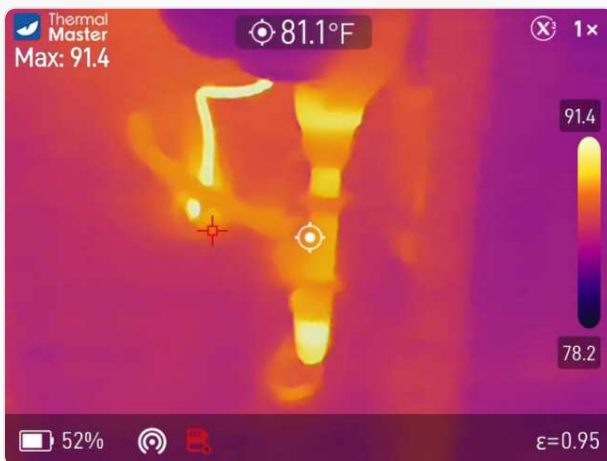
**SATISFACTORY 309**

Sink and Plumbing — Sink and faucet were functional. Hot and cold water were present. And the drain was free flowing.

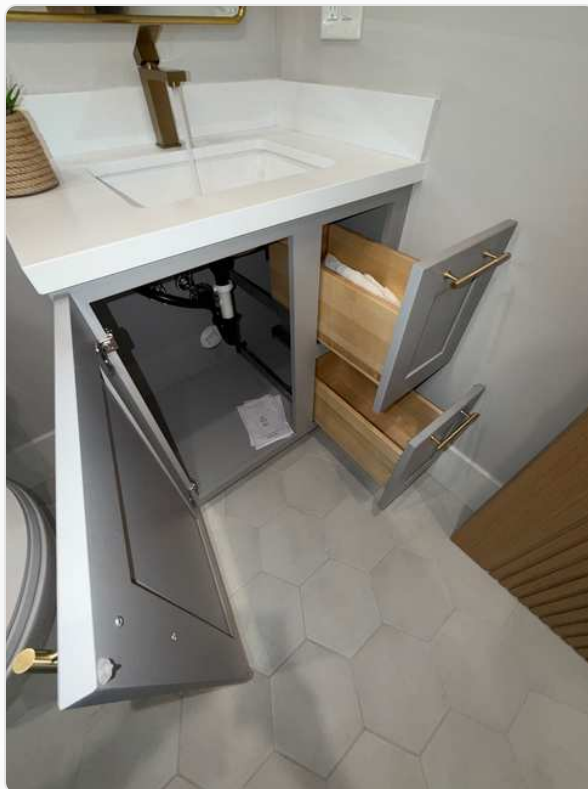
**SATISFACTORY** **310: Cabinet**  
**Satisfactory**

Cabinet Conditions — Cabinets are showing signs of normal wear and tear. All doors and drawers function normally.

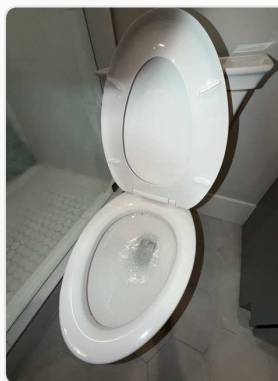
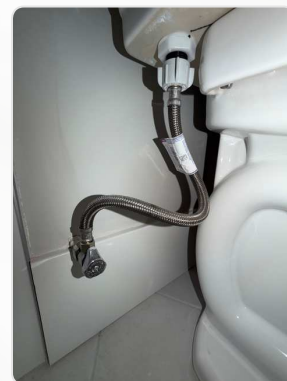
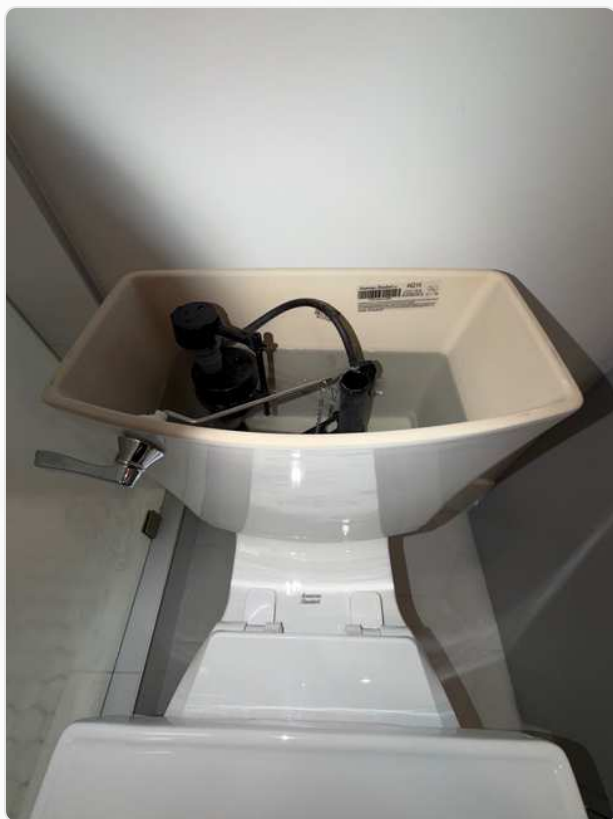
**SATISFACTORY** **311**

Toilet — The toilet was functional and in satisfactory condition.

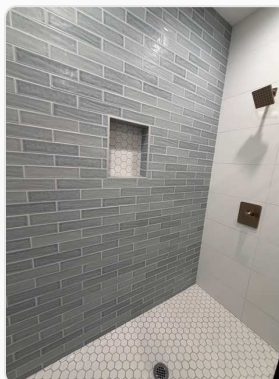
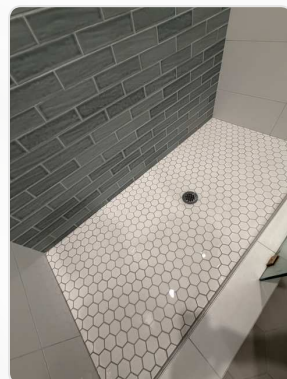
**SATISFACTORY****312: New Shower**

Tub and Showers — The shower was in new condition. Hot and cold running water was present. The drain was free flowing.

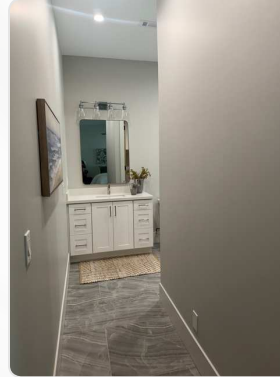
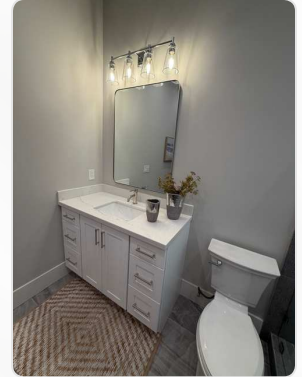
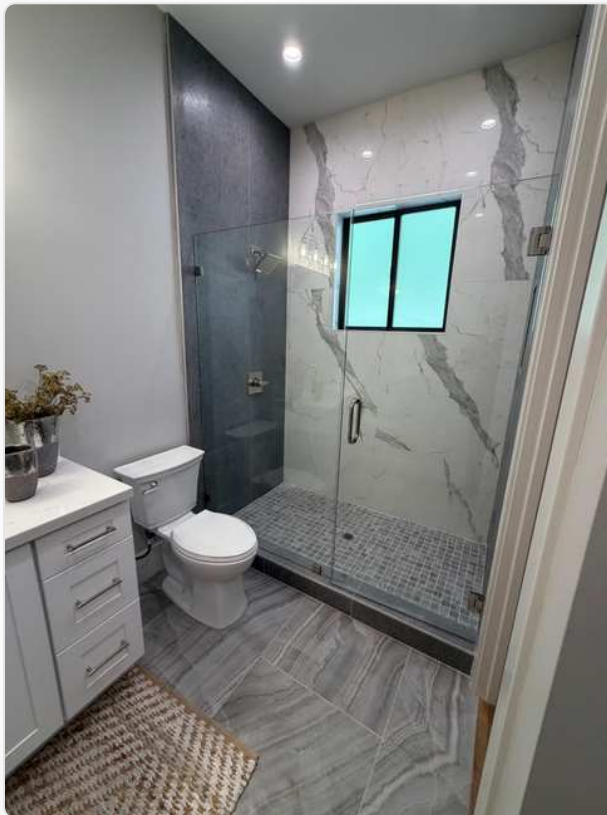
## NOTE 314

Overall Conditions — The floor, walls and ceiling were in satisfactory condition. There were no significant deficiencies noted.

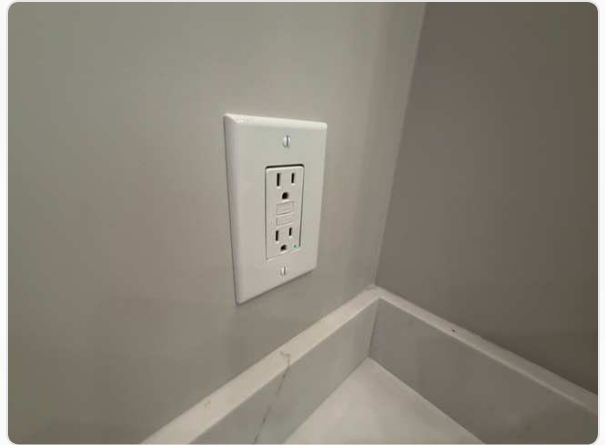
**NOTE 315**

GFCI Outlets — GFCI receptacle was present and functional.

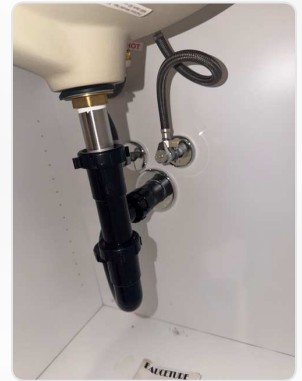
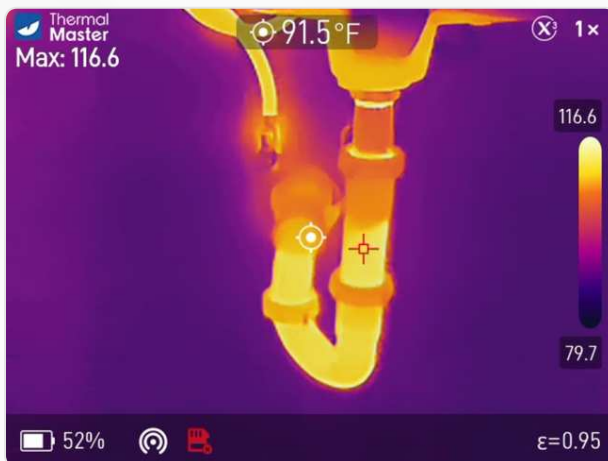
**SATISFACTORY 316**

Sink and Plumbing — Sink and faucet were functional. Hot and cold water were present. And the drain was free flowing.

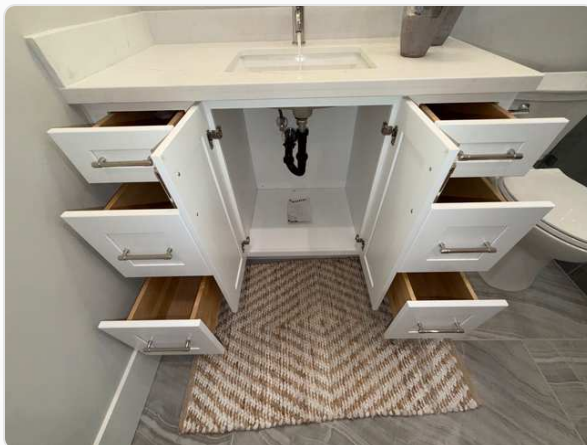
**SATISFACTORY** **317: Like New Condition**

Cabinet Conditions — Bathroom cabinets are in new condition.

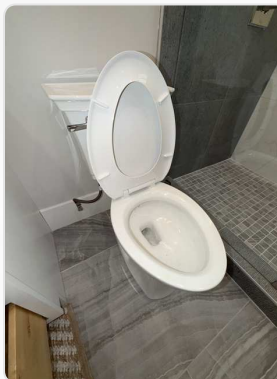
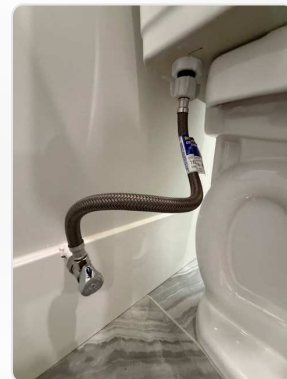
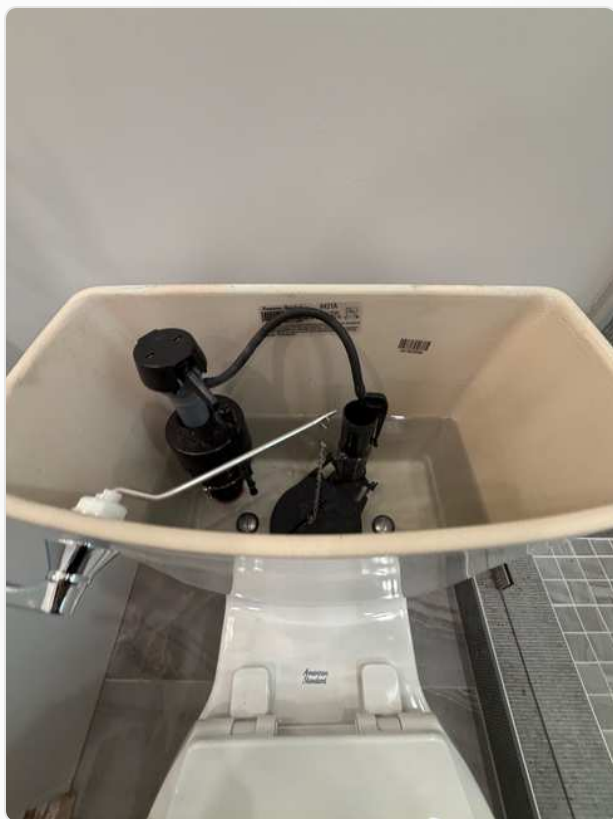
**SATISFACTORY** **318**

Toilet — The toilet was functional and in satisfactory condition.

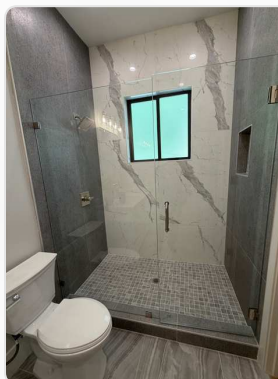
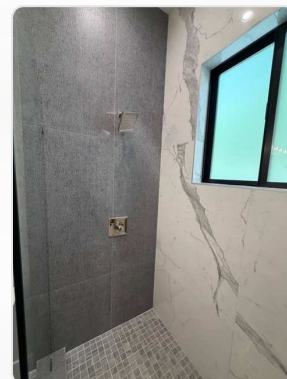
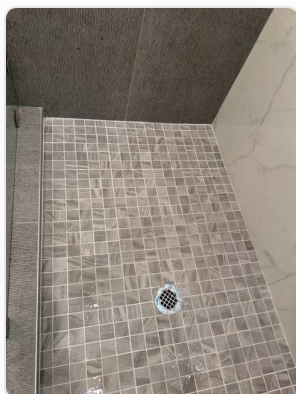
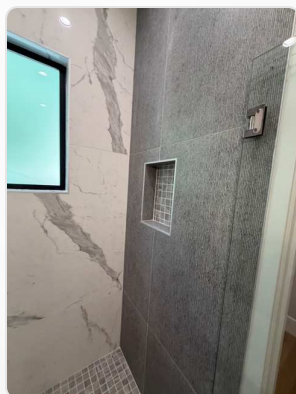
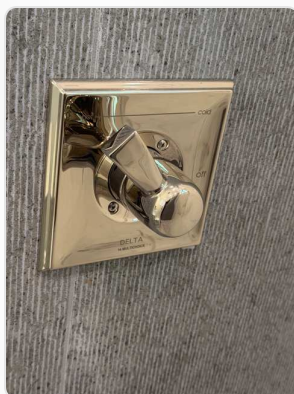
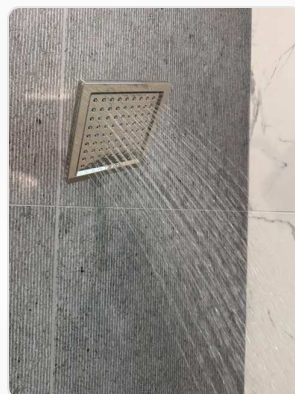
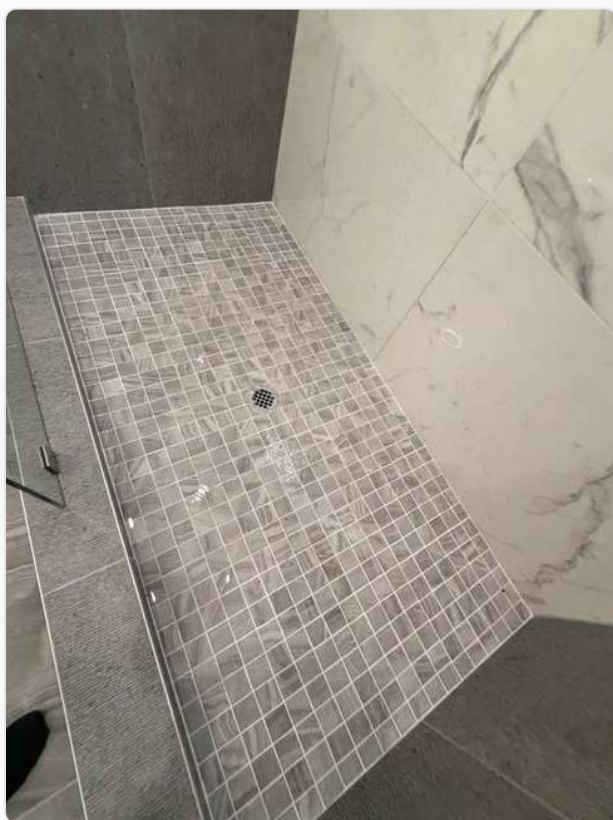
**SATISFACTORY** **319: New Shower**

Tub and Showers — The shower was in new condition. Hot and cold running water was present. The drain was free flowing.

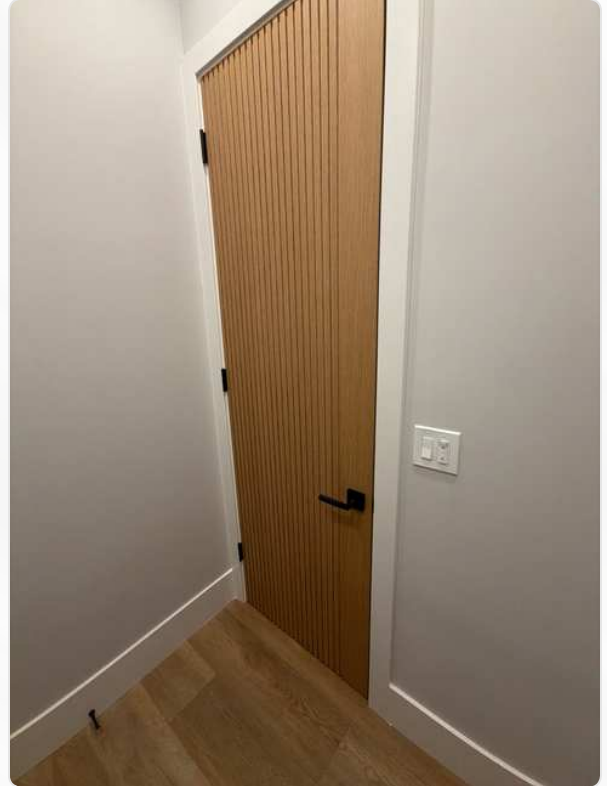
### SATISFACTORY 321

Laundry Door — The door was in satisfactory condition.

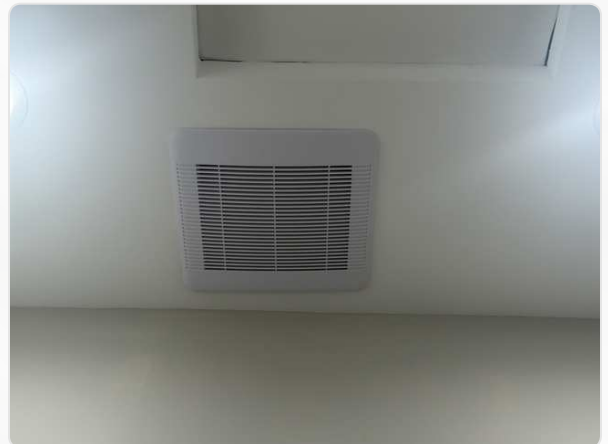
**SATISFACTORY 327**

Ventilator Condition — Laundry room ventilator was satisfactory.

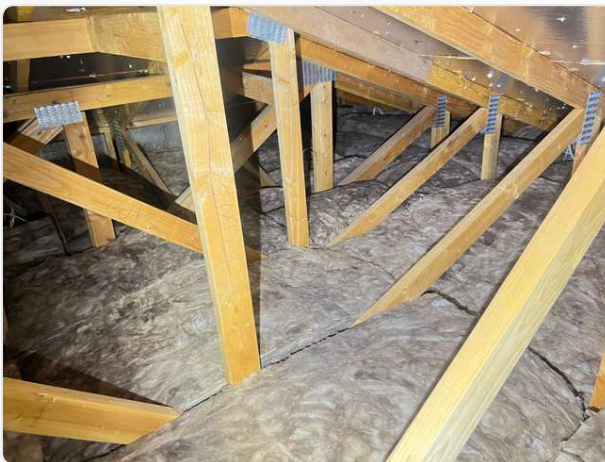
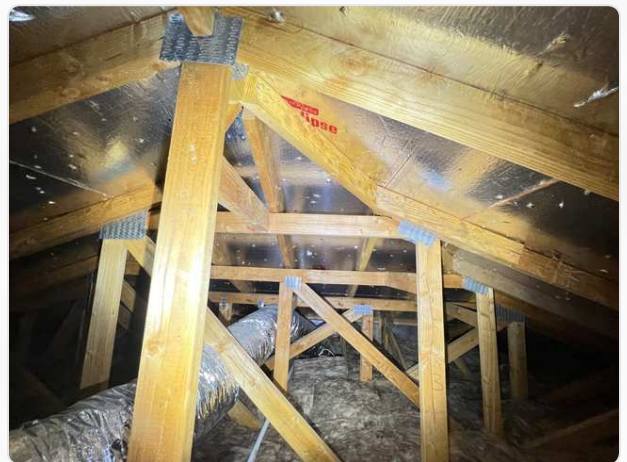
### SATISFACTORY 329

Attic Structure Conditions — The visible portions of the roof trusses were in good condition. There were no apparent signs of damage or alterations. There was no rust or corrosion noted on the visible truss connector plates.
