# HOME INSPECTION REPORT

PROFESSIONAL PROPERTY EVALUATION

INSPECTION DATE

Tuesday, July 7, 2026

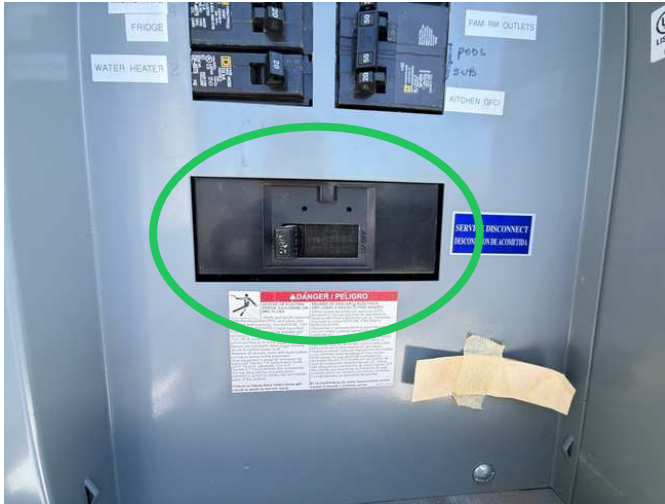
- **Amperage Rating:** 200 Amp Panel

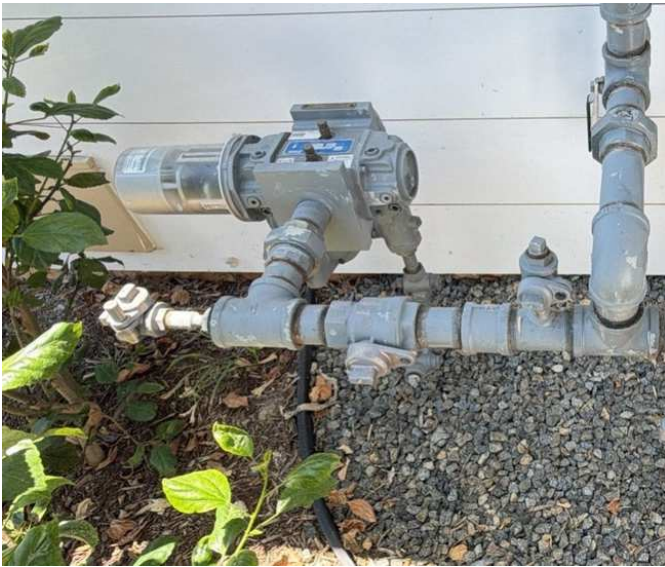
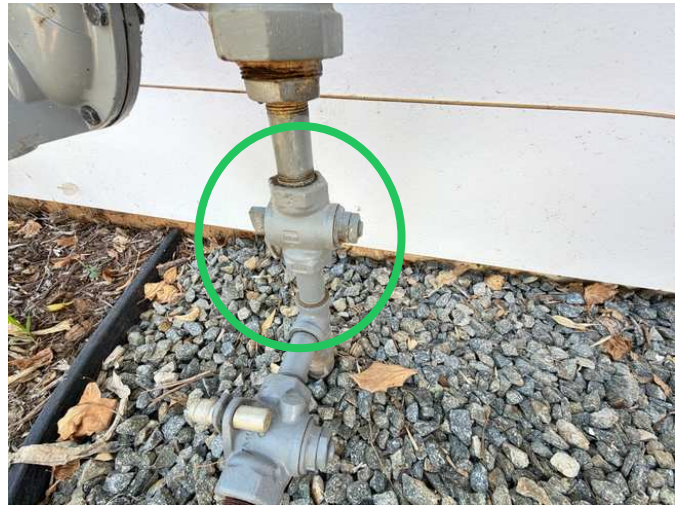
- **Main Disconnect Location:** The service disconnect switch is located at the main electrical panel at the exterior of the home.
- **Gas Utility:** Gas Service Established

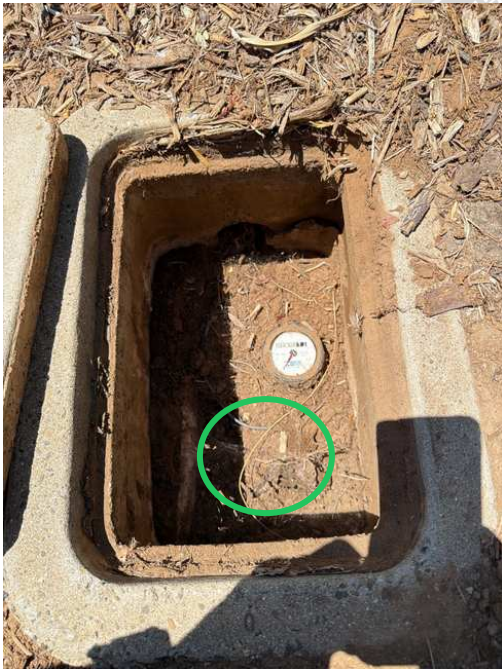
● **Water Utility:** Satisfactory Conditions

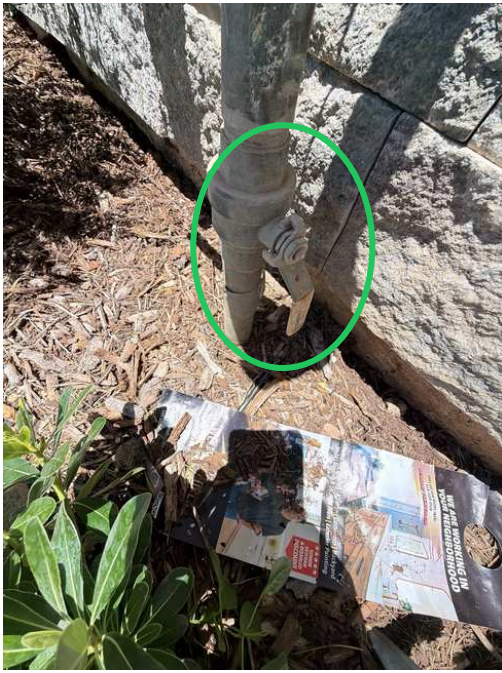
● **Main Shutoff Location:** Front of home location

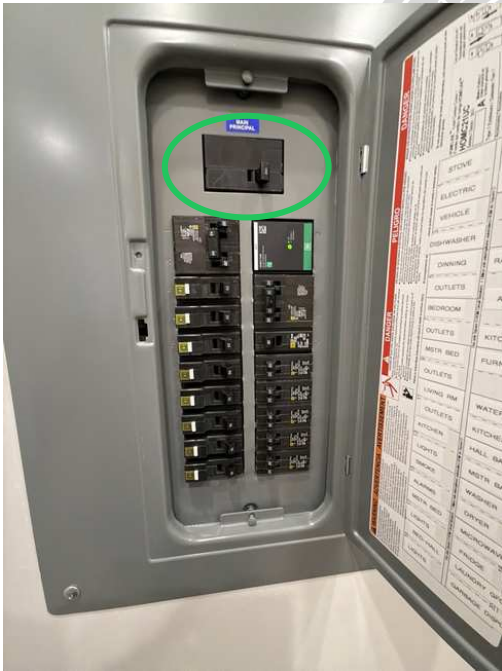
- **Main Disconnect Location:** Subpanel main disconnect is located within the subpanel and there is an additional main service disconnect located at the exterior of the home near the main electrical panel.

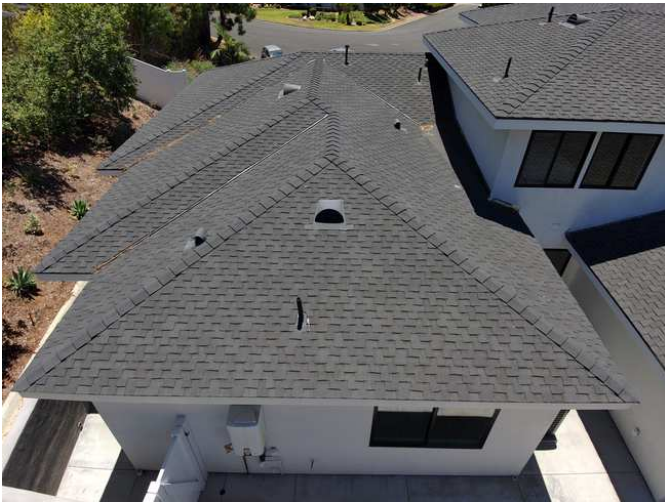
- 1:  
The roof was evaluated using a drone.

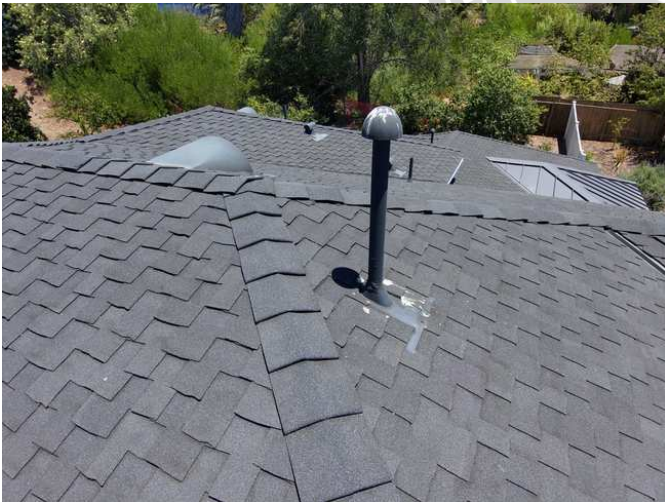
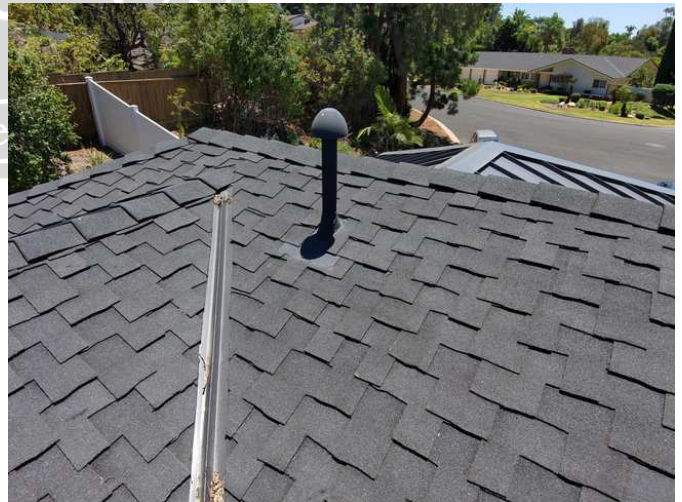
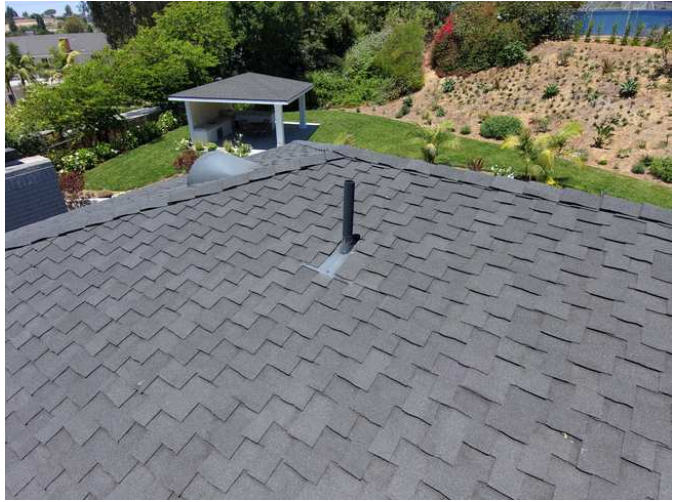
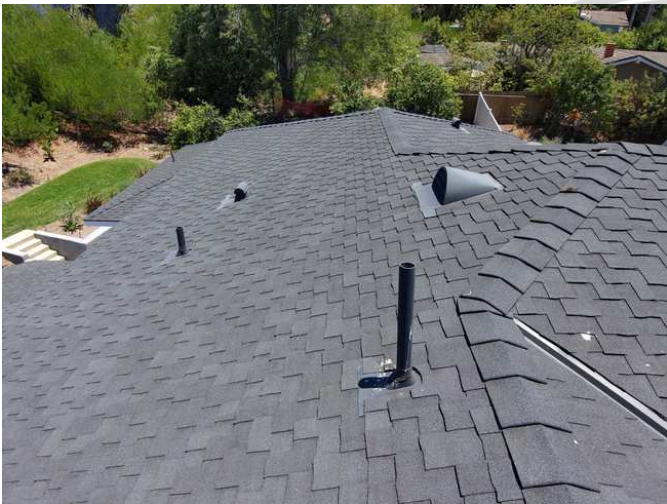
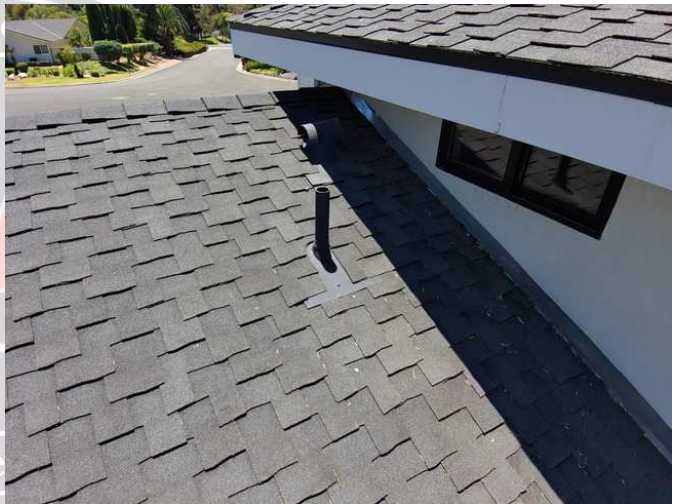
**3:**

Roof penetrations were in good condition. There were no apparent signs of water infiltration. Roof penetrations should be resealed every 5 to 8 years as part of regular home maintenance. And prevent water intrusion.

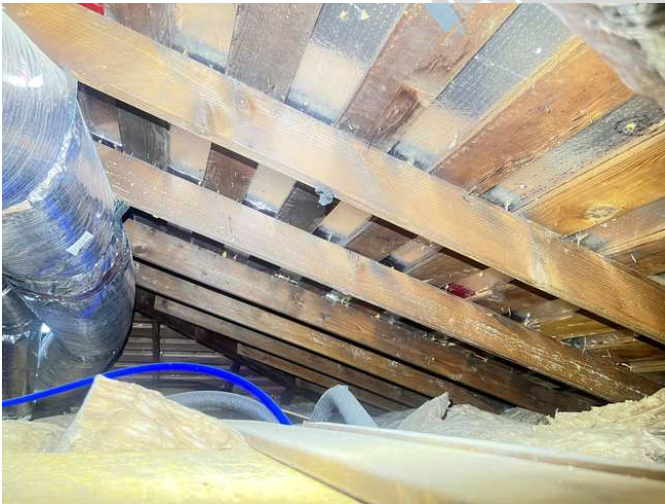
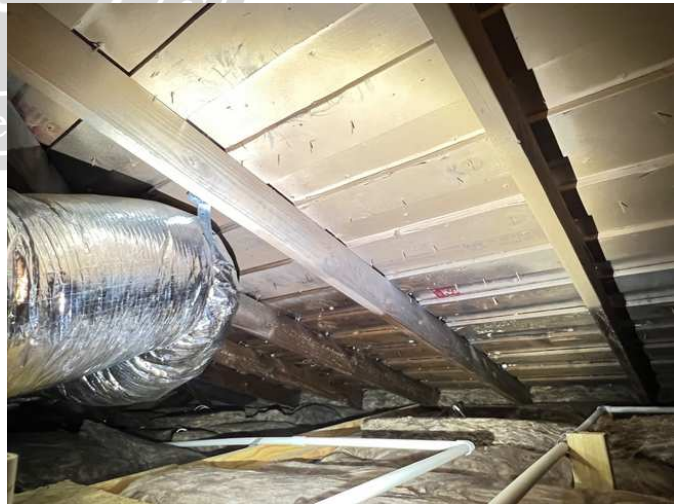
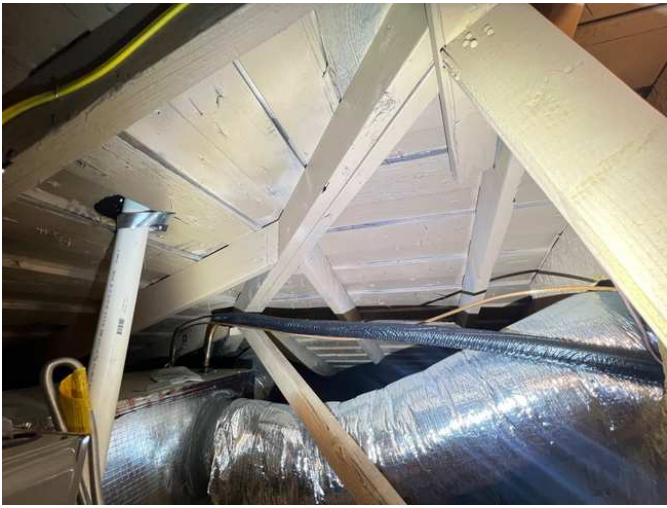
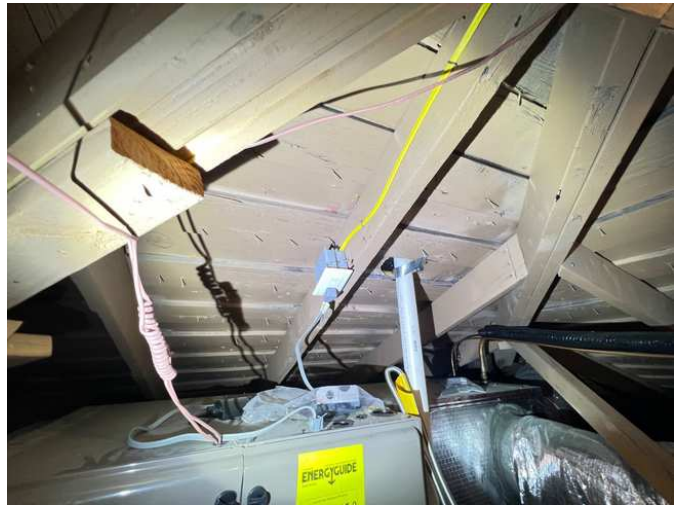
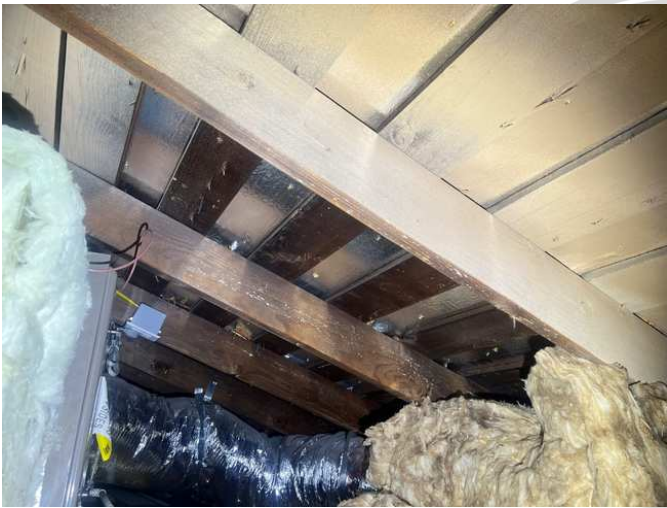
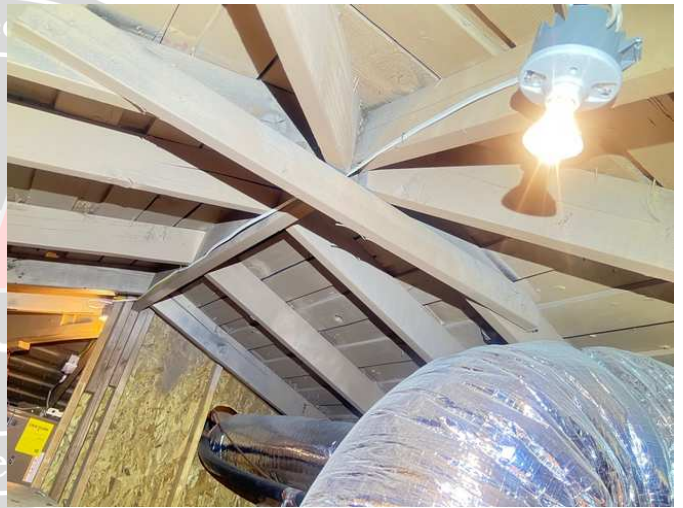
### ✓ 4: Roof Deck Satisfactory

The visible portions of the attic roof decking were in satisfactory condition.

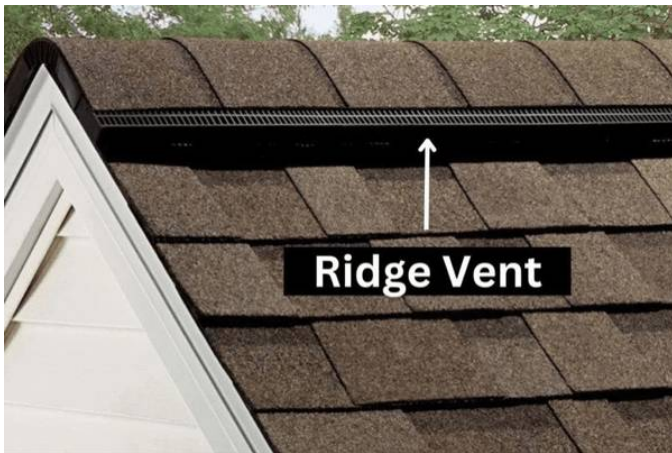
### **W5: Missing Ridge Vent**

Manufacturers of composition shingles recommend continuous roof vent systems to maintain the manufacturer's warranty. Dormer vents were utilized. A lack of ventilation will result in early deterioration of the shingles. Upgrades recommended.

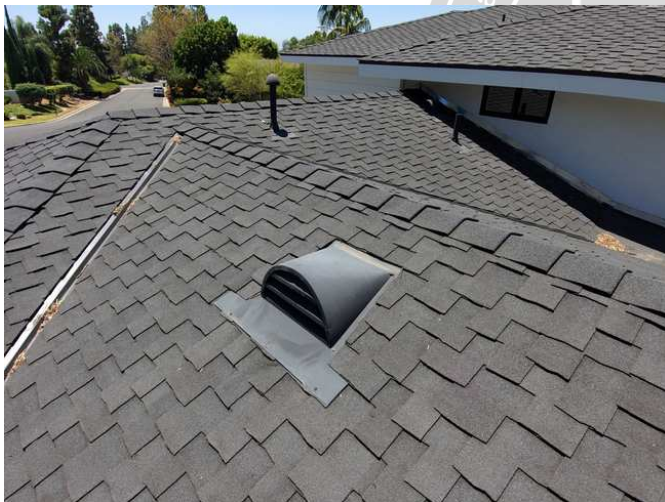
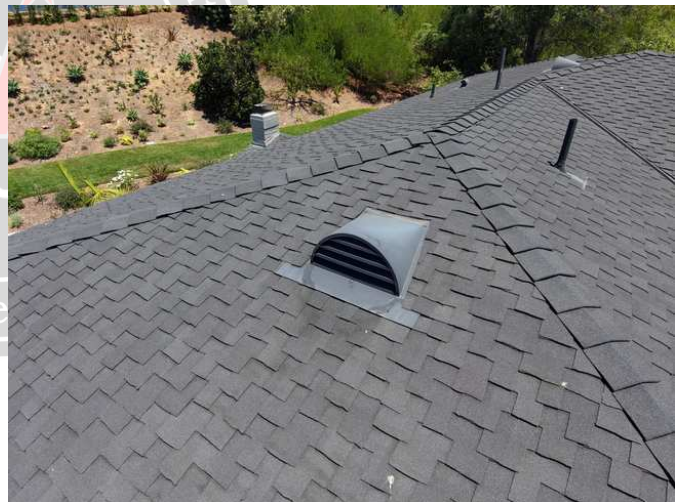
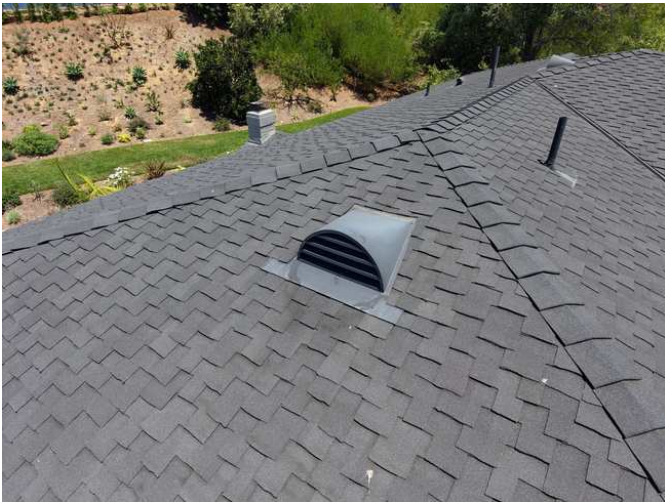
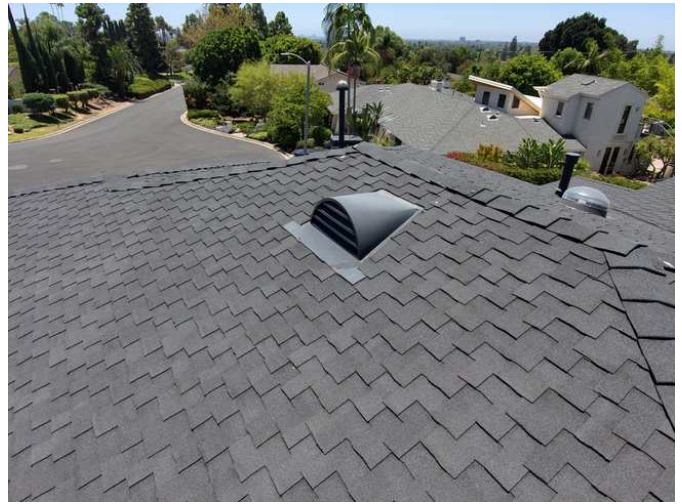
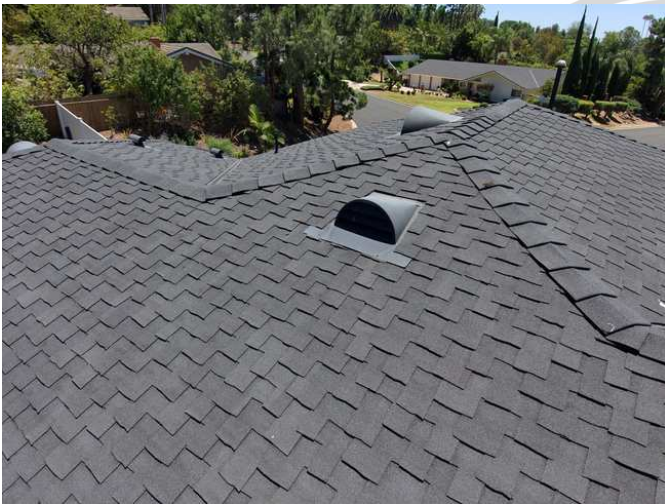
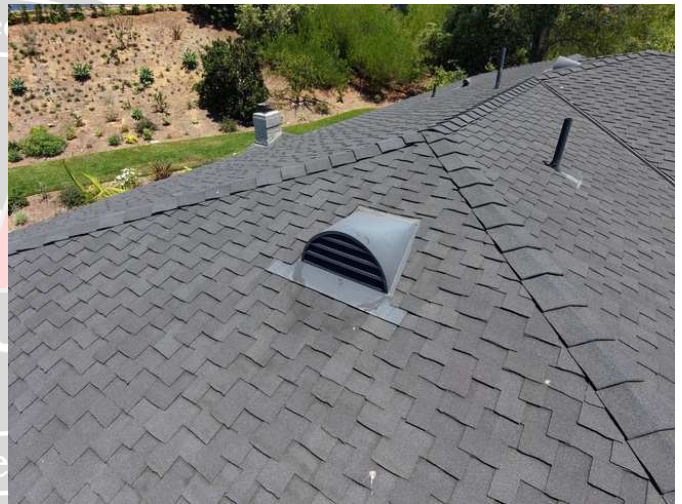
6:

Dormer vents were used to help elate the attic system. Dormer vents were in satisfactory condition.

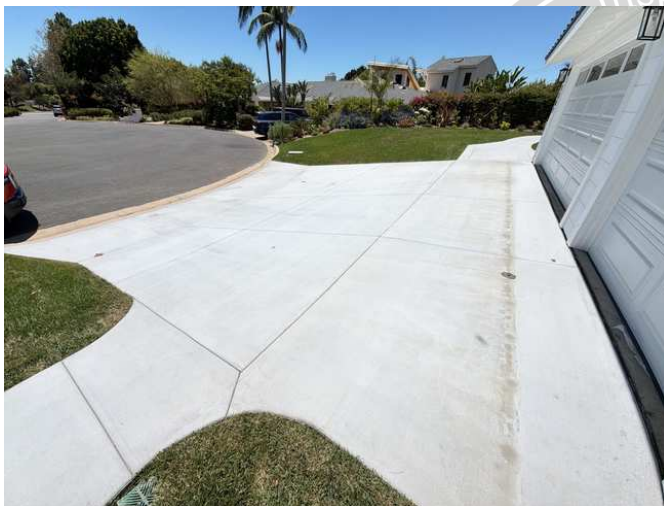
**8:**

The driveway appeared to be in satisfactory and usable condition at the time of the inspection.

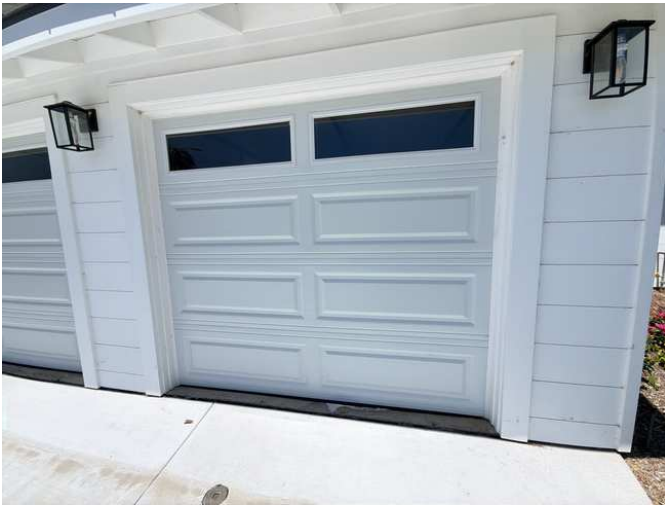
**9:**

The garage door was tested and found to be functional on the day of inspection. Signs of normal wear and tear were present.

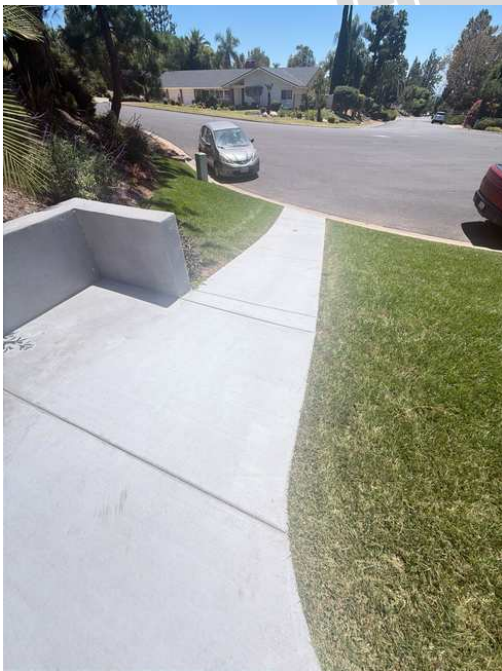
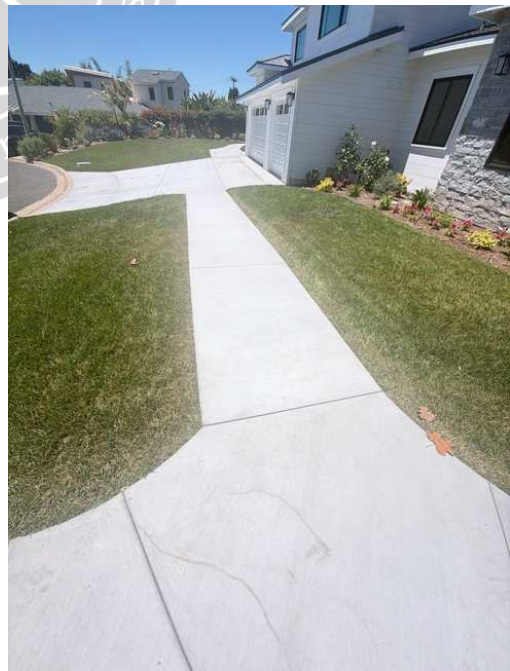
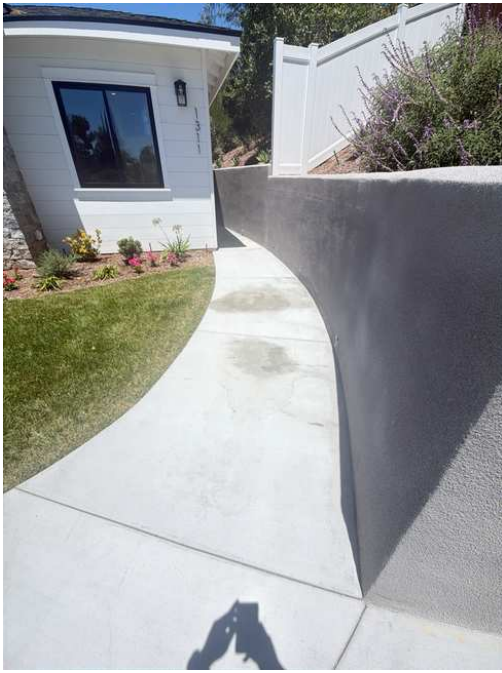
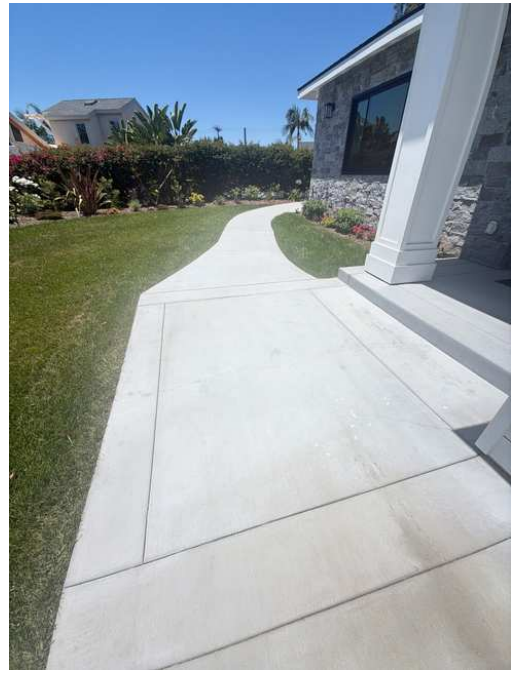
**10:**

The visible areas of the sidewalk appeared to be in serviceable condition at the time of the inspection.

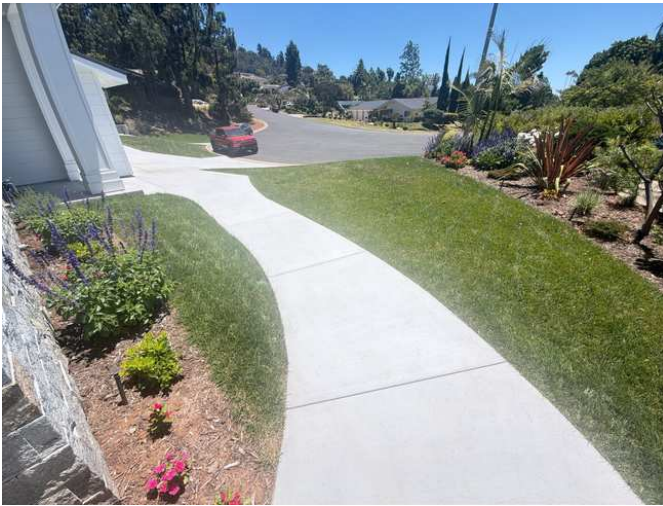
- ✓ **11:** Drainage at the front of the home is satisfactory.

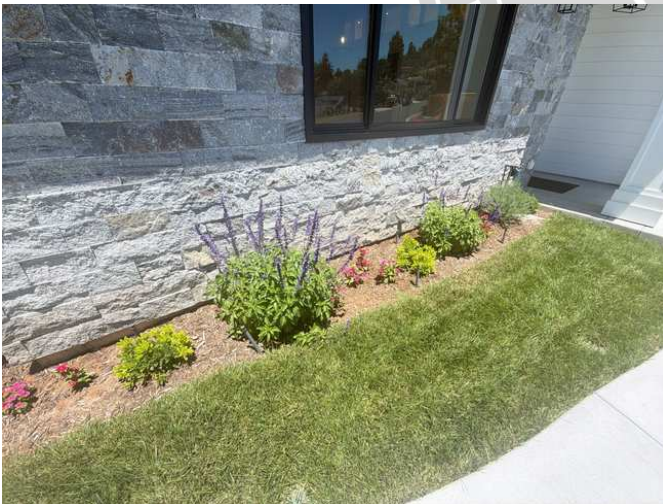
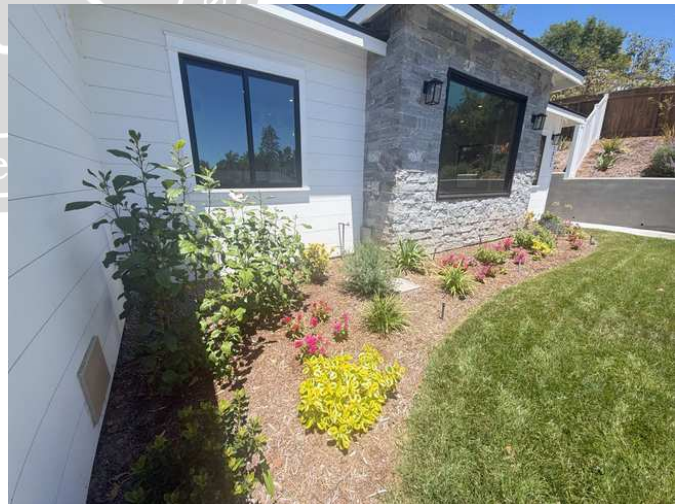
**W12: Planters Warning**

Caution should be exercised not to over water planters at the front of the home. There was no evidence of water proofing against the foundation at the planters. Excessive watering can lead to water intrusion and deterioration of the foundation walls.

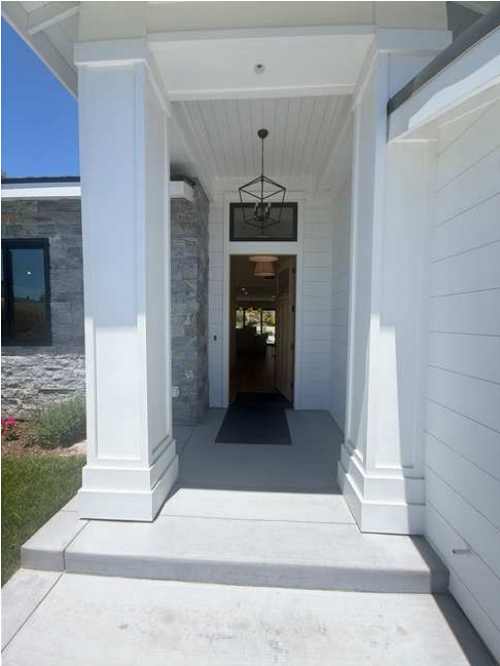
- ✓ **13:**  
Front porch was in satisfactory condition.

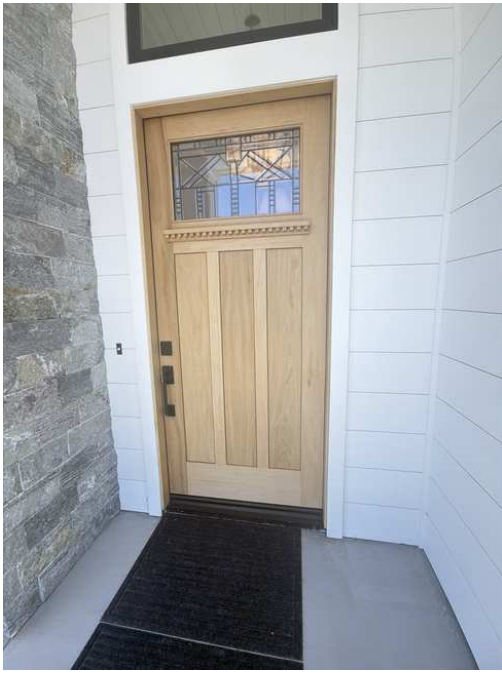
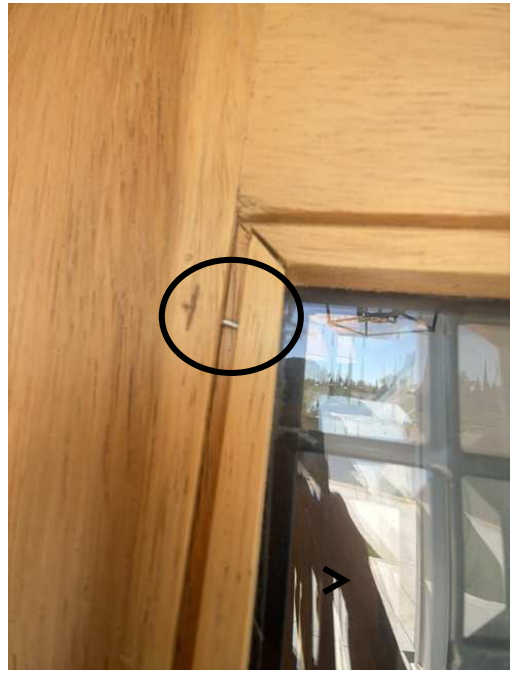
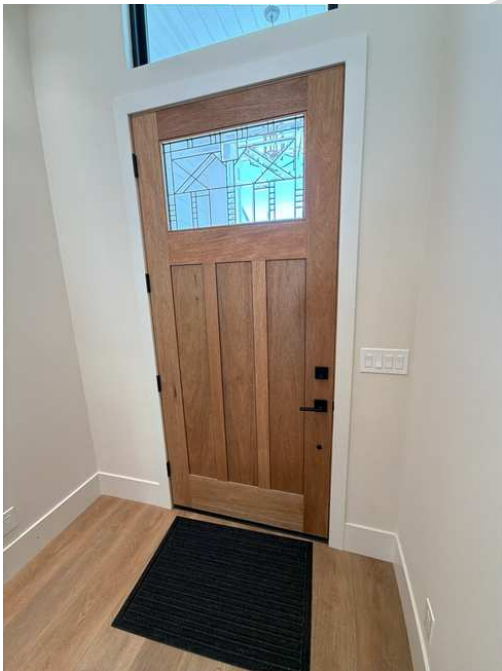
- ✓ **14:**  
The entry door was functional. Cosmetic deficiencies exist, but do not affect the doors performance, and there was no signs of water intrusion.

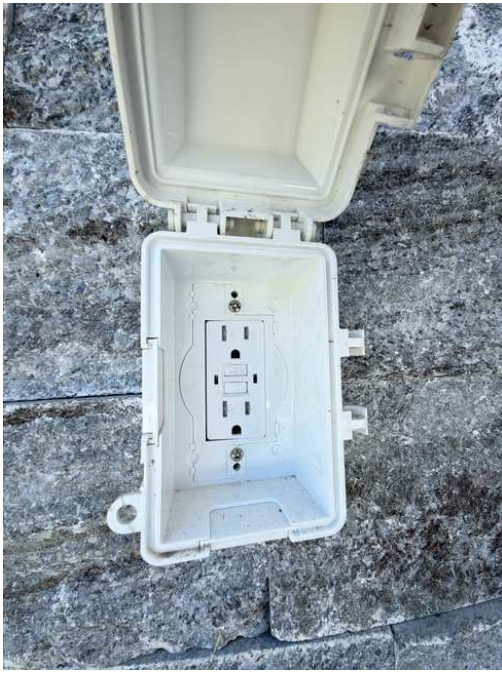
### ✓ 15: GFCI's Satisfactory

The receptacle photographed was tested and found to be GFCI protected. The inspector will make an attempt to verify that all outlets are GFCI protected. However, some receptacles such as those hidden in flower planters or those that are outside view may-not be tested.

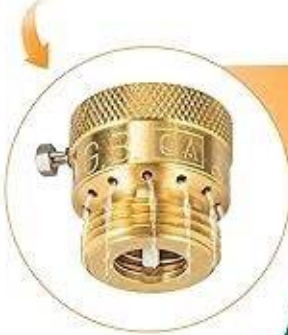
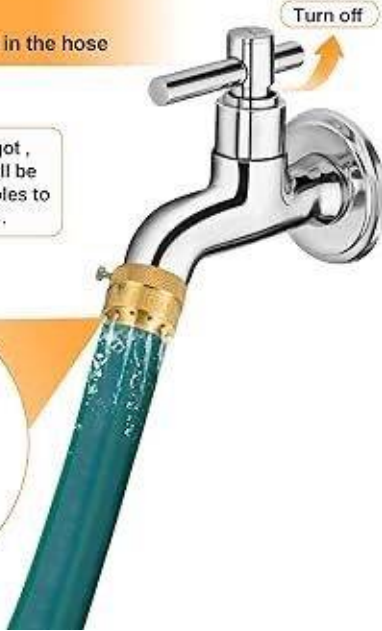
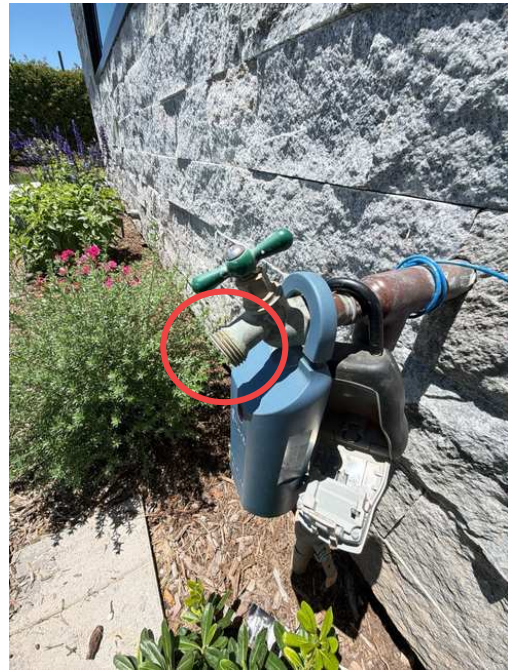
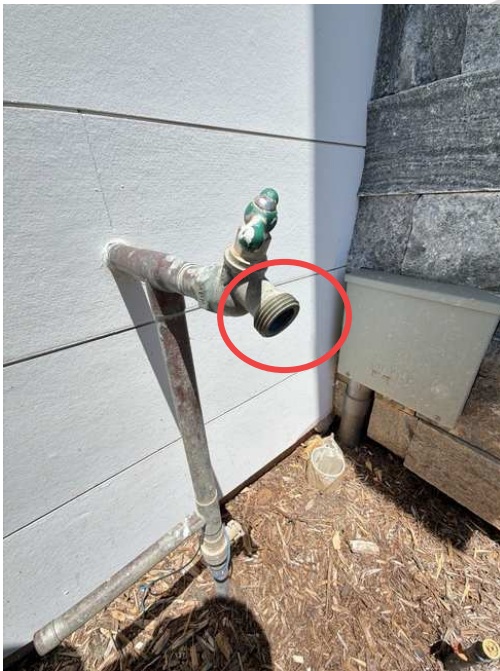
### **W16: Missing Backflow Preventer**

When turn off the spigot ,  
the remained water will be  
sprayed from drain holes to  
achieve anti backflow .

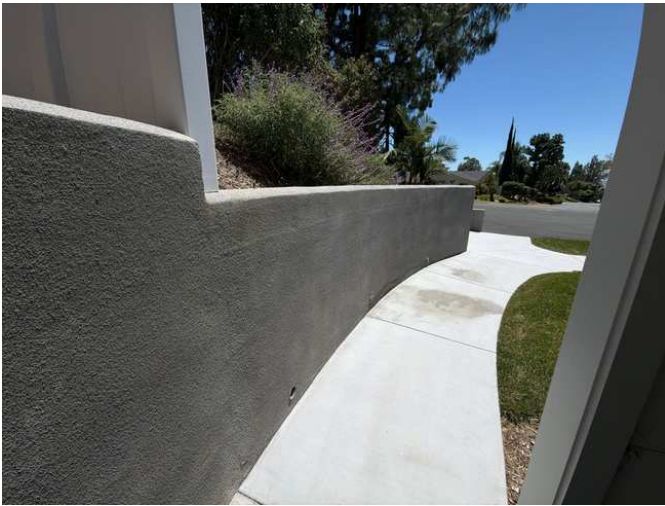
### ✓ 17: Appeared Serviceable

The visible and accessible portions of the retaining walls appeared to be in serviceable condition at the time of the inspection.

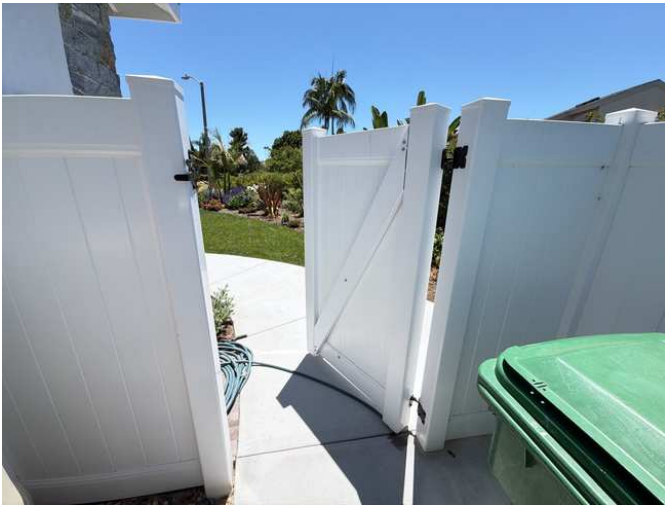
- ✓ **18:** Gates were in satisfactory condition.

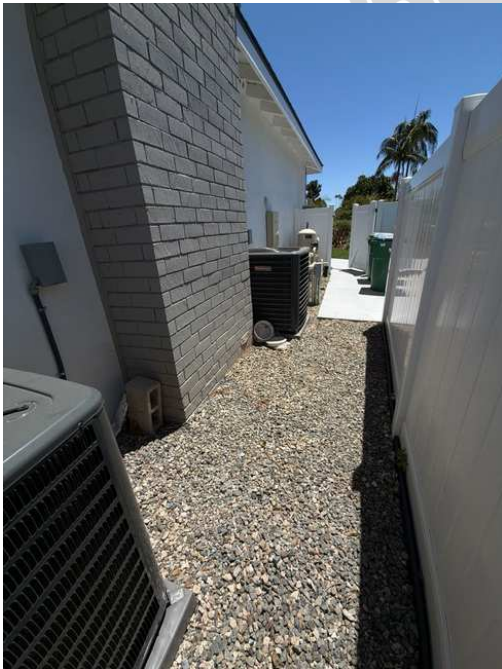
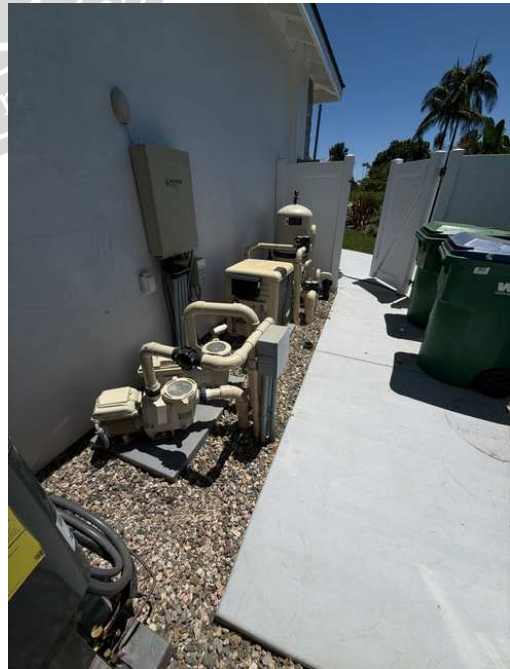
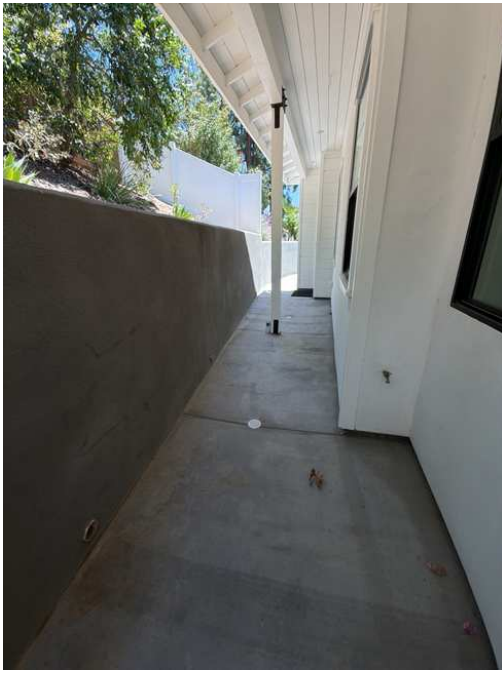
✓ **19: Satisfactory**

Drainage at the front of the home is satisfactory.

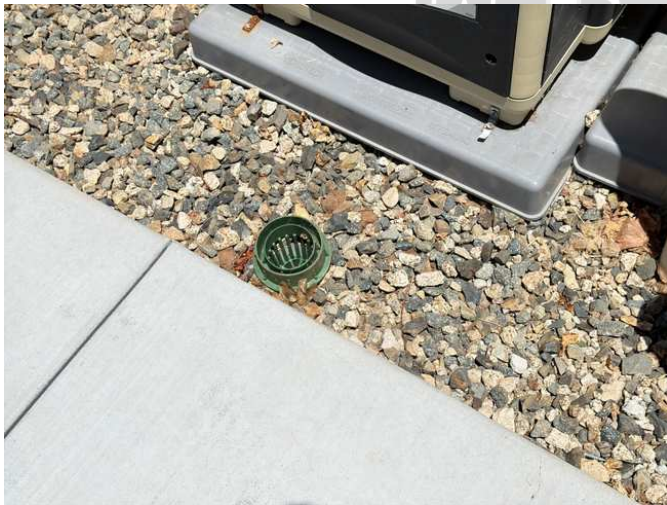
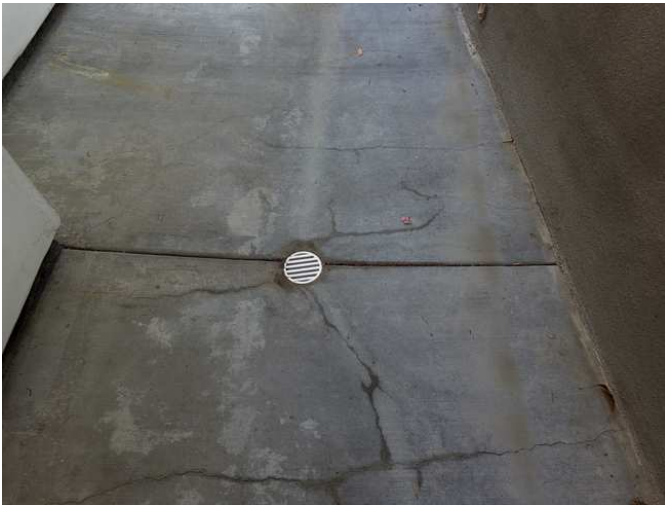
**W20: Storm Drain Warning**

It is vital to maintain clear storm drains. This will help prevent flooding during long sustained rains.

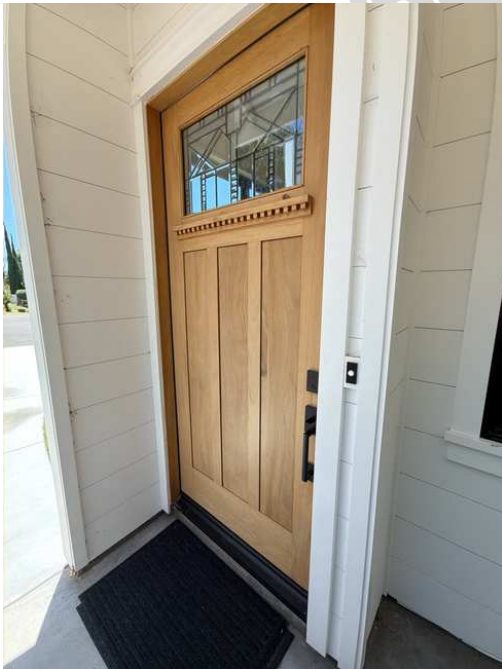
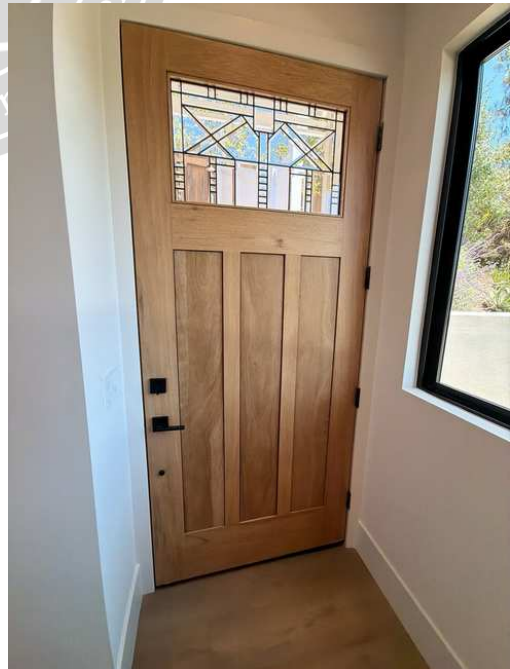
✓ **21: Satisfactory**

The side ADU main entry door was functional. There were no signs of water infiltration.

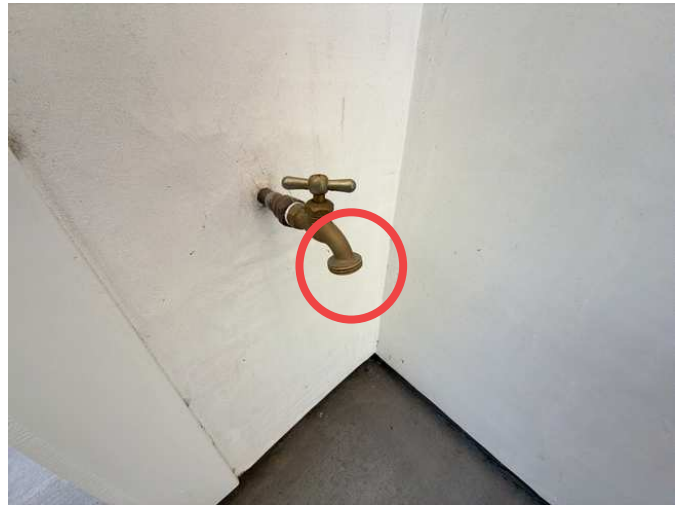
#### ⚠ W23: Missing Backflow Preventer

Draining the remained water in the hose

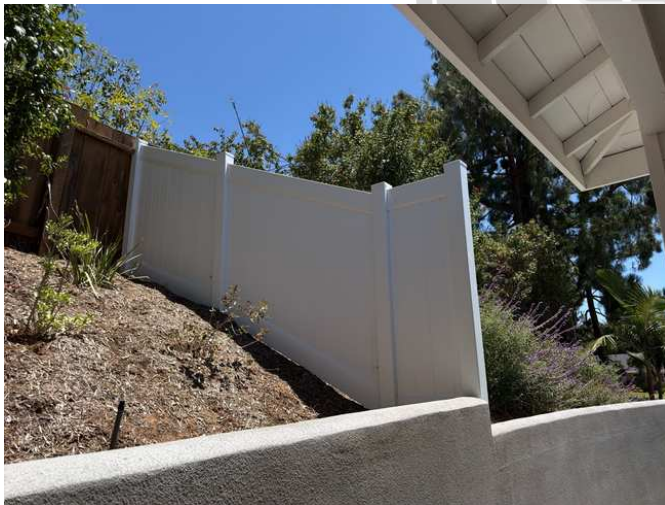
24:

The vinyl fencing is in satisfactory condition.

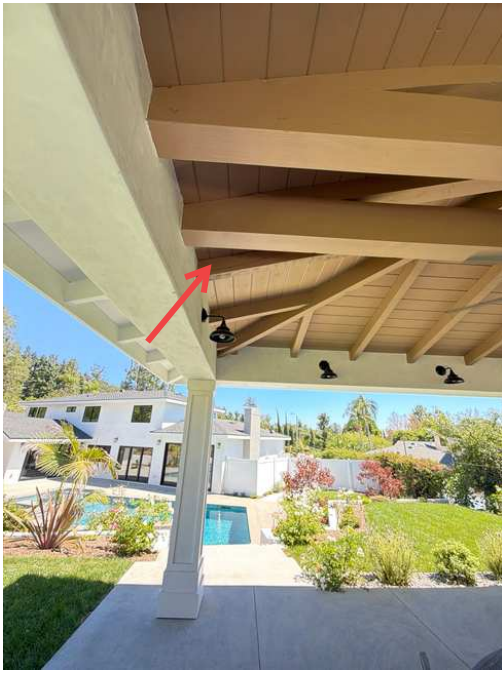
One of the wooden support timbers for the roof over the barbecue was split. Client may wish to discuss this condition with a qualified individual for repair or replacement.

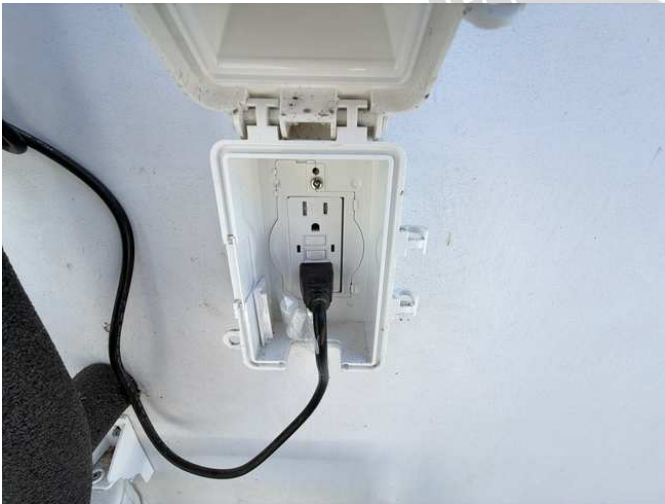
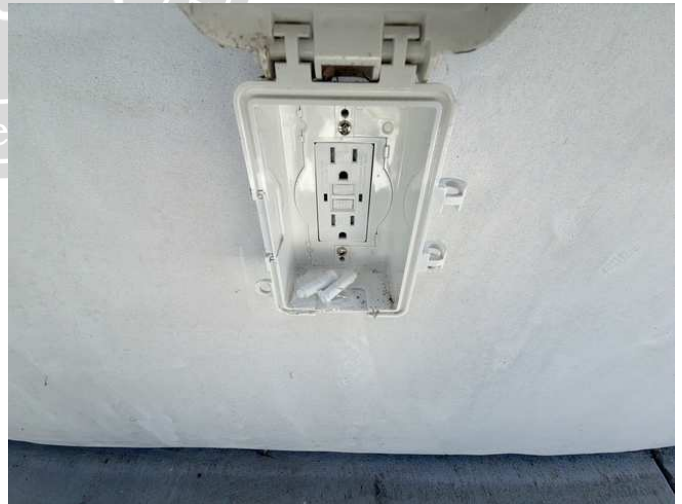
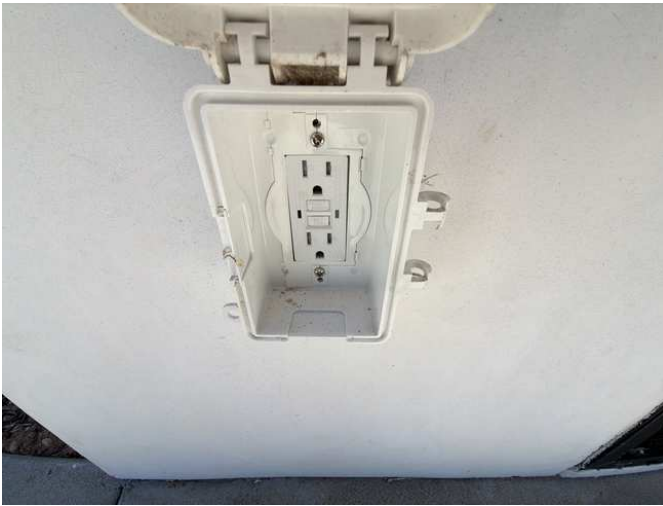
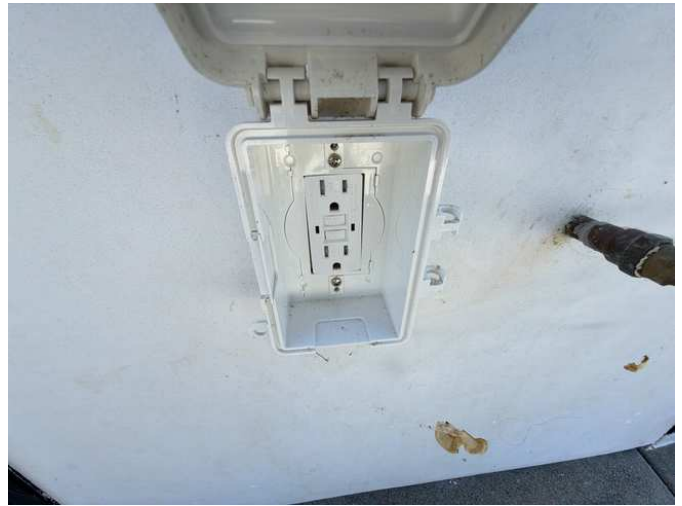
✓ **28:**

The receptacles photographed were tested and found to be GFCI protected. The inspector will make an attempt to verify that all outlets are GFCI protected. However, some receptacles such as those hidden in flower planters or those that are outside view may-not be tested.

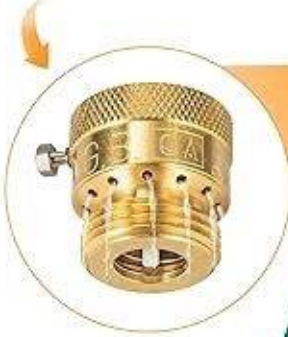
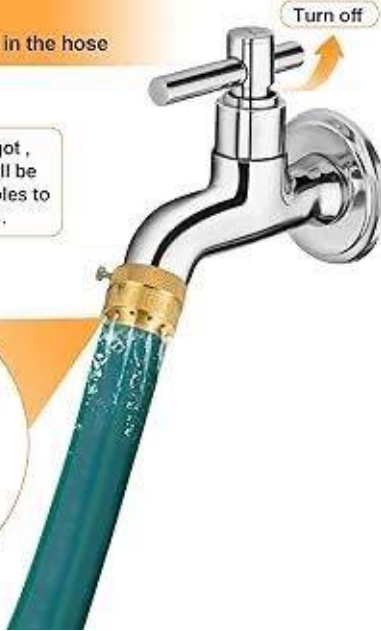
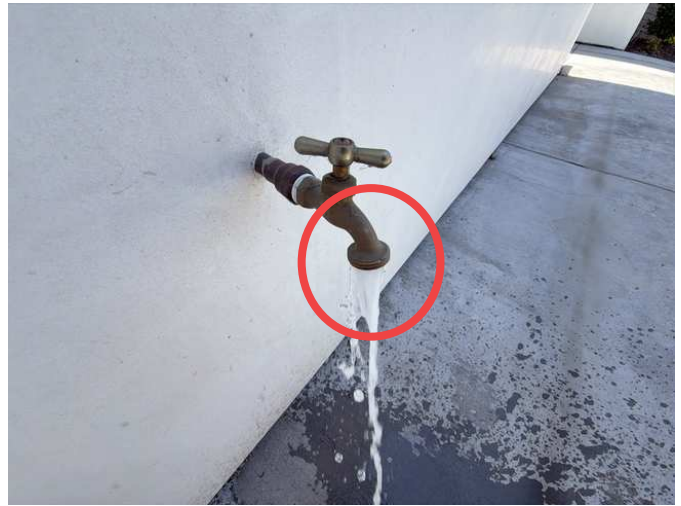
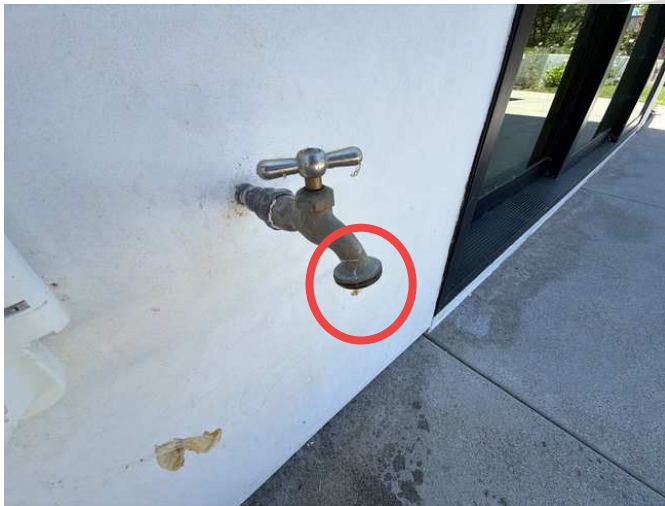
### **W29: Missing Backflow Preventer**

When turn off the spigot ,  
the remained water will be  
sprayed from drain holes to  
achieve anti backflow .

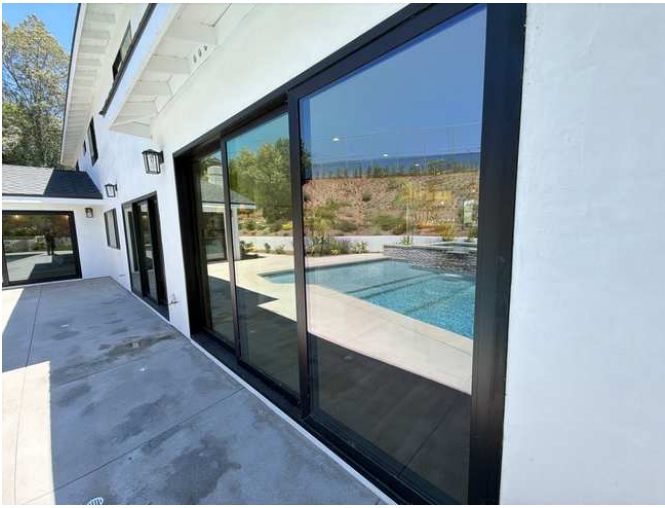
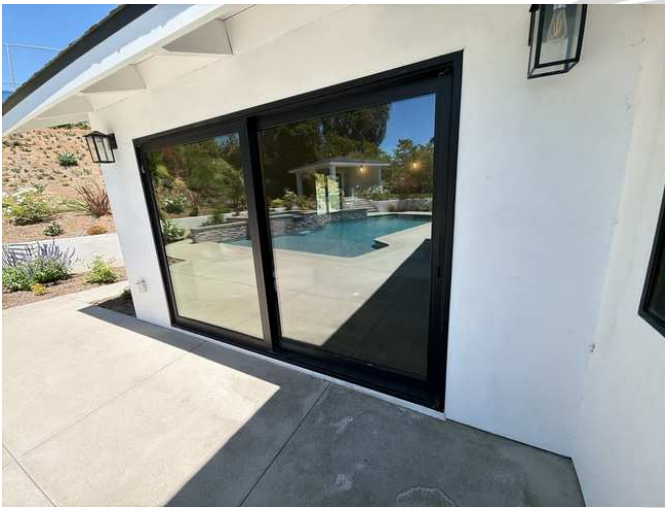
30:

Patio doors were tested and found to be functional on the day of inspection. Doors show signs of normal wear and tear.

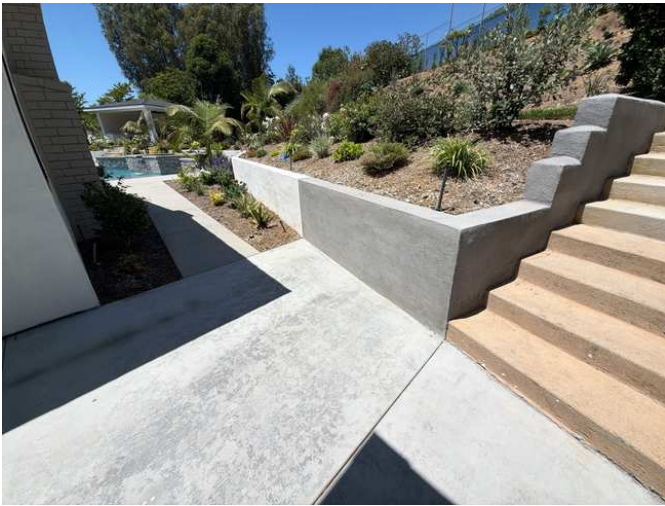
✓ **31: Appeared Serviceable**

The visible and accessible portions of the retaining walls appeared to be in serviceable condition at the time of the inspection.

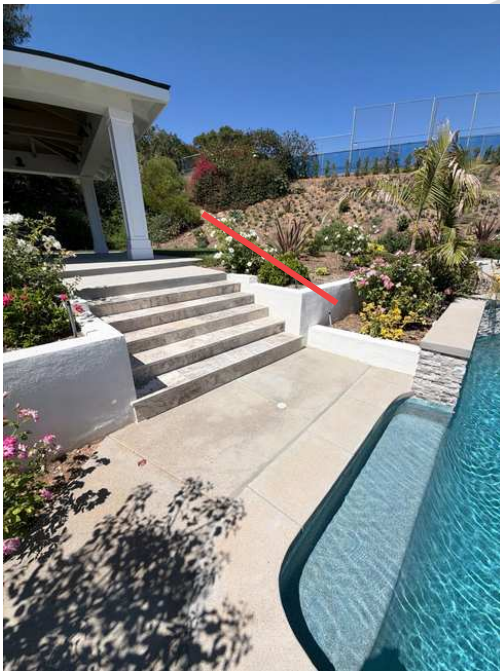
**S33: Handrail Damaged/Missing**

The handrail had damaged/missing components. Consult with a general contractor for repairs. Safety concern.
