# HOME INSPECTION REPORT

PROFESSIONAL PROPERTY EVALUATION

INSPECTION DATE

Tuesday, July 7, 2026

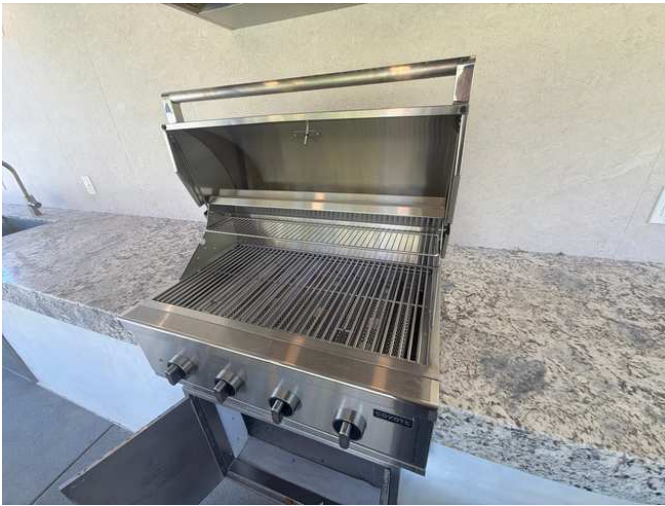
### ✓ 34: Not Inspected

Barbecue is in new condition and appear serviceable. Barbecues are excluded from the home inspection process. Furthermore barbecues are excluded from the industry standards of practice of which your home inspection was performed. The barbecue may have been tested for gas leaks as a courtesy to the client only.

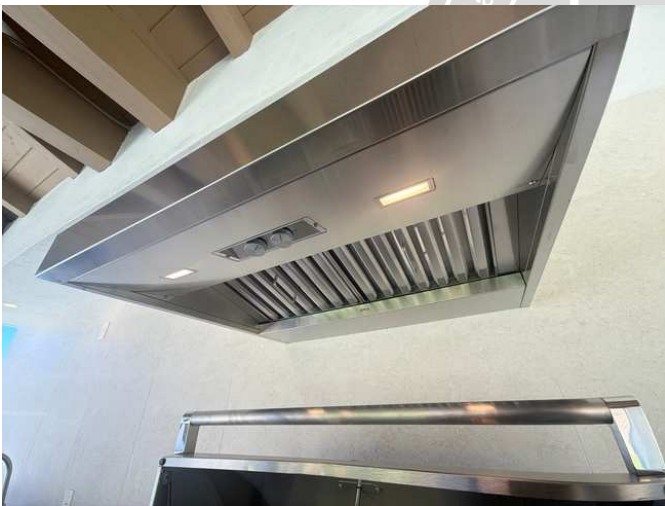
Ventilator was tested and found to be functional on the day of Inspection.

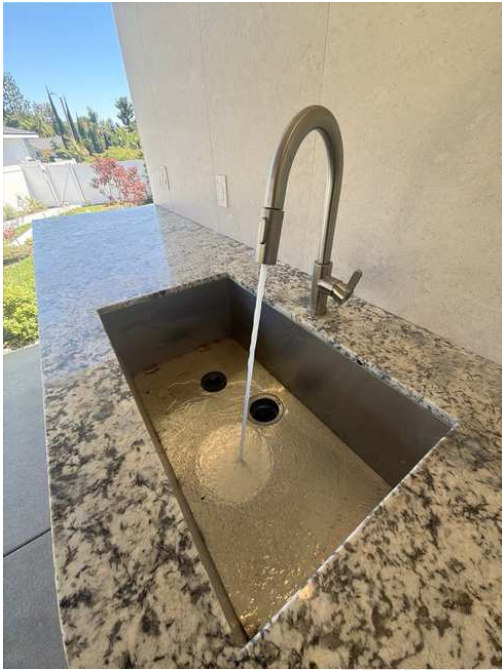
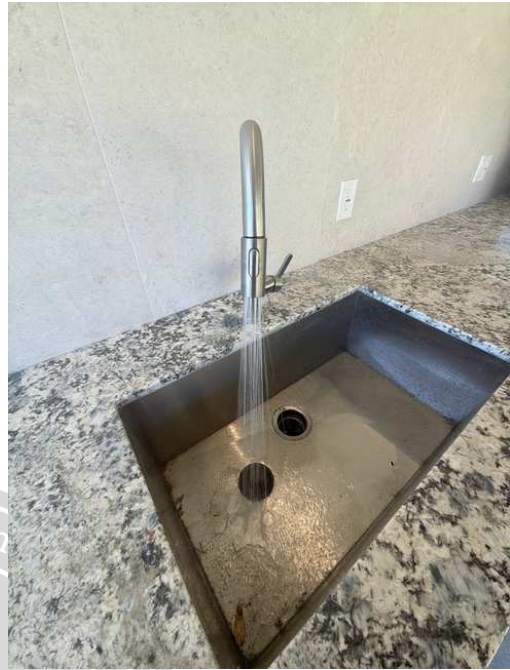
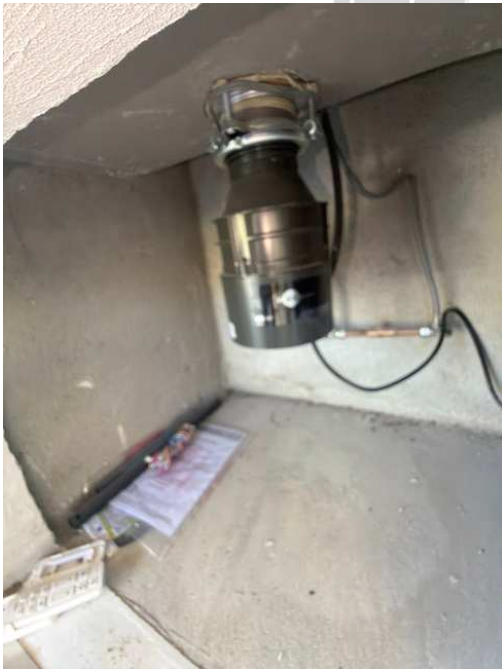
✓ **36: Satisfactory**

The outdoor sink was in satisfactory condition. Faucet was functional.

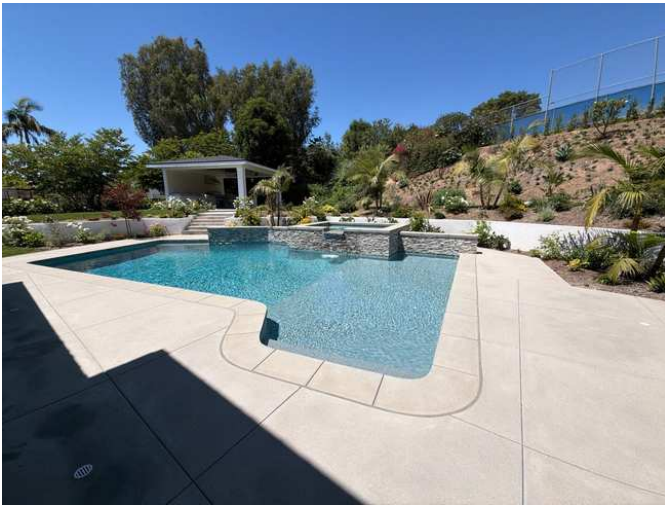
A properly installed child barrier fence is highly recommended for pool safety. Client should consult with a pool contractor for cost of installation.

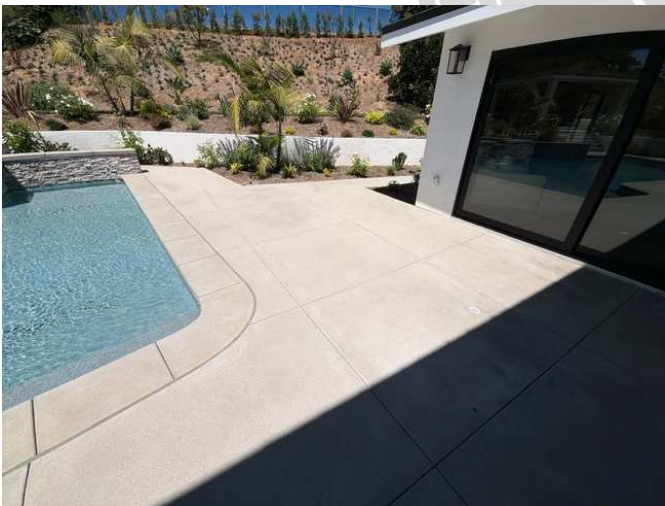
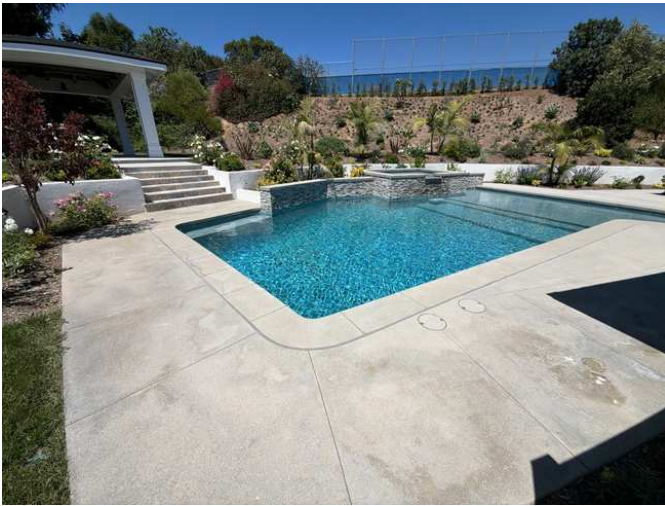
The concrete decking surrounding the swimming pool was in satisfactory condition. Minor hairline cracks were noted but are considered normal.

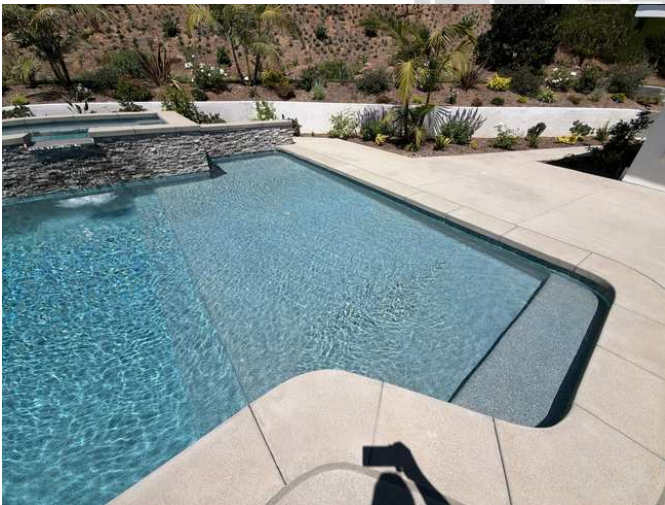
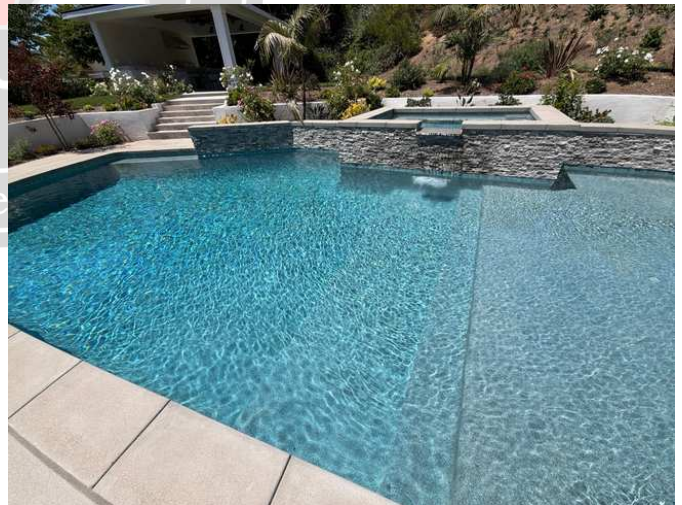
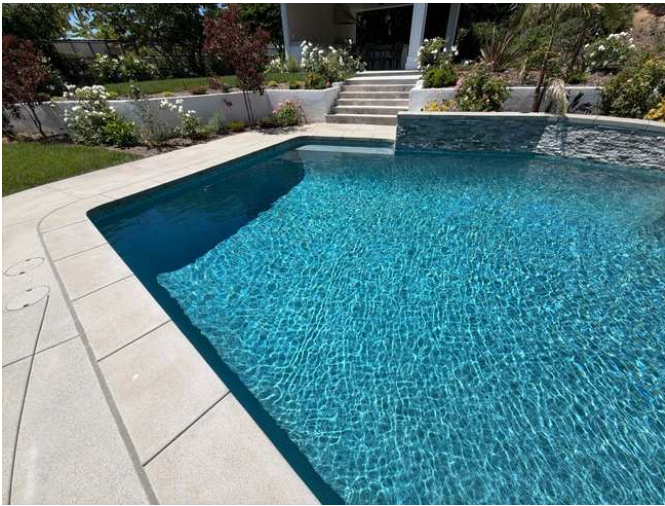
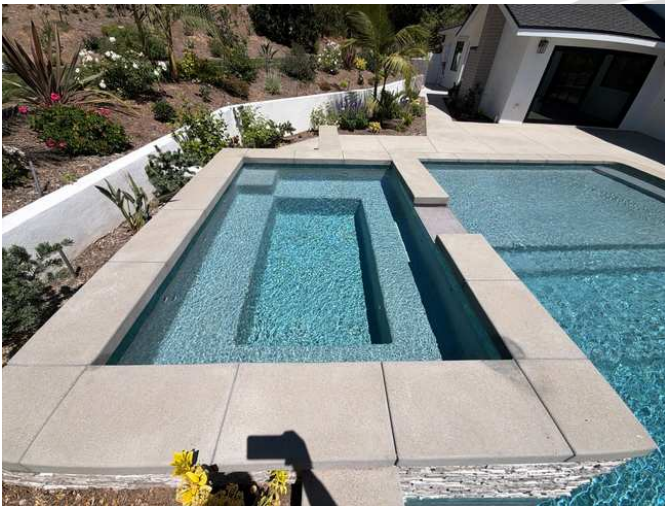
- ✓ **40:**  
Pebble-Tec liner was in satisfactory condition.

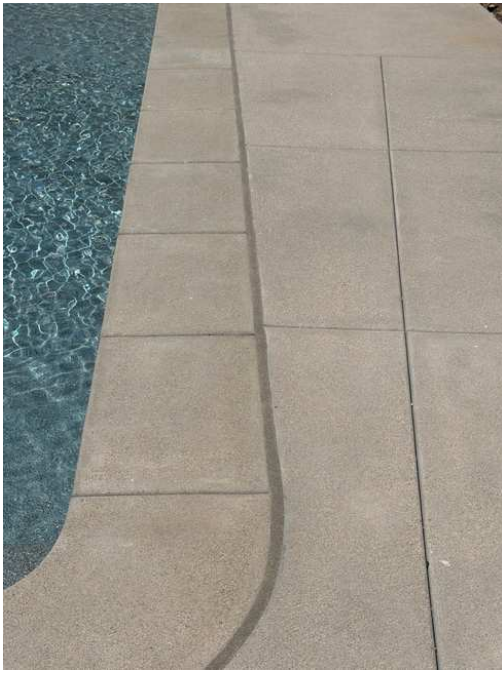
The elastomeric seal was in satisfactory condition.

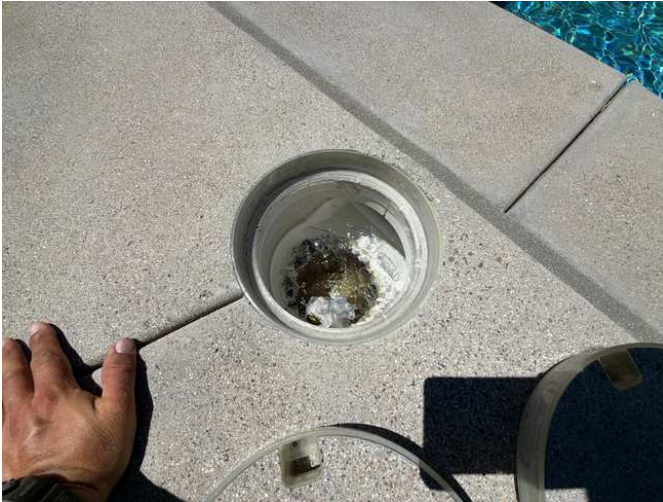
The skimmer was in satisfactory condition. The cover was intact.

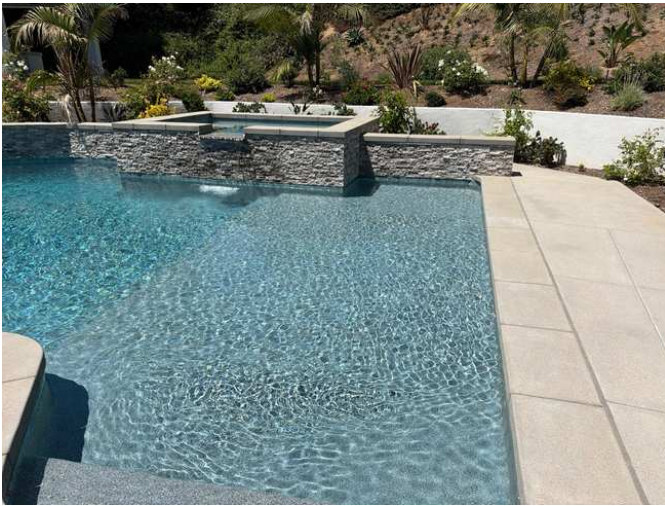
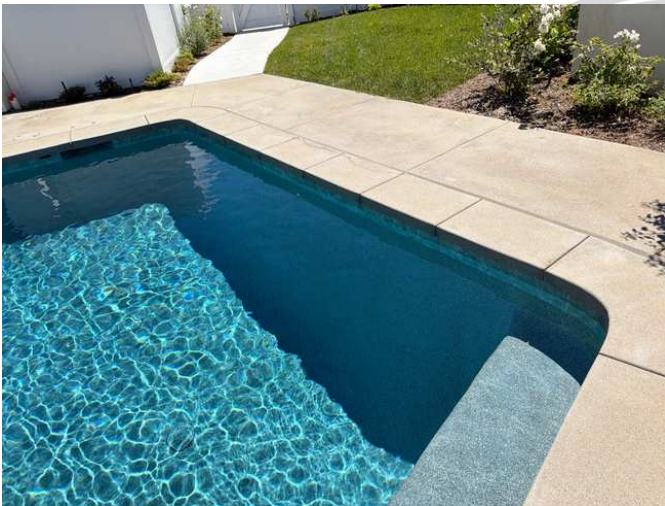
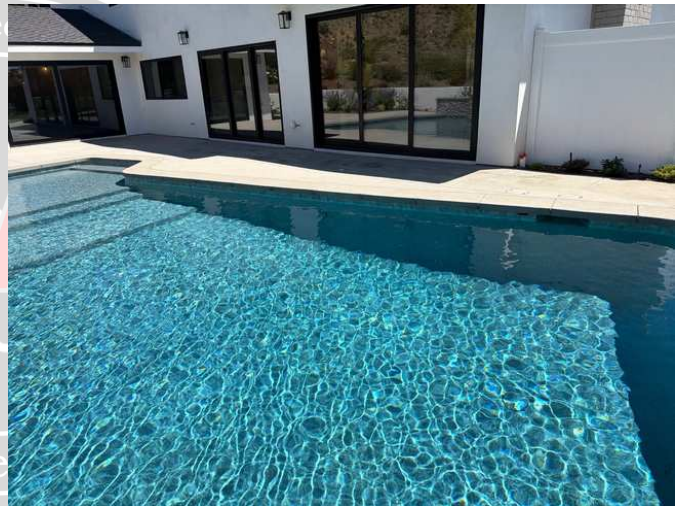
The pool tile surrounding the waterline was in satisfactory condition.

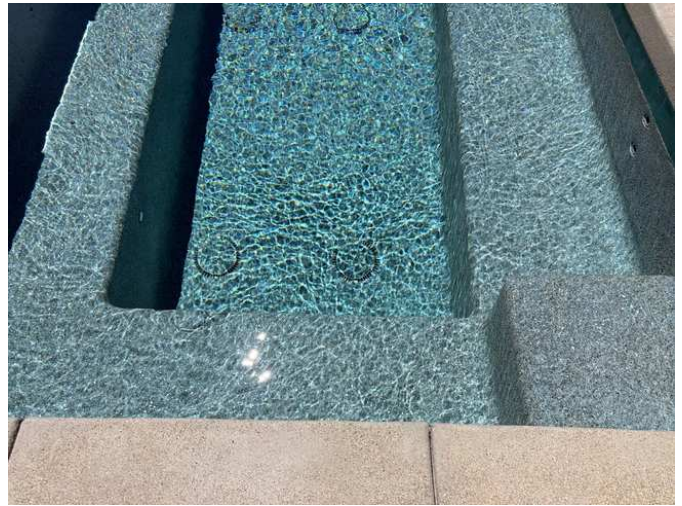
The anti-vortex drain cover was in satisfactory condition.

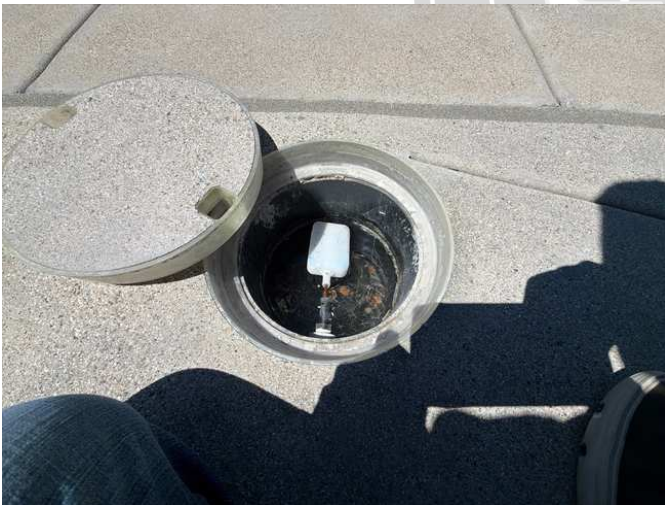
The pool fill valve was present and functional. Backflow preventer present and functional.

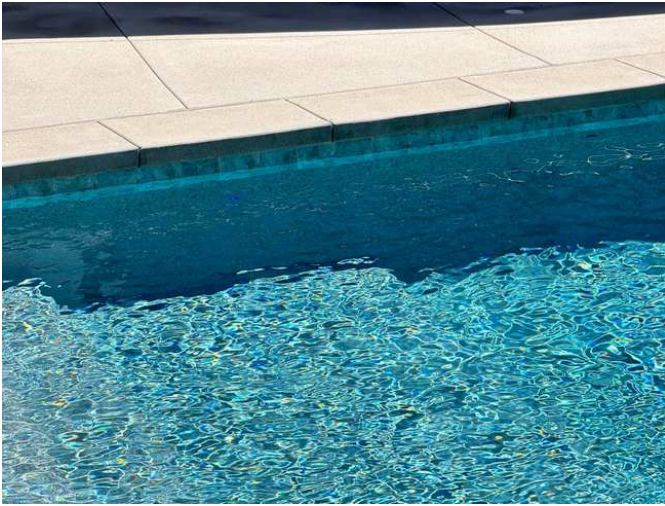
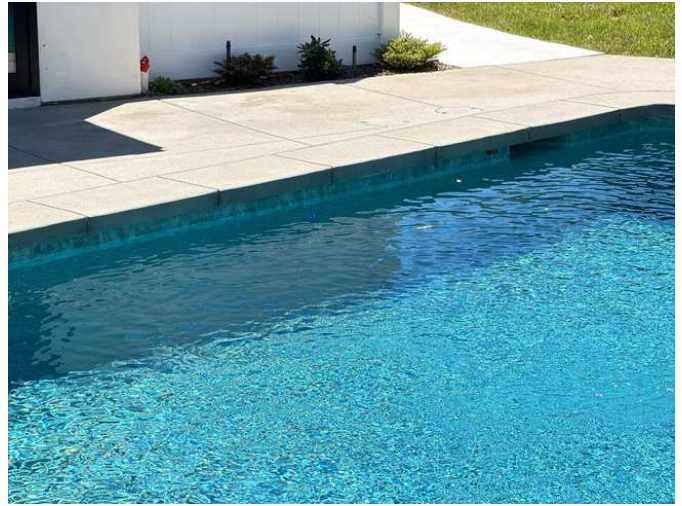
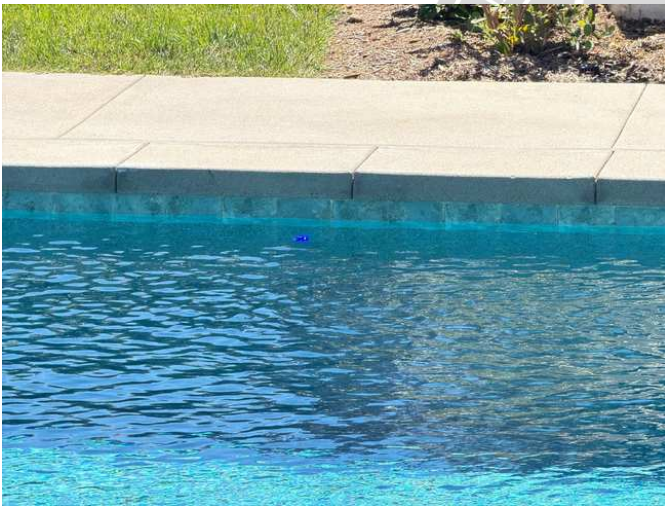
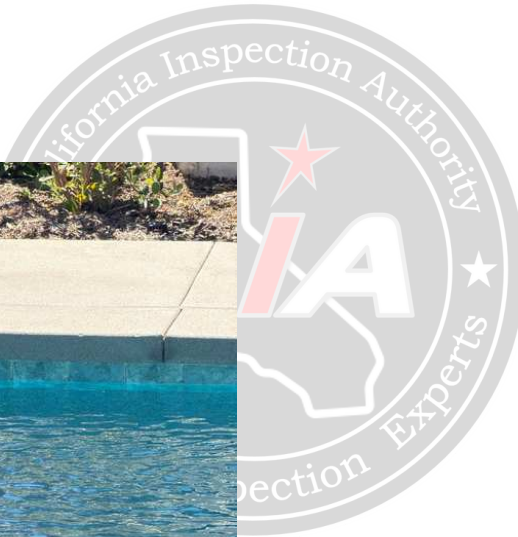
Underwater lights were tested and found to be functional on the day of inspection.

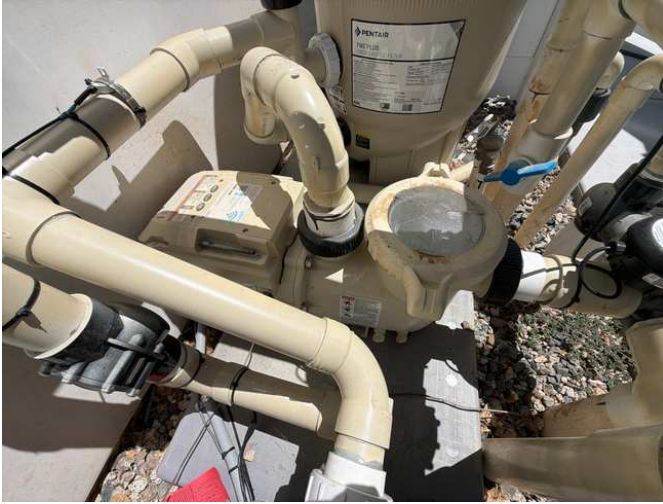
Pump is an energy compliant, variable speed pump.

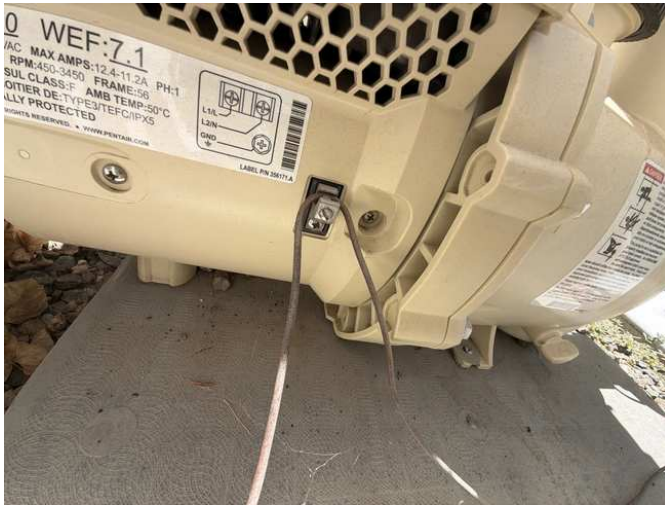
✓ **50: Bonding Ground Present**

Bonding ground was present and tight.

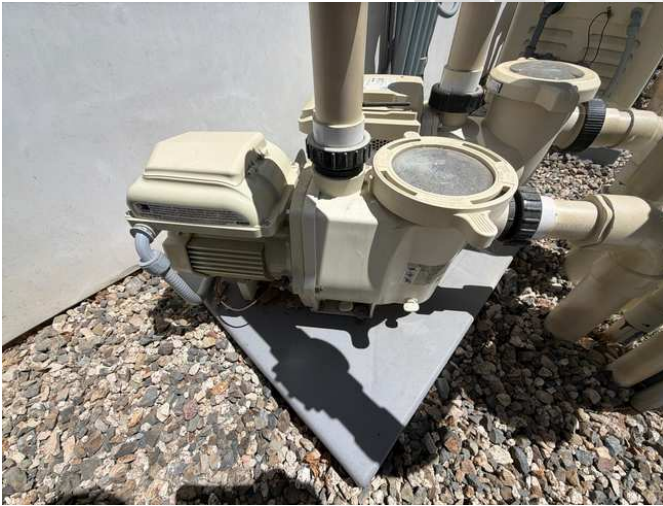
- **51:** Pump is an energy compliant, variable speed pump.

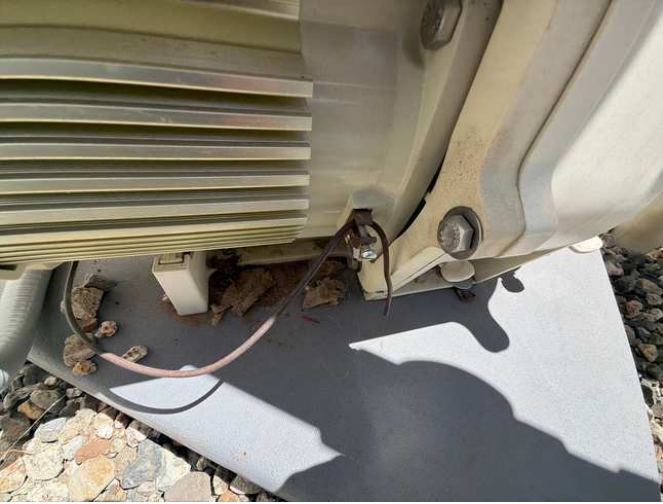
- ✓ **52:**  
Bonding ground was present and tight.

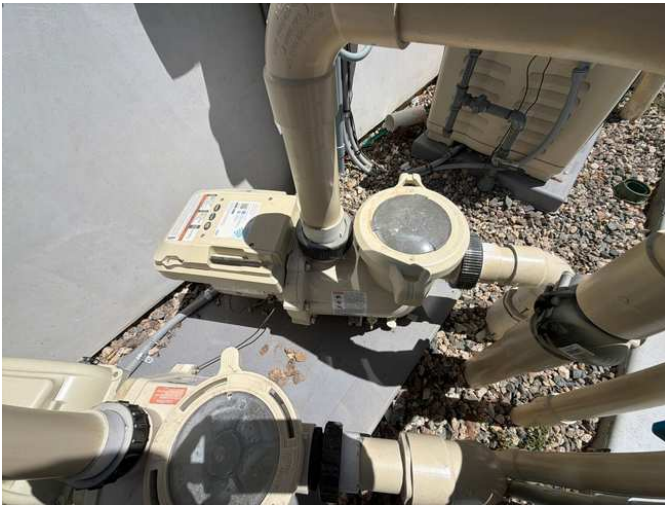
Pump 2

✓ **54: Bonding Ground Present**

Bonding ground was present and tight.

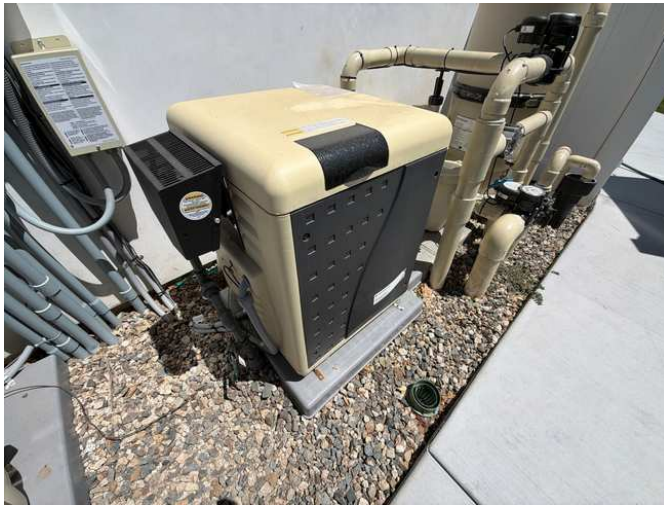
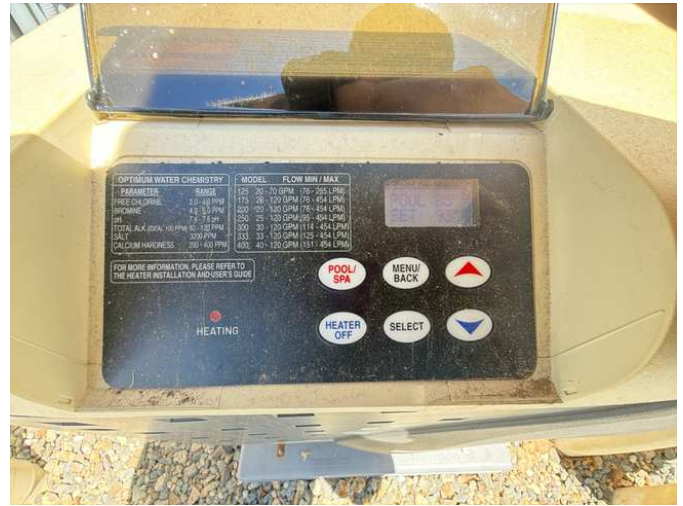
#### ✓ 58: Bonding Ground Present

Bonding ground was present and tight.

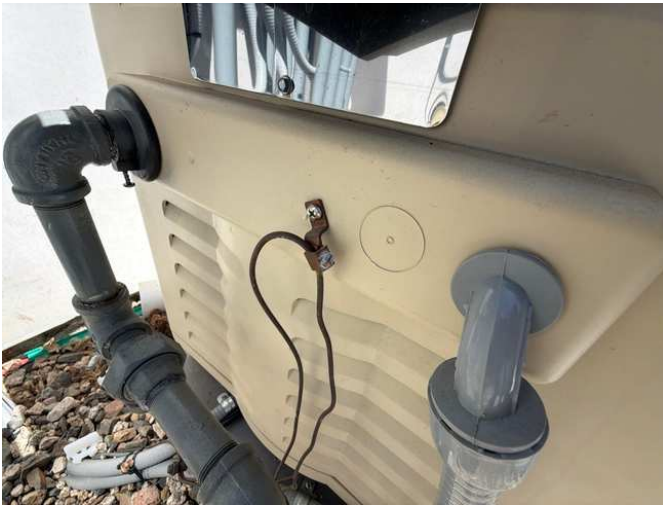
- ✓ **59:** Timeclock and controllers were in satisfactory condition.

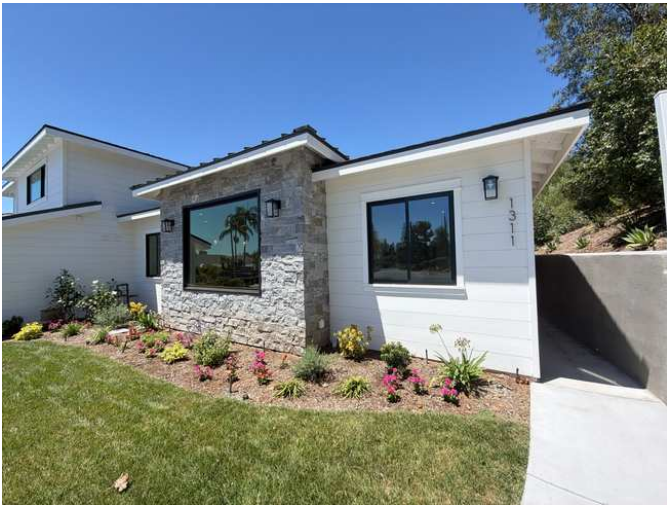
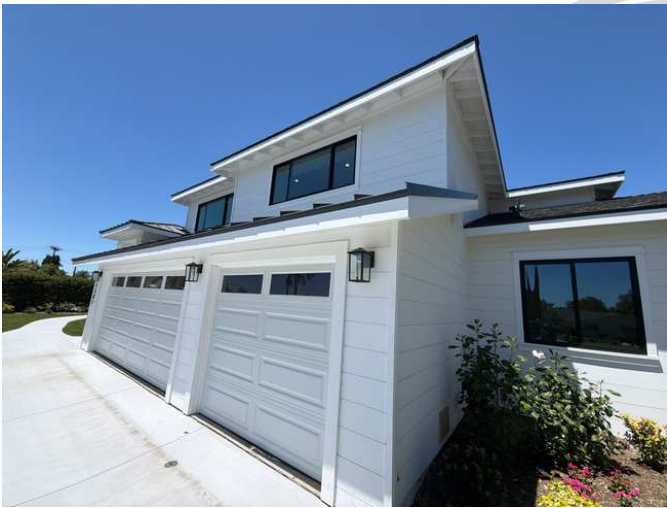
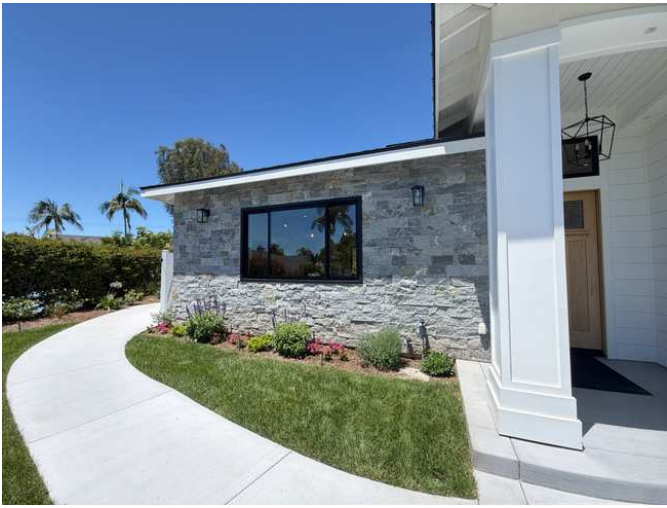
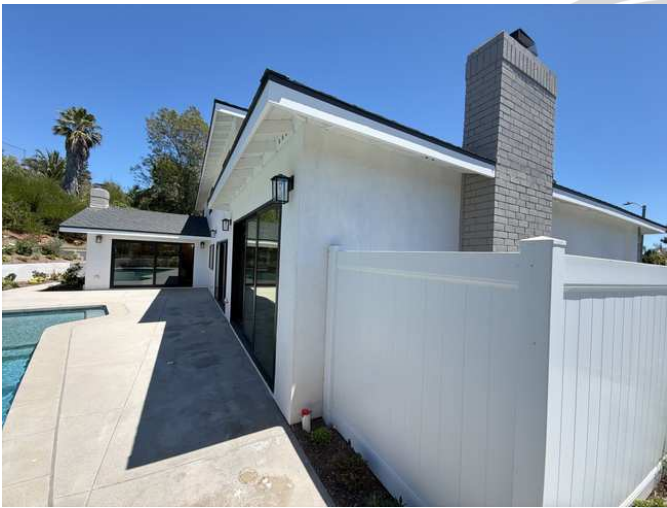
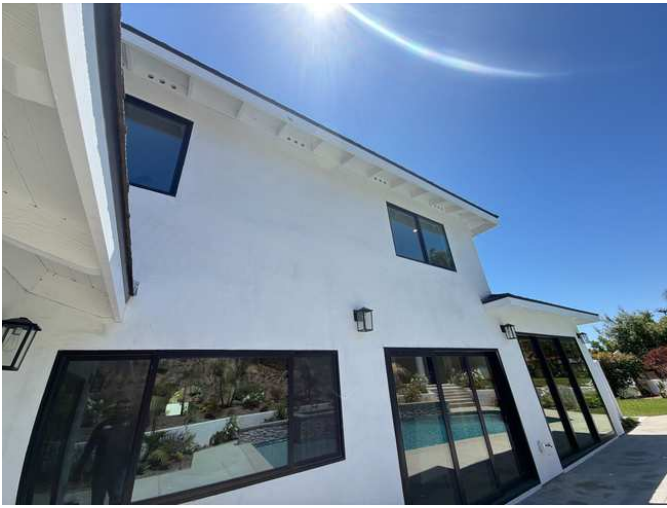
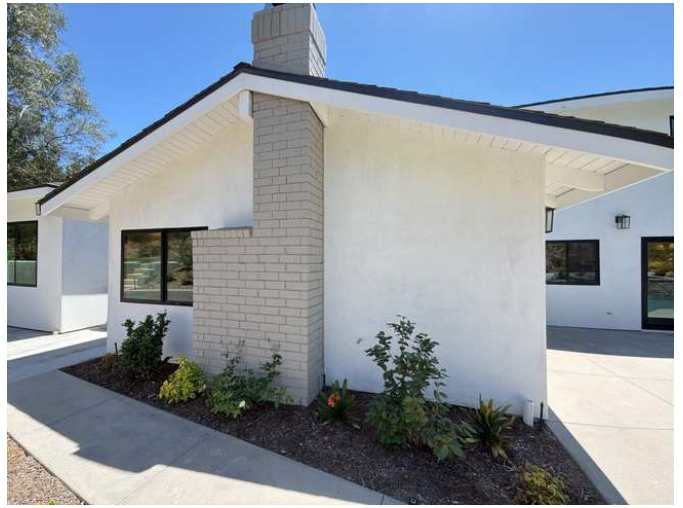
**63:**

Exterior wall surfaces are comprised of siding, stone, veneer, and stucco. Wall conditions appear to be normal and in good overall condition.

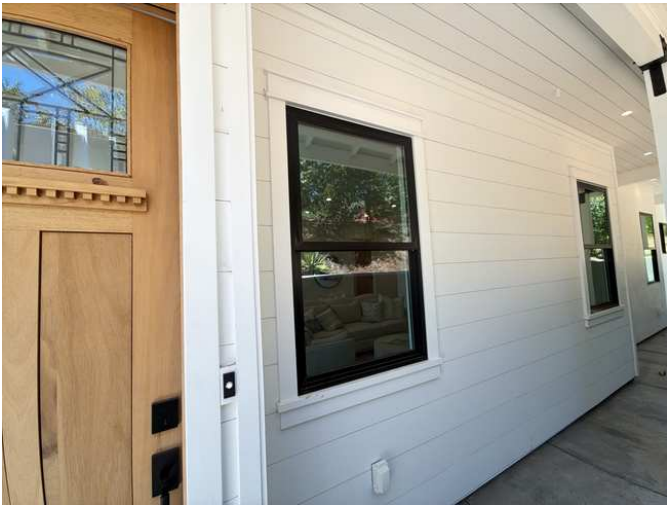
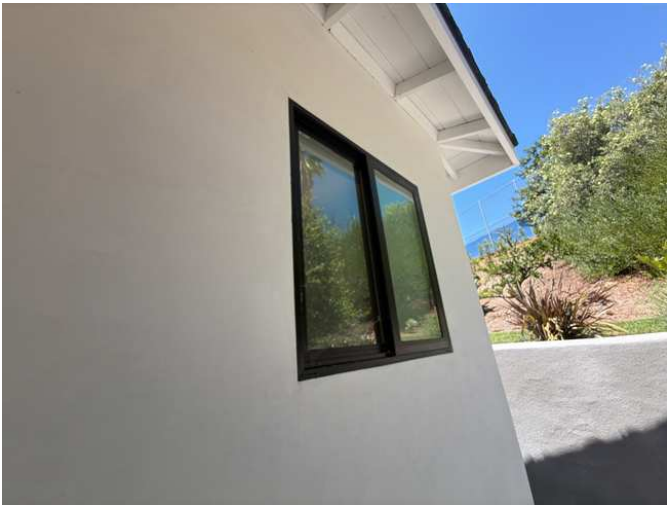
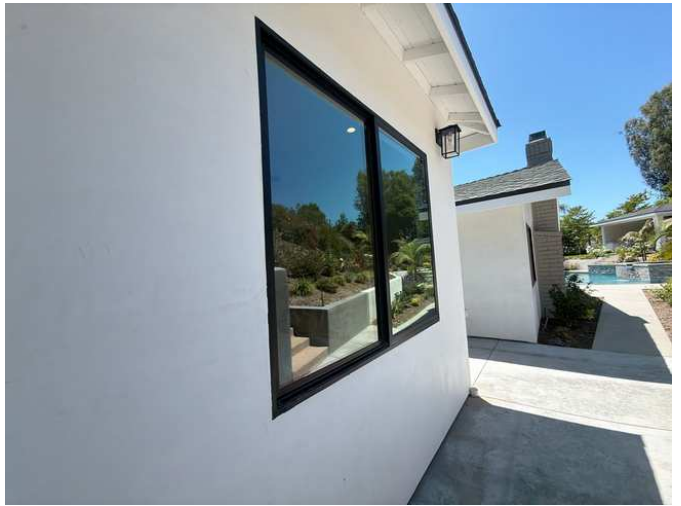
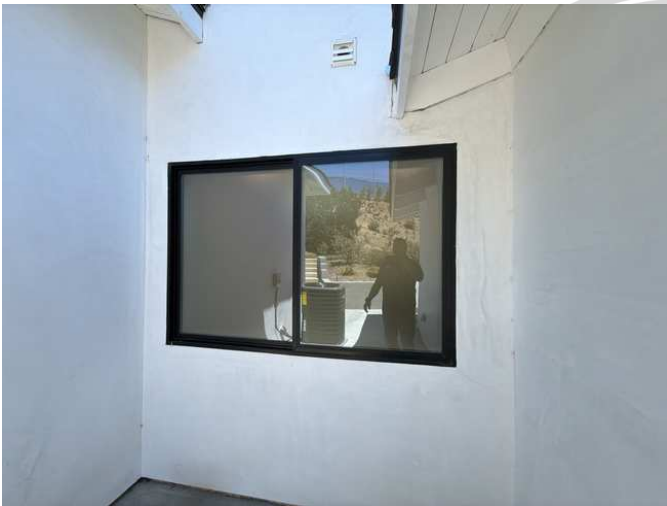
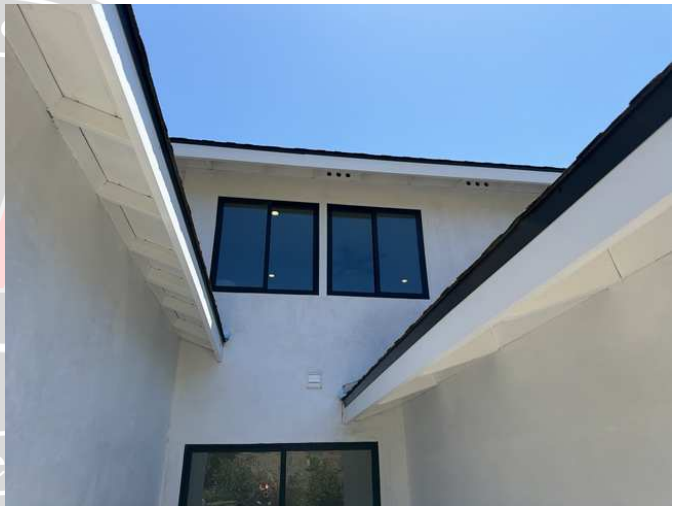
- ✓ **65:** Vinyl pane thermal windows were in satisfactory condition there were no cracked or broken window panes observed. Client should be aware that all vinyl windows are sealed using caulking and or other sealants that may break down overtime. Resealing vinyl windows is part of normal and regular home maintenance.

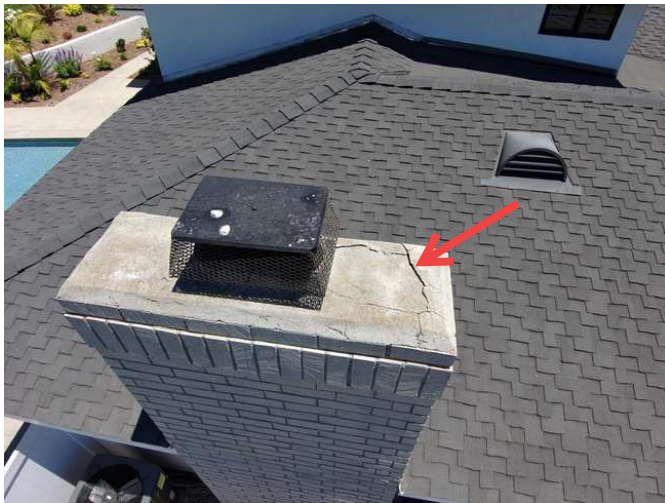
Evidence of weathering and cracks were noted at the chimney crown. Repairs are needed to help prevent water intrusion into the chimney cavity. Consult with a brickmason for evaluation and repairs.

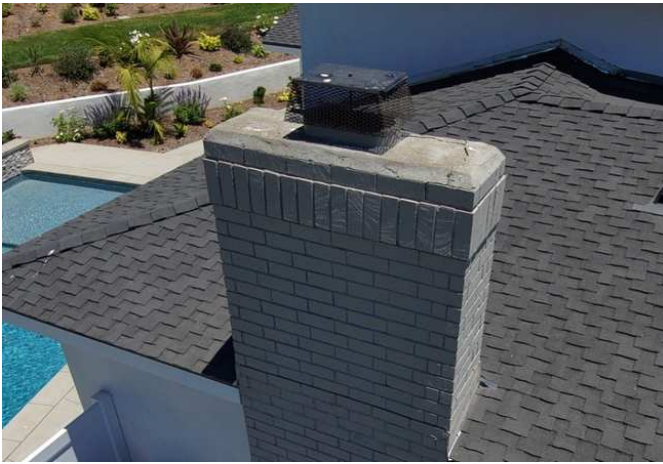
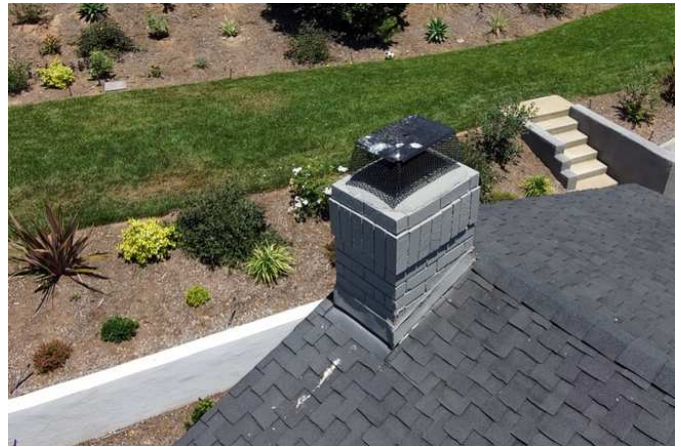
### **68: Storm Cap Present**

Storm cap and spark arrestor were present.

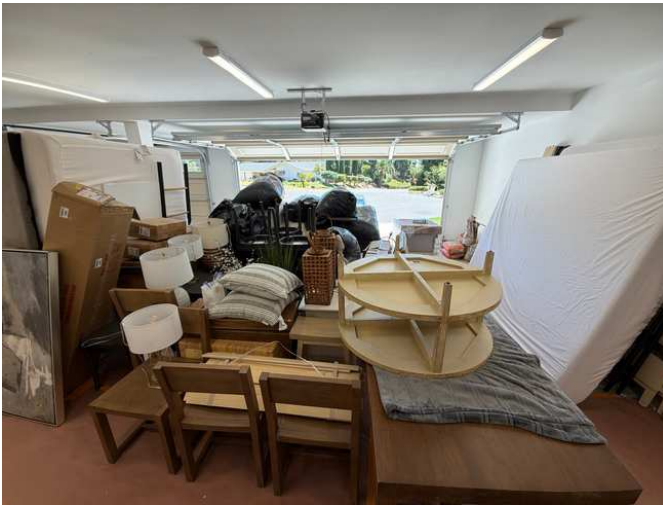
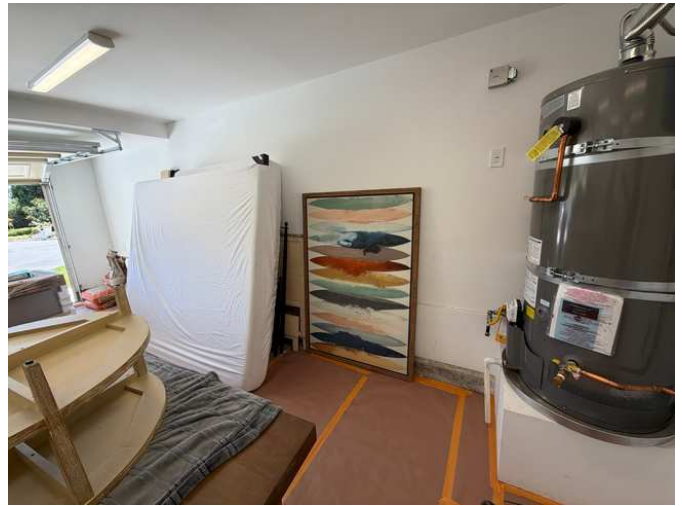
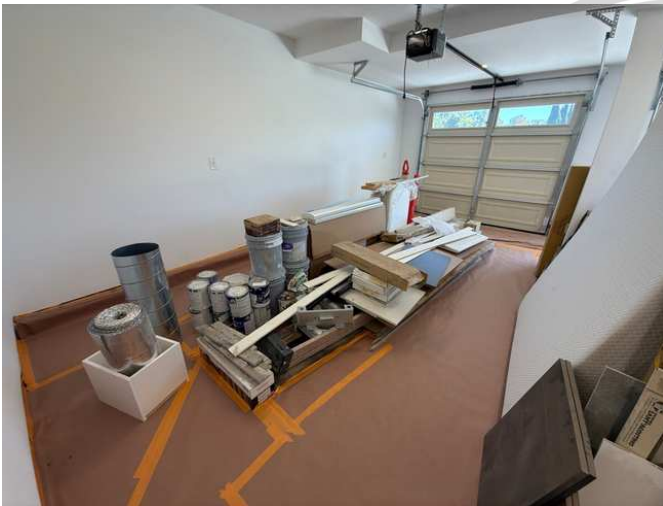
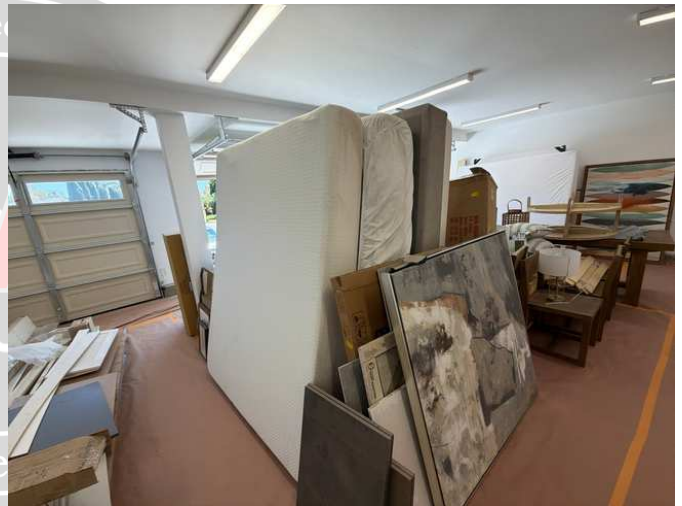
**72: Obstructed View**

Personal items and storage obstructed a complete visual assessment of the garage area. Client may request clearing of said personal items and storage. Then call for re-inspection.

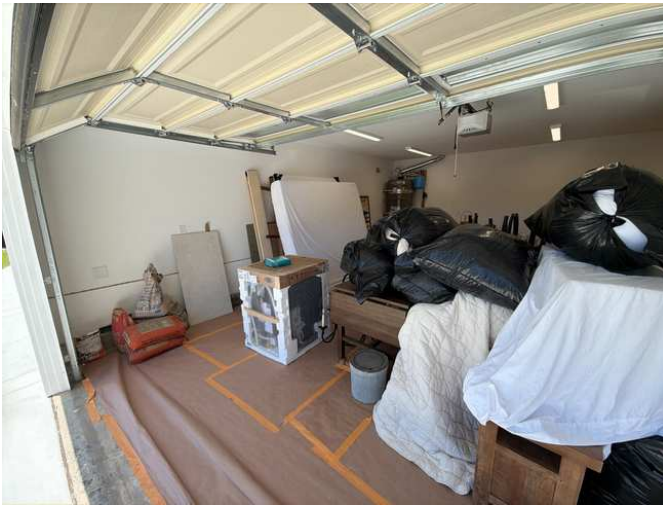
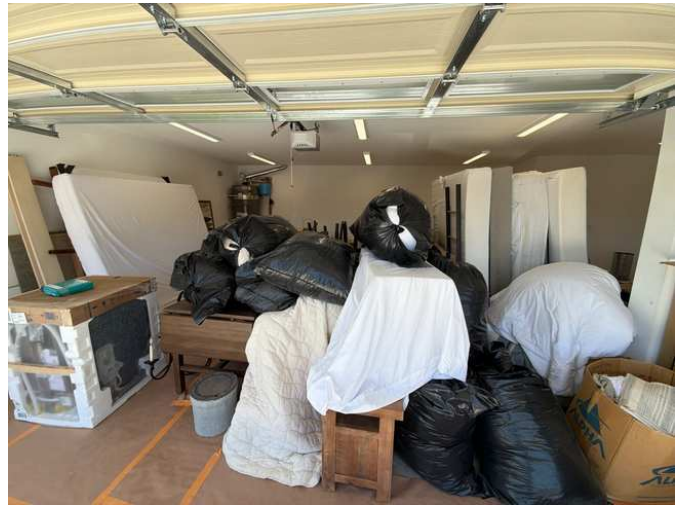
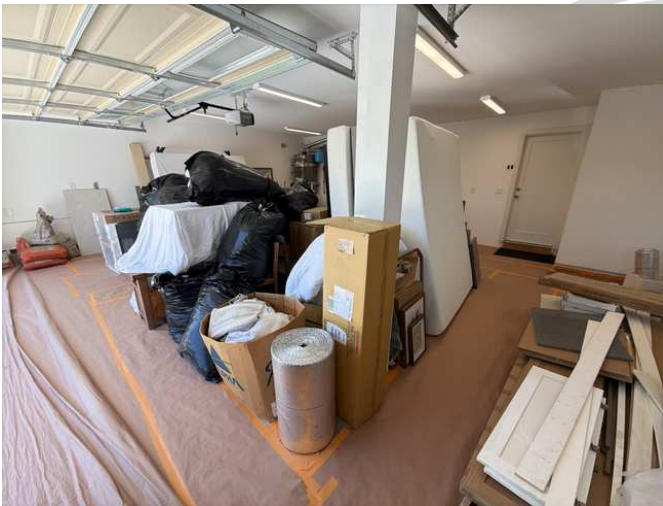
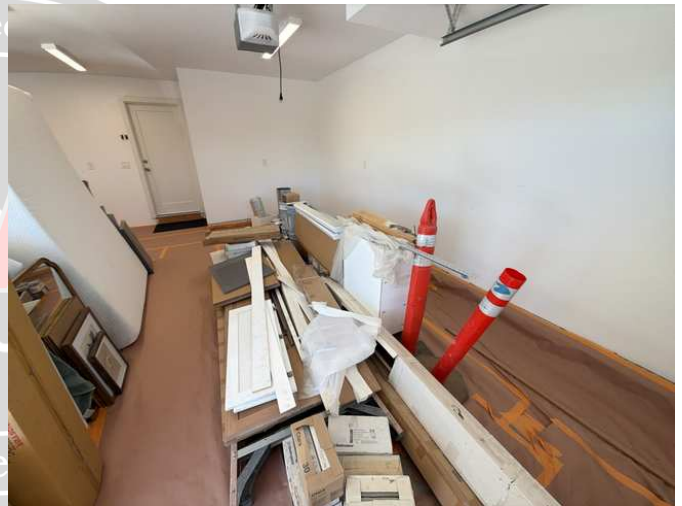
- **73:** Three-car attached garage.

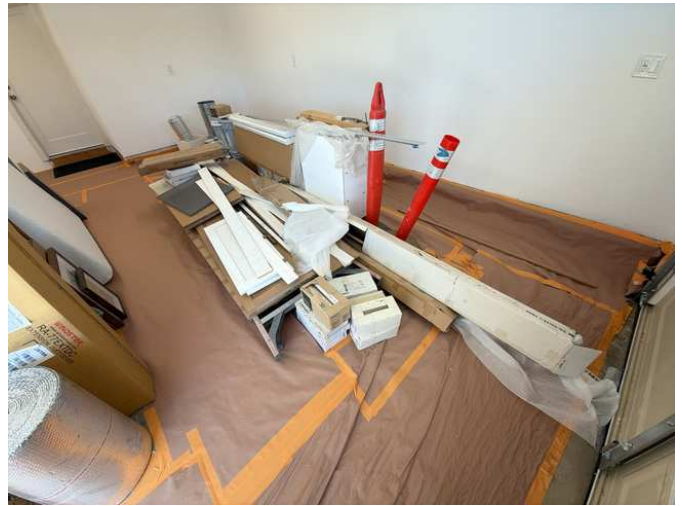
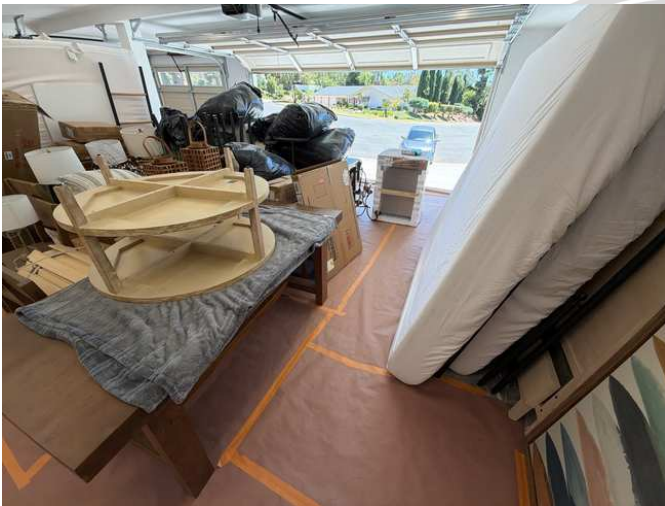
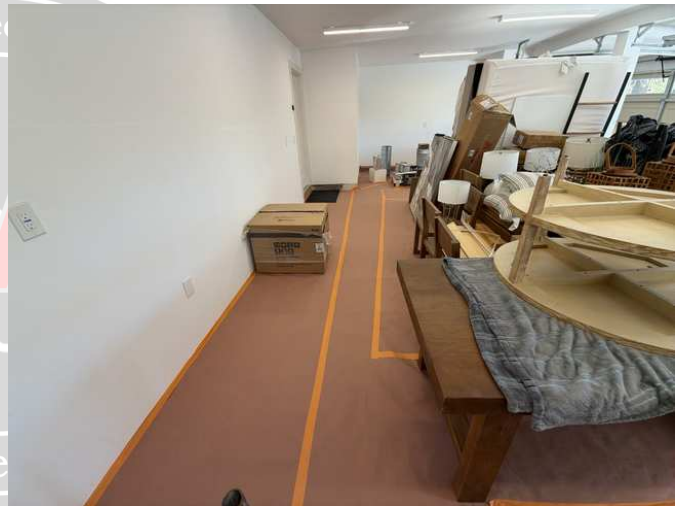
### W74: Could Not Be Inspected

The slab could not be inspected because it was covered by floor covering. Floor covering may cover significant defects and deficiencies that may adversely affect your decision to purchase the property. It is strongly suggested that any floor coverings be removed and the slab be evaluated prior to the close of escrow.

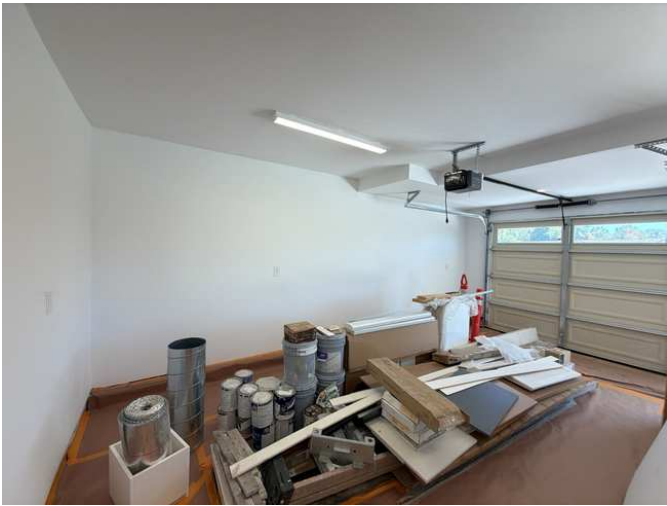
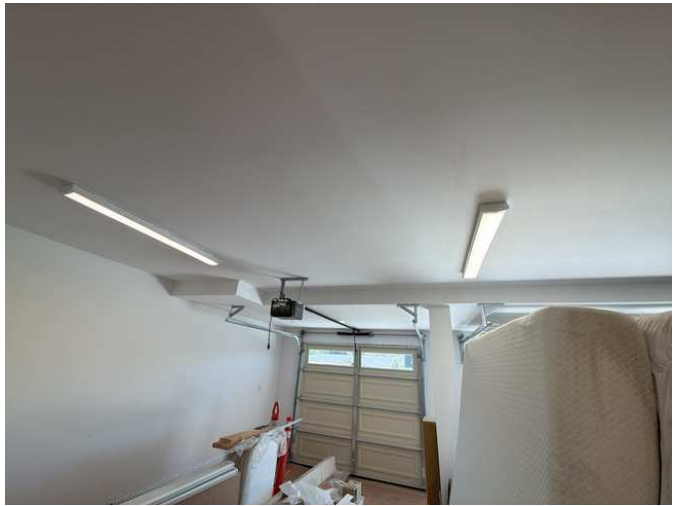
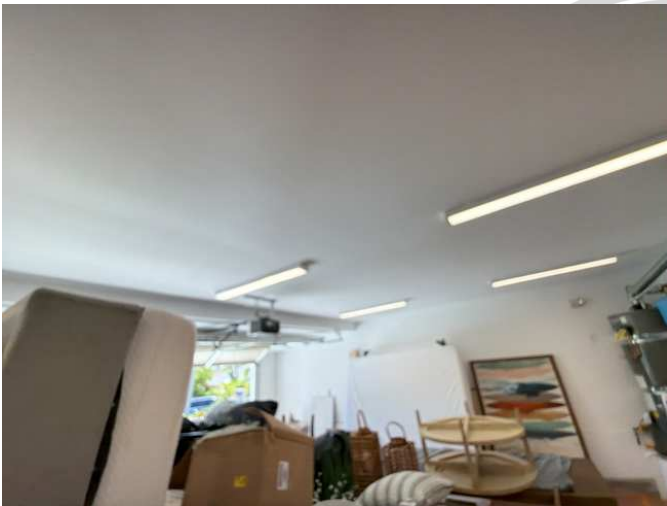
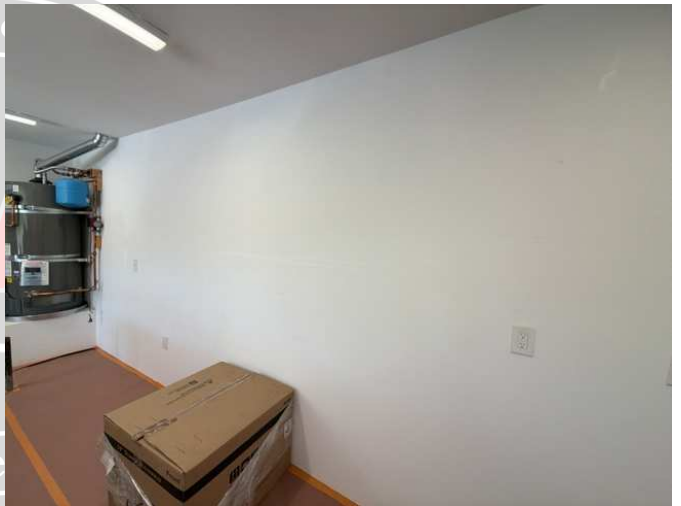
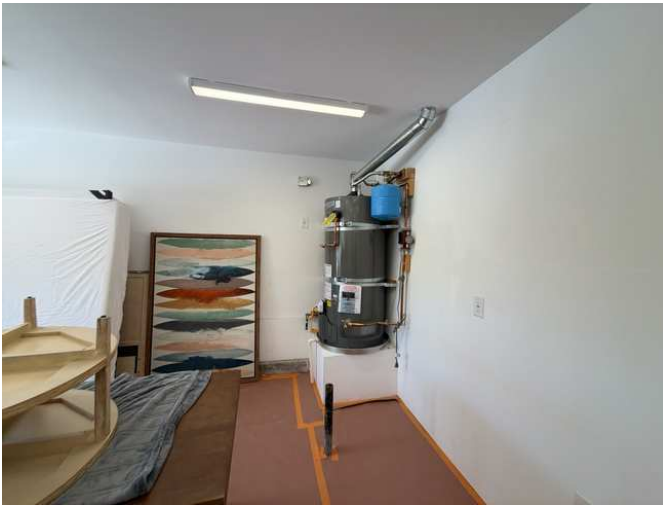
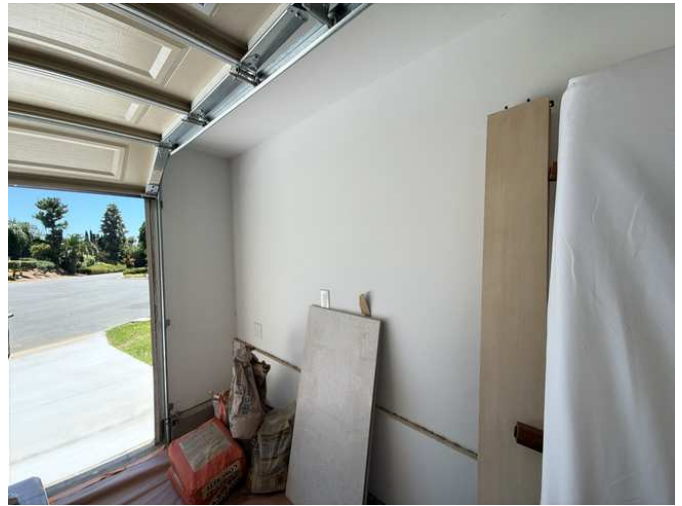
✓ 75:

The visible portions of the garage walls and ceilings were in satisfactory condition overall. No significant deficiencies to report.

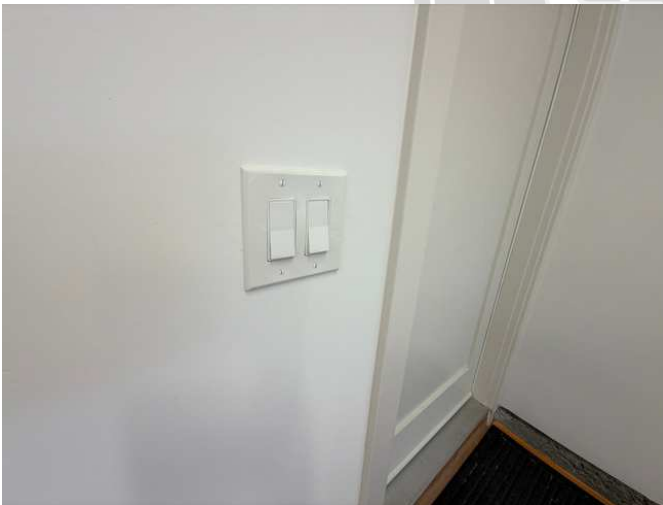
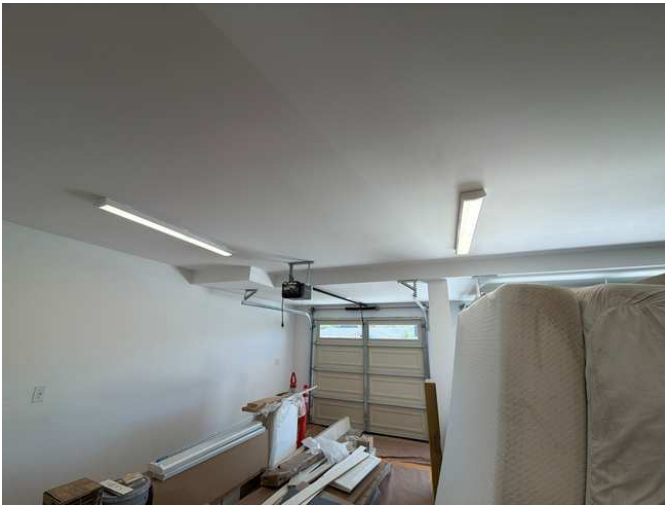
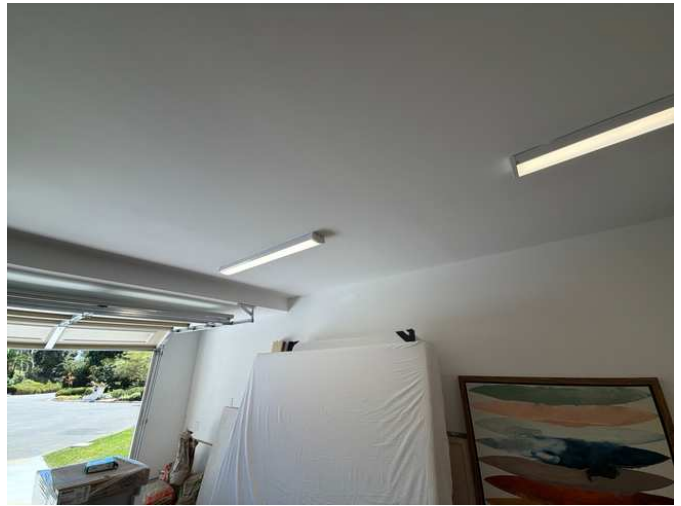
- ✓ **76:**  
Garage lighting was satisfactory.
