# HOME INSPECTION REPORT

PROFESSIONAL PROPERTY EVALUATION

INSPECTION DATE

Tuesday, July 7, 2026

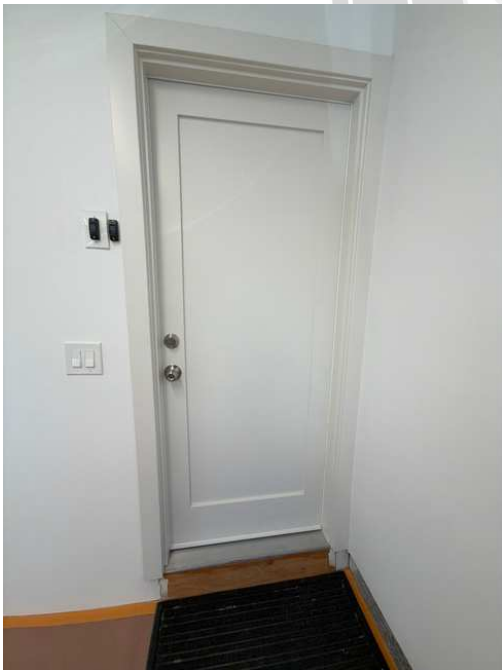
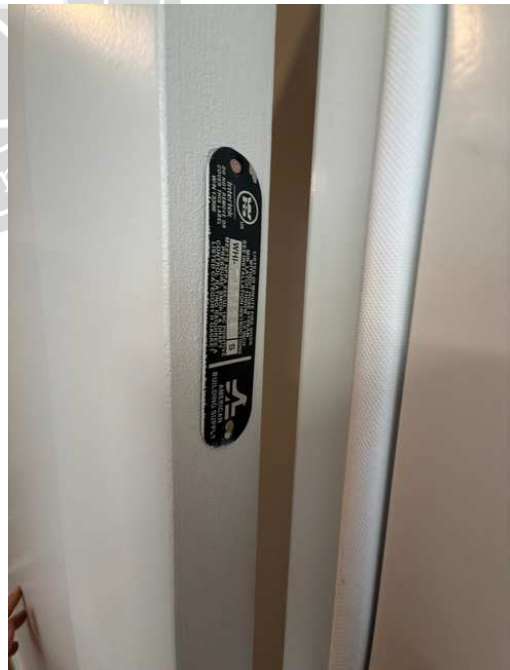
77:

The fire door was tested and found to be functional on the day of inspection.

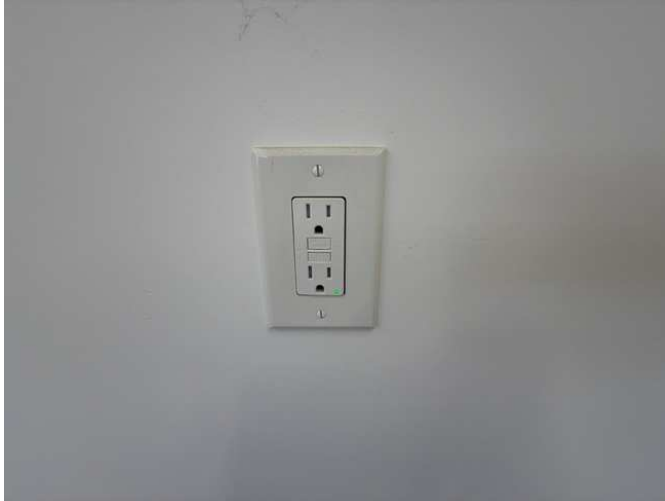
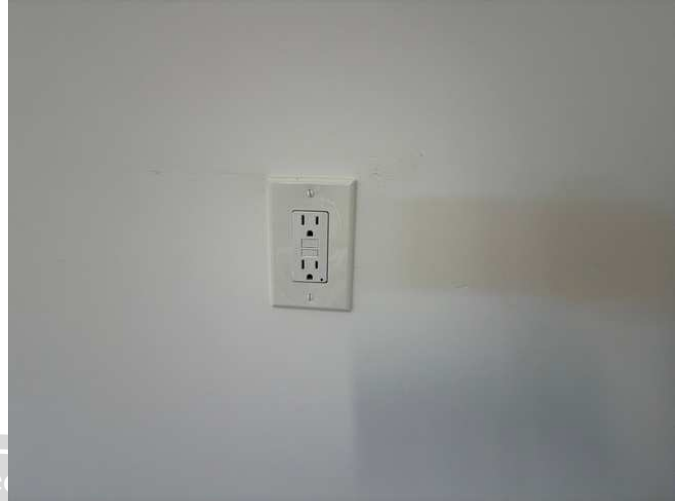
✓ **78:**

All garage outlets that could be tested were functional on the day of inspection. GFCI protection has been provided where needed.

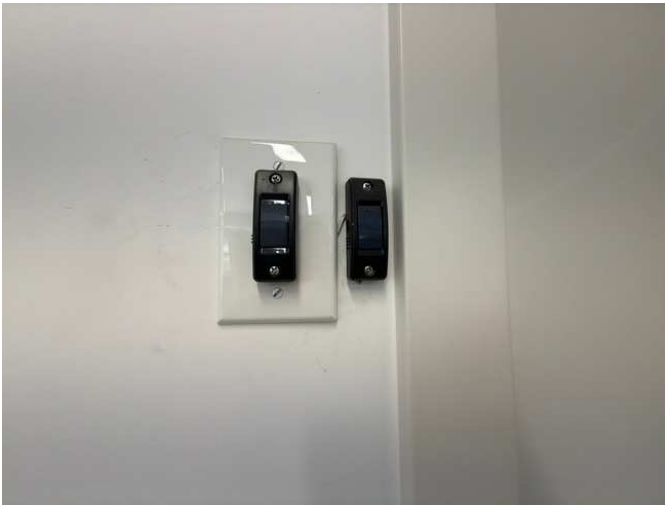
✓ **79:**

The operator button was in satisfactory condition and responded normally to testing.

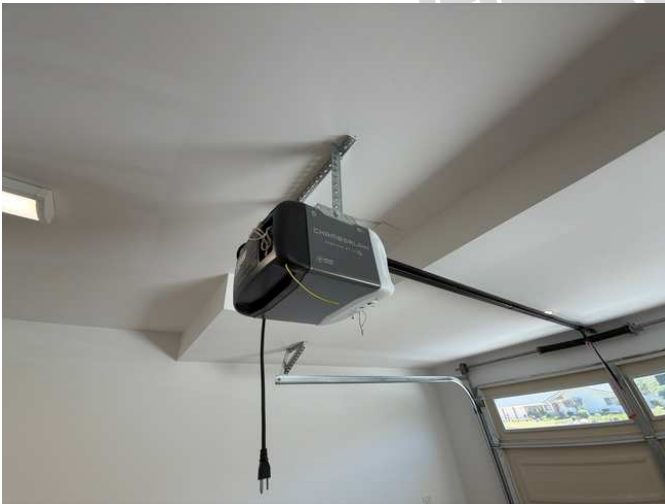
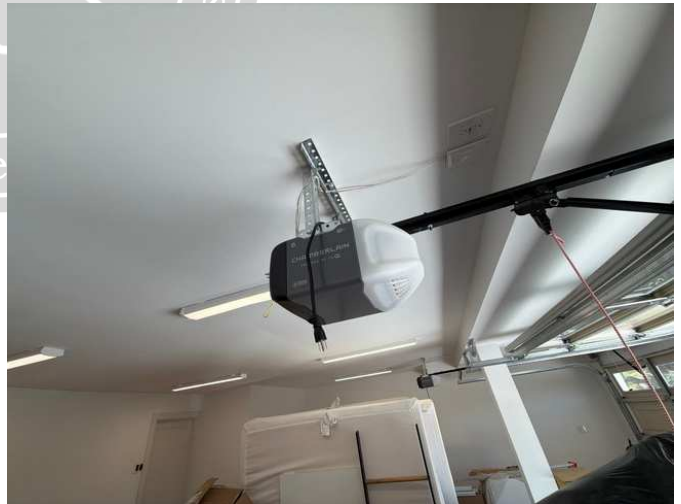
- **80:** Garage door opener and safety sensors were new condition, but could not be tested because they were not plugged in on the day of inspection.

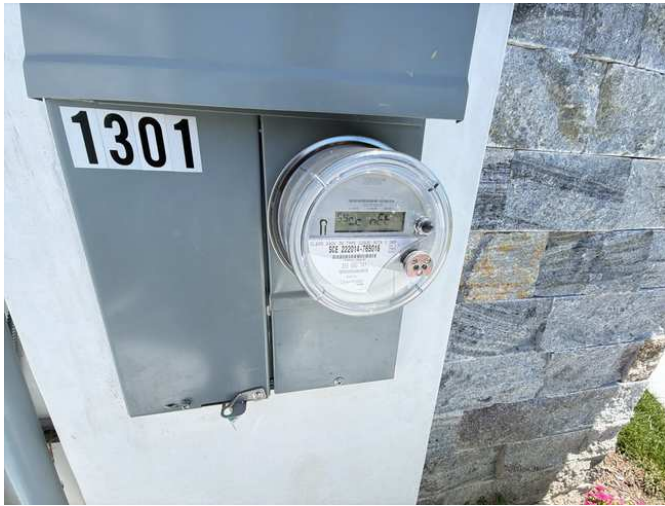
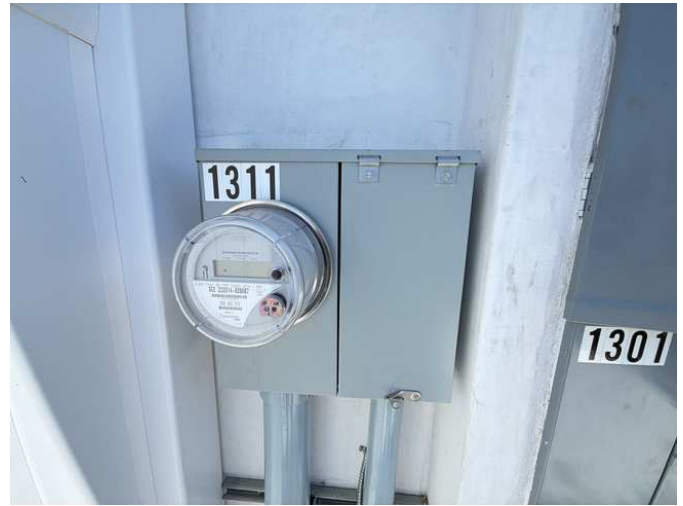
- **81:** Electrical service was provided to the home by public utility. Voltage was tested and well within guidelines.

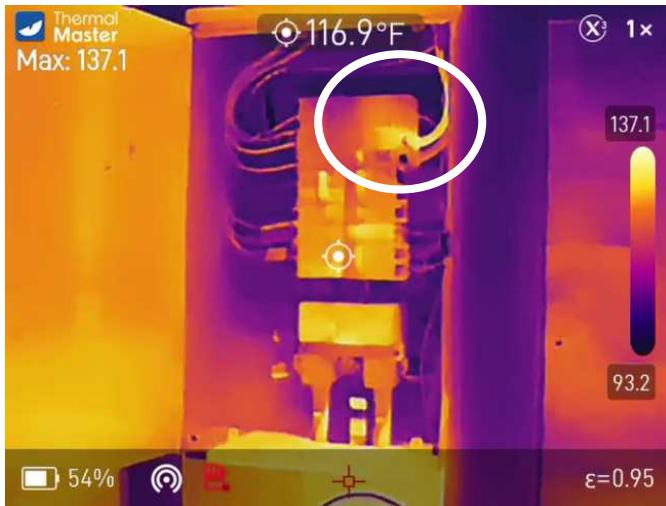
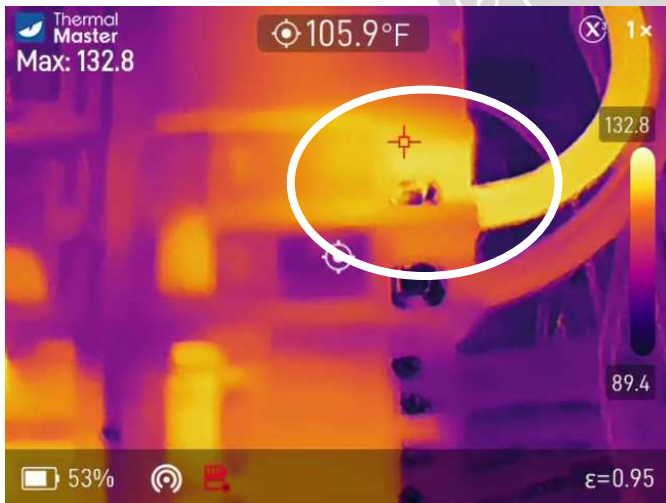
- i E84:** Thermal imaging inspection of the main electrical panel revealed abnormal temperature patterns or hotspots indicative of loose connections, overloaded circuits, or deteriorated components at the time of scanning. Consult with a qualified individual for further evaluation and resolution

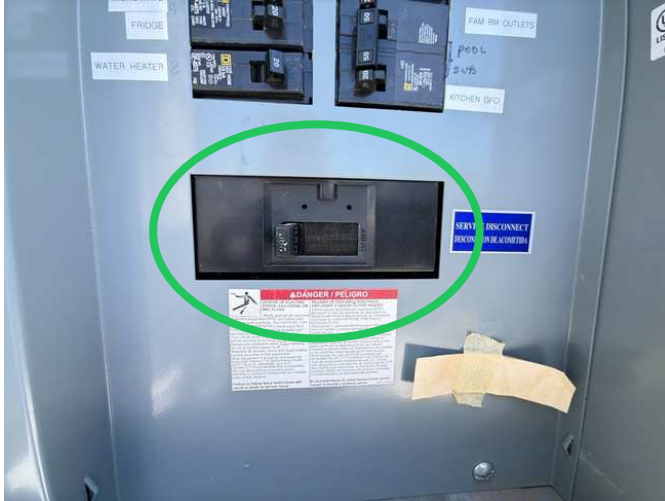
#### 85:

The main electrical panel is rated for 125/250 Volts 200 Amps The main service disconnect switch is located at the main electrical panel.

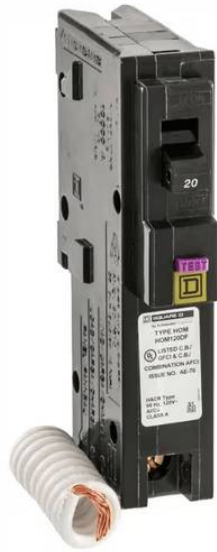
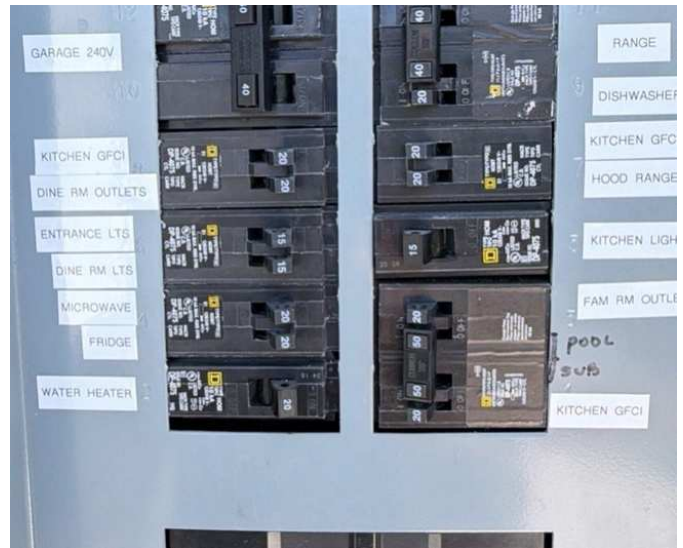
#### **W86: Missing AFCI Circuit Breakers**

In 2020 the National Electrical Code (NEC) 210.12 required that all 120v 15 and 20 amp branch circuits feeding convenience outlets and devices be protected by an AFCI circuit breaker. Including but not limited to kitchen, family rooms, dining room, living room, parlors, libraries, dens, bedrooms, Sun rooms and patios, recreation rooms, closets, hallways, laundry areas and or similar rooms. The National Fire Protection Authority (NFPA) recognizes that AFCI circuit breaker's can greatly reduce the risk of fire at receptacles throughout the dwelling caused by arc fault conditions. It is for that reason we at California Inspection Authority recommend the client consult with a licensed electrical contractor for installation of such safety devices.

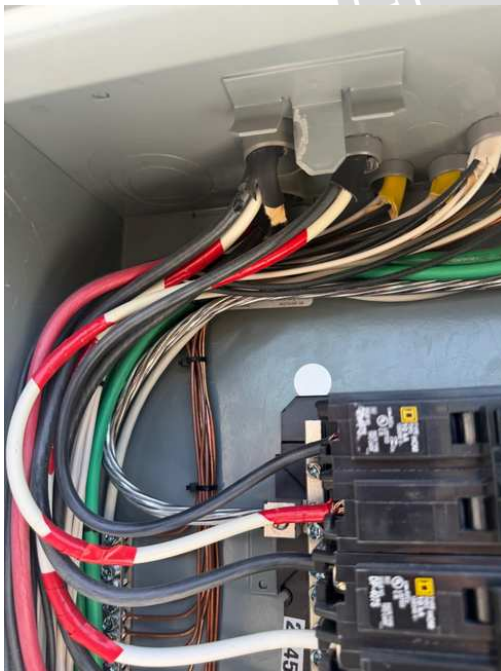
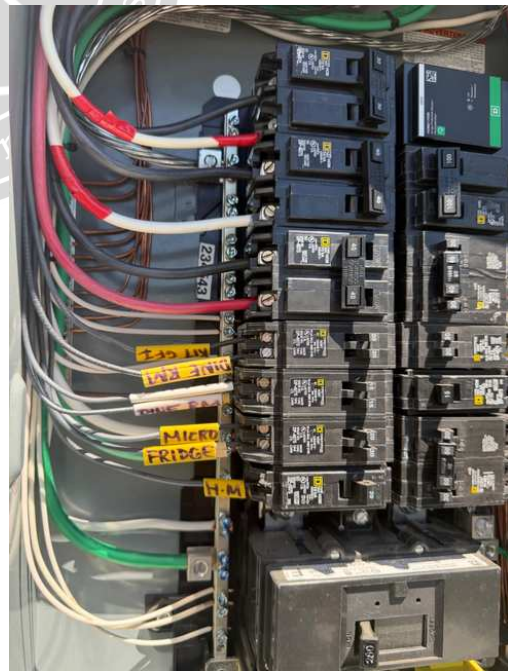
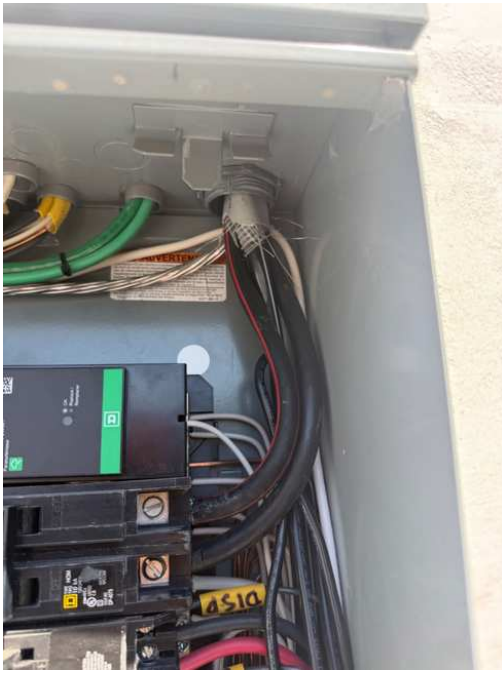
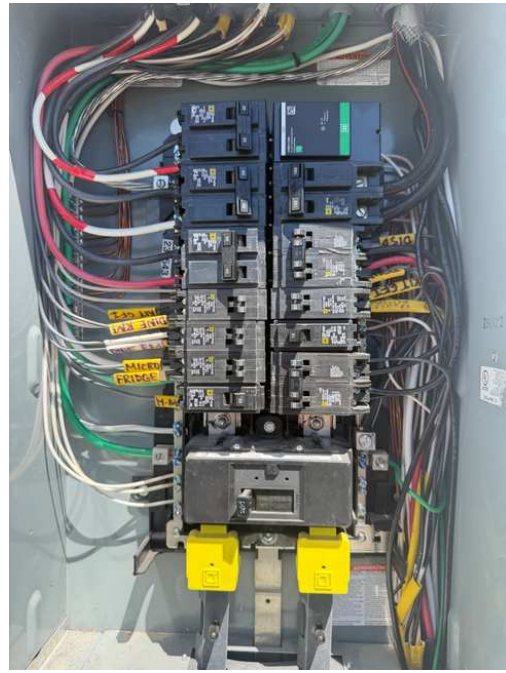
87:

Copper nonmetallic sheathed cable also referred to as Romex was utilized throughout the home for all branch circuits.

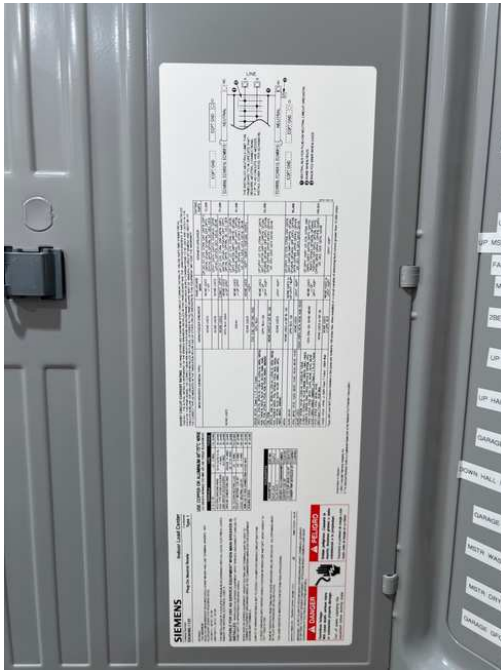
- ✓ **89: Siemens Electric**  
The sub panel was manufactured by Siemens Electric Corporation. The panel is rated for 125/250 Volts and is in good condition. Voltage was tested and well within guidelines.

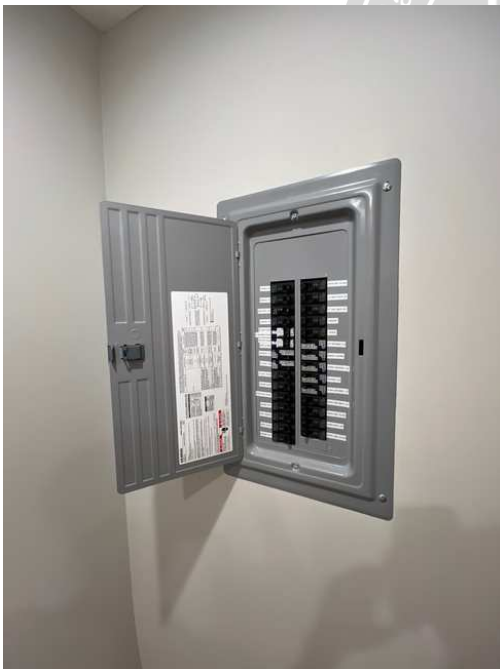
91:

The panel was in satisfactory condition overall.

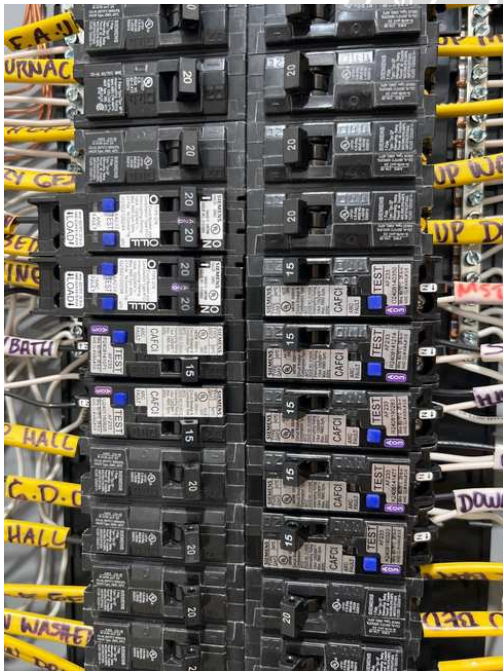
### ✓ 94: AFCI breakers present and functional. AFC circuit breakers should be tested according to manufacturers guidelines to ensure functionality.

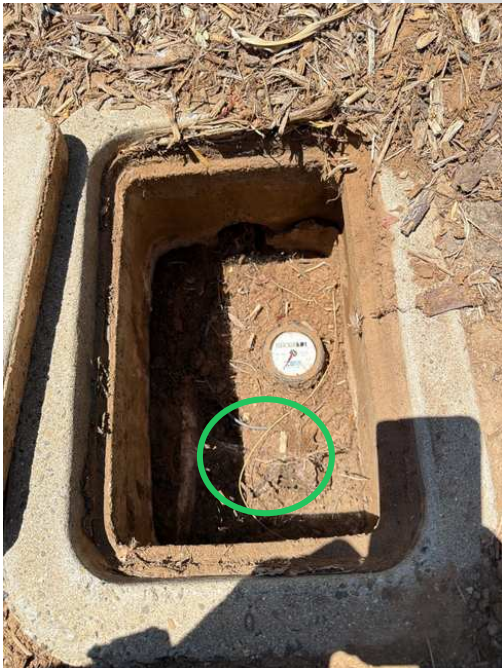
- ✓ **98:** Public water service has been provided to the home via public utility.

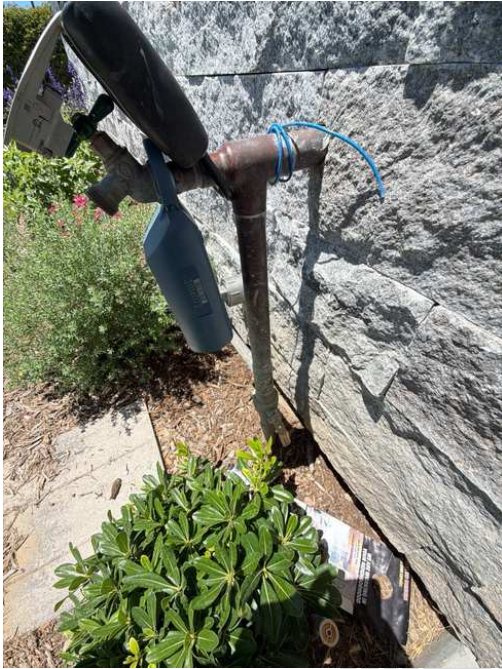
99:

Copper was observed exiting the wall. Materials used underground are unknown.

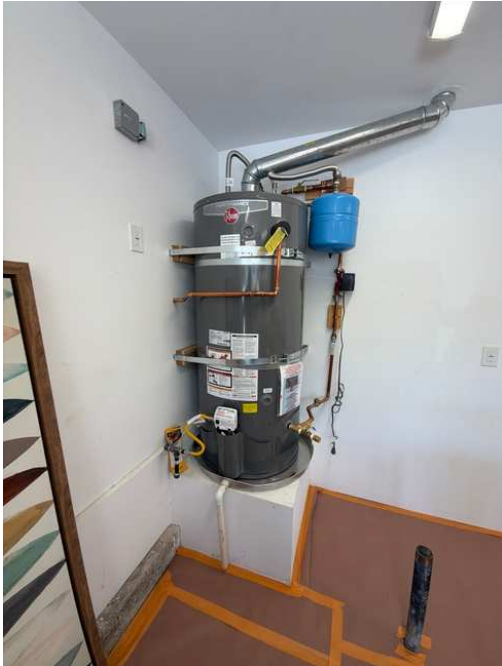
107:

The hot water heater was located in the garage.

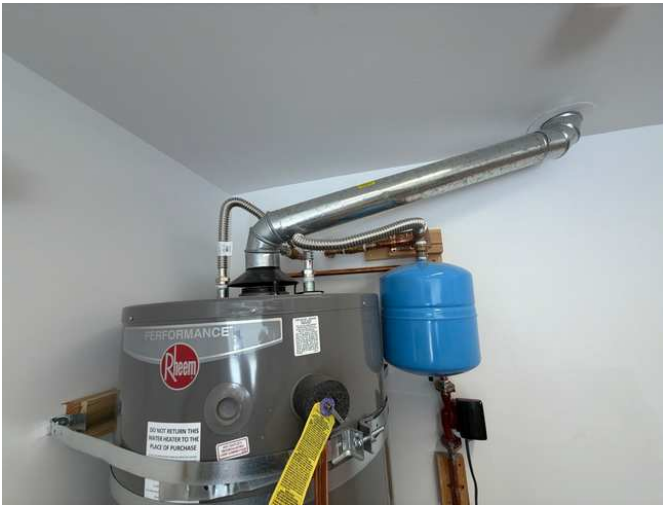
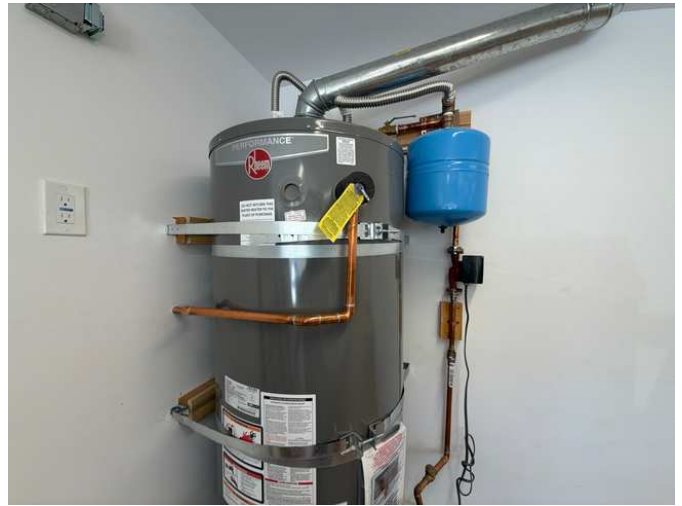
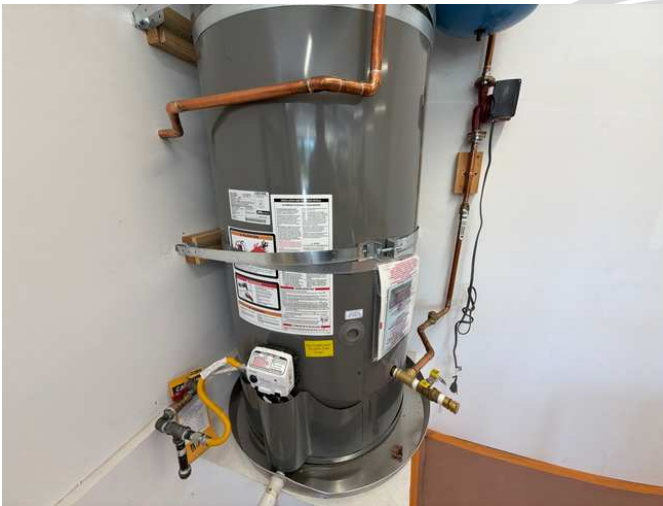
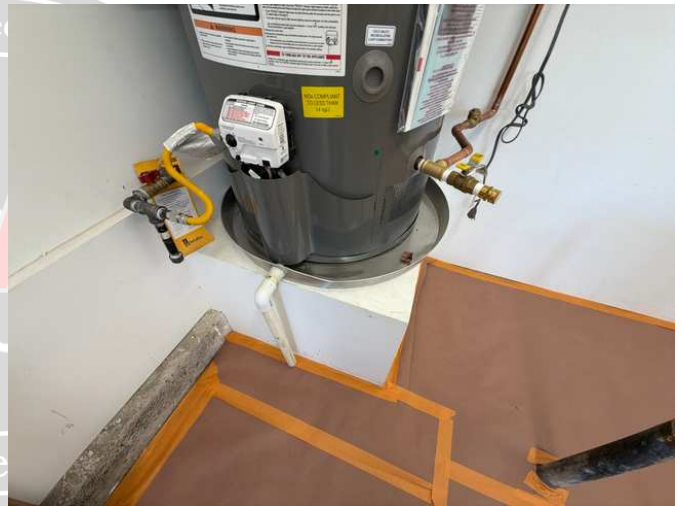
✓ **108: Gas-fired Water Heater**

Natural gas fired hot water storage tank.

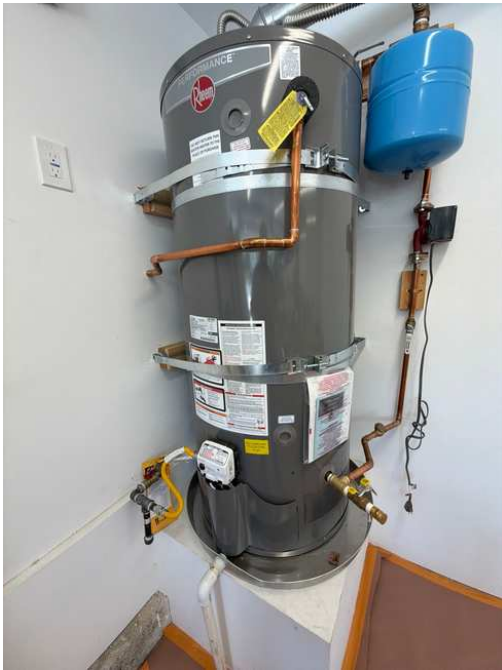
- ✓ **109:**  
Hot water heater was in satisfactory condition.

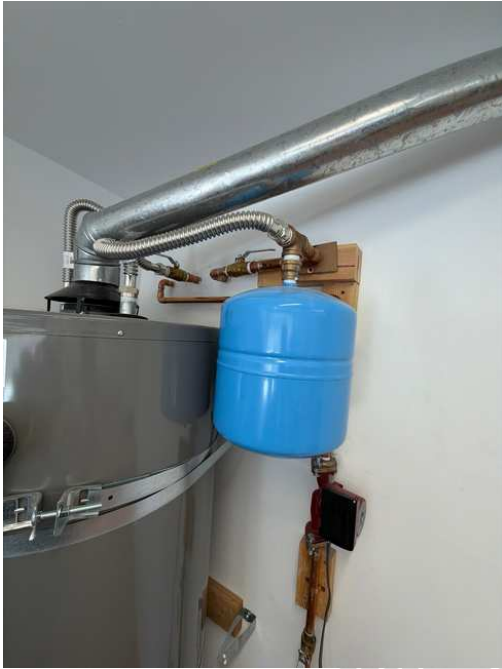
✓ **111:**

The expansion tank/valve was present and functional. There was no signs of rust corrosion or leaks.

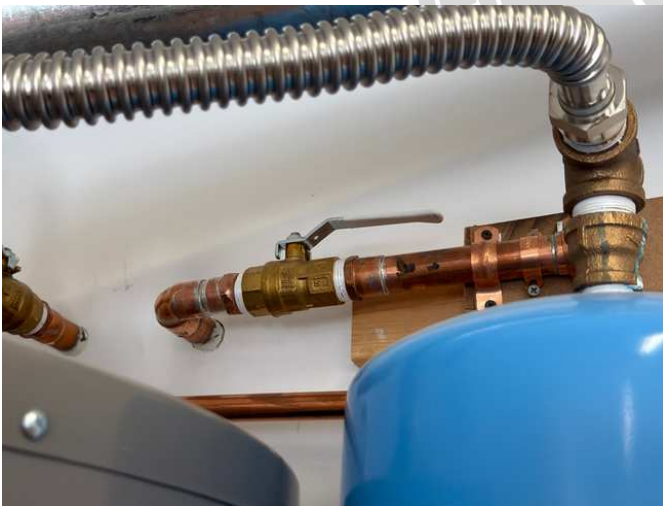
**113:**

The hot water heater shut off valve was in satisfactory condition. There were no signs of leaks rust or corrosion.

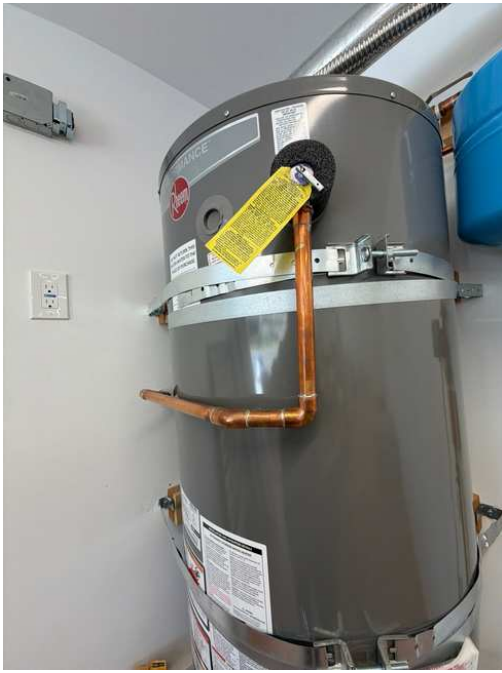
**115:**

The TPR valve was in satisfactory condition. There were no signs of leaks, rust or corrosion.

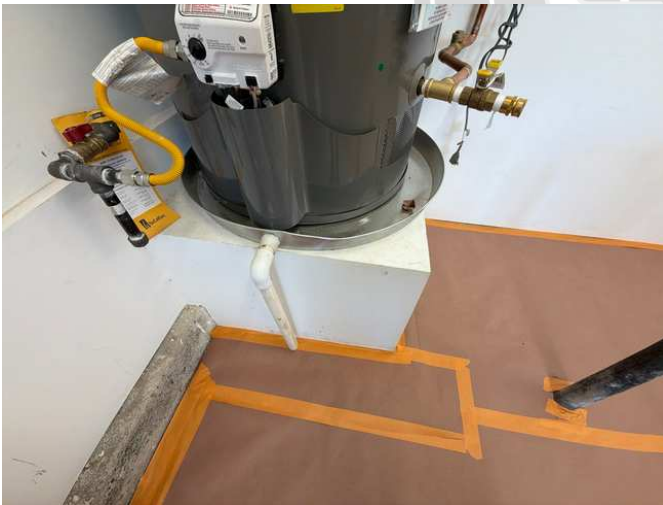
- ✓ **116:**  
The drip pan is in satisfactory condition.

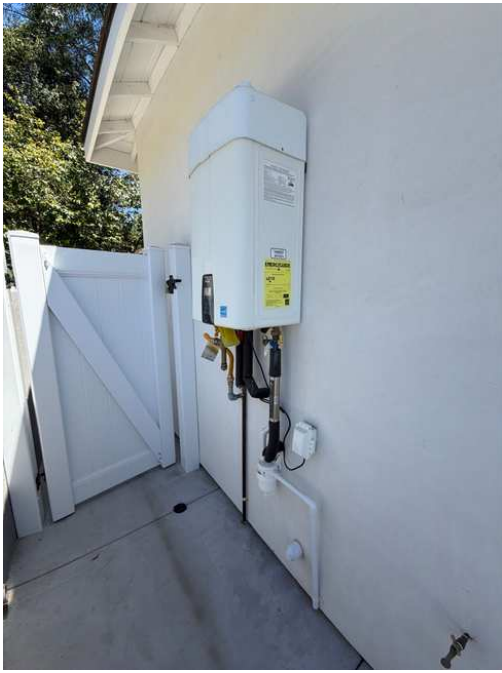
### **118:**

Tankless hot water heater is located at the rear of the property behind the ADU

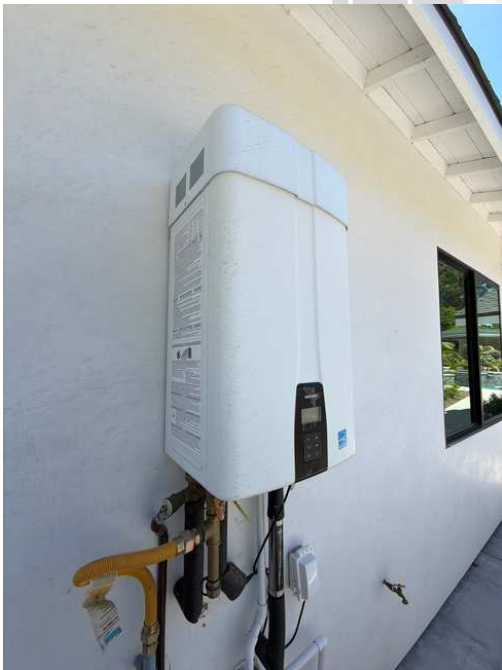
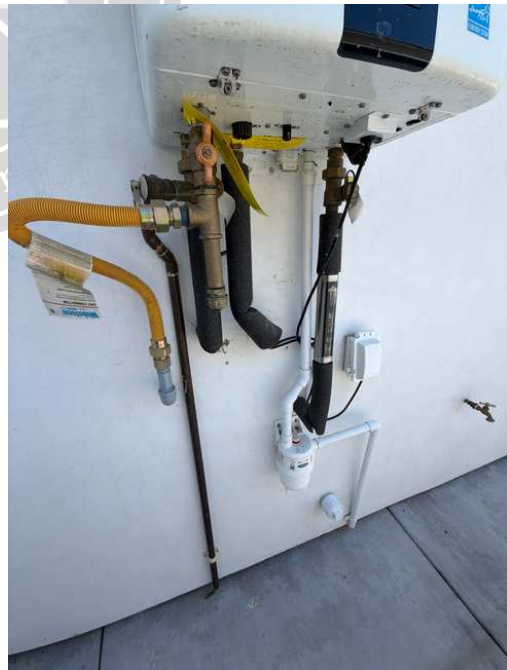
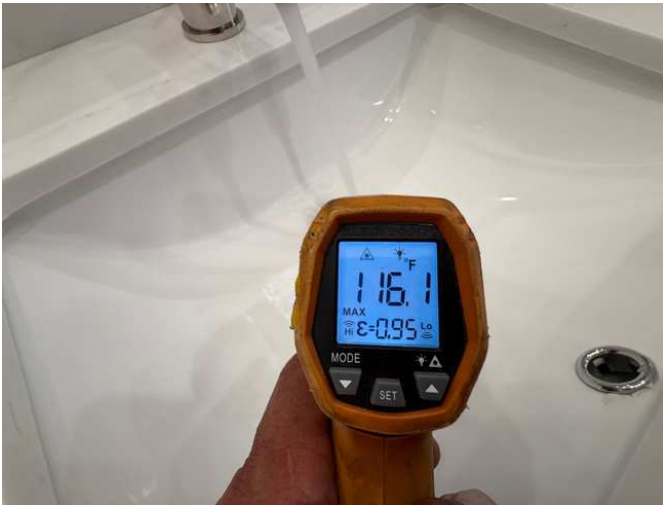
- ✓ **119:**  
Hot water heater was in satisfactory condition.

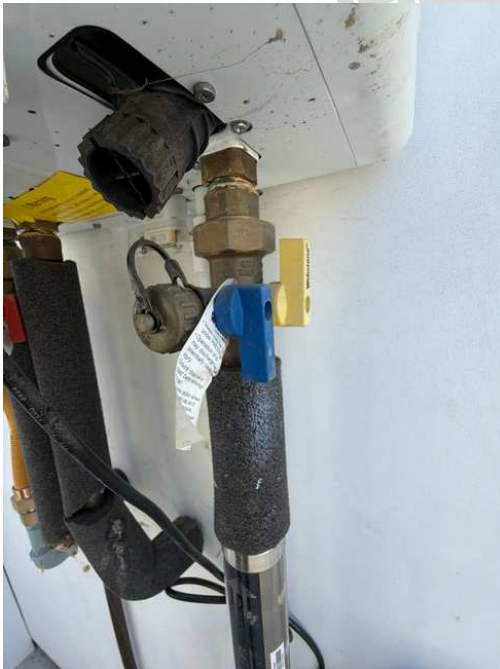
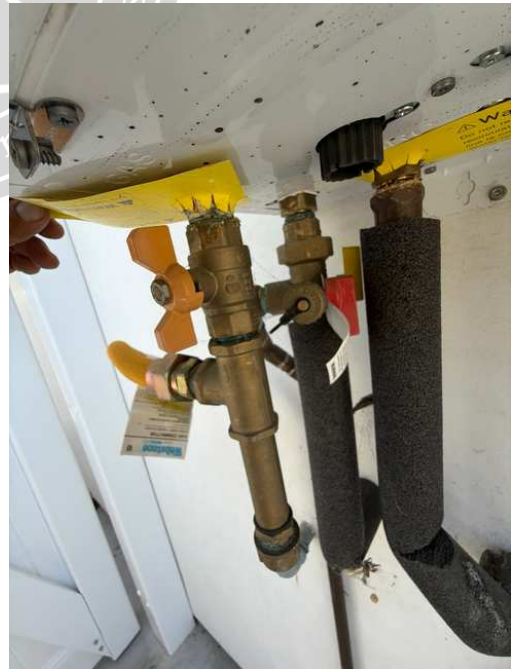
✓ **120:**

The hot water heater shut off valve was in satisfactory condition. There were no signs of leaks rust or corrosion.

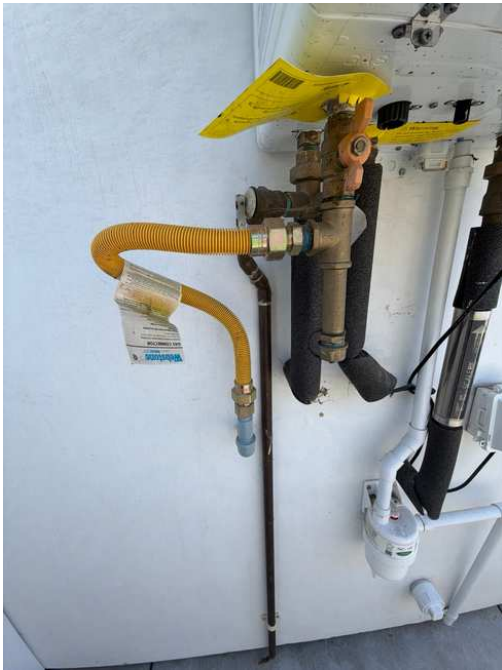
✓ **122: Satisfactory**

The gas line was in satisfactory condition. No gas leaks were detected.

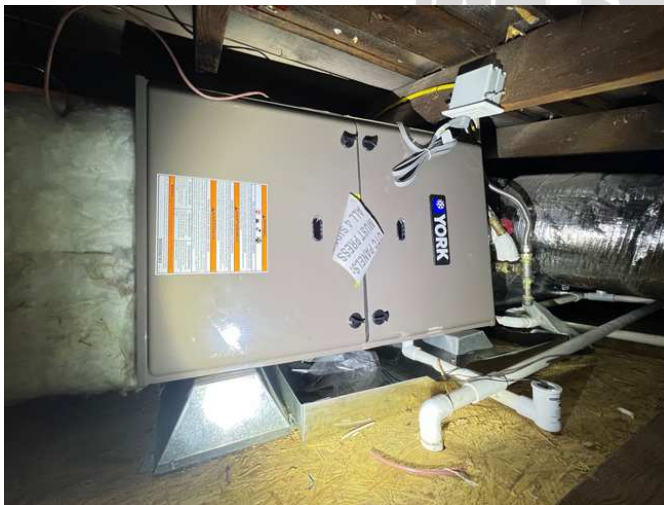
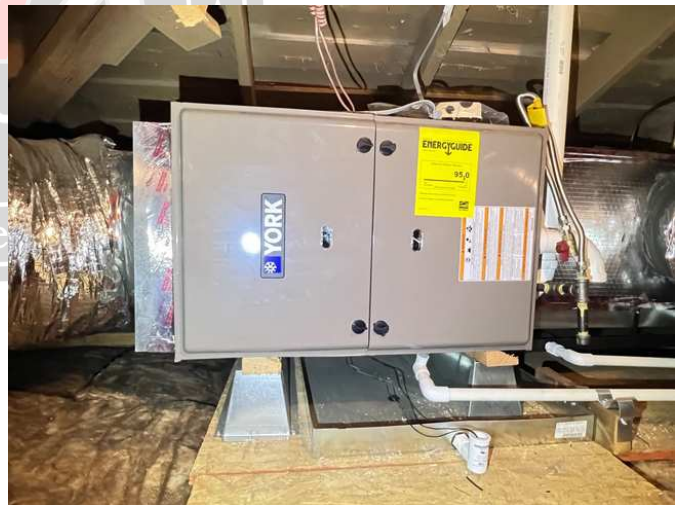
### **W125:**

The ambient temperatures were above testing requirements. Testing the furnace in higher than recommended temperatures can cause immediate damage to the unit. It is suggested that the client return to the home in the early morning hours or during colder temperatures so the furnace can be tested safely.

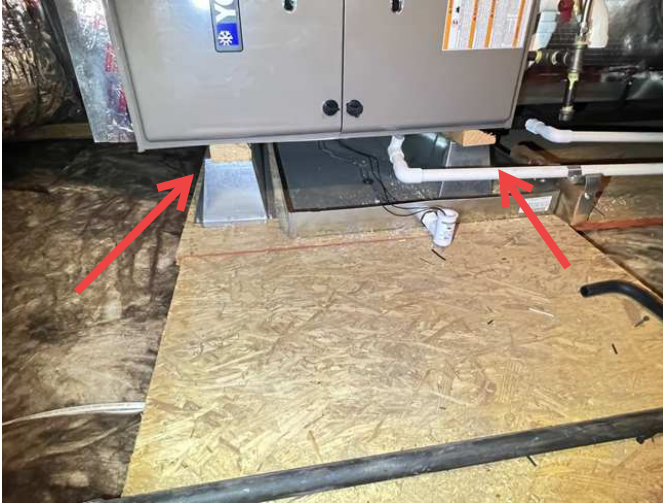
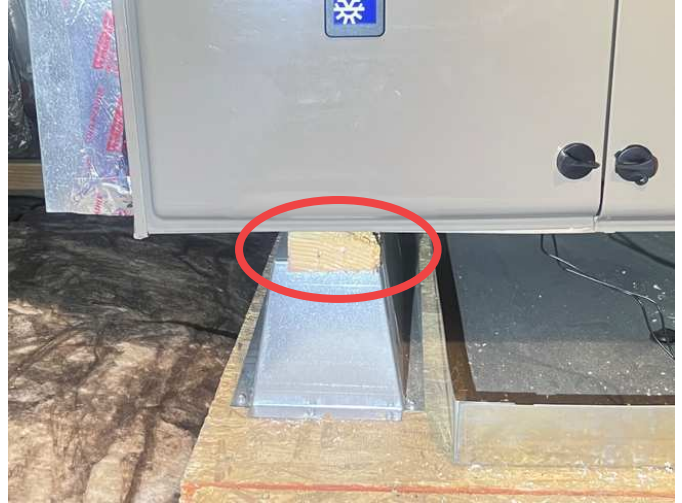
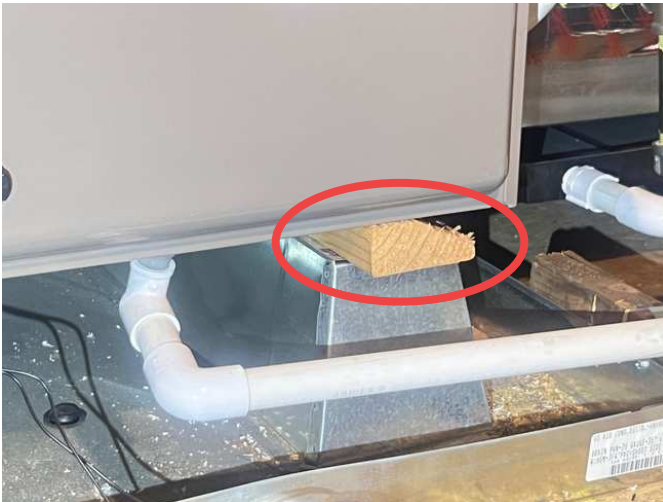
The horizontal gas furnace was observed to be elevated using wood blocking placed on top of the metal furnace stand supports. While the furnace is supported, the use of combustible wood spacers is not considered an appropriate support method for this type of installation. If additional elevation

was required, properly sized code-compliant metal furnace stands or supports should have been used. Recommend consultation with the builder or a qualified HVAC contractor to evaluate the installation and provide proper support as necessary.

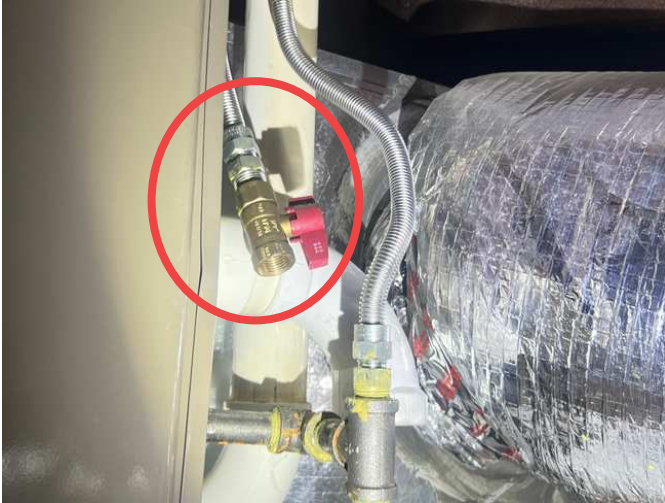
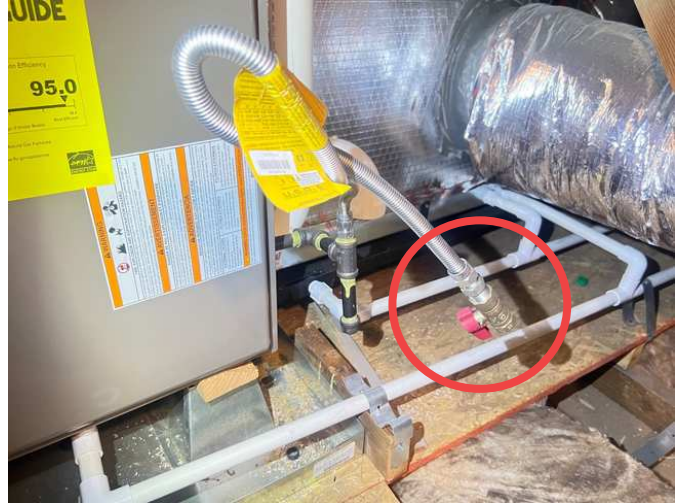
The gas supply lines for both furnace units were not connected to the gas supply at the time of the inspection. As a result, the furnaces could not be operated or evaluated for proper function. Recommend consultation with the builder to complete the gas connections and verify proper operation of both furnace units prior to occupancy.

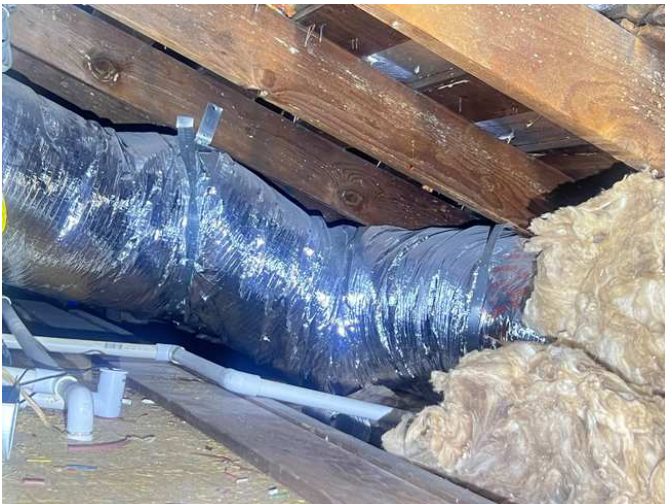
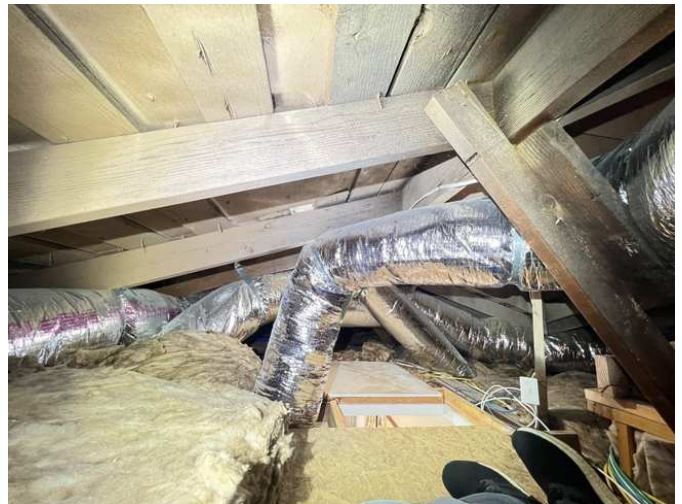
**128:**

Flexible insulated duct work was utilized. The duct work was in satisfactory condition where visible.

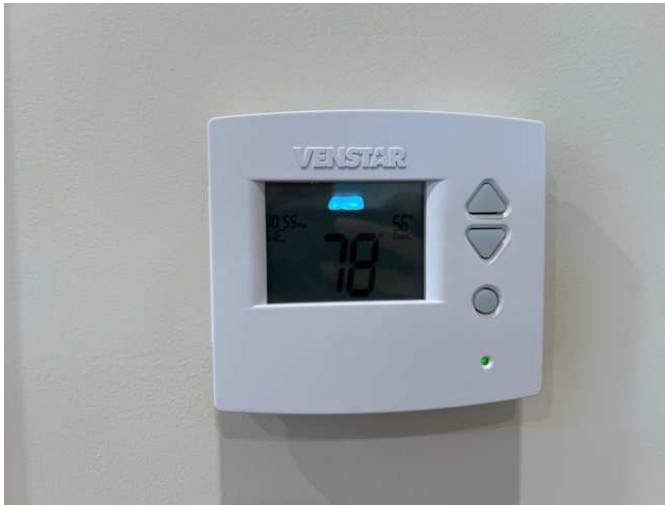
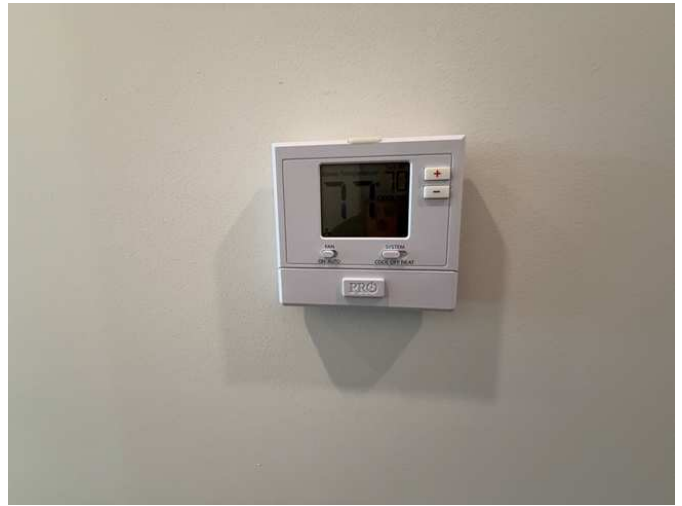
#### ✓ 129:

Thermostat #1 and #2 are located at the first and second floor level, respectively. Both thermostats appear to be properly installed and the unit responded to the basic controls. This is a programmable device with many options for setback settings, timed events, etc. No attempt was made to test all functions of the thermostat. To do so would be time consuming and outside of the scope of a general home inspection.

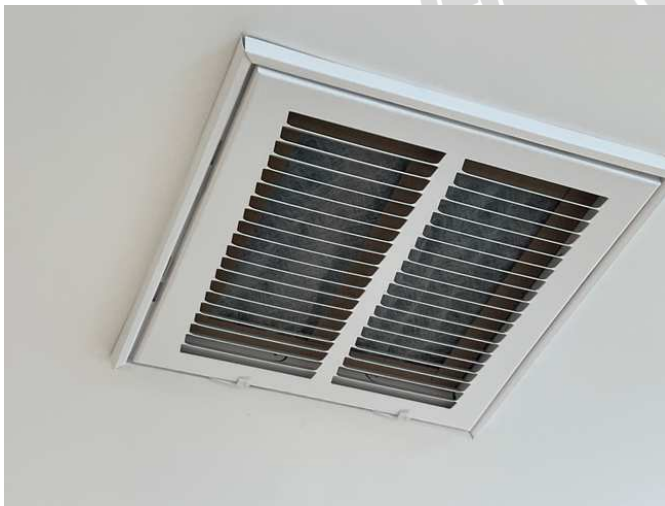
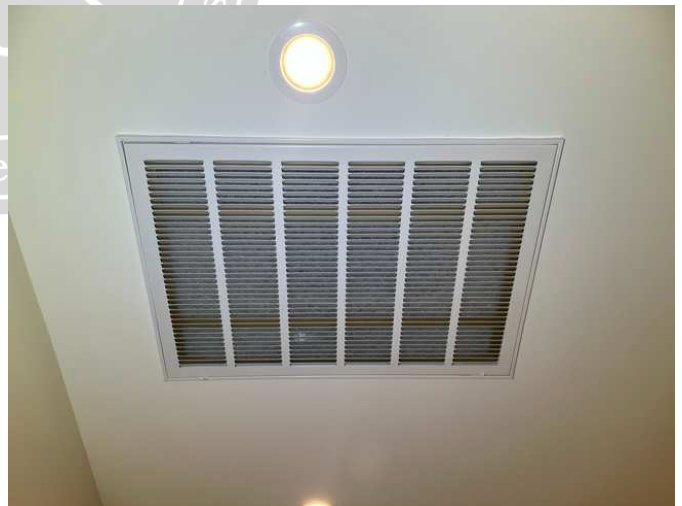
**130:**

The filter is in satisfactory condition. Filter should be replaced every 3 to 6 months as part of regular home maintenance.

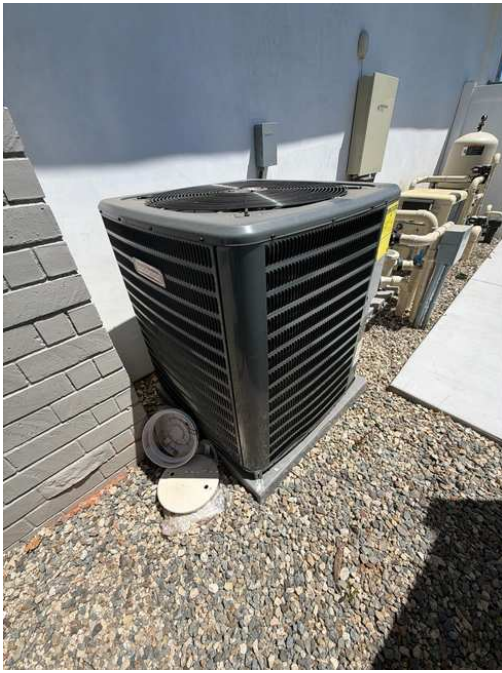
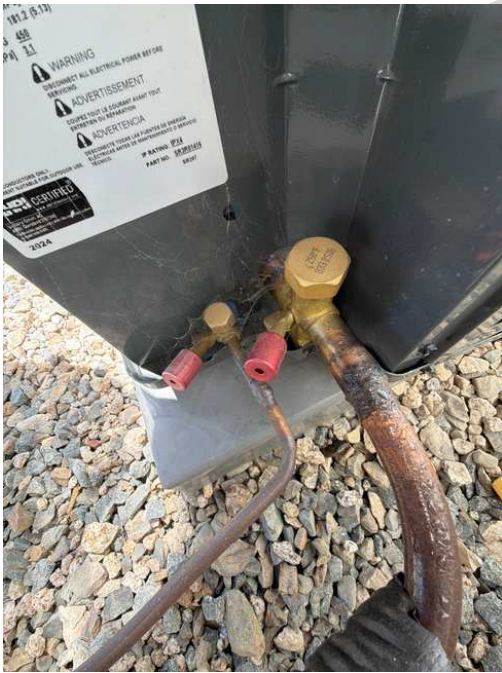
- ✓ **133:**  
A/C condenser responded normally to testing.

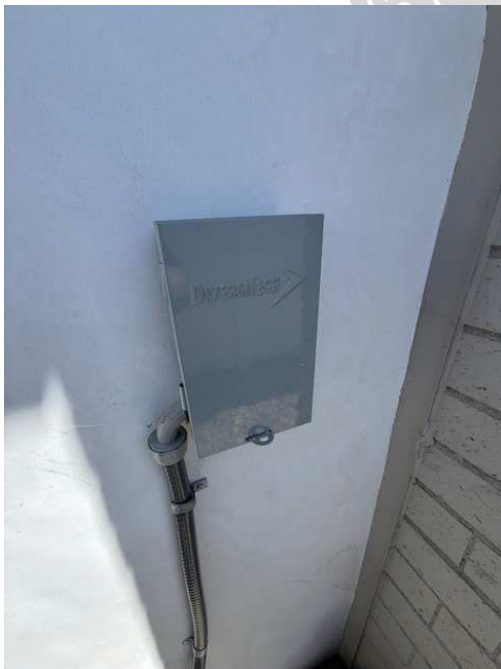
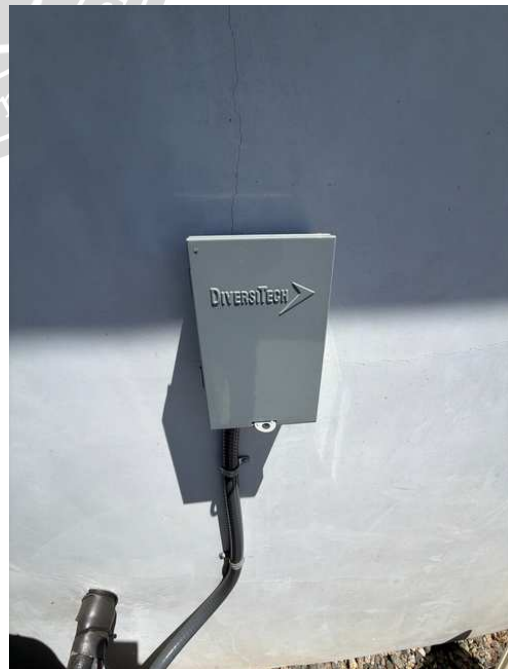
**M134: Caulking Needed**

The service disconnect should be properly sealed to the structure.

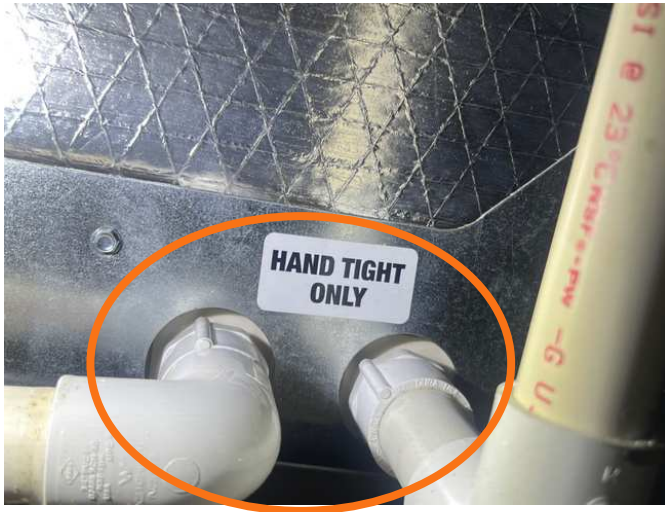
### **R135: Evaporator Leaking Air**

The evaporator was leaking a significant amount of air during inspection. Thus reducing energy efficiency. Consult with an HVAC contractor to seal the evaporator.

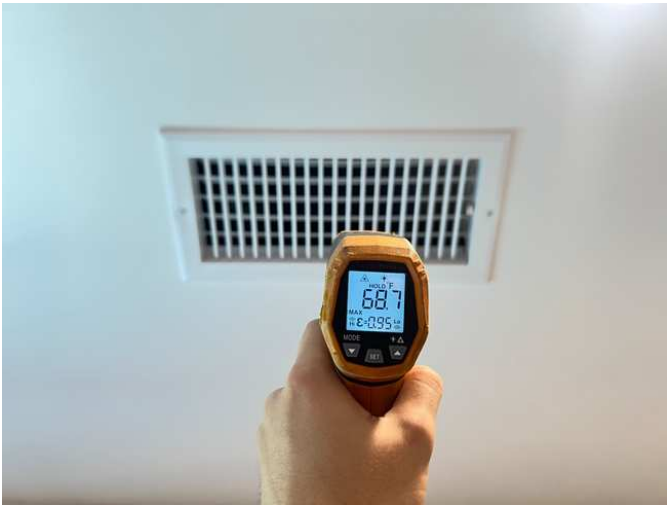
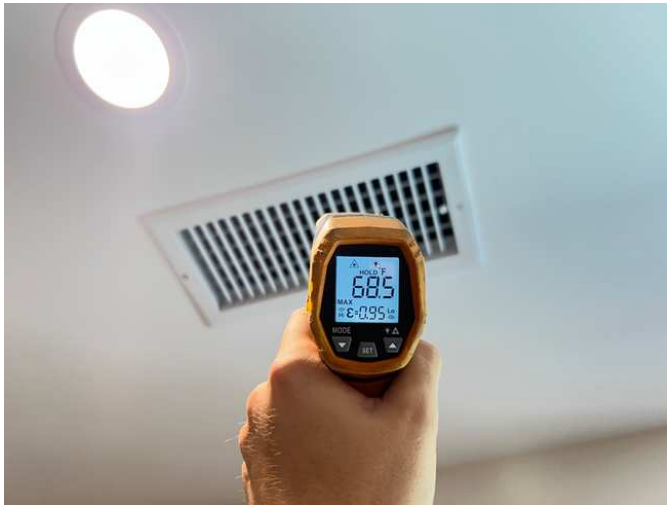
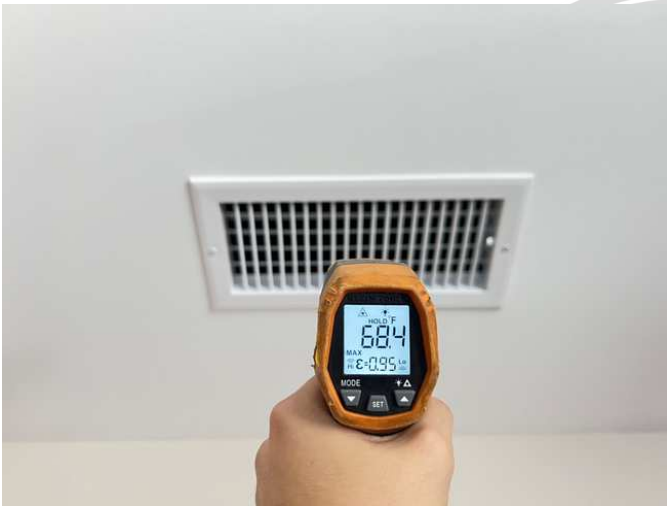
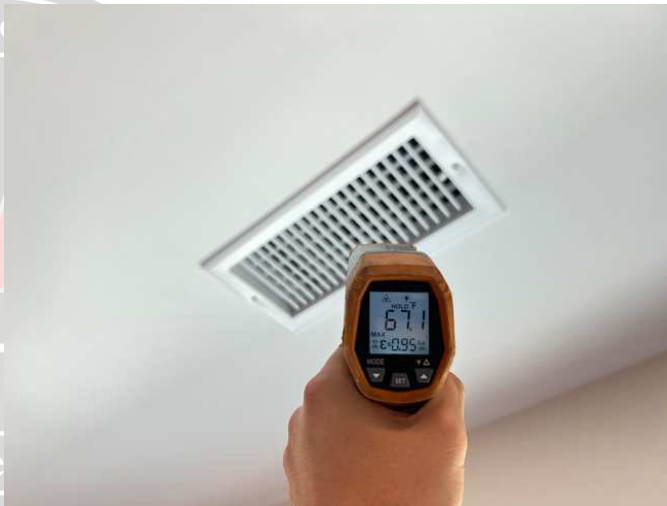
The air-conditioning output temperatures were poor for the second level of the home. It is recommended that an HVAC contractor be consulted for complete evaluation and resolution.

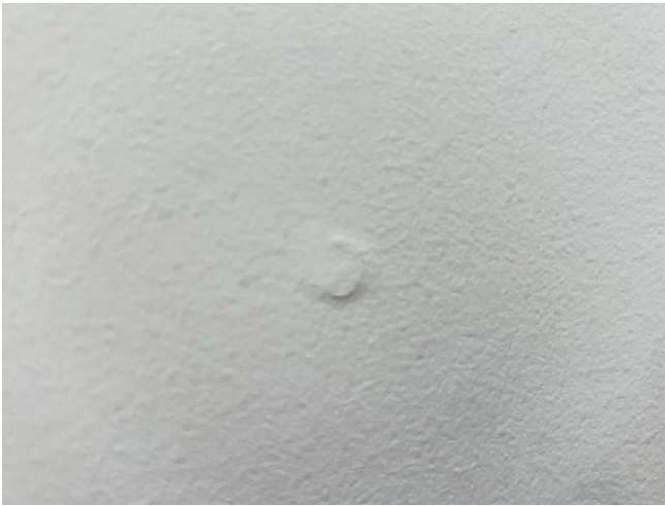
One or more nail pops was observed. Client should consult with the builder for a complete audit and resolution.

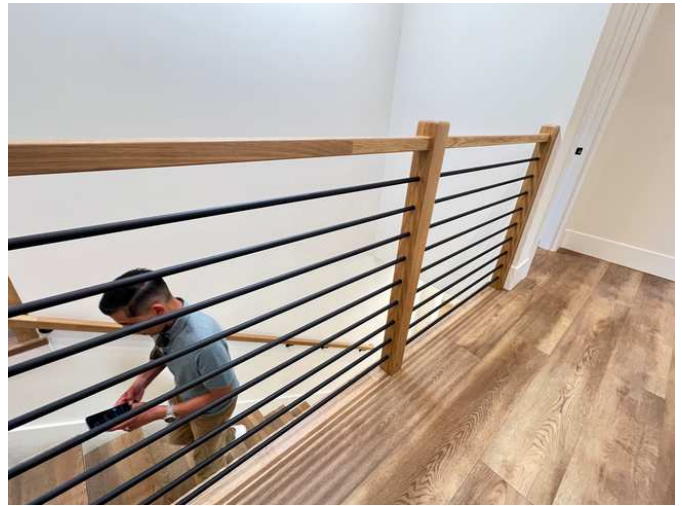
# CHILD SAFETY RAILING

Ladder type guard rail pose a significant safety hazard for small children. Children can use the guard rail as a ladder to climb up and over the guard rail. Recommend improvements. Safety concern.
