# HOME INSPECTION REPORT

PROFESSIONAL PROPERTY EVALUATION

INSPECTION DATE

Tuesday, July 7, 2026

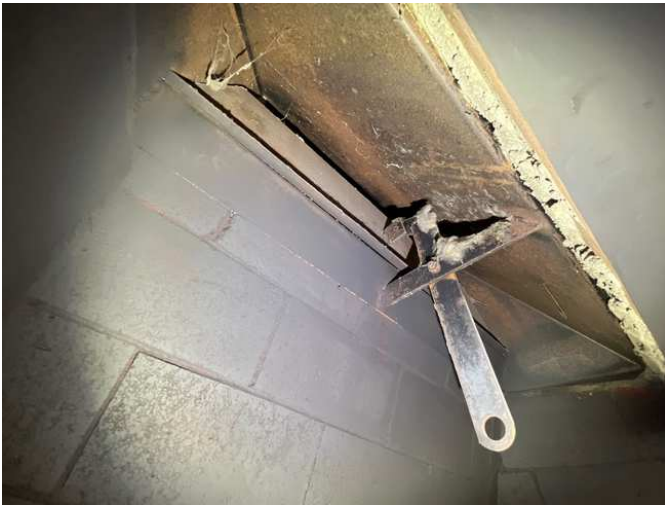
✓ **149: Satisfactory**

The fireplace was in satisfactory condition. Our inspection does not include actual operation of the fireplace and we cannot offer opinions regarding its performance. We suggest inquiries of the owner or occupant in this regard. Fireplaces should have annual maintenance performed. The client is advised to have the fireplace service by a qualified chimney specialist.

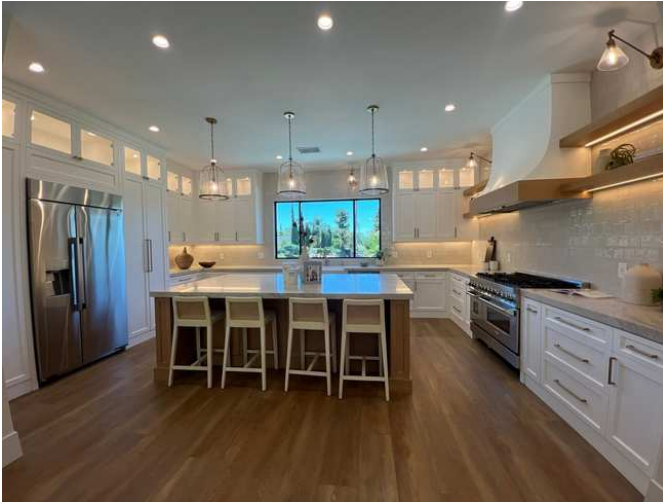
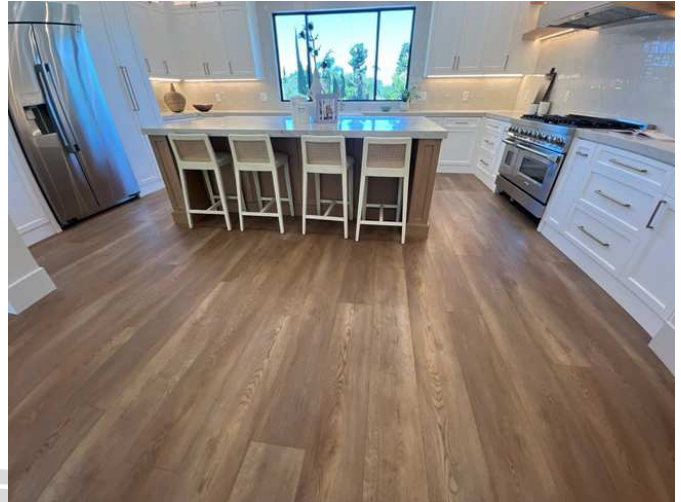
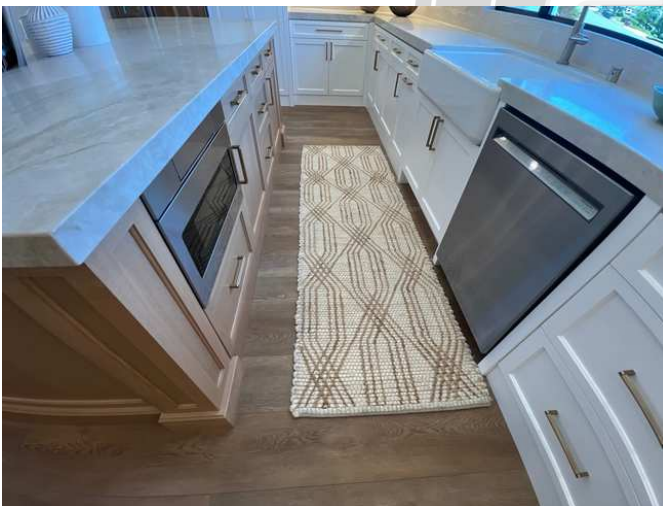
✓ **150:**

Floor, walls and ceiling in the kitchen area were in satisfactory condition overall.

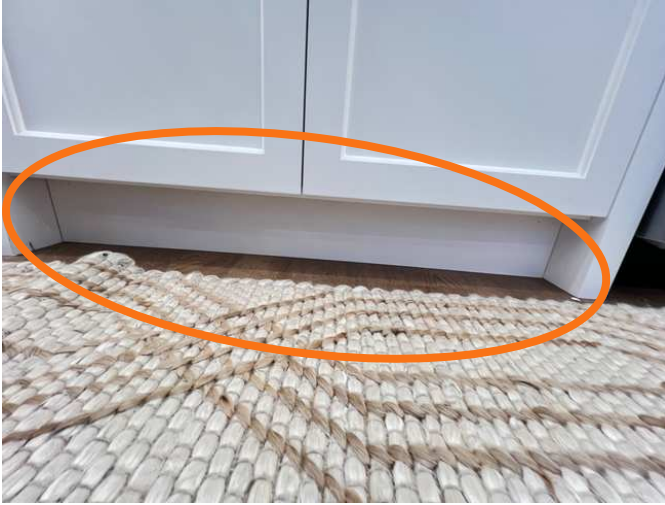
The toe kick beneath the kitchen sink cabinet was not properly secured at the time of the inspection. The toe kick detached during the inspection and was reinstalled by the inspector in its original location. Recommend consultation with the builder to properly secure the toe kick using appropriate

fastening methods.

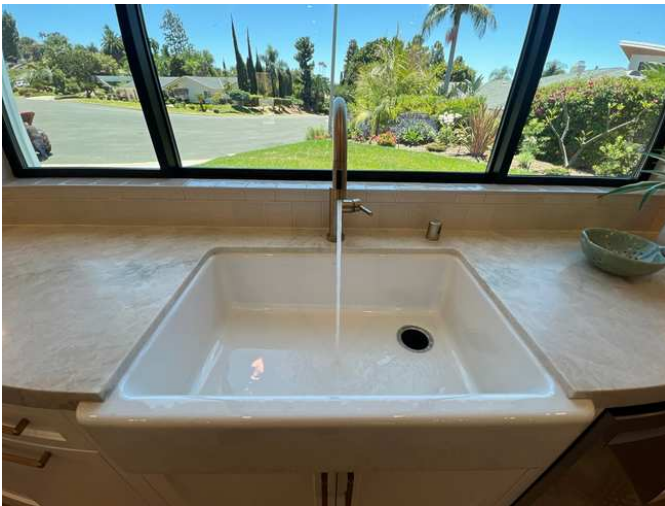
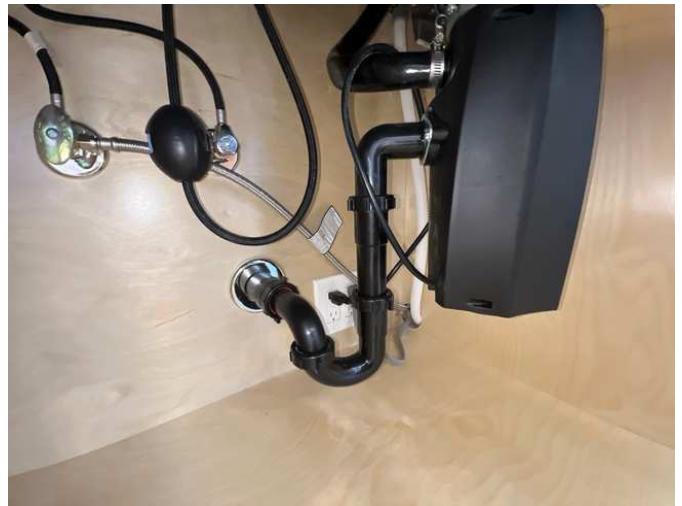
**152:**

The kitchen sink was in satisfactory condition. Faucet was functional.

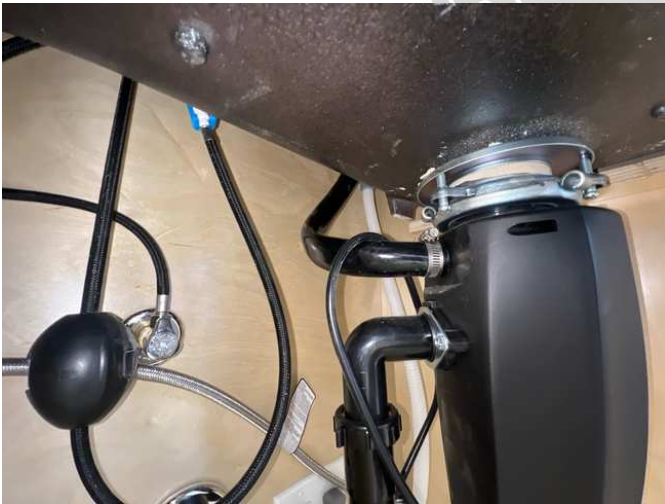
✓ **153: Satisfactory**

The garbage disposal was in satisfactory condition.

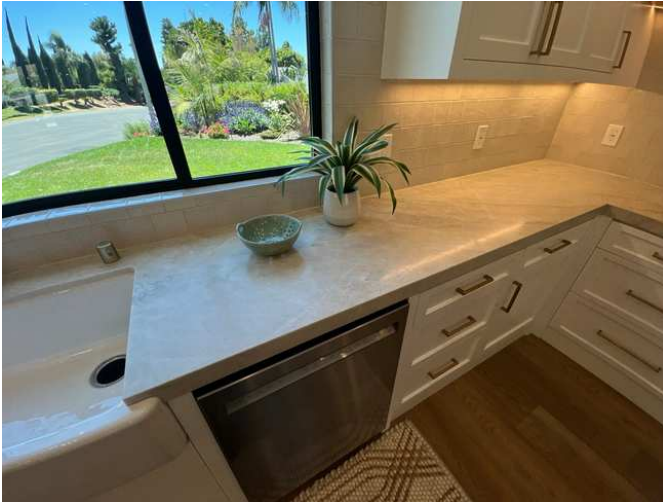
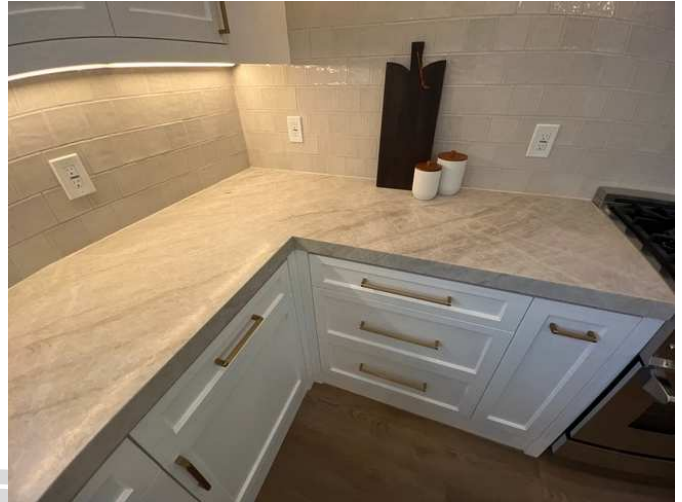
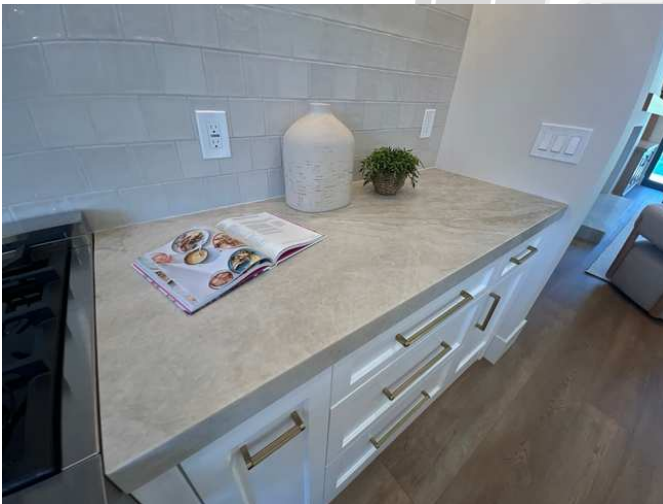
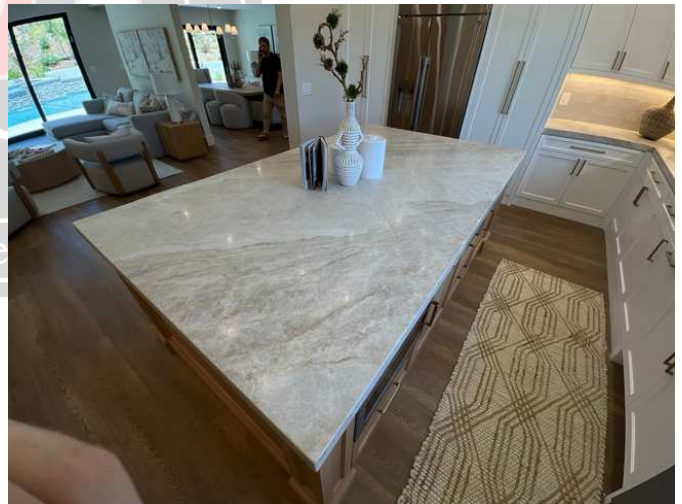
✓ **154:**

Quartz countertops were in satisfactory condition and professionally finish the edges and seams.

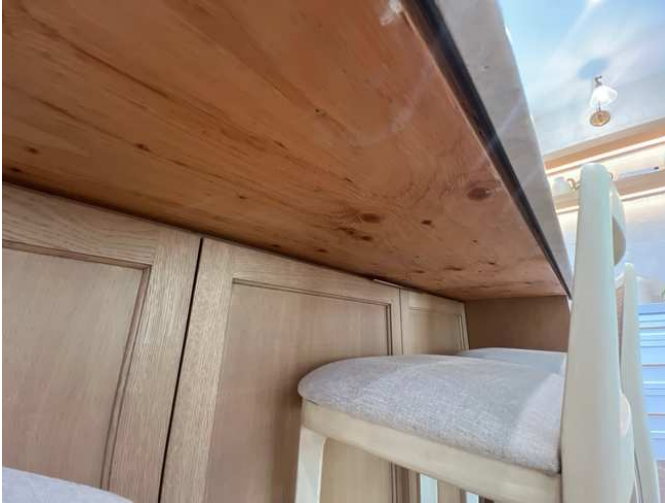
The underside of the bar was not painted or lacking paint. Painting below the bar is a standard for cleanliness and cleaning of the surfaces.

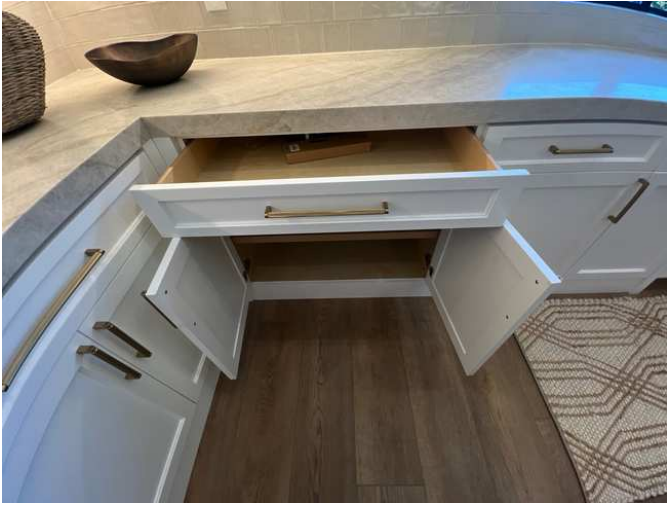
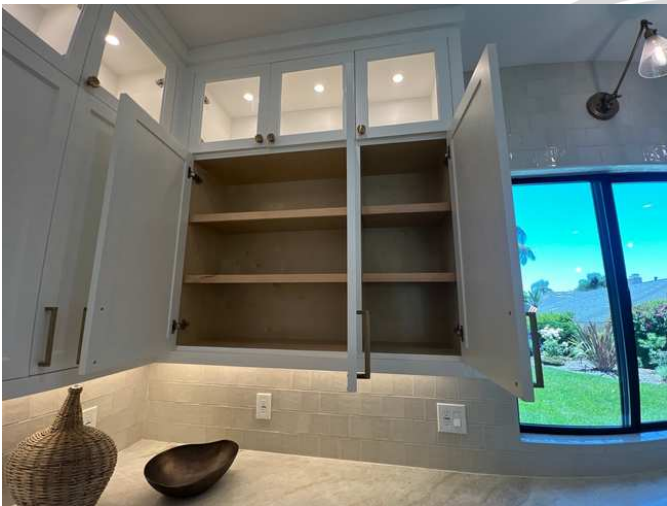
**156:**

Kitchen cabinets are in new condition. All doors and drawers function normally.

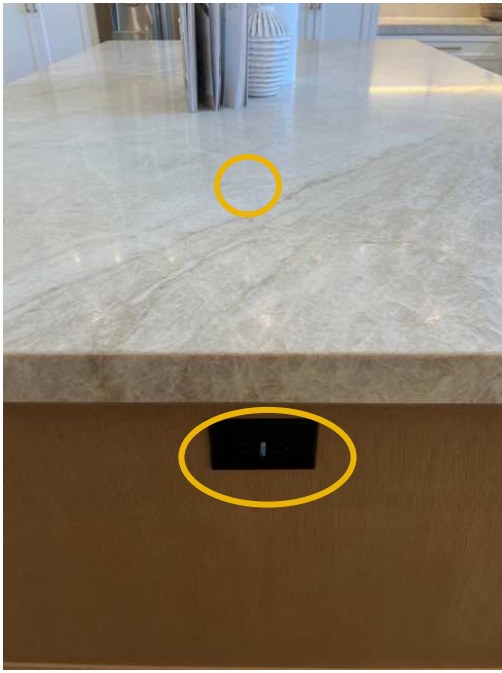
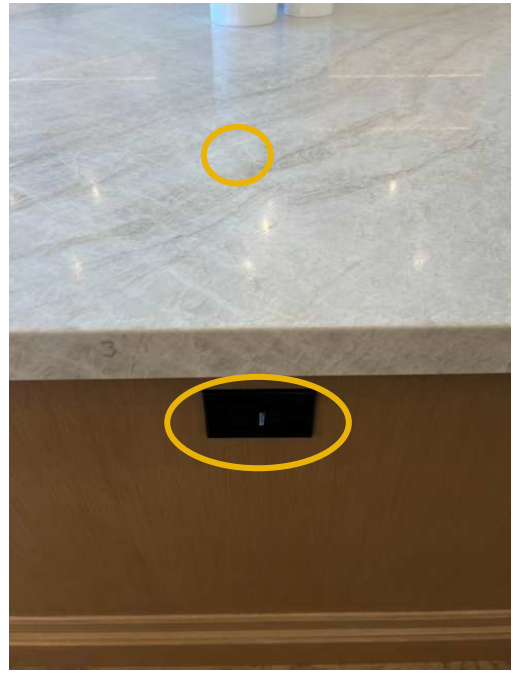
### **Pop-Up Island Receptacle**

Countertop pop-up outlet for kitchen islands. Meets NEC Section 210.52(C)(3) requirements for island countertop receptacle installation.

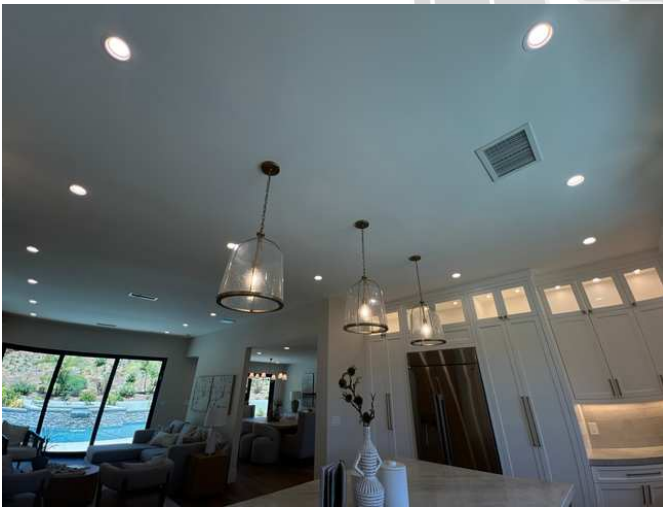
- ✓ **158:**  
Kitchen lighting was satisfactory.

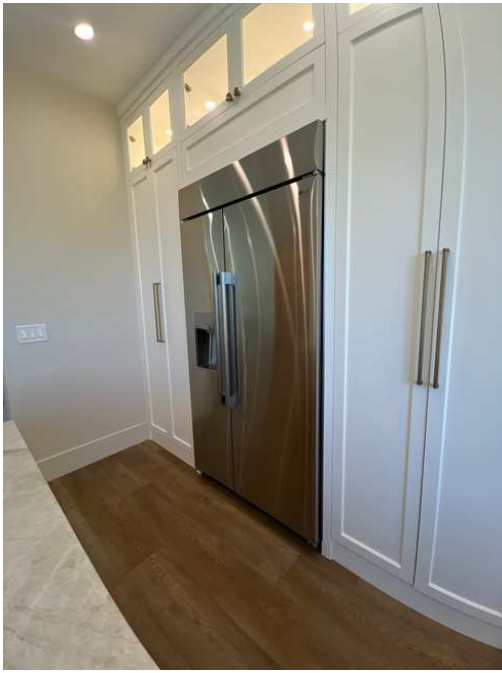
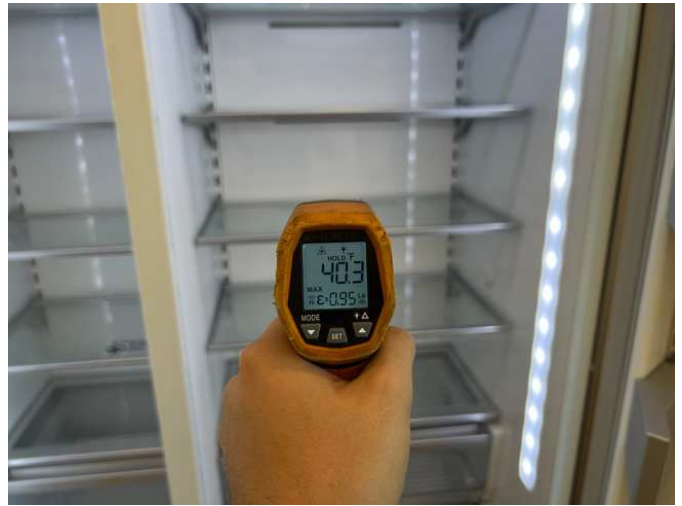
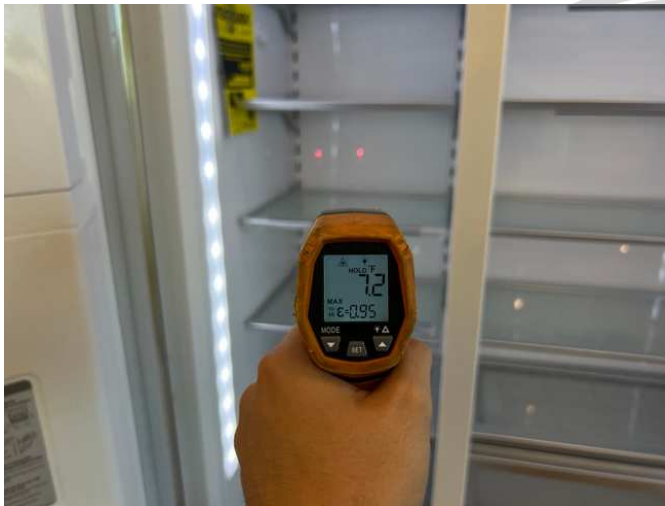
✓ **159: Satisfactory**

The refrigerator was in satisfactory condition.

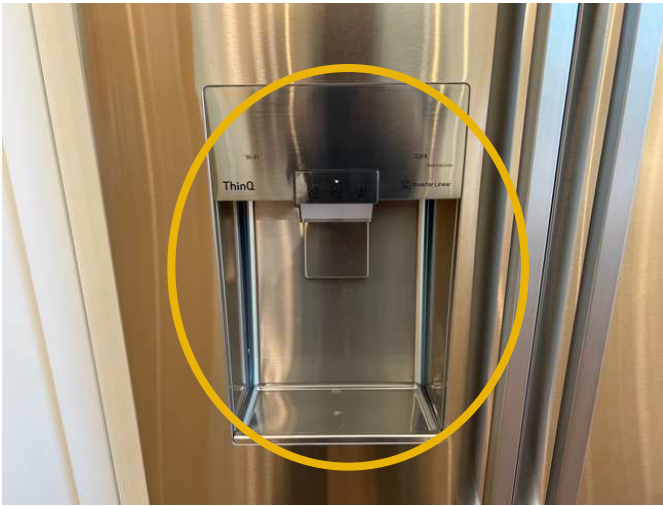
**W160: Icemaker Disclaimer**

It should be noted that the refrigerator was equipped with an ice/water dispenser. These components are not tested during a general home inspection. Client should inquire with the seller regarding its functionality prior to the close of escrow to satisfy any concerns.

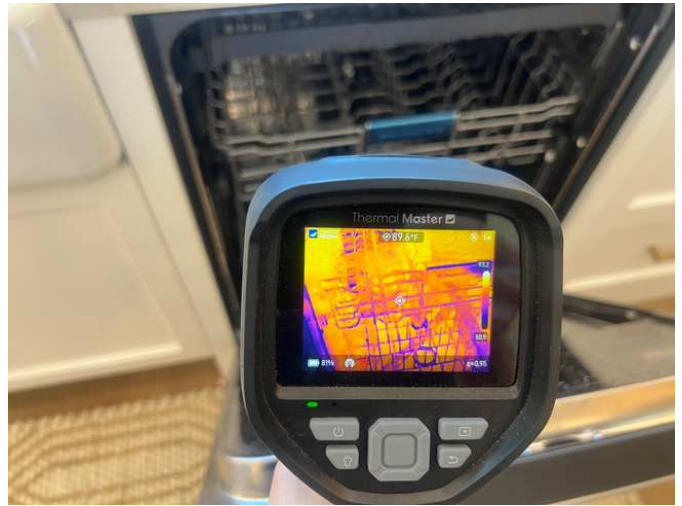
The dishwasher was successfully tested on the day of the inspection by temporarily utilizing the garbage disposal receptacle. However, the dedicated receptacle intended to supply power to the dishwasher was found to be non-functional. Recommend consultation with a qualified electrician for further evaluation and repair of the dedicated dishwasher receptacle to ensure proper operation.

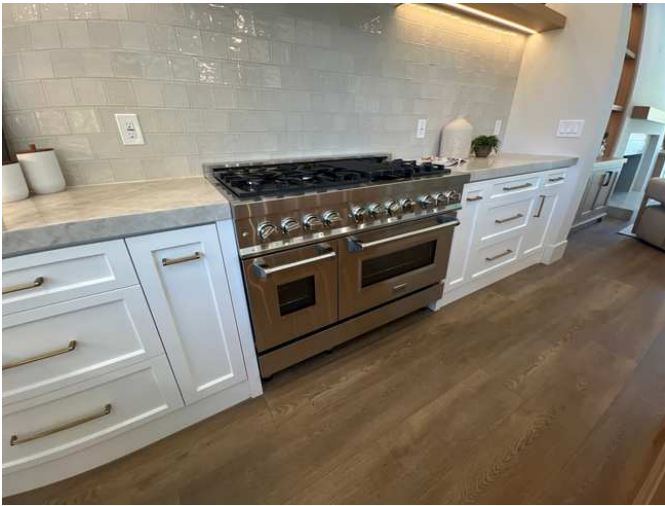
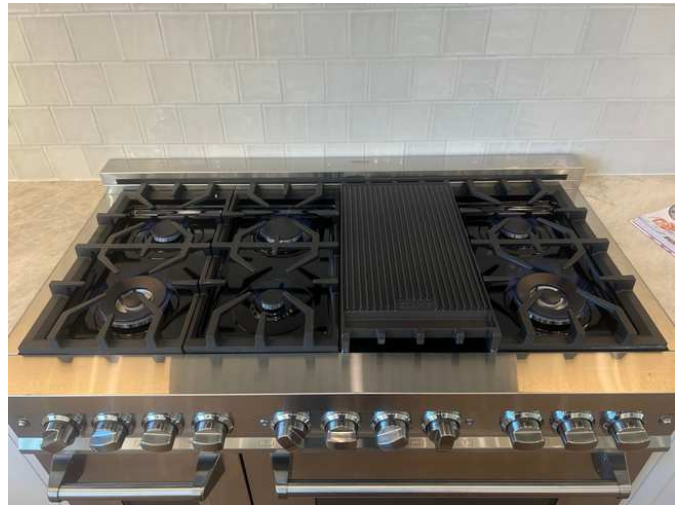
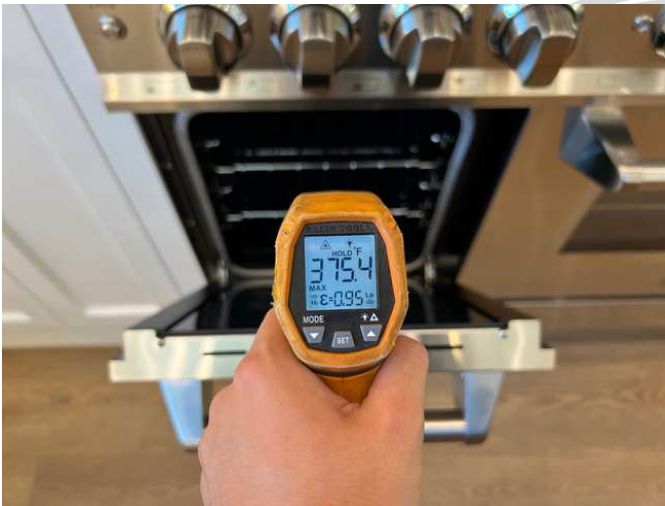
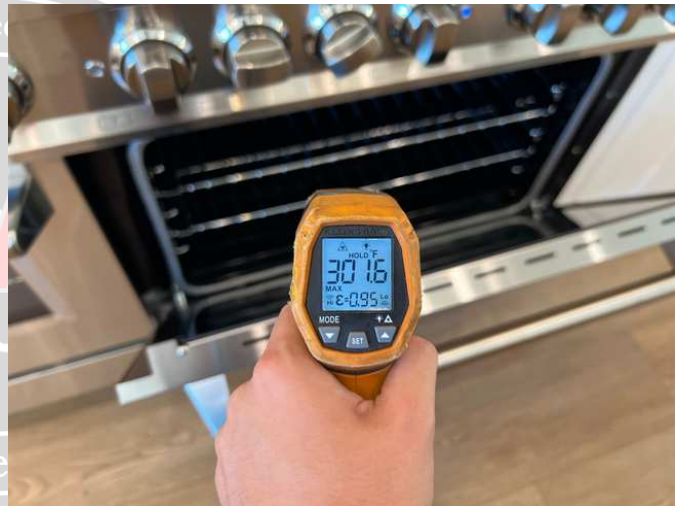
✓ **162: Satisfactory**

The range was thoroughly tested. Temperatures were satisfactory. The unit was found to be functional.

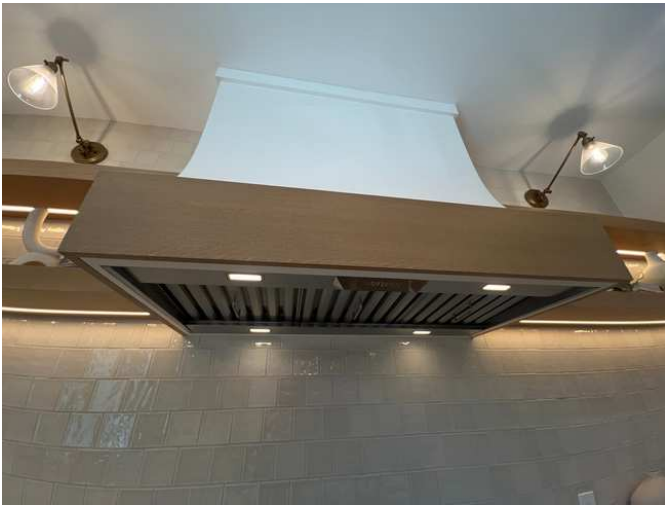
✓ **163: Satisfactory**

The vent hood was in satisfactory condition.

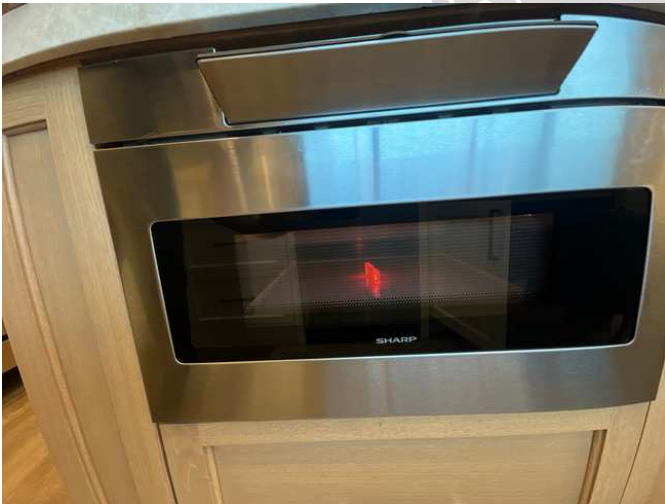
✓ **164: Satisfactory**

The built-in microwave was tested and found to be in satisfactory condition on the day of inspection.

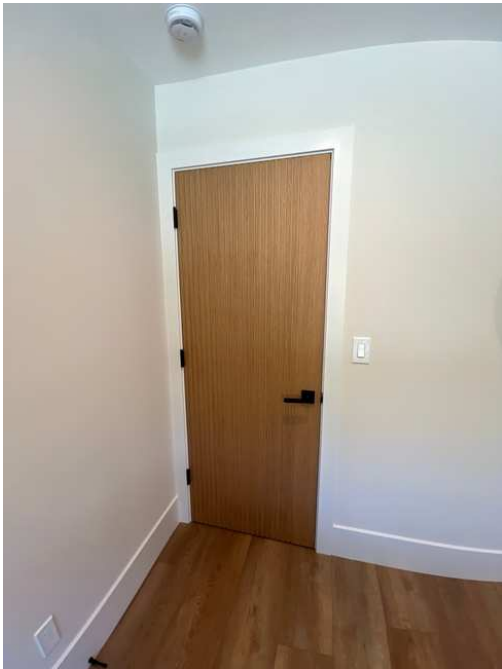
- ✓ **165:**  
The door was in satisfactory condition.

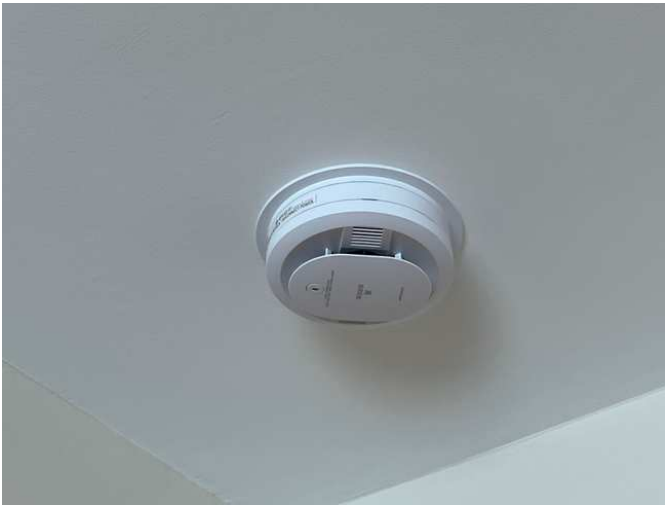
- ✓ **166:**  
Smoke detector present and functional.

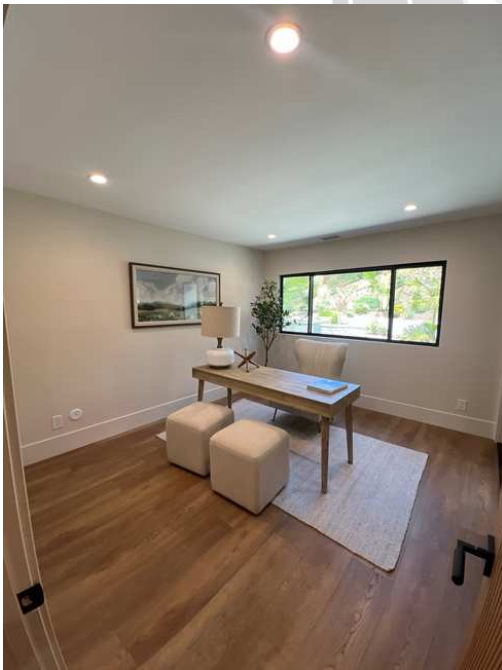
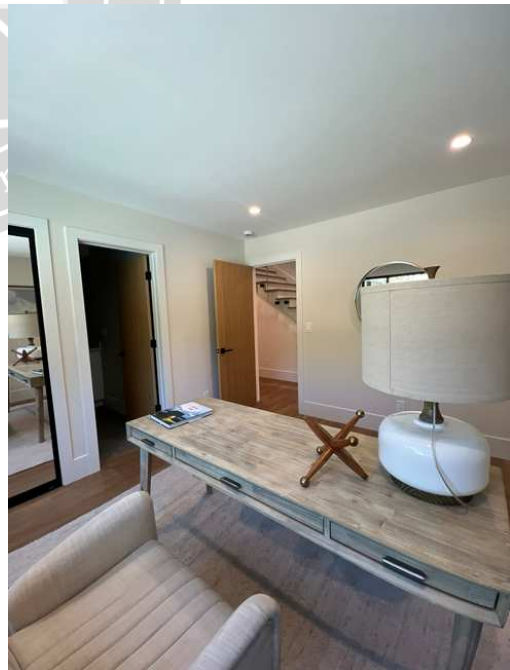
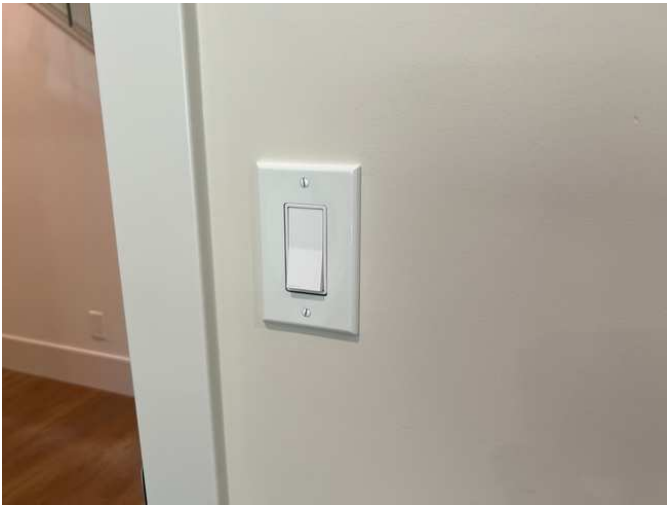
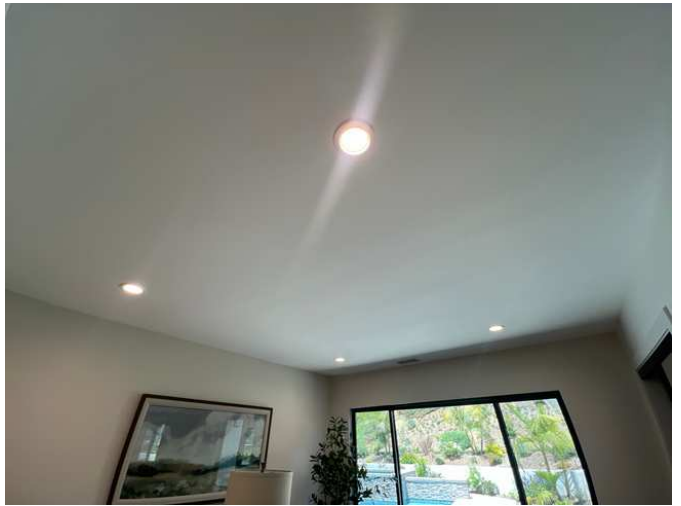
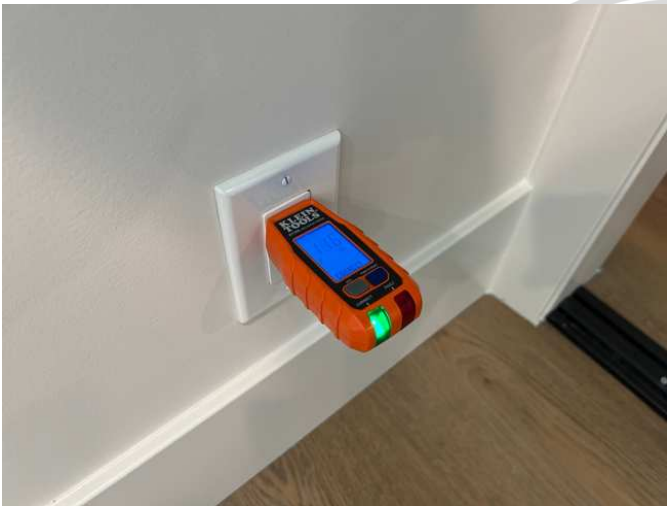
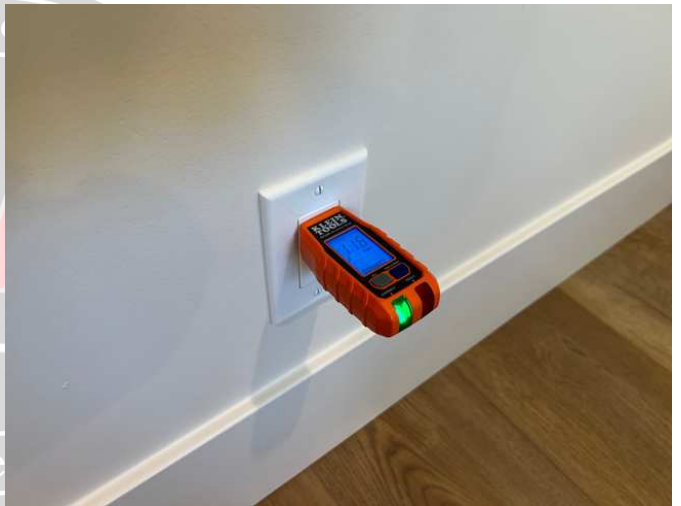
- ✓ **167:**  
Bedroom was satisfactory.

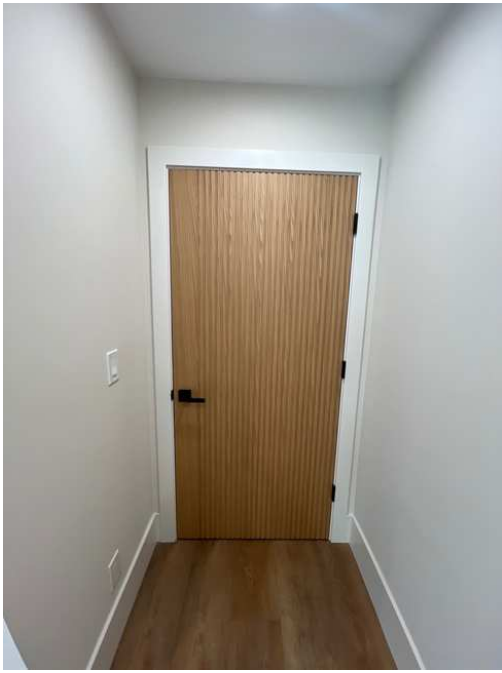
**168:**

The door was in satisfactory condition.

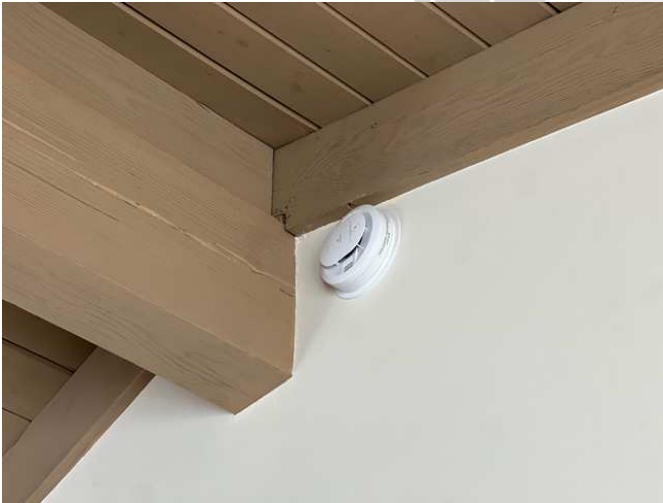
- ✓ **169:** Smoke detector present and functional.

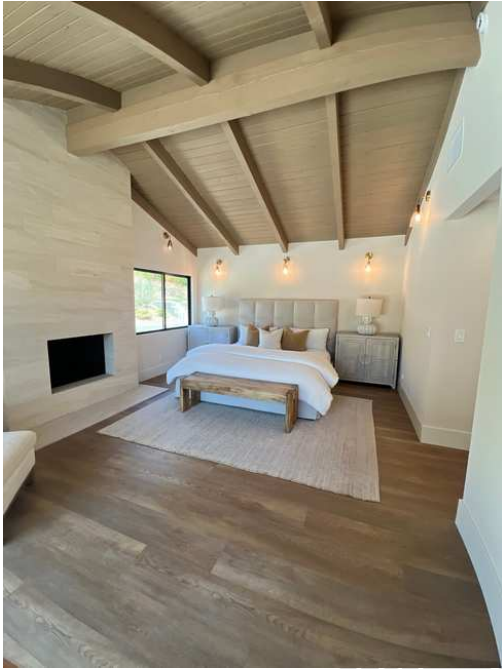
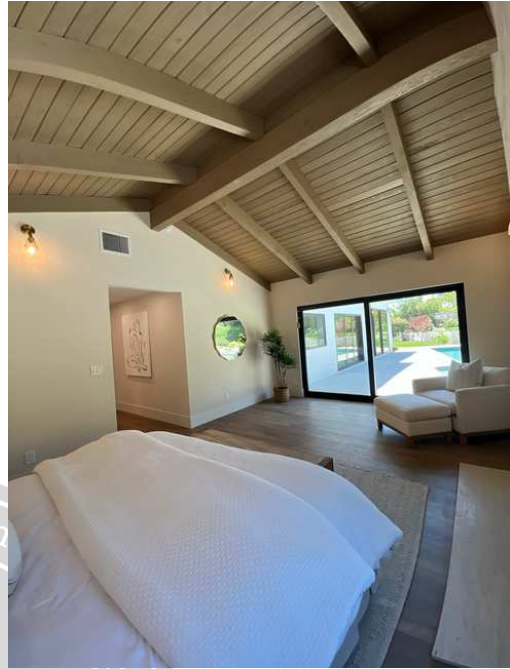
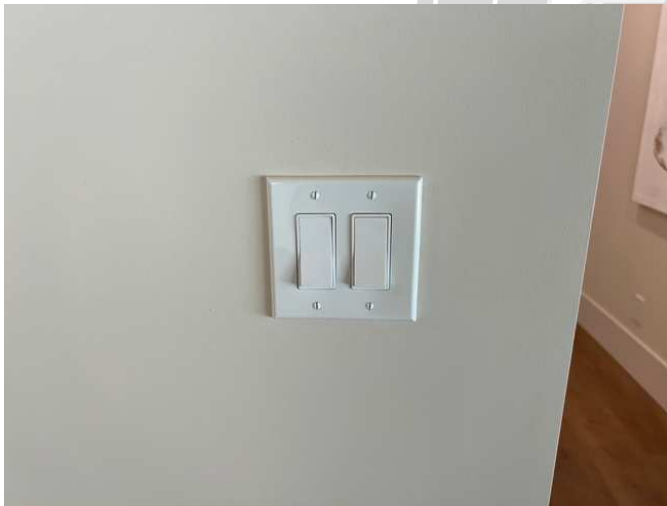
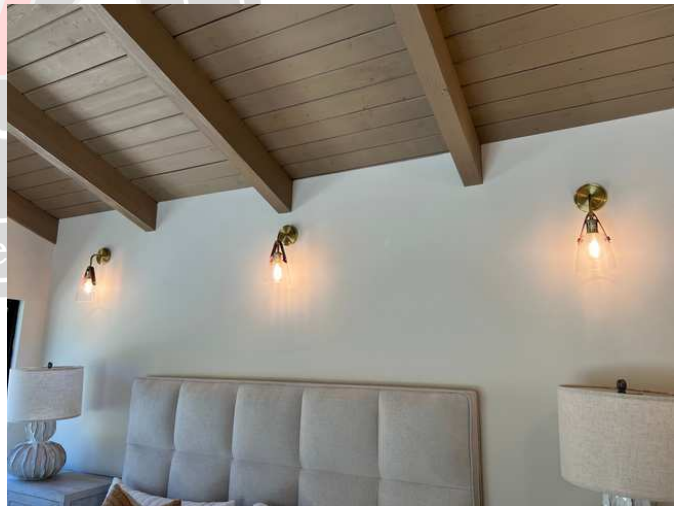
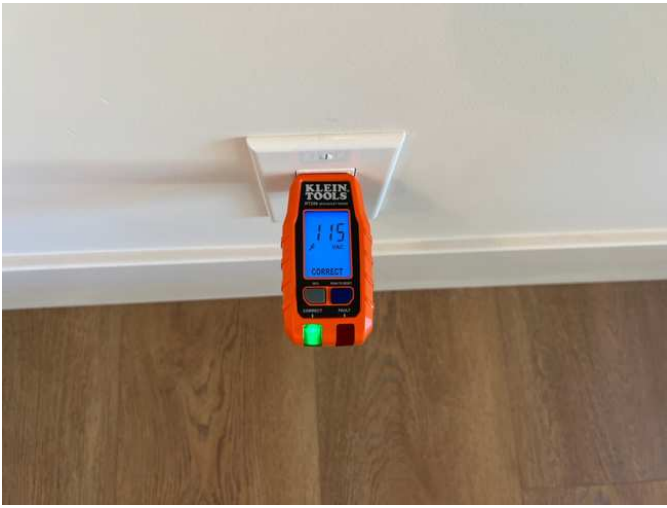
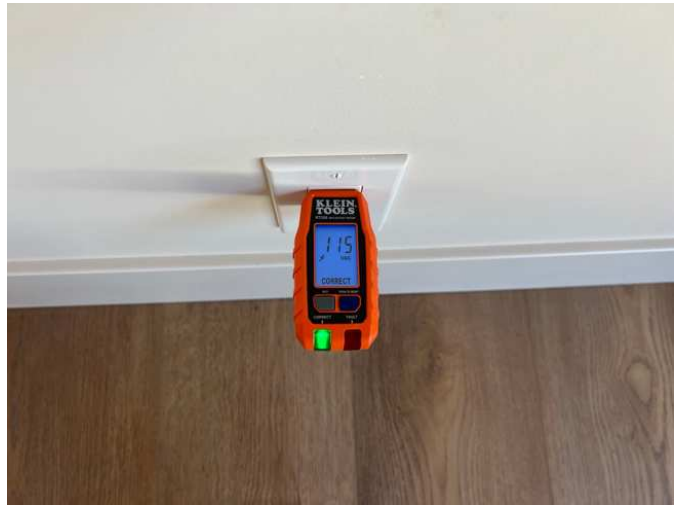
- ✓ **170:**  
Bedroom was satisfactory.

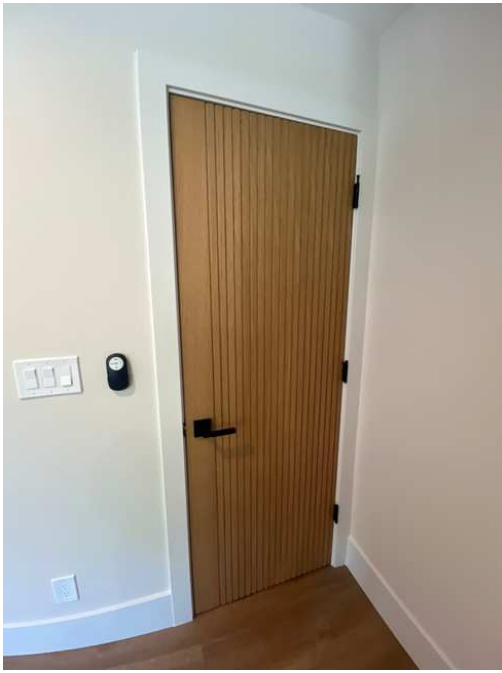
**171:**

The door was in satisfactory condition.

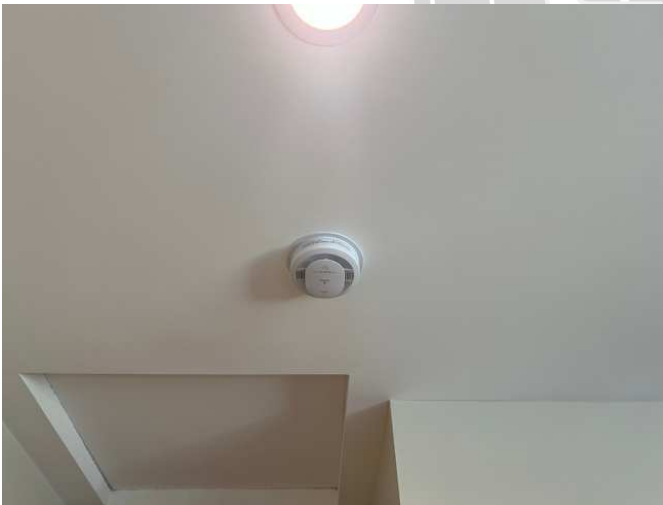
**172:**

Smoke detector present and functional.

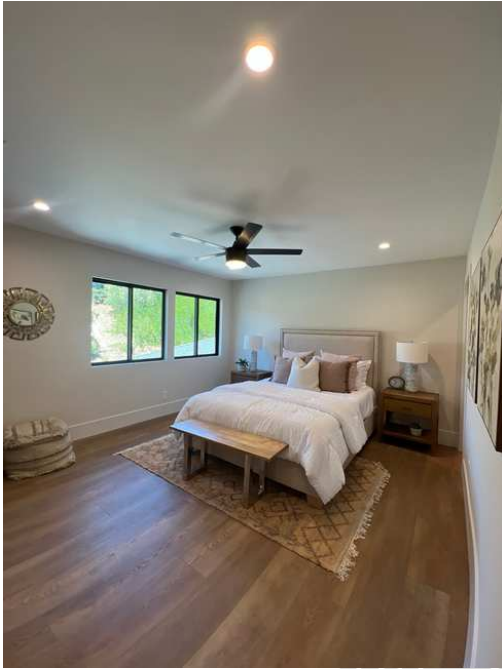
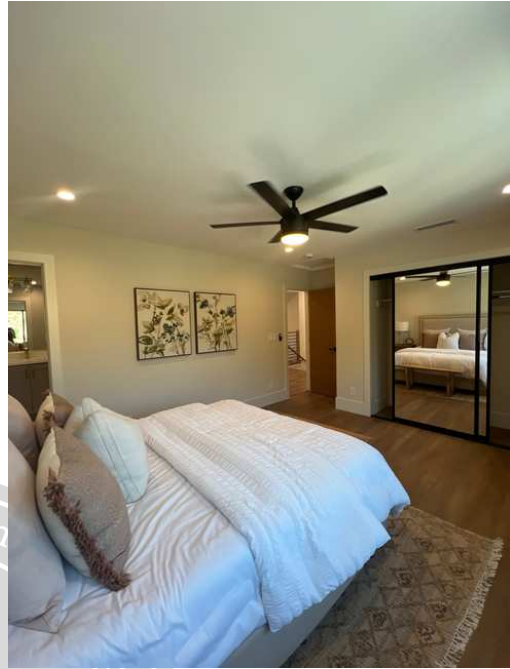
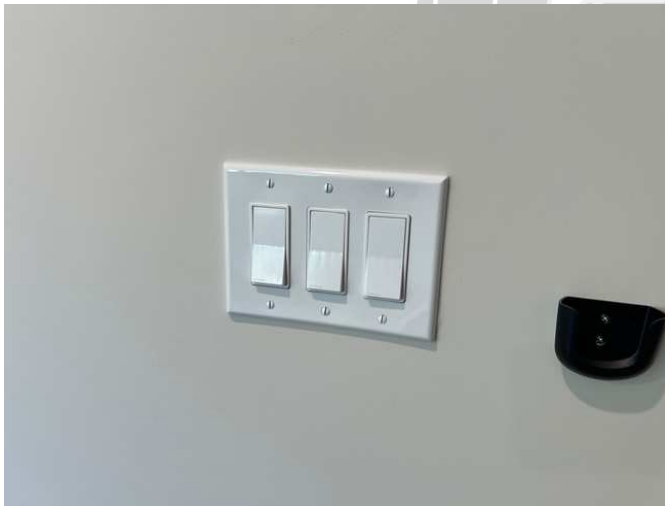
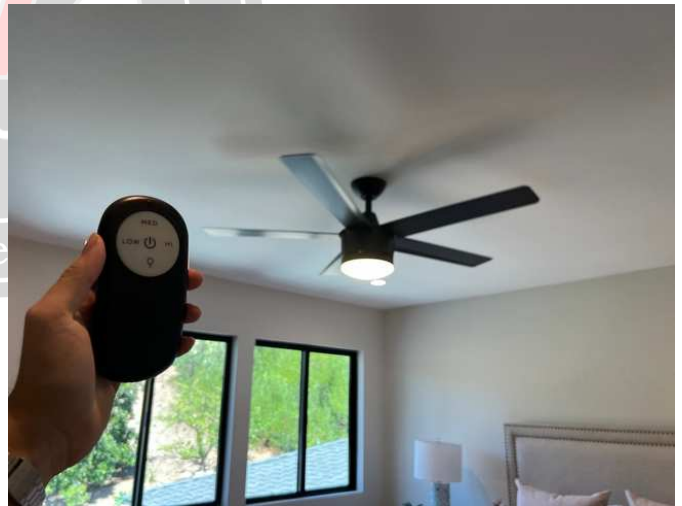
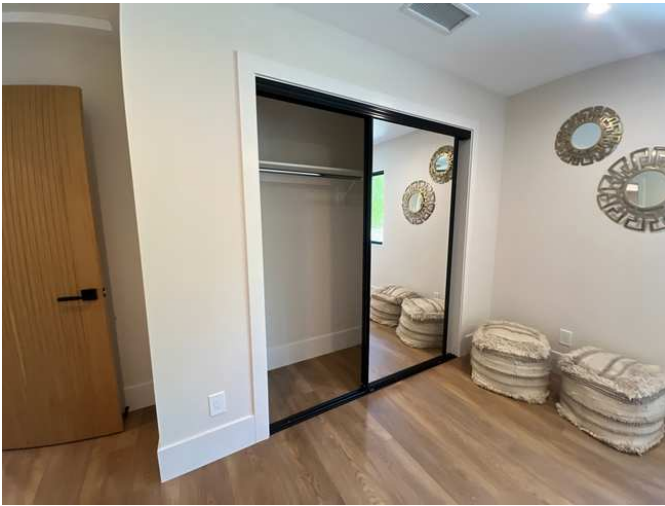
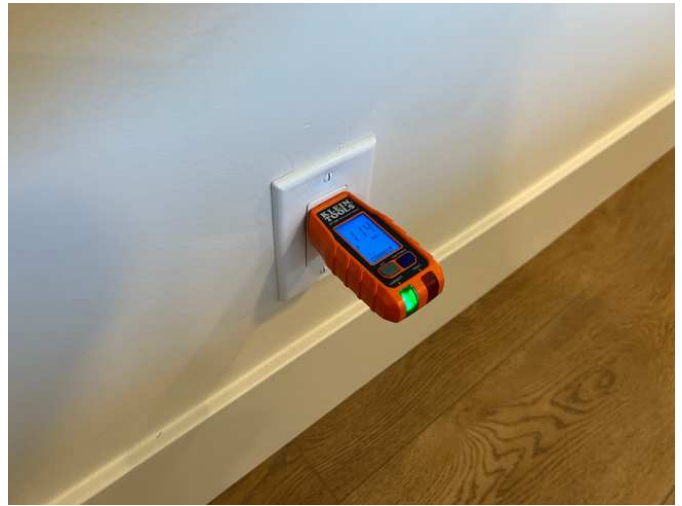
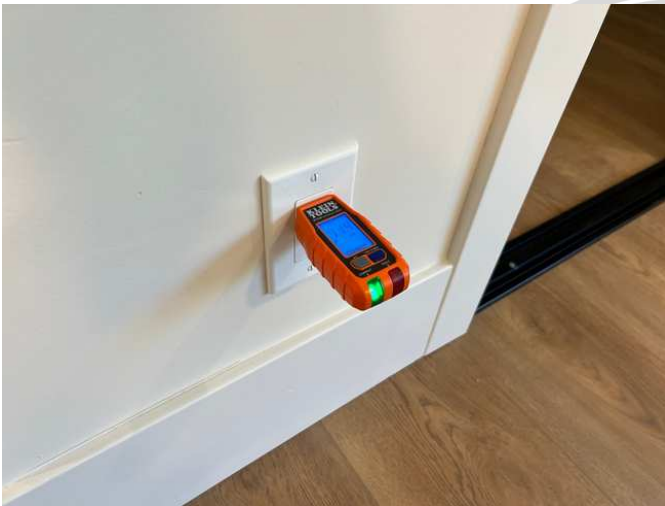
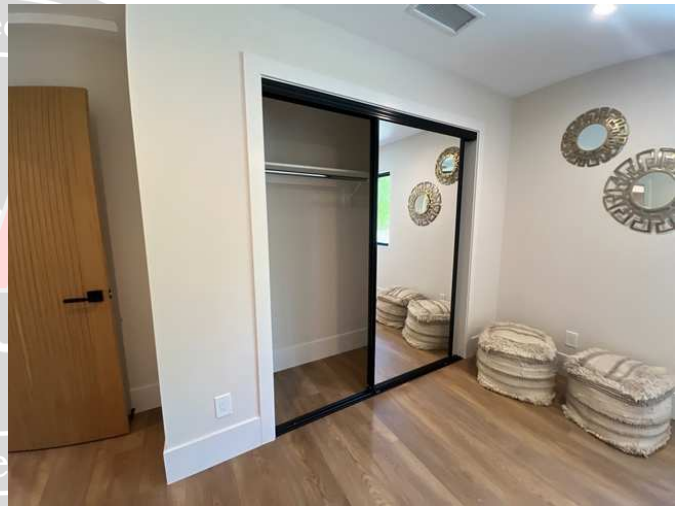
- ✓ **173:**  
Bedroom was satisfactory.

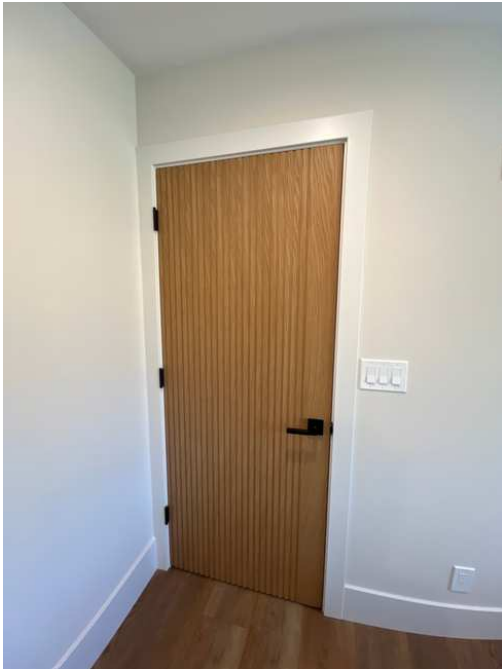
✓ **174:**

The door was in satisfactory condition.

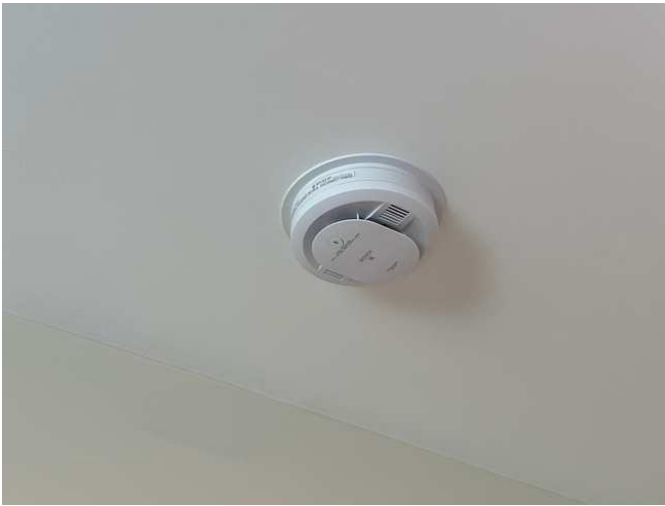
✓ **175:**

Smoke detector present and functional.

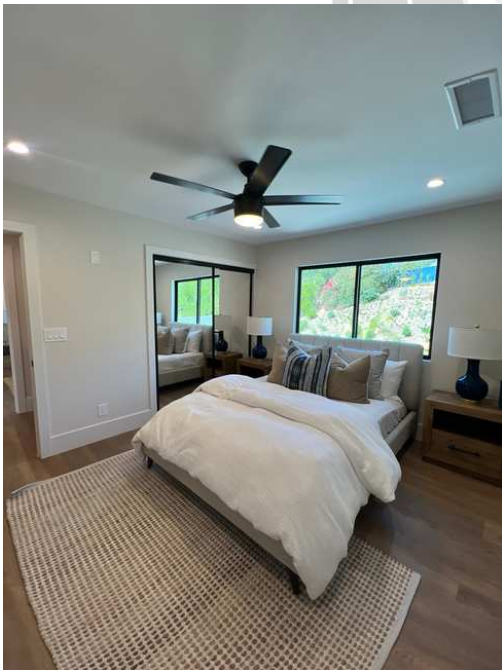
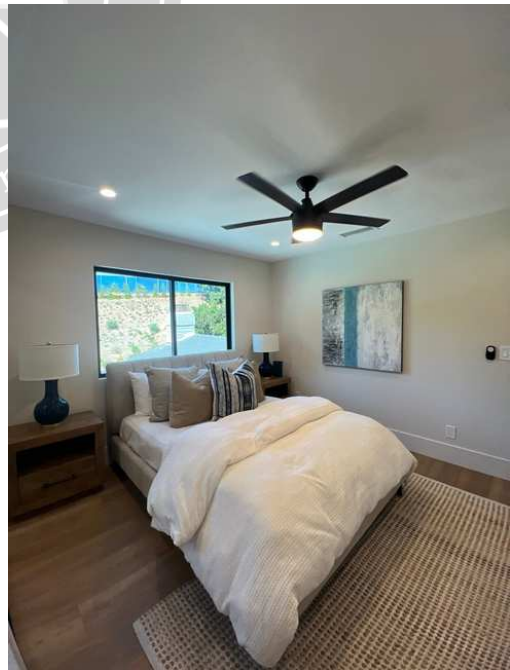
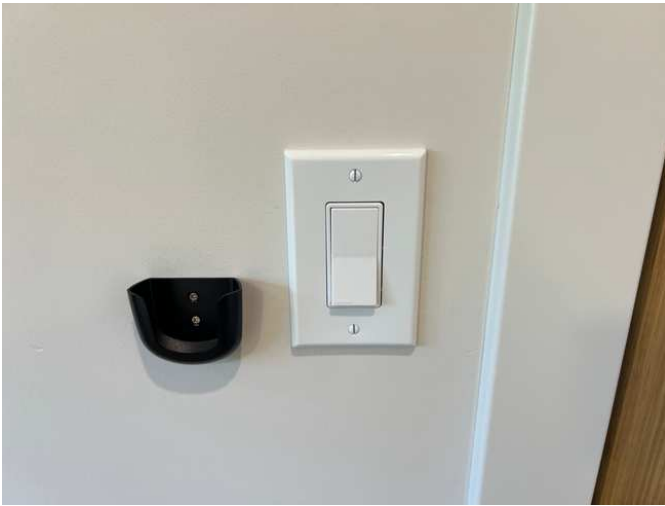
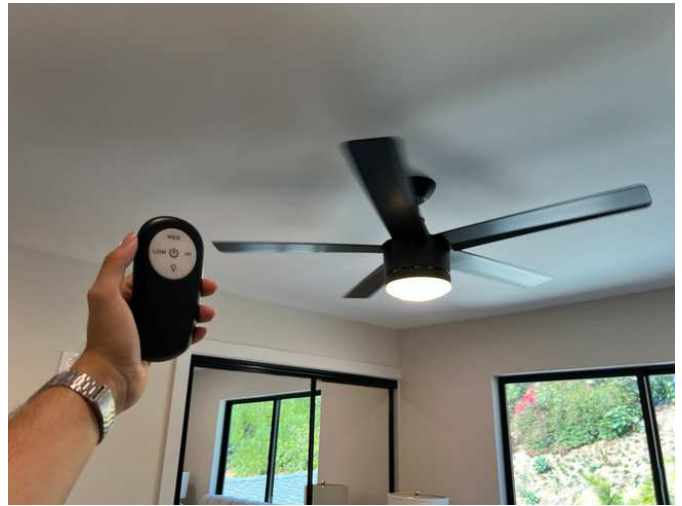
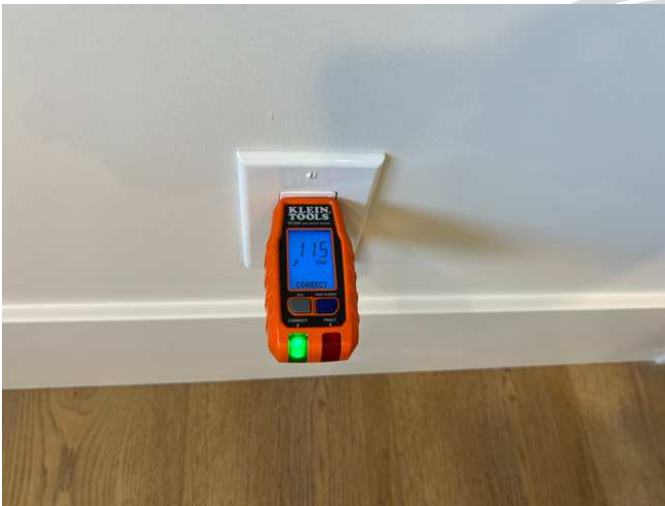
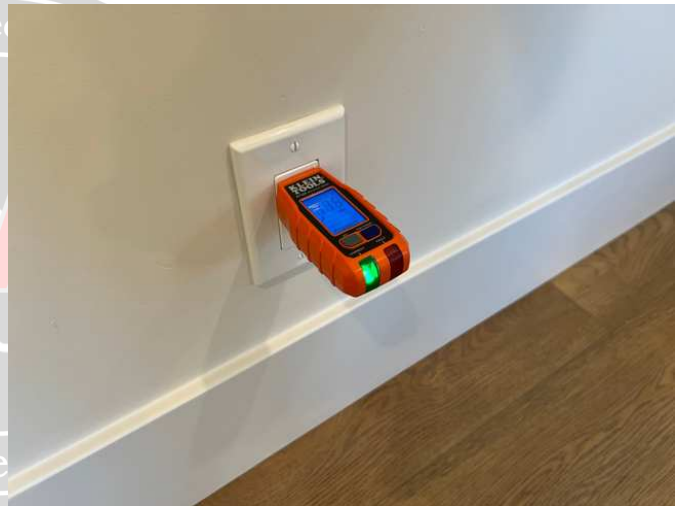
- ✓ **176:**  
Bedroom was satisfactory.

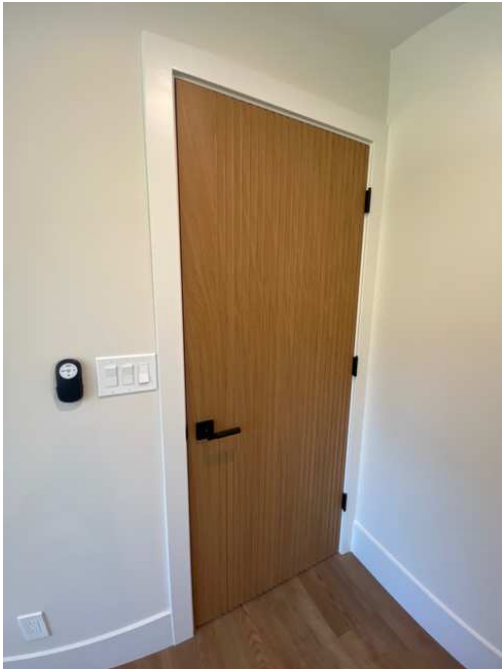
✓ **177:**

The door was in satisfactory condition.

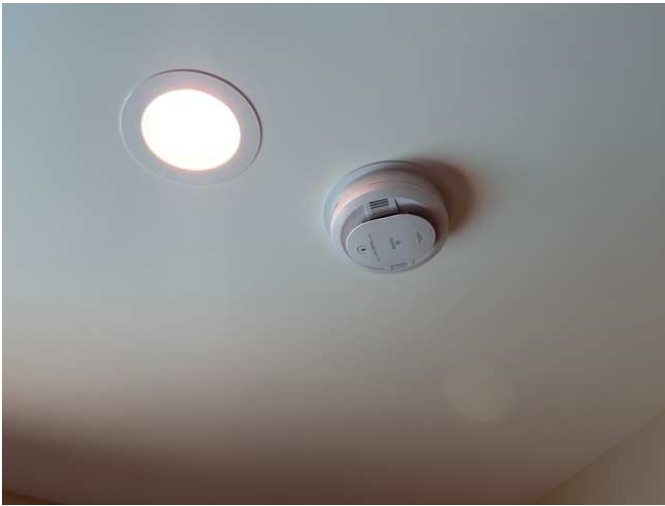
✓ **178:**

Smoke detector present and functional.
