# HOME INSPECTION REPORT

PROFESSIONAL PROPERTY EVALUATION

INSPECTION DATE

Tuesday, July 7, 2026

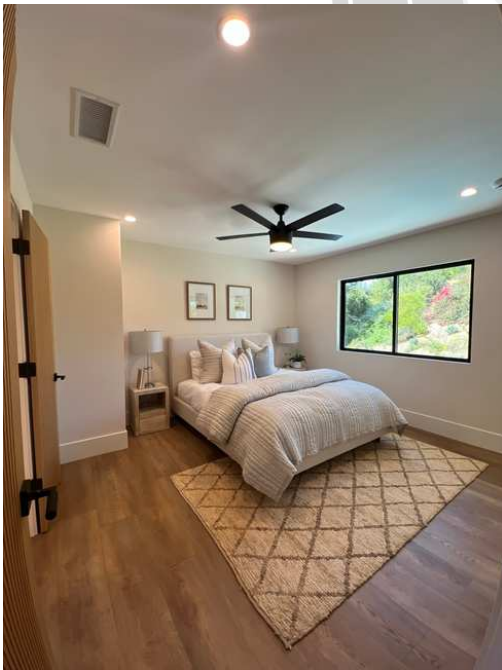
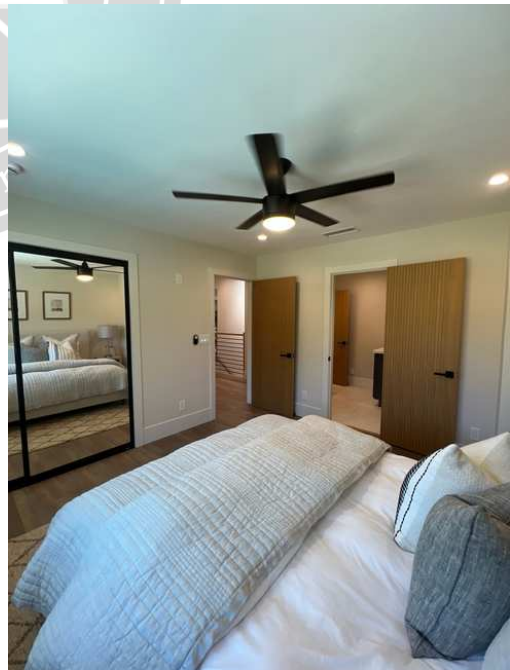
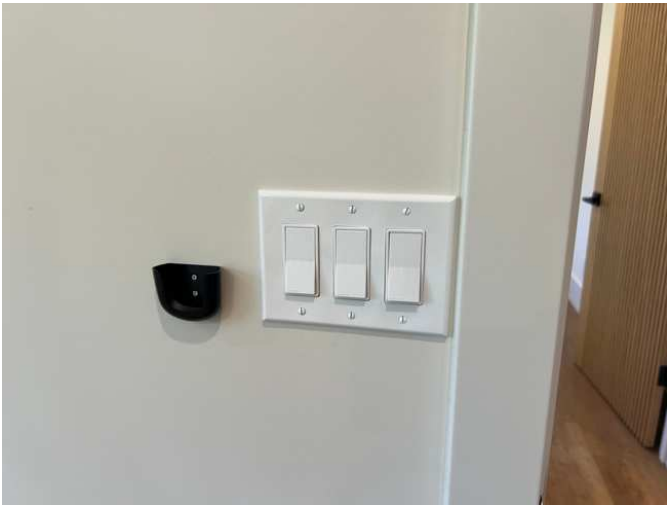
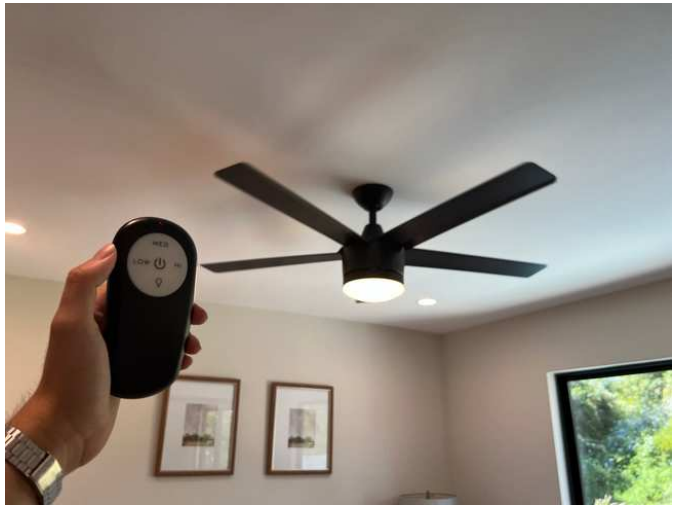
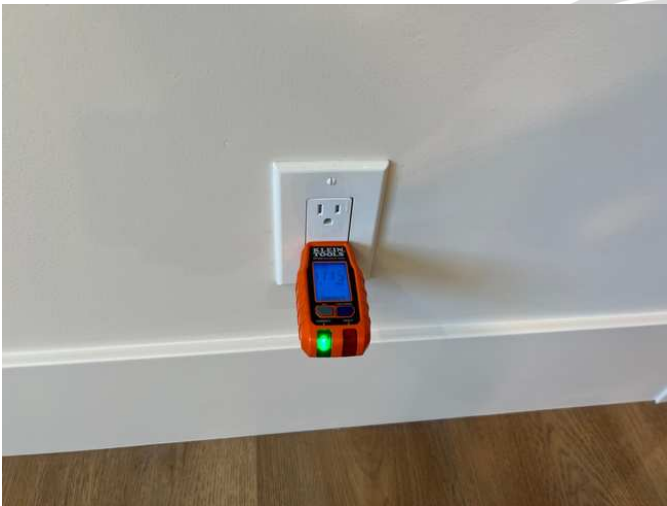
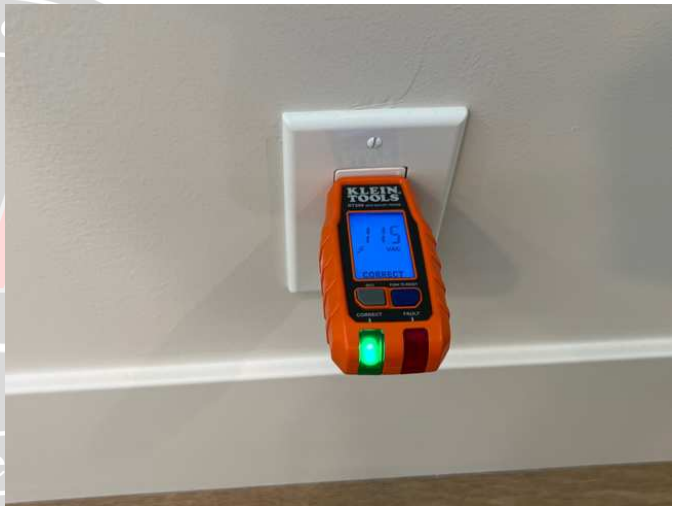
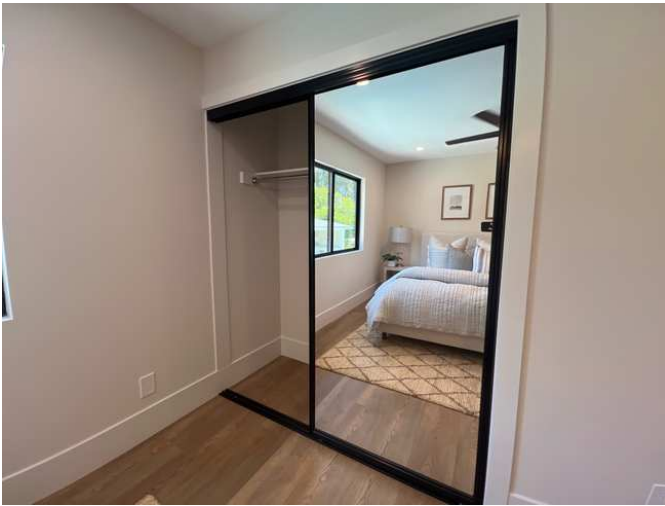
- ✓ **179:**  
Bedroom was satisfactory.

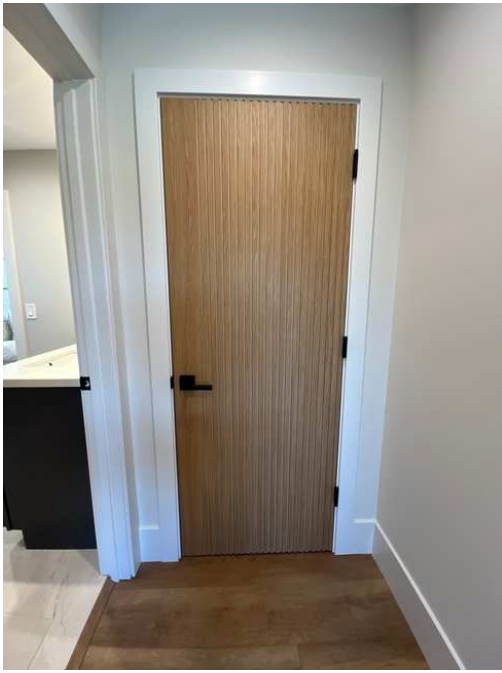
**180:**

The door was in satisfactory condition.

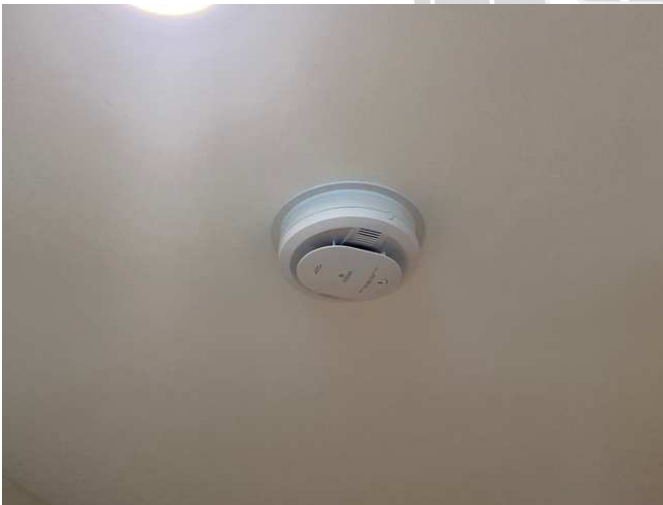
- ✓ **181:**  
Smoke detector present and functional.

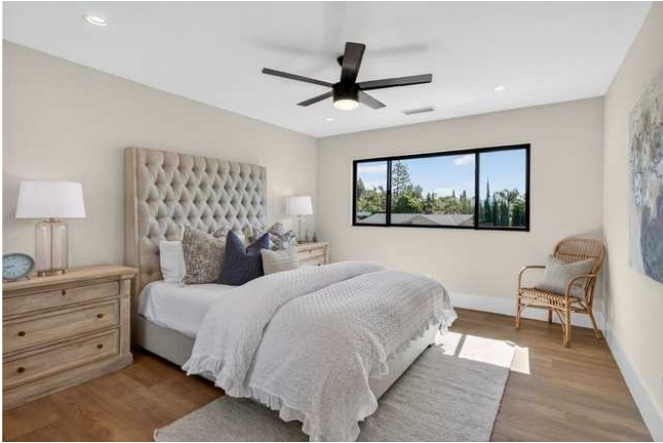
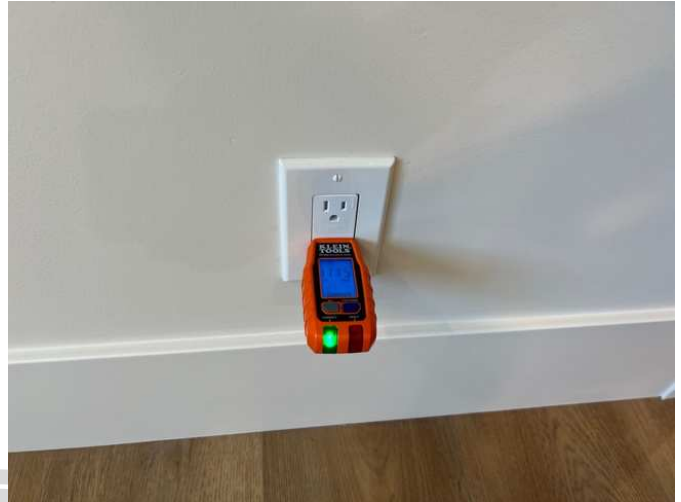
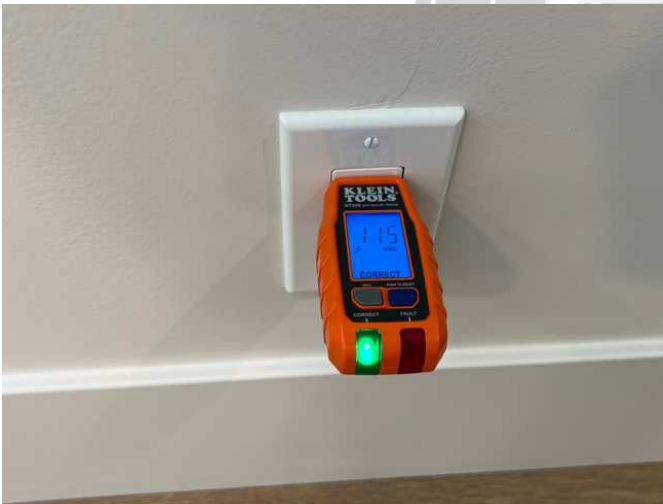
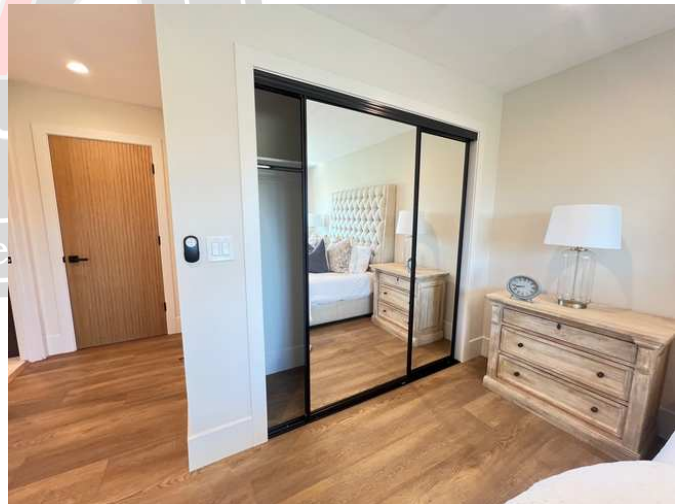
- ✓ **182:**  
Bedroom was satisfactory.

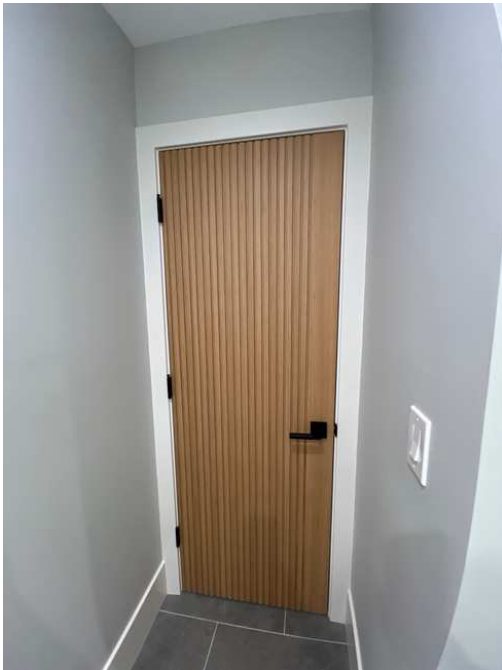
- ✓ **183:**  
The door was in satisfactory condition.

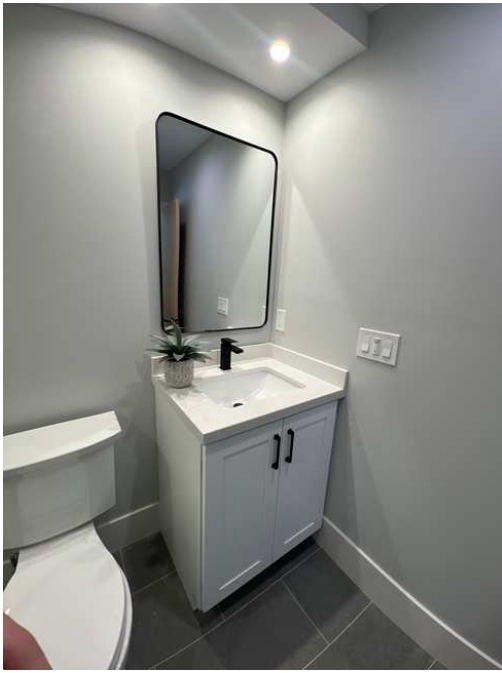
- ✓ **184:**  
The floor, walls and ceiling were in satisfactory condition. There were no significant deficiencies noted.

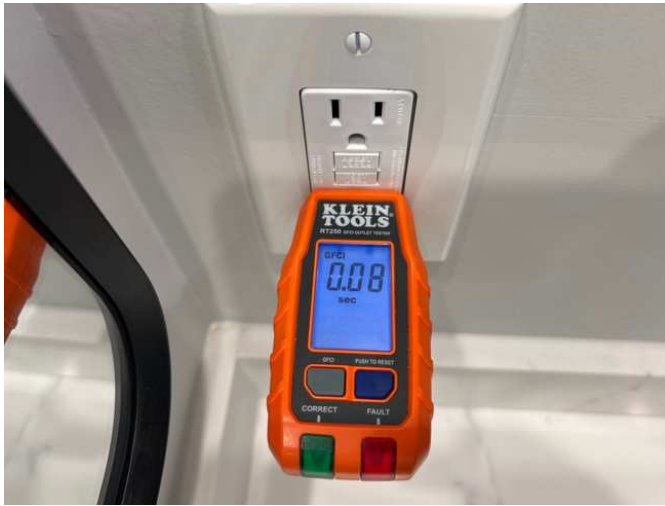
- ✓ **185:** GFCI receptacle was present and functional.

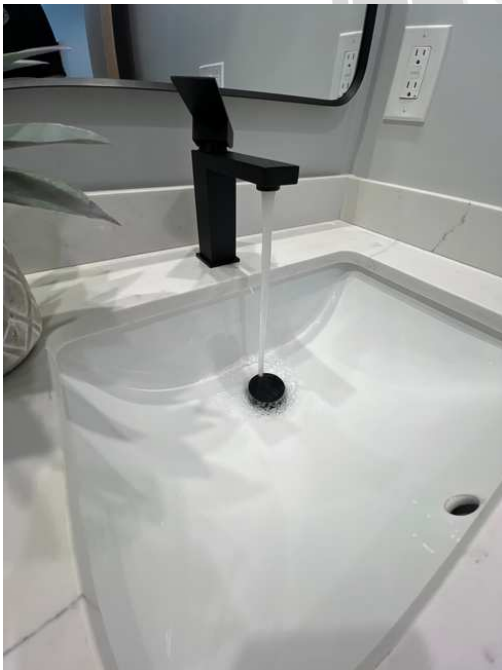
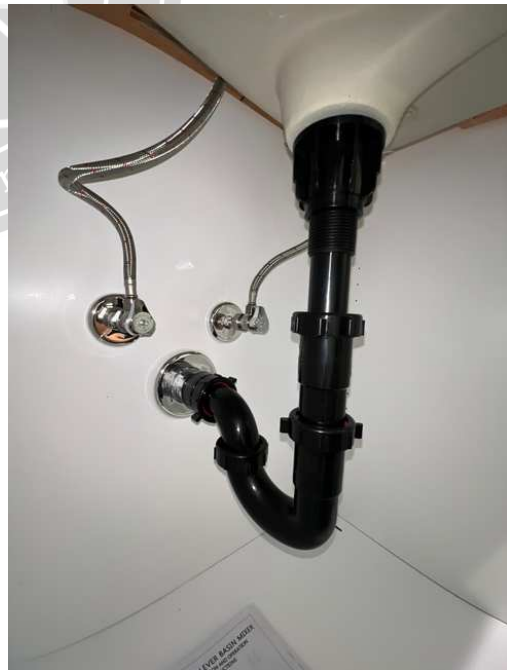
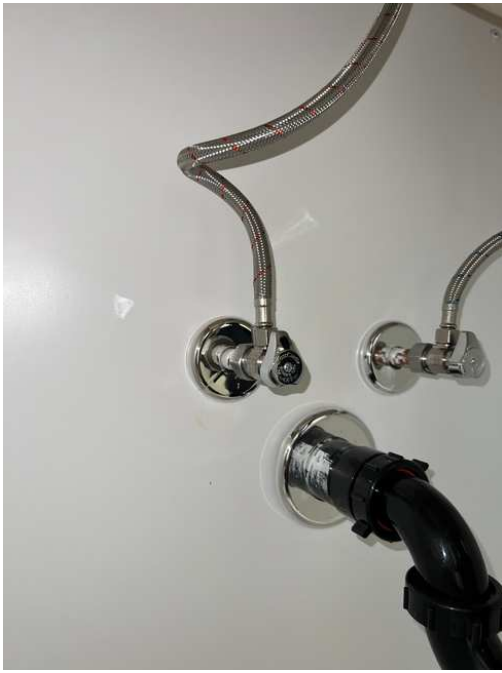
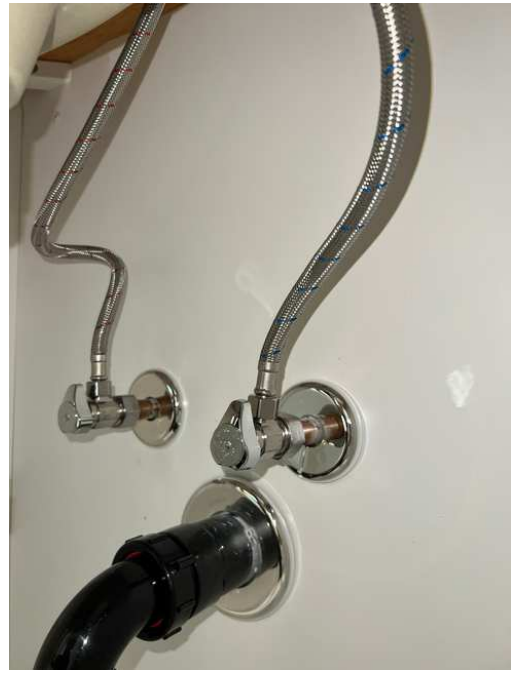
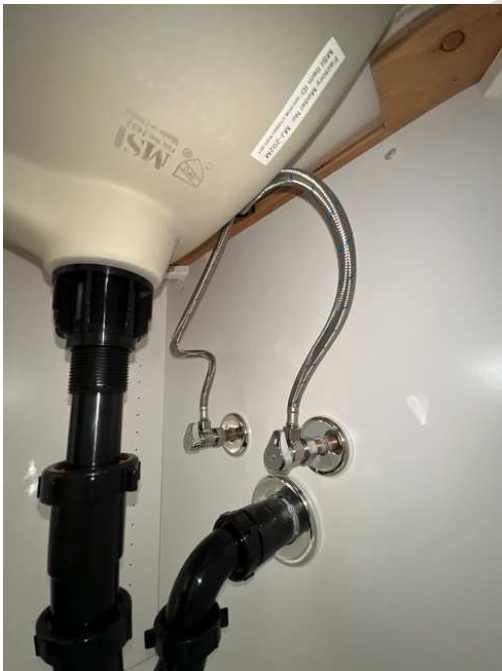
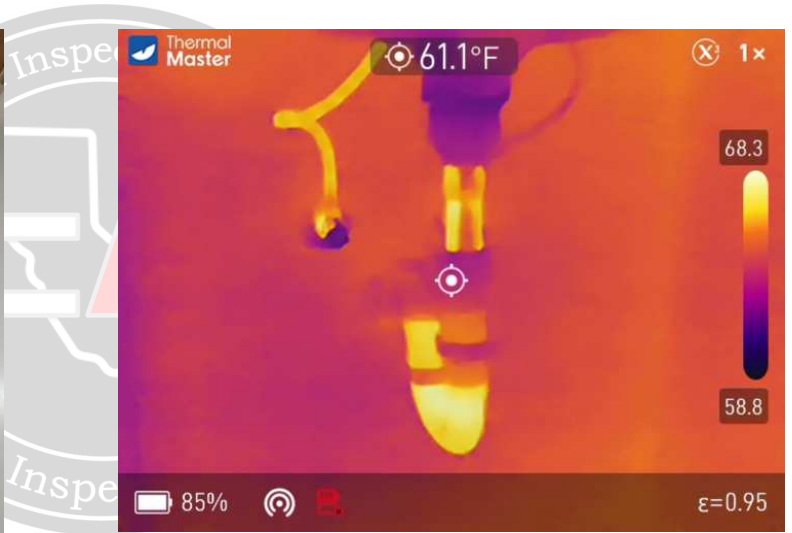
**186:**

Sink and faucet were functional. Hot and cold water were present. And the drain was free flowing.

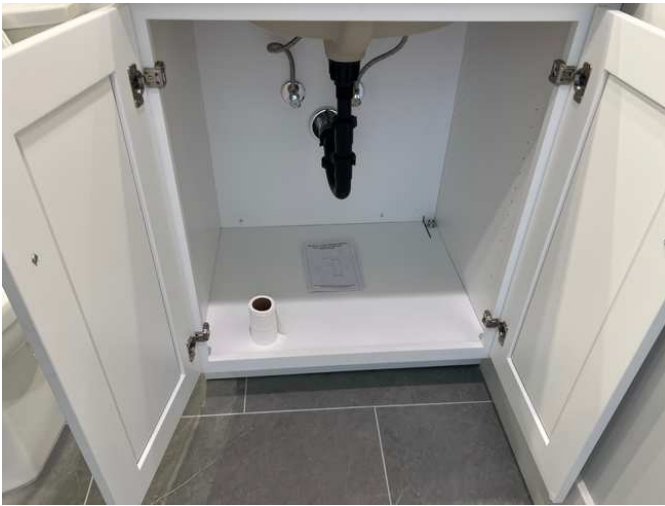
- ✓ **187:** Bathroom cabinets are in new condition.

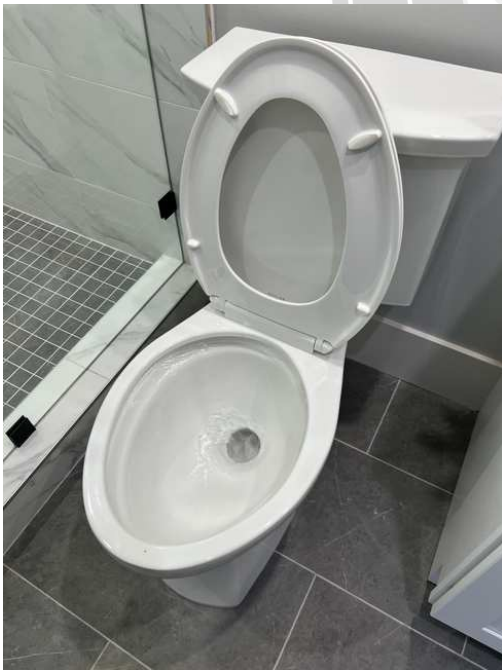
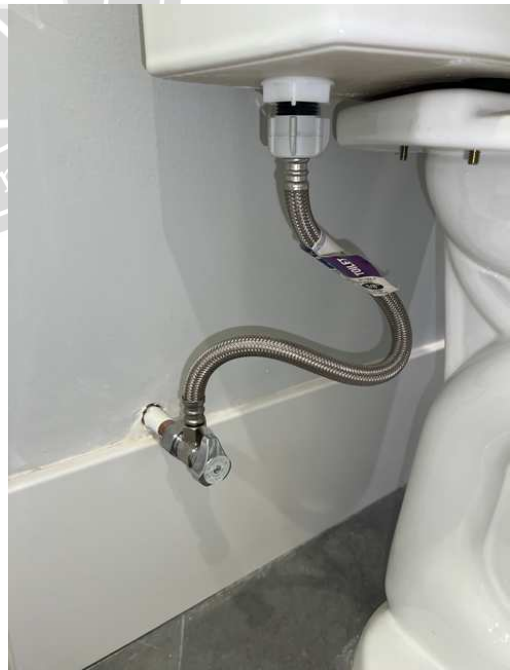
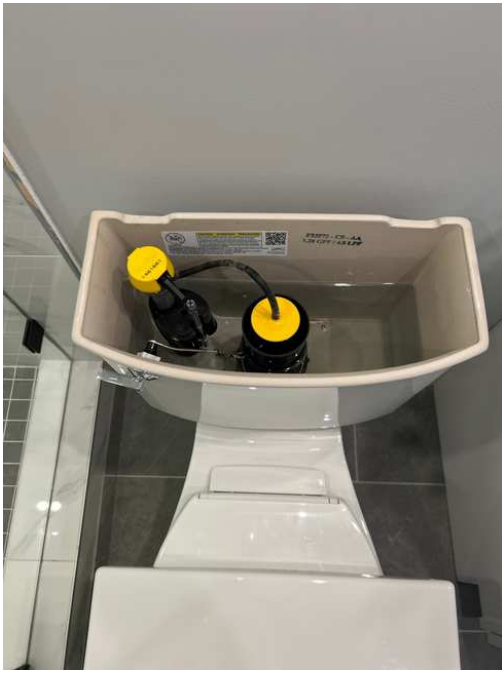
**188:**

The toilet was functional and in satisfactory condition.

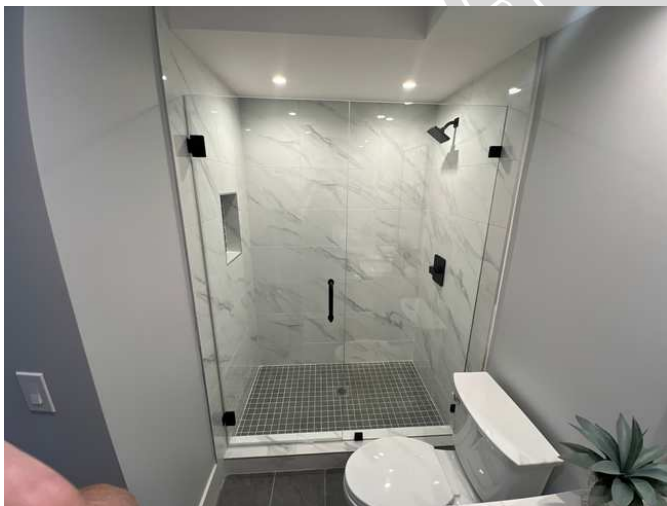
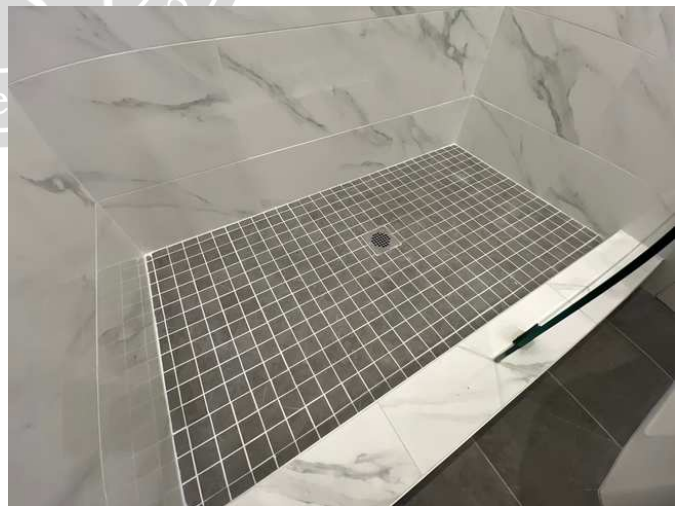
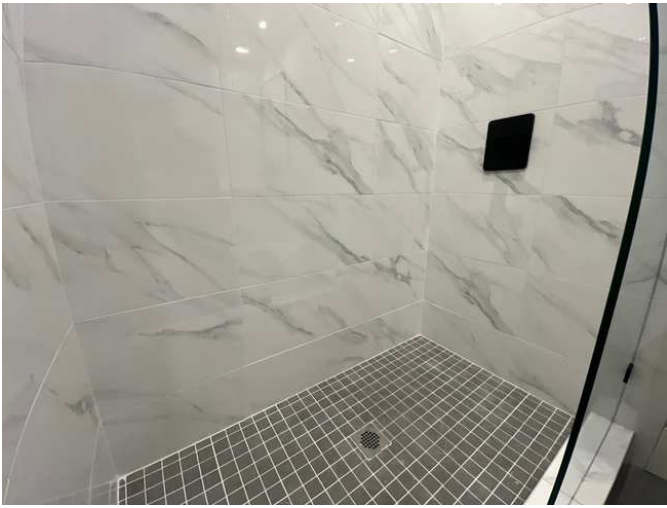
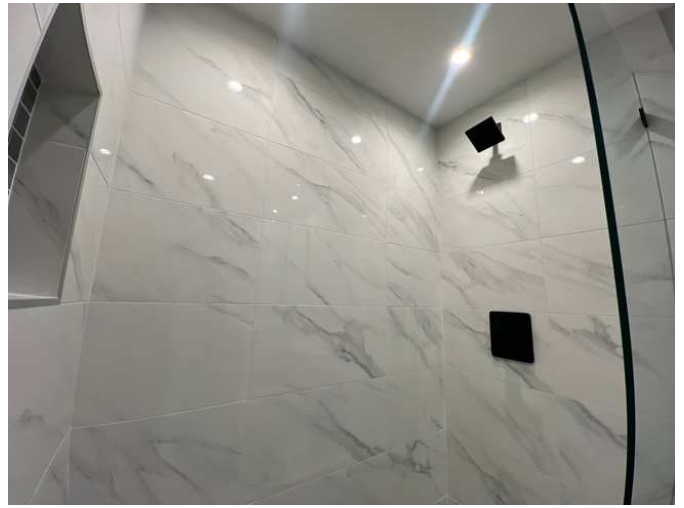
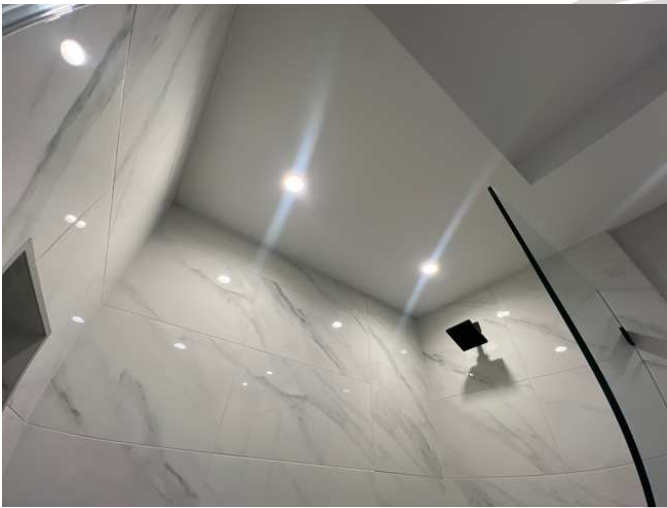
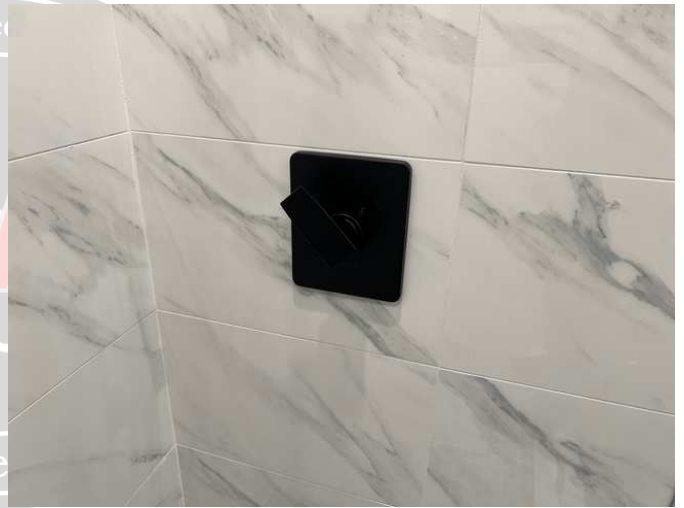
**189:**

The shower was in new condition. Hot and cold running water was present. The drain was free flowing.

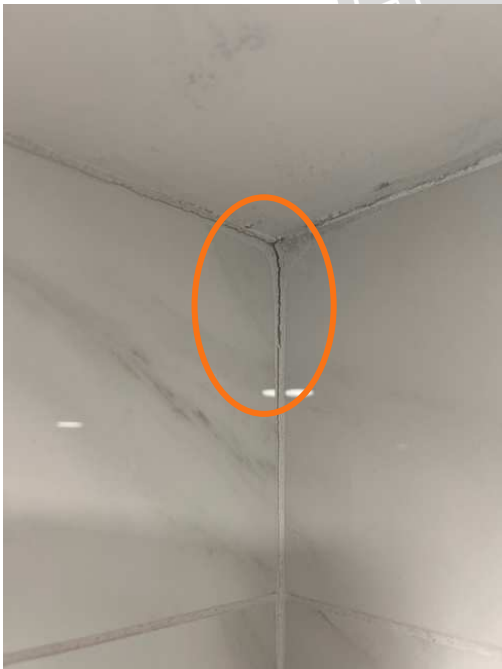
**R190: Deficient Tile Grout**

Deficient and or missing tile grout was noted. This condition can lead to water infiltration and concealed mold. Repairs needed.

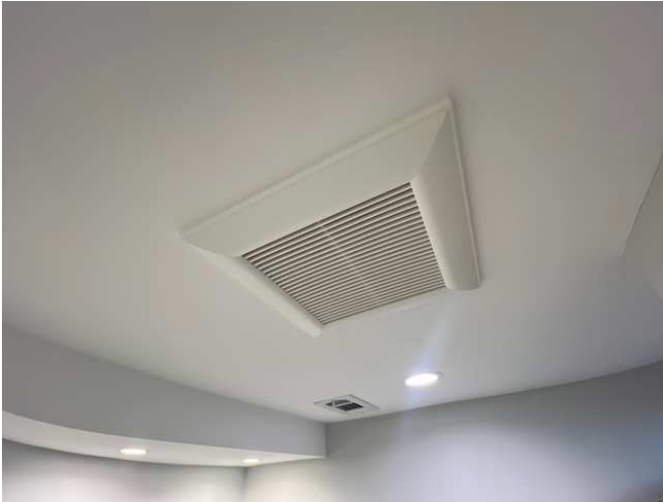
- ✓ **191:**  
The bathroom ventilator was tested and found to be functional on the day of inspection.

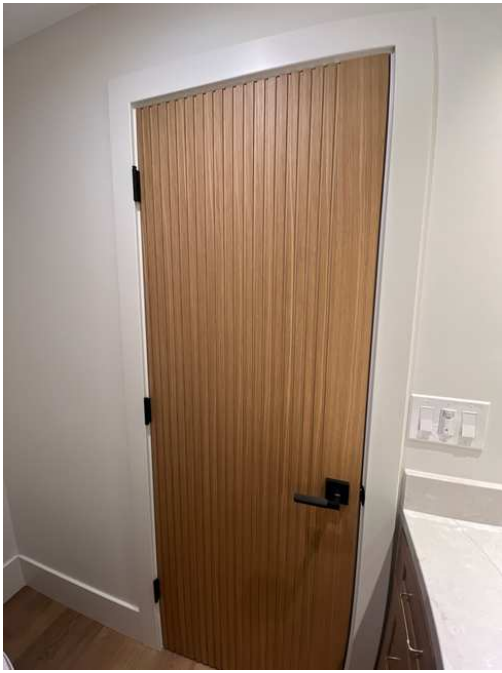
- ✓ **192:**  
The door was in satisfactory condition.

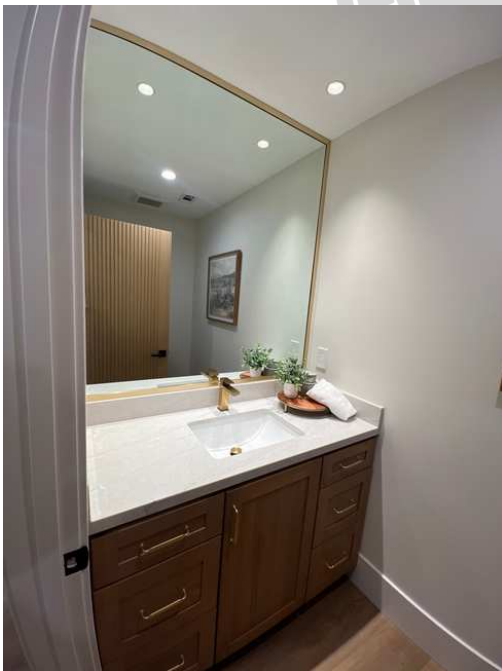
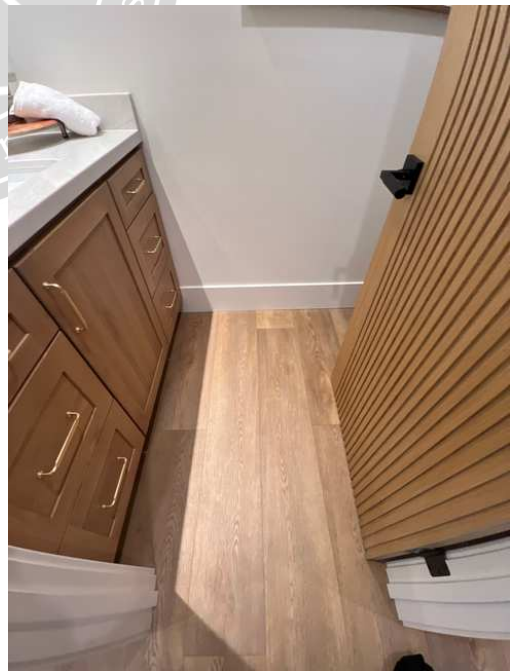
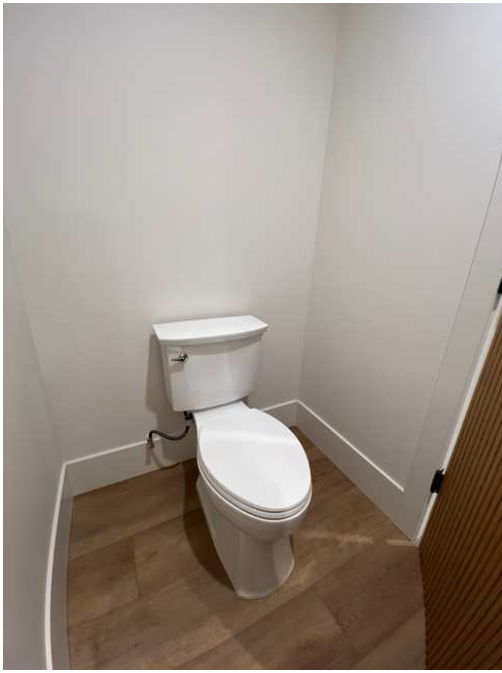
**193:**

The floor, walls and ceiling were in satisfactory condition. There were no significant deficiencies noted.

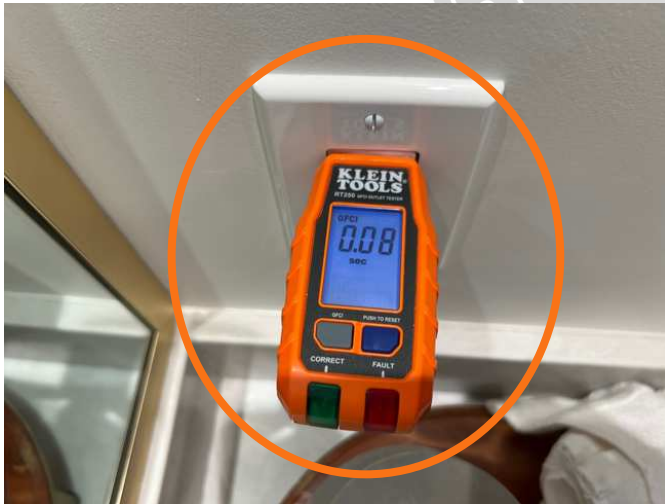
✓ **194: GFCI Satisfactory**

GFCI receptacle was present and functional.

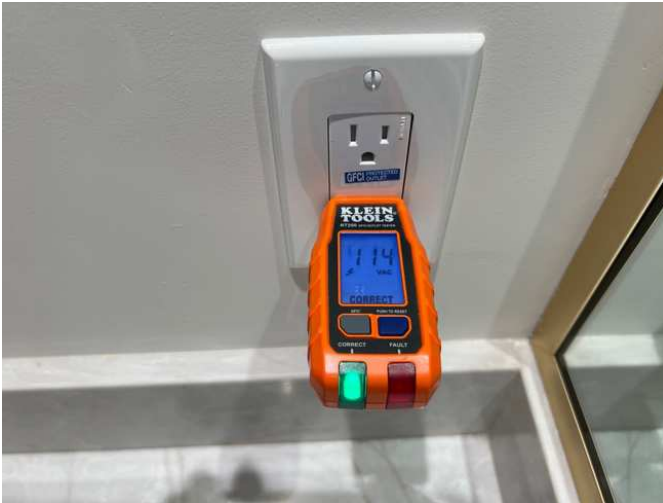
✓ **195: GFCI Protected**

Bathroom receptacle was GFCI protected from another location.

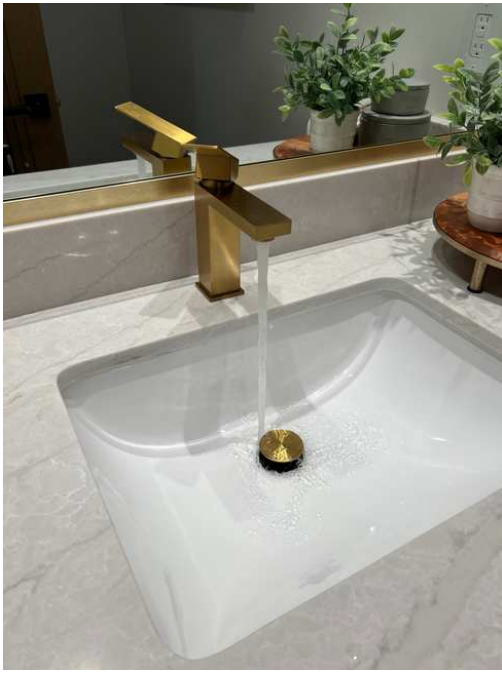
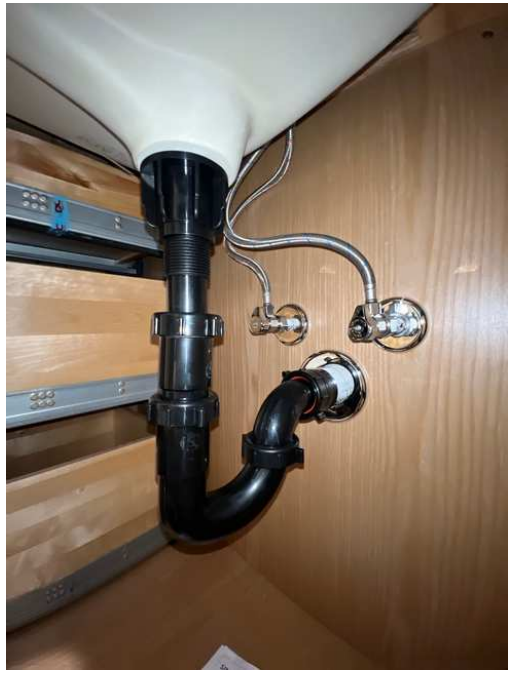
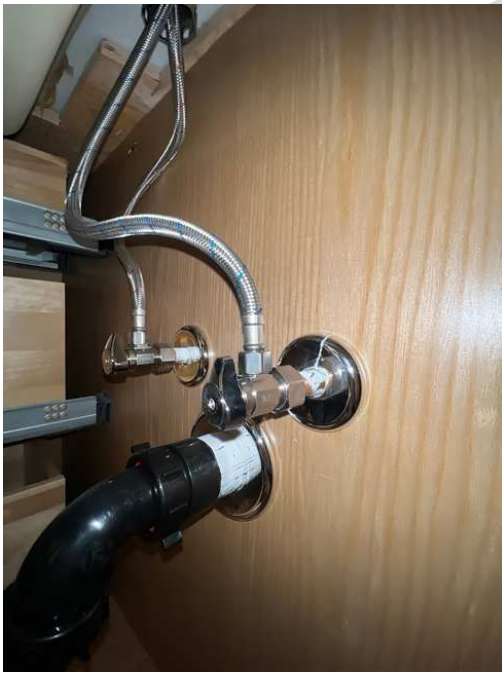
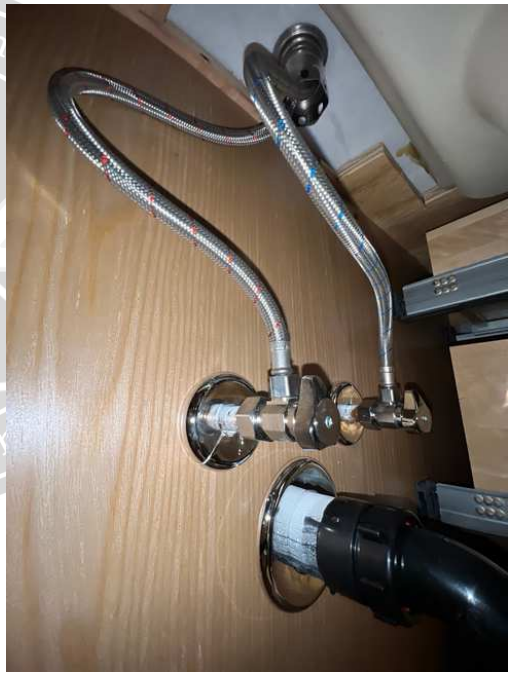
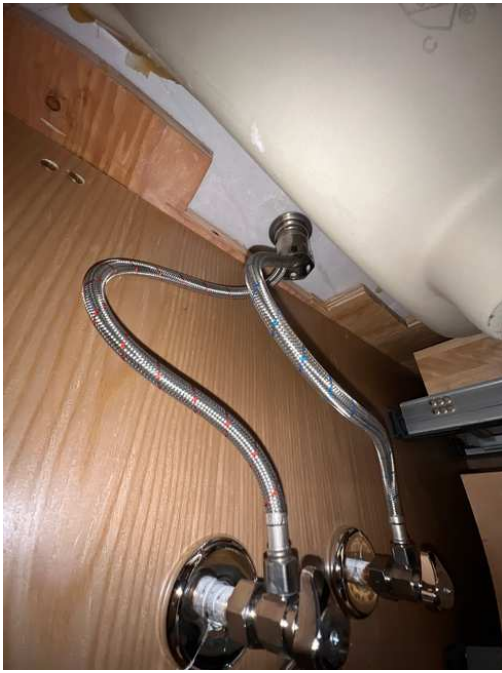
✓ **196:**

Sink and faucet were functional. Hot and cold water were present. And the drain was free flowing.

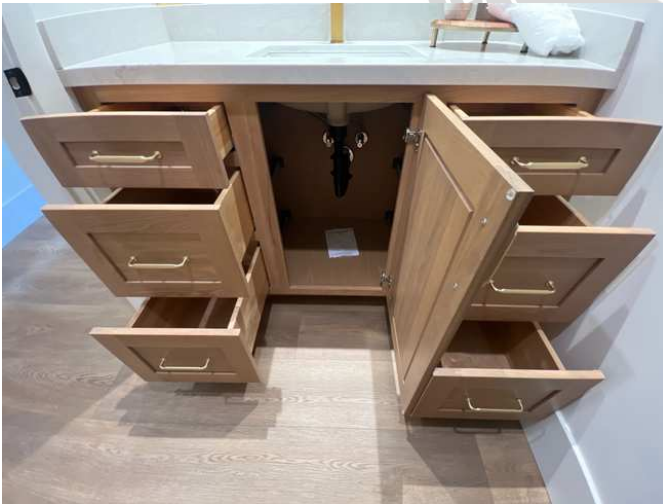
- ✓ **197:**  
Bathroom cabinets are in new condition.

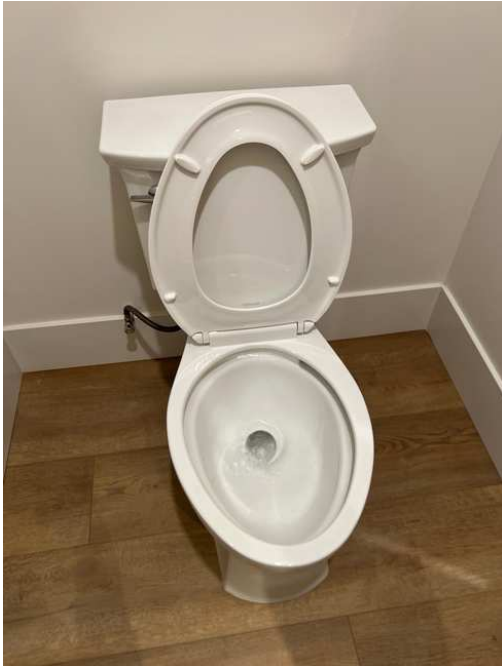
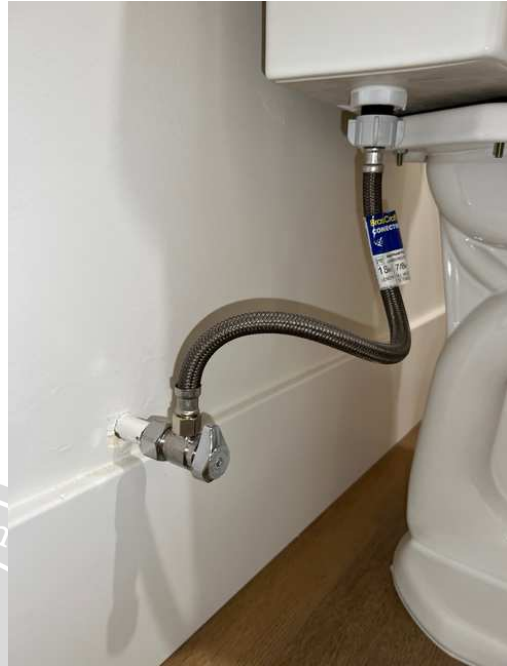
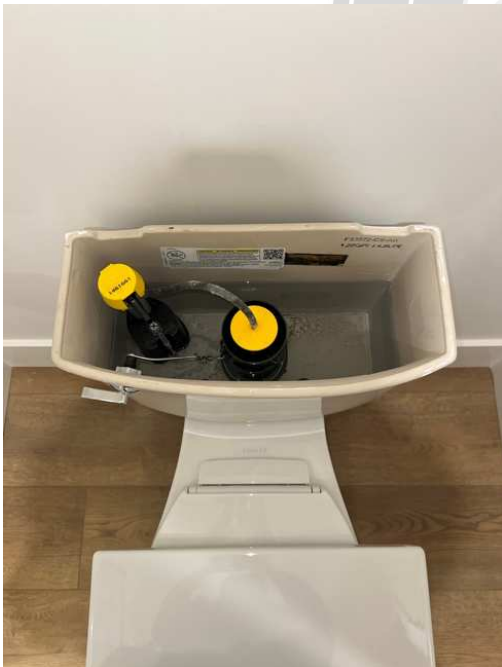
**198:**

The toilet was functional and in satisfactory condition.

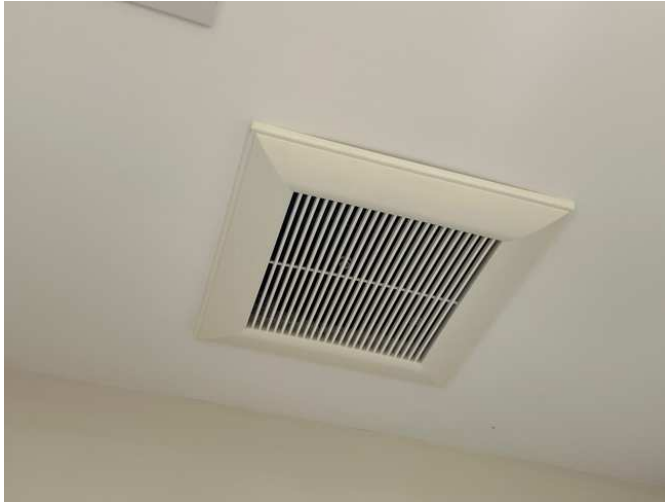
The bathroom ventilator was noisy. This may be an indication that the fan motor and blade housing needs cleaning and or replacement.

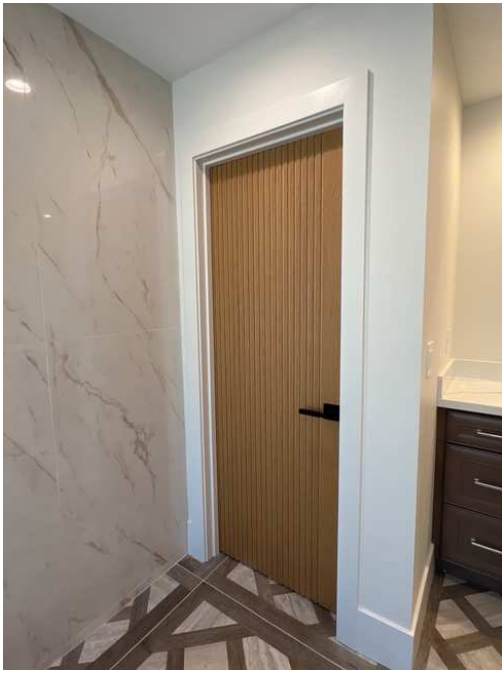
**200:**

The door was in satisfactory condition.

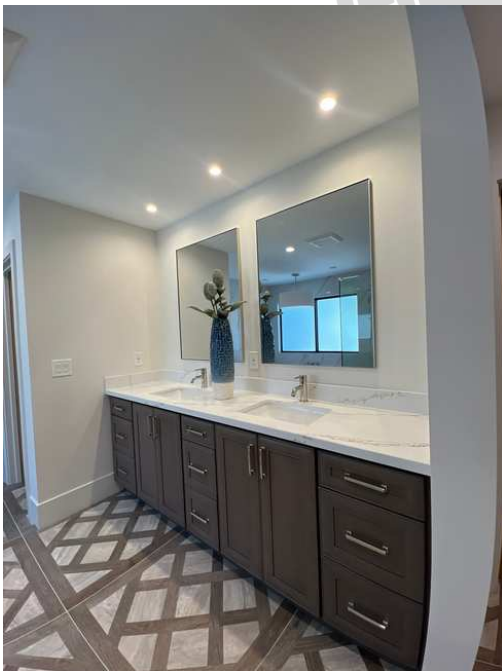
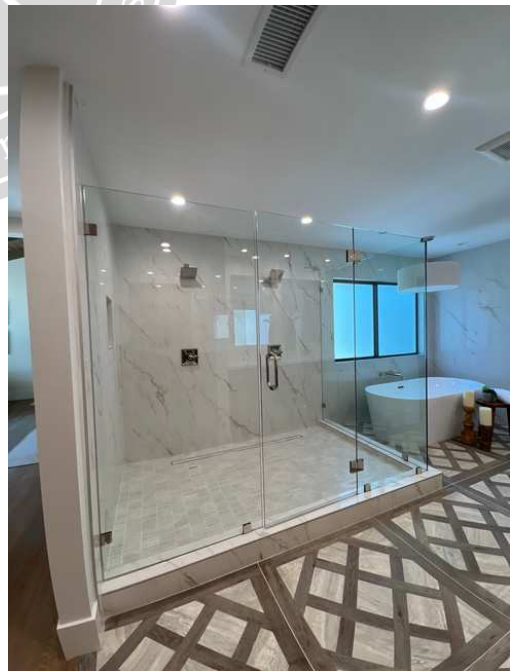
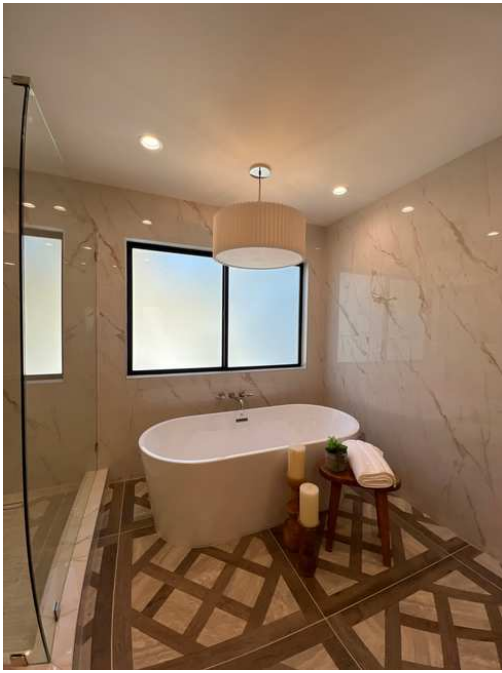
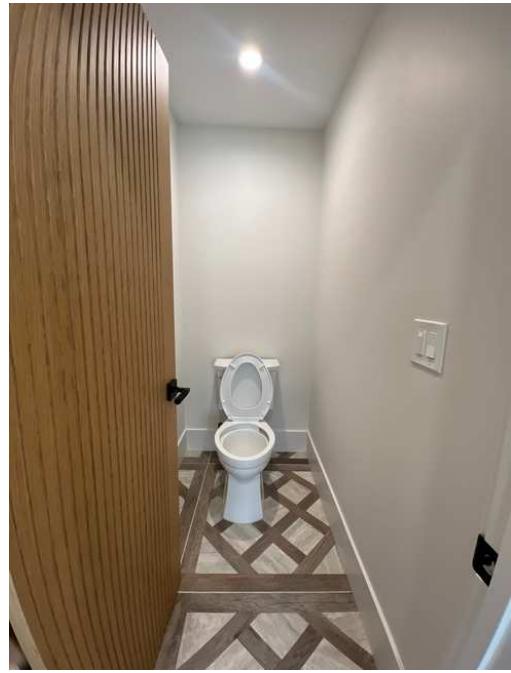
**201:**

The floor, walls and ceiling were in satisfactory condition. There were no significant deficiencies noted.

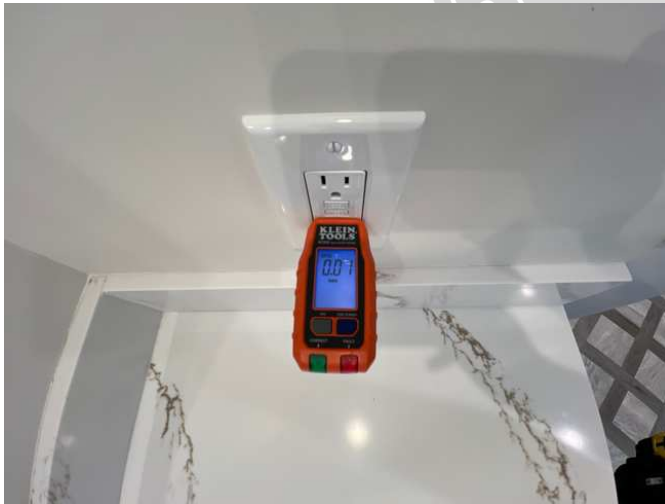
✓ **202: GFCI Satisfactory**

GFCI receptacle was present and functional.

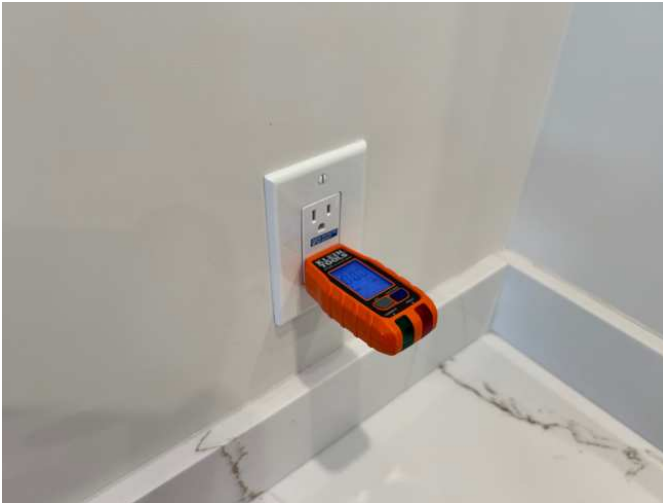
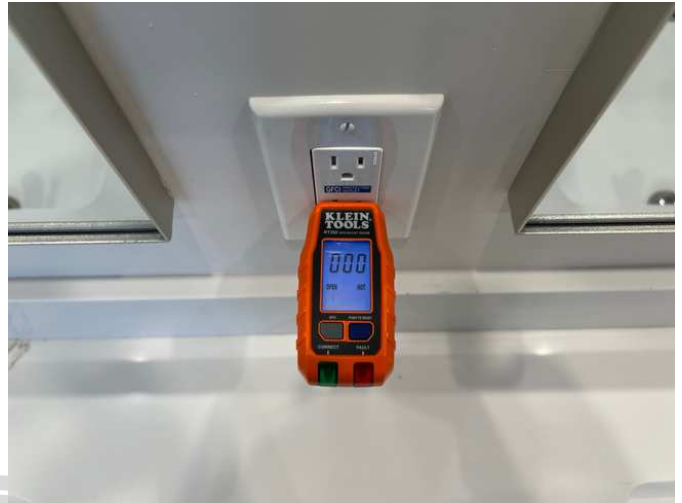
✓ **203: GFCI Protected**

Bathroom receptacle was GFCI protected from another location.

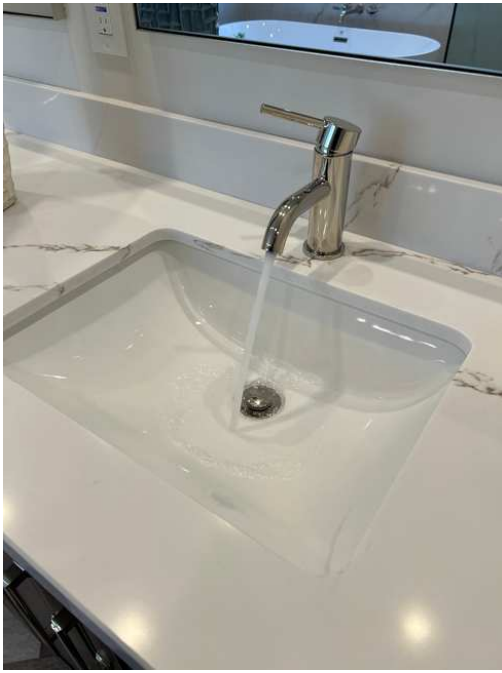
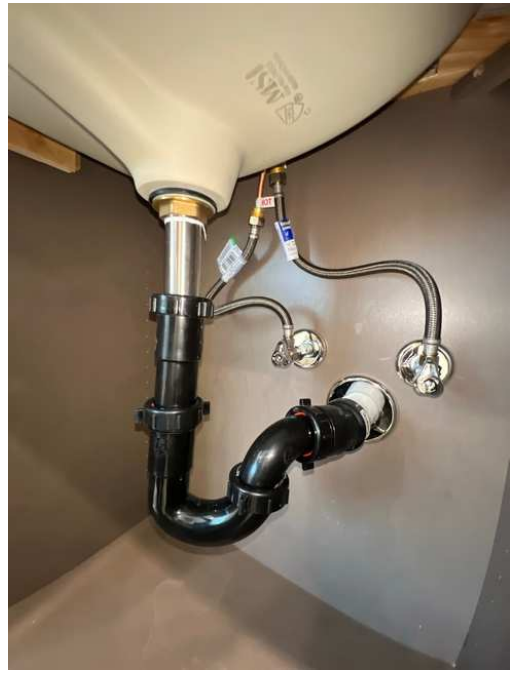
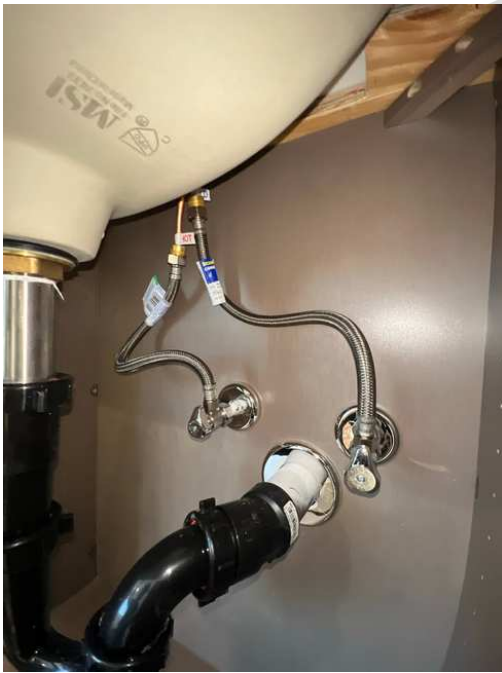
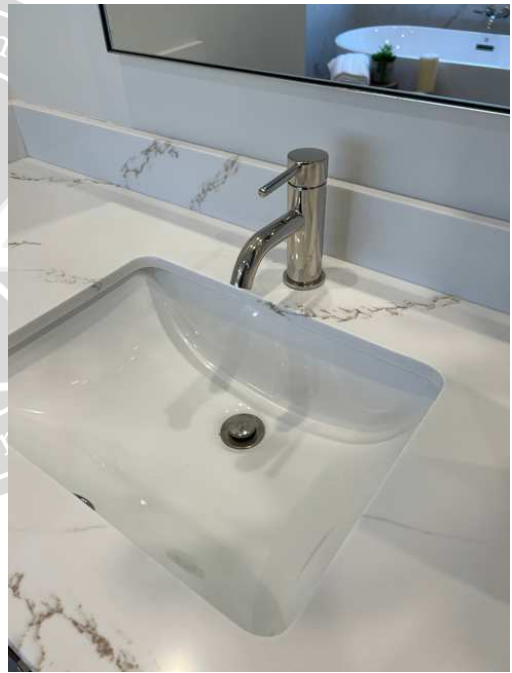
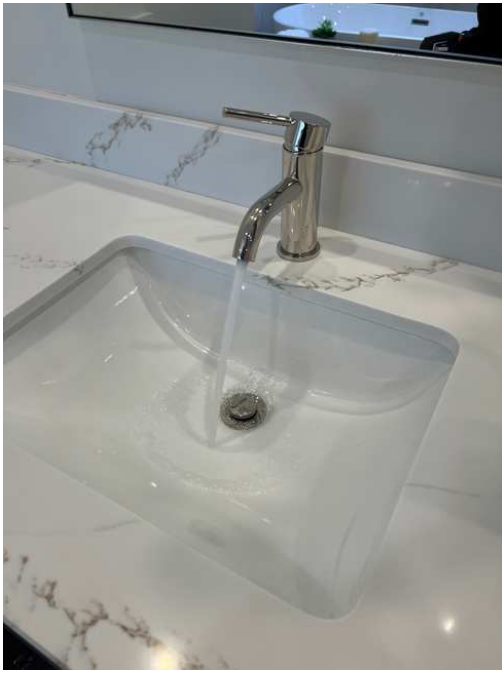
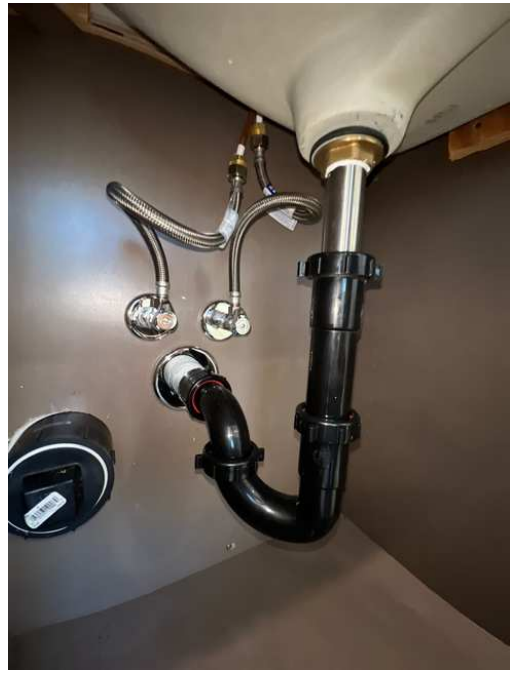
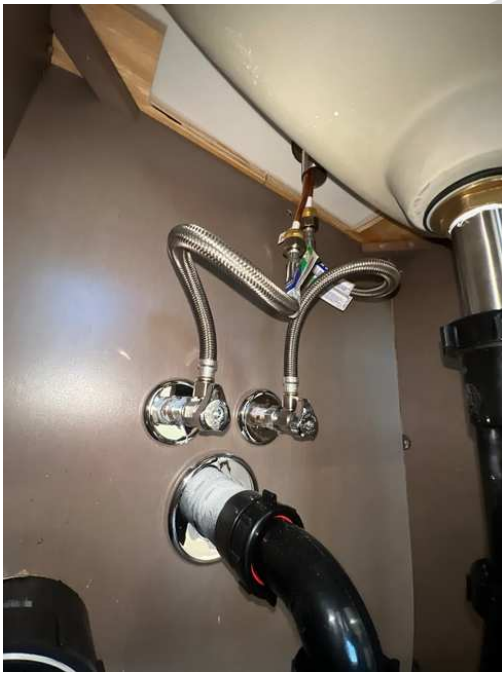
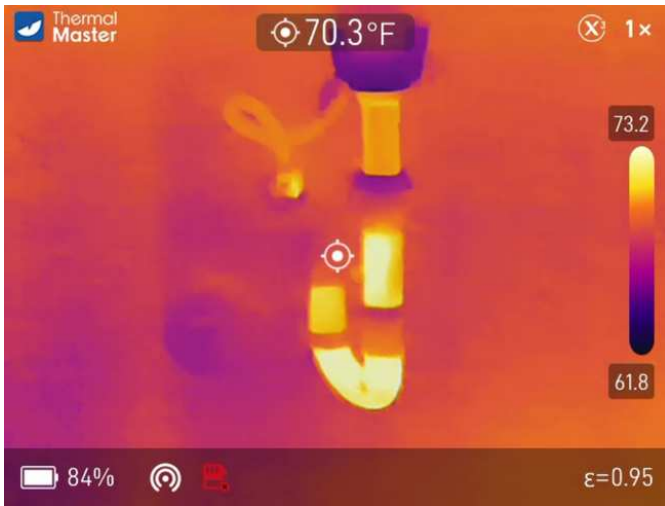
✓ **204:**

Sink and faucet were functional. Hot and cold water were present. And the drain was free flowing.
