# HOME INSPECTION REPORT

PROFESSIONAL PROPERTY EVALUATION

INSPECTION DATE

Tuesday, July 7, 2026

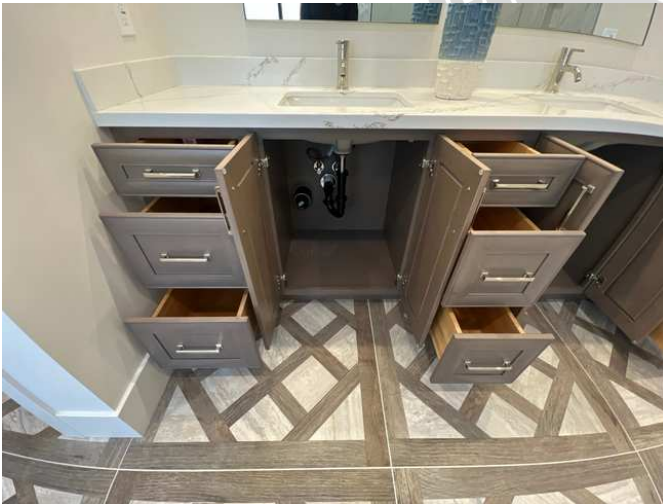
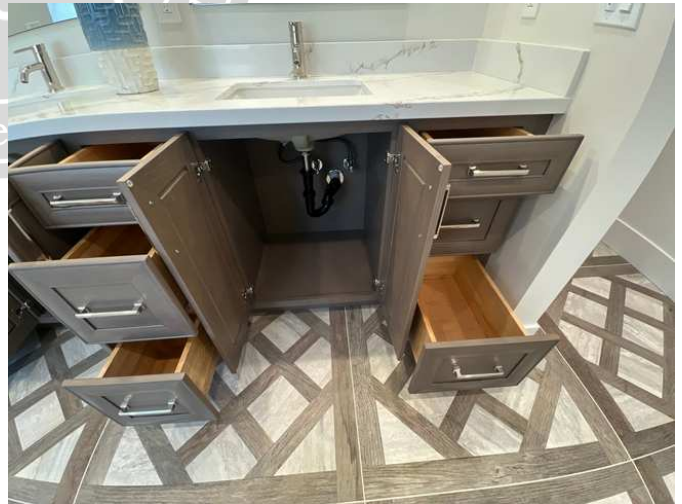
- ✓ **205:**  
Bathroom cabinets are in new condition.

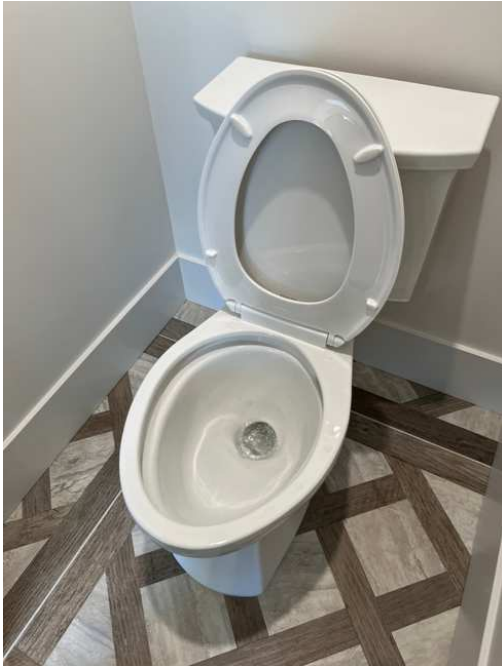
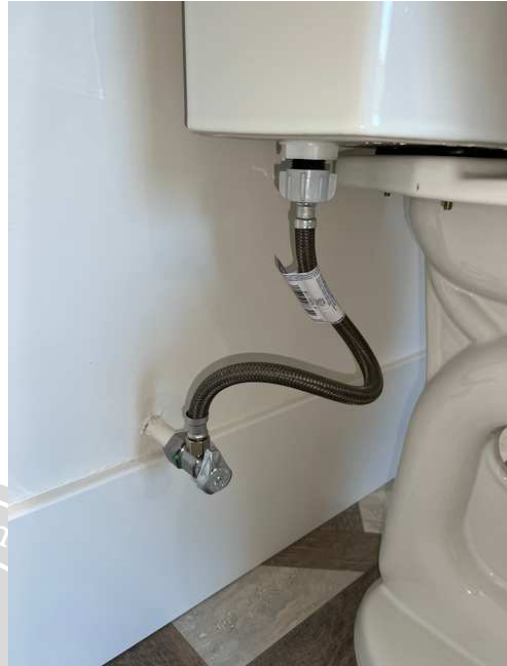
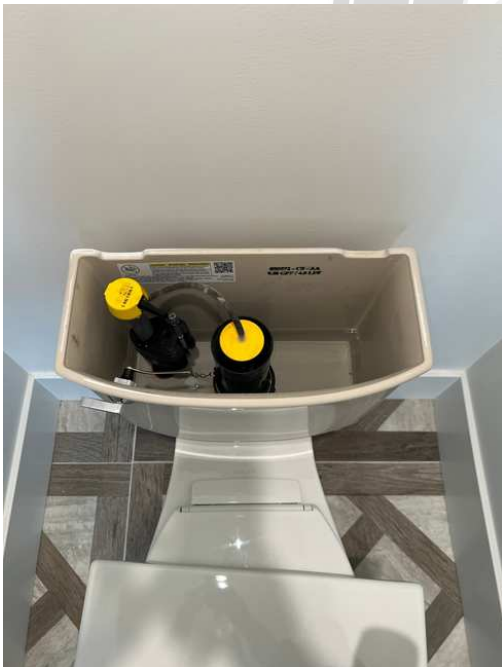
**206:**

The toilet was functional and in satisfactory condition.

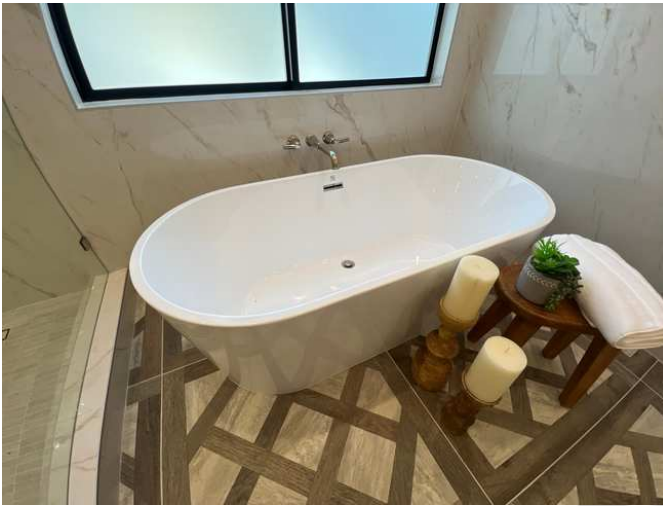
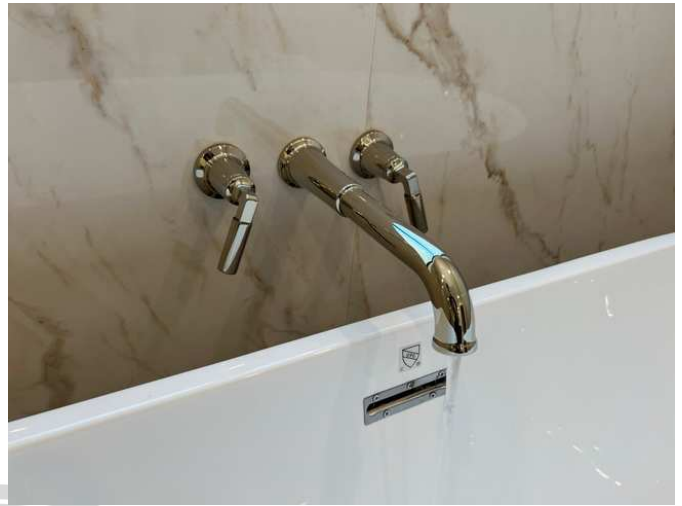
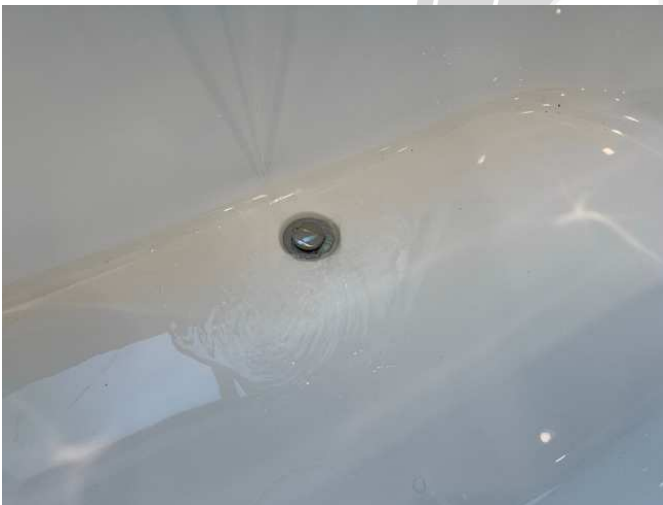
✓ **207:**

The tub was in new condition. Hot and cold running water was present. The drain was free flowing.

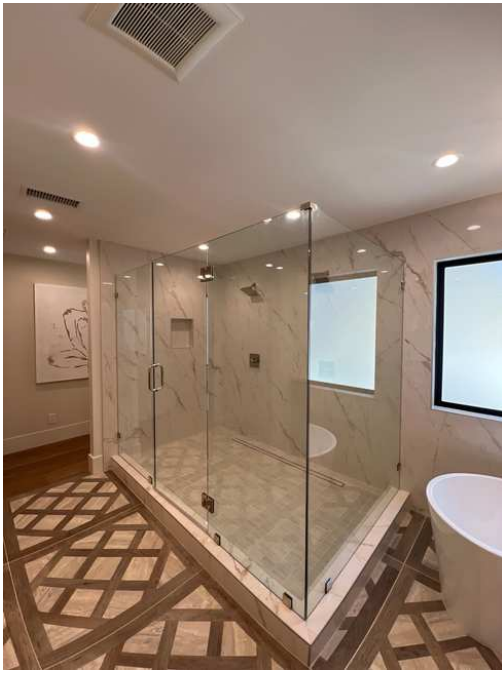
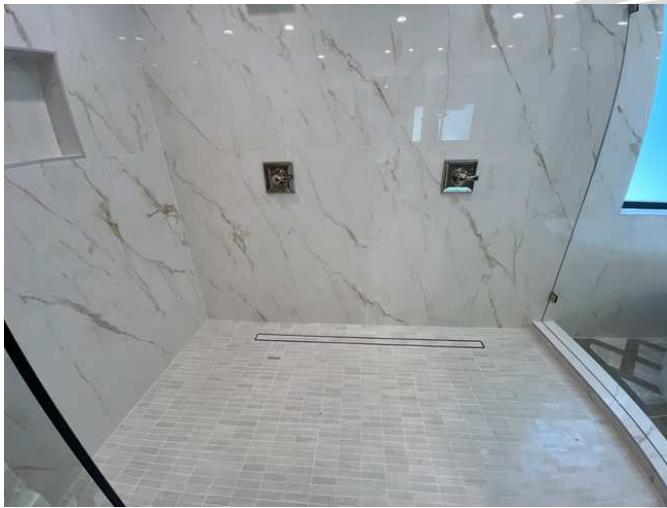
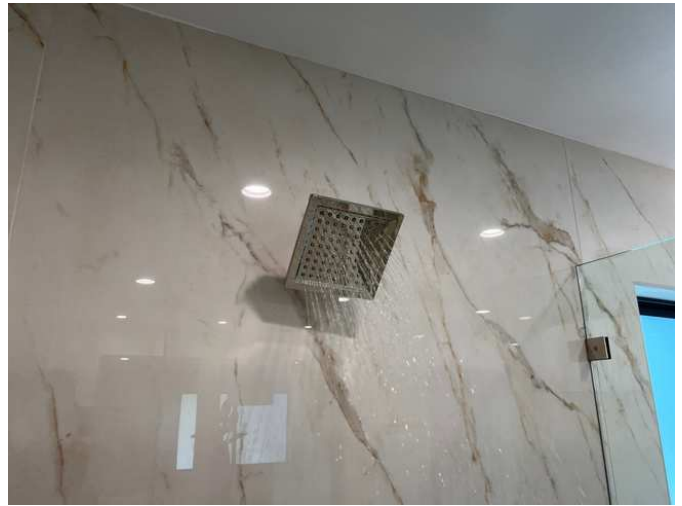
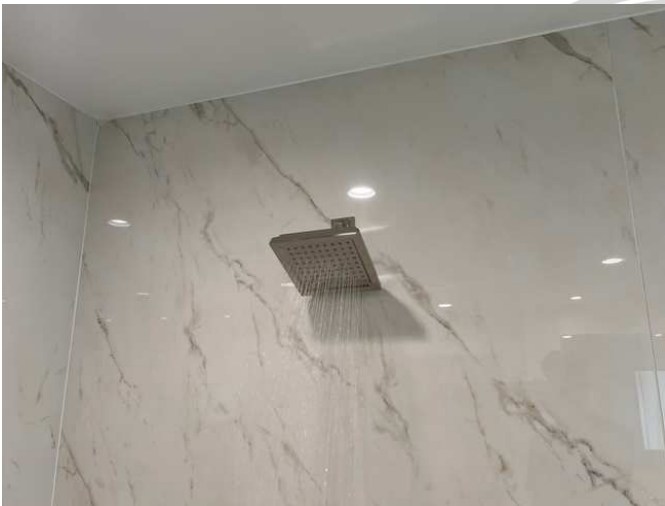
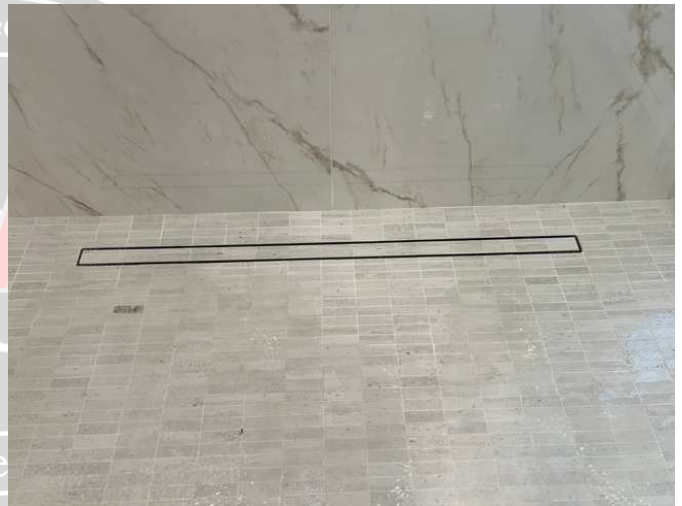
✓ **208:**

The shower was in new condition. Hot and cold running water was present. The drain was free flowing.

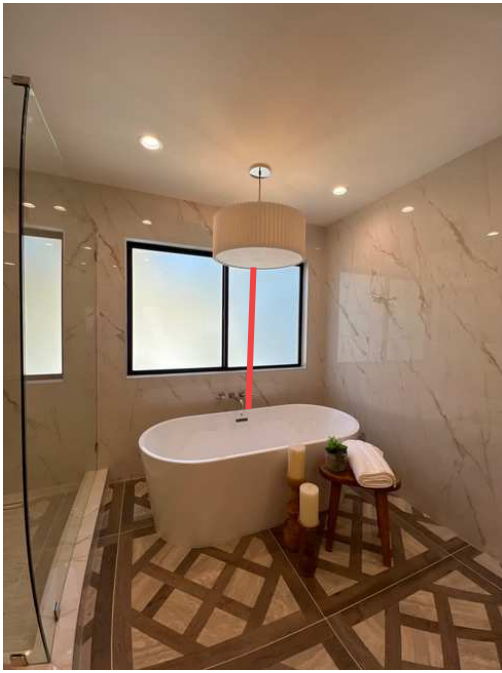
Per the National Electrical Code NEC section 410.10 D. Code violation. Pendant lights, chandeliers, or any cord chain or cable suspended fixture within a zone measuring 3 feet horizontally and 8 feet vertically from the top of the tub rim or shower stall threshold.

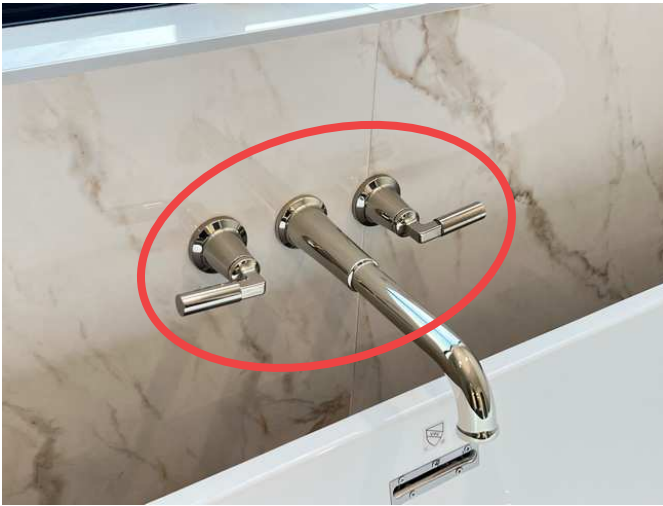
**S210: Missing Temperature Control Valve**

The whole house temperature control valve designed to maintain a stable, safe, and energy-efficient temperature throughout the home.

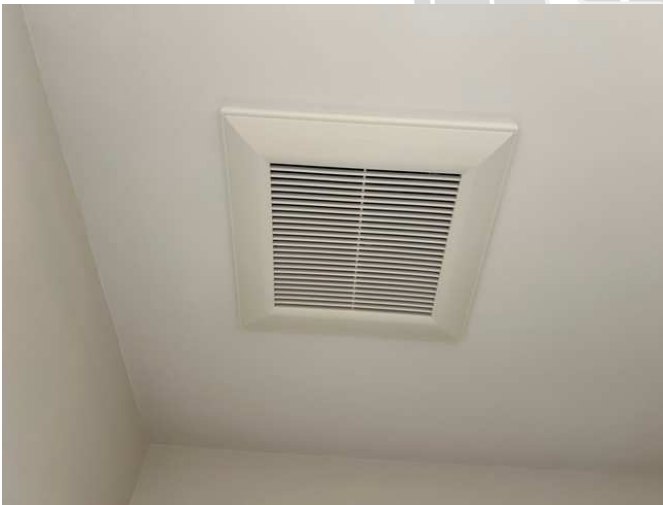
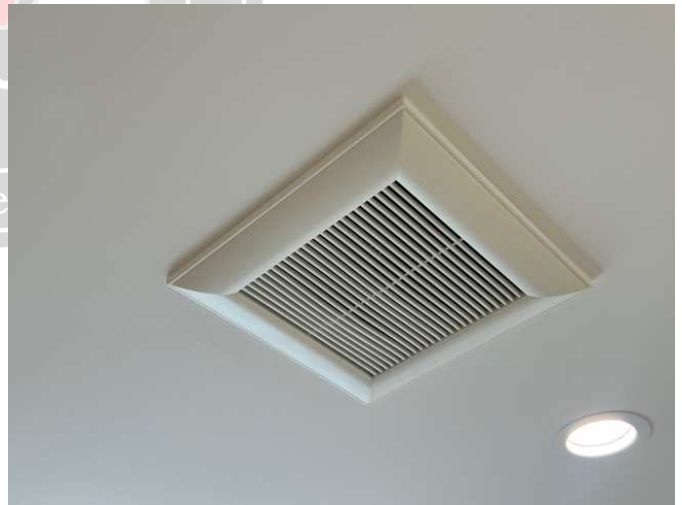
✓ **211:**

The bathroom ventilator was tested and found to be functional on the day of inspection.

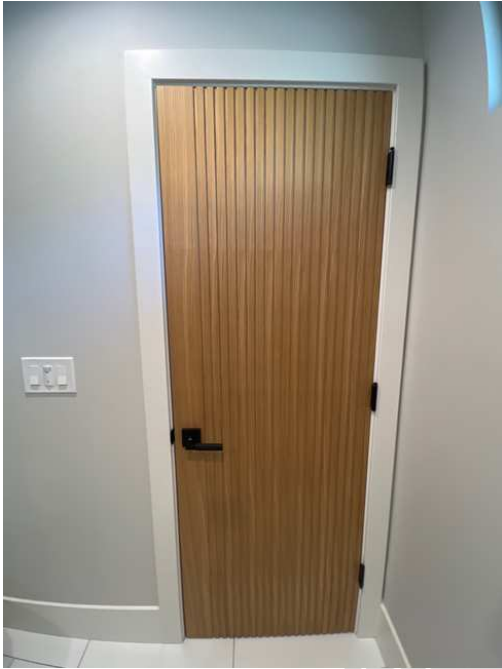
- ✓ **212:**  
The door was in satisfactory condition.

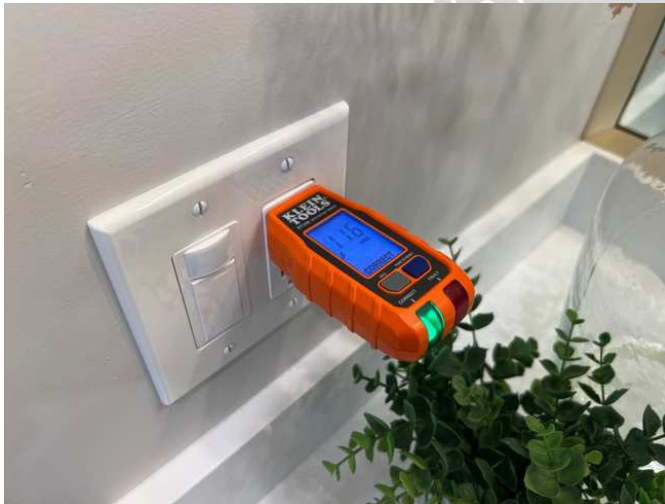
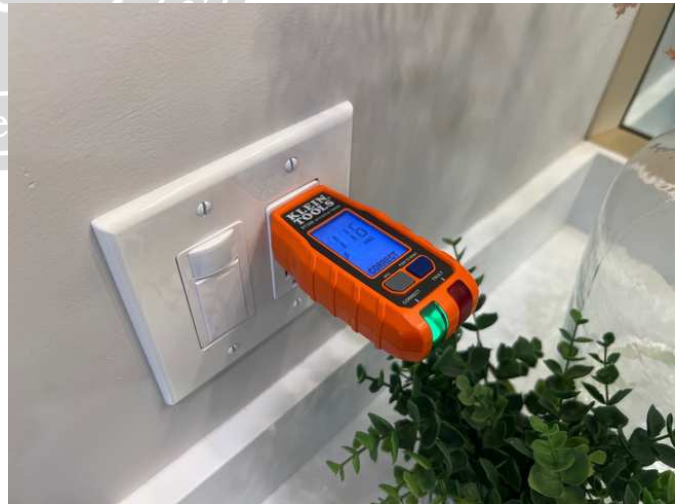
**215:**

Sink and faucet were functional. Hot and cold water were present. And the drain was free flowing.

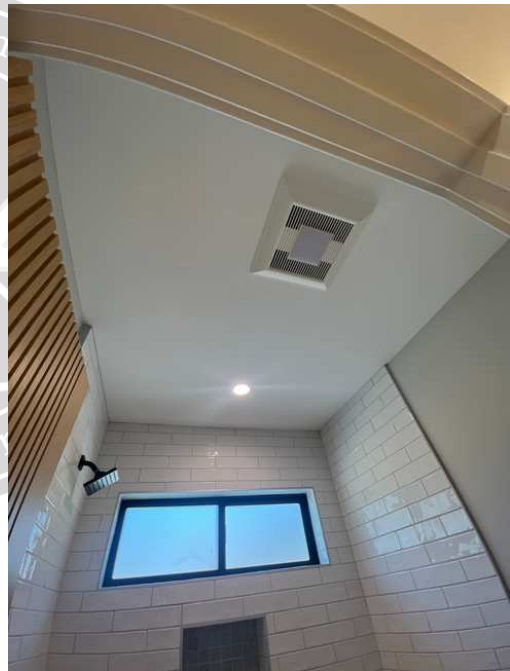
No HVAC supply air register was present in Bathroom #4 at the time of the inspection. The absence of a supply register may result in reduced comfort and inadequate temperature conditioning within the bathroom. Recommend consultation with a qualified HVAC contractor to determine whether a supply air register should be installed.

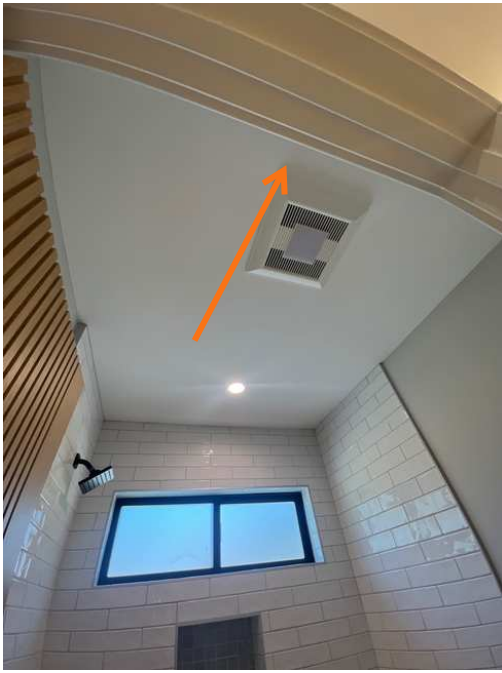
✓ **224: GFCI Satisfactory**

GFCI receptacle was present and functional.

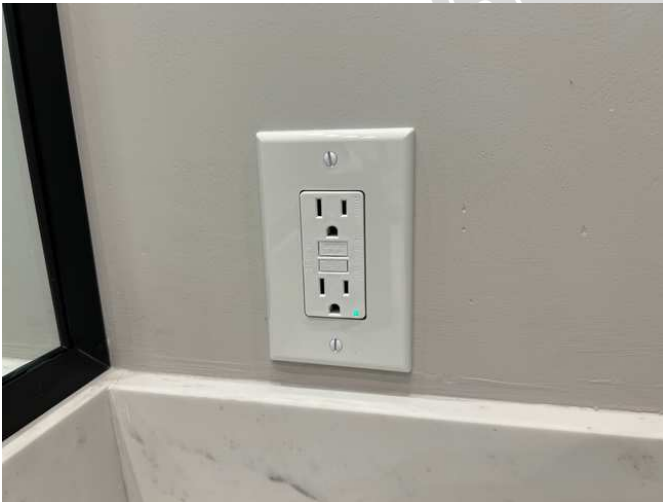
✓ **225: GFCI Protected**

Bathroom receptacle was GFCI protected from another location.

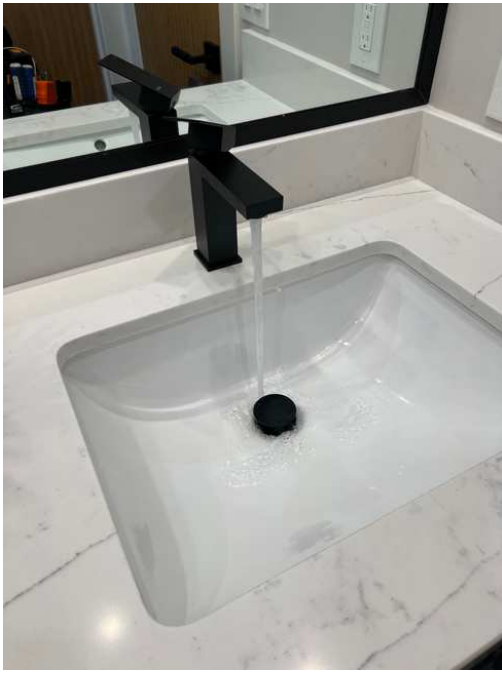
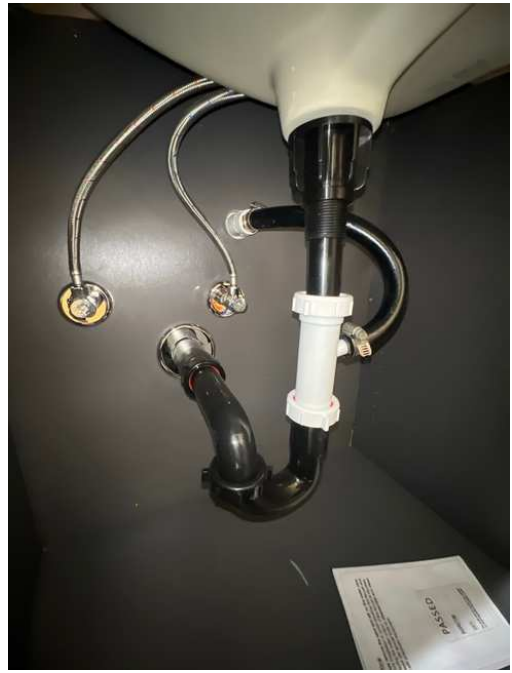
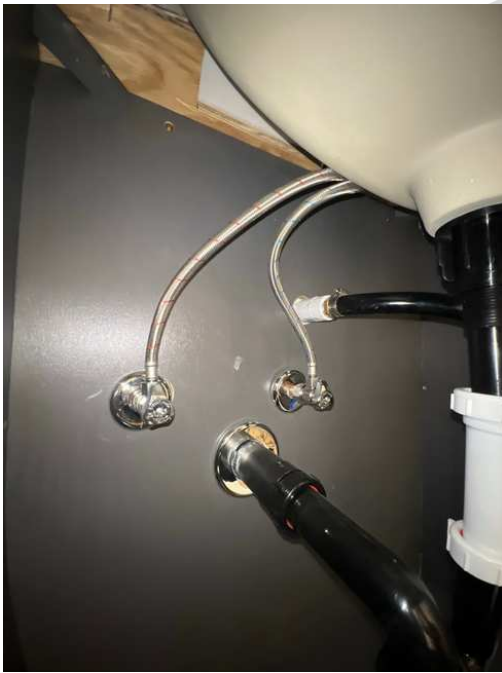
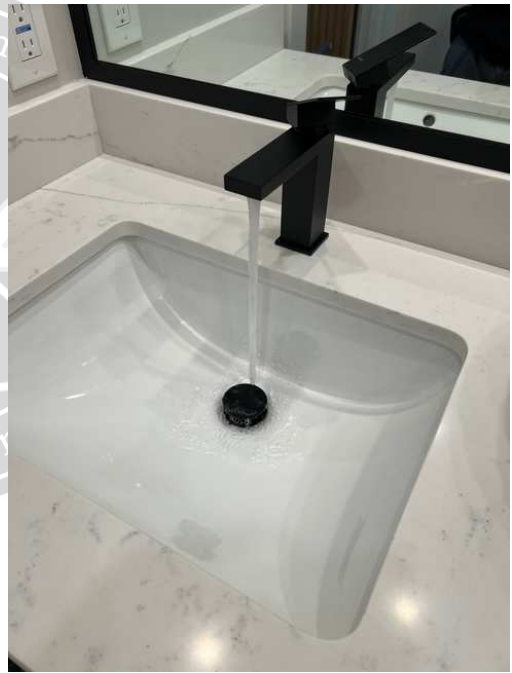
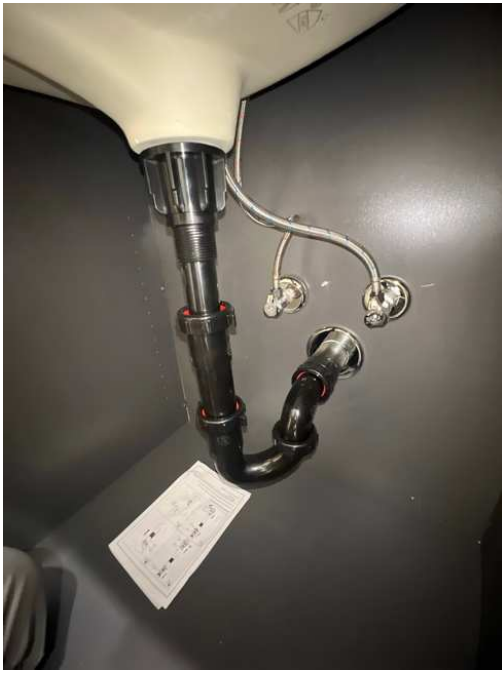
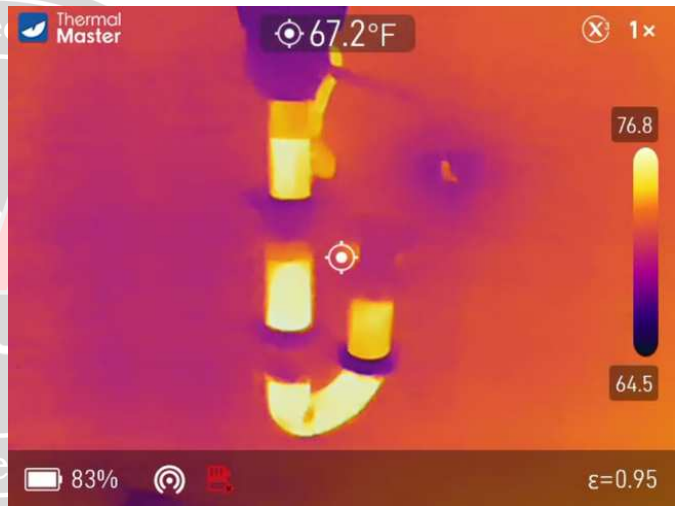
✓ **226:**

Sink and faucet were functional. Hot and cold water were present. And the drain was free flowing.

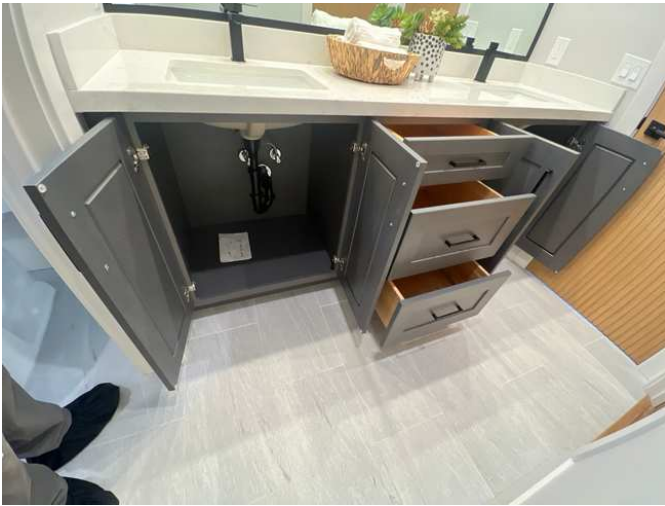
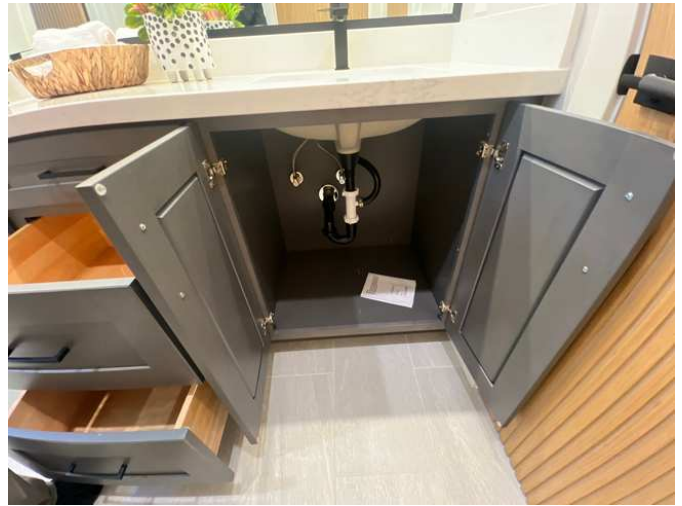
- ✓ **227:** Bathroom cabinets are in new condition.

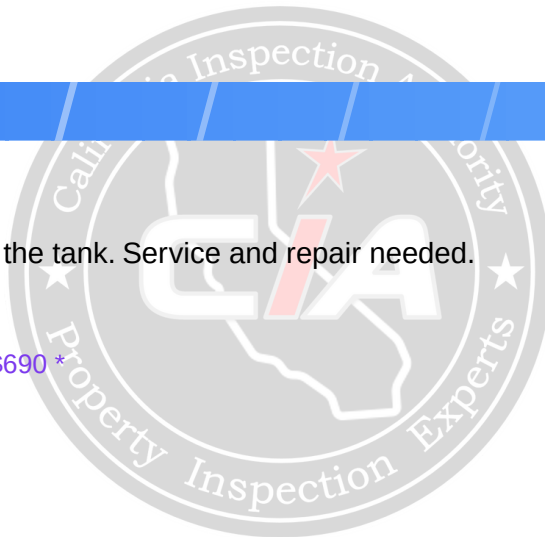
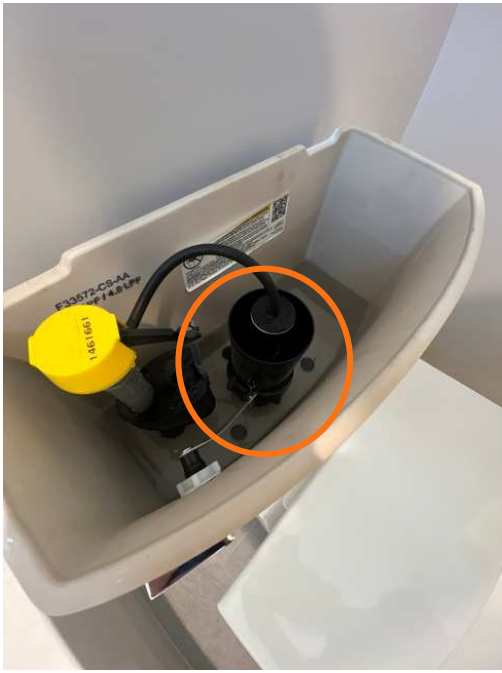
### **R228: Leaks At Tank**

Water leaks were noted at the tank. Service and repair needed.

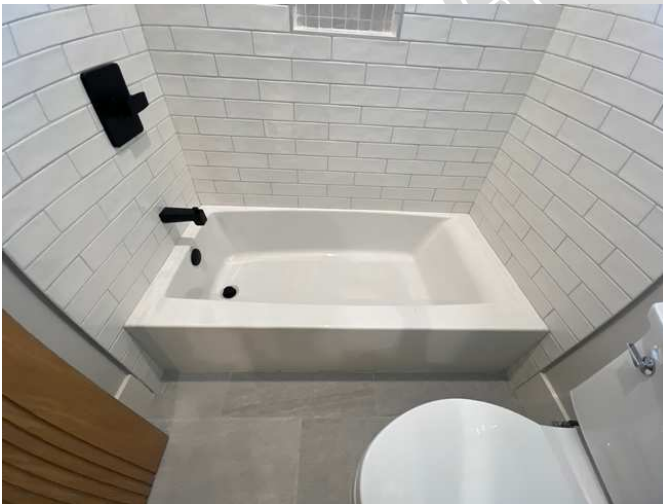
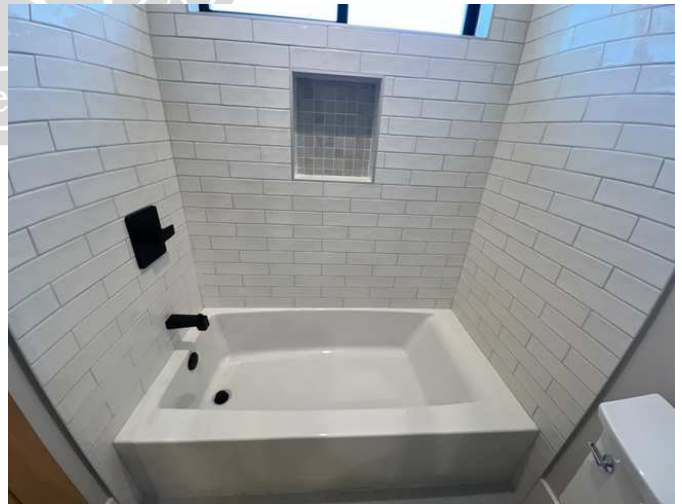
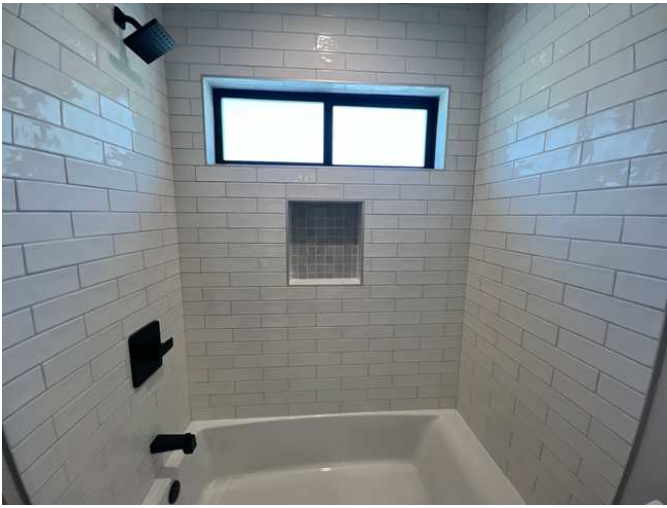
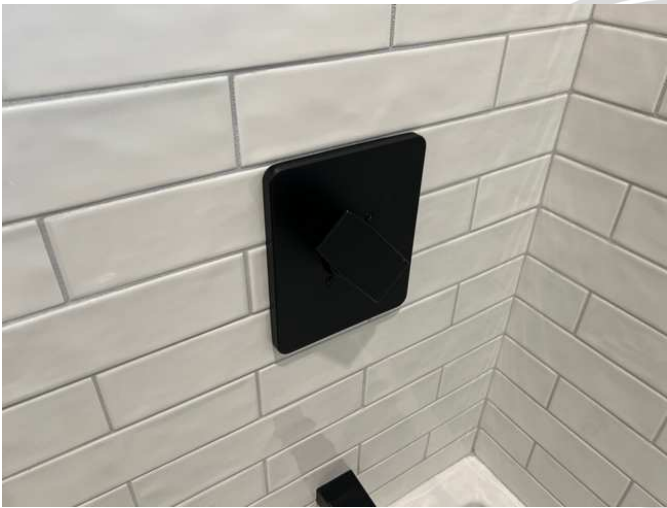
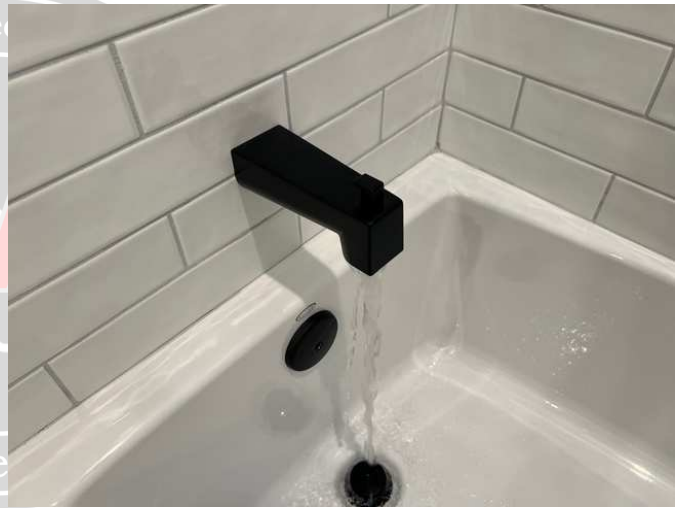
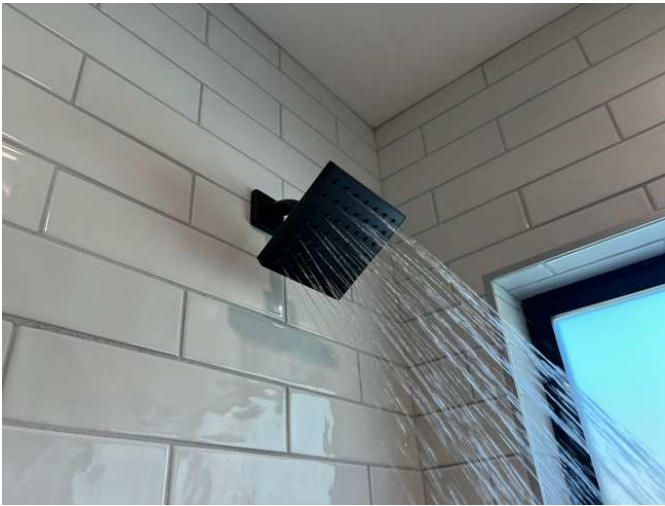
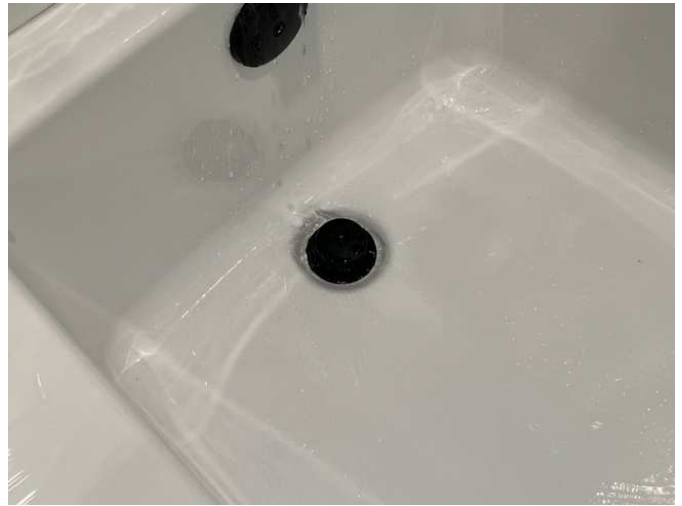
**229:**

The shower was in new condition. Hot and cold running water was present. The drain was free flowing.

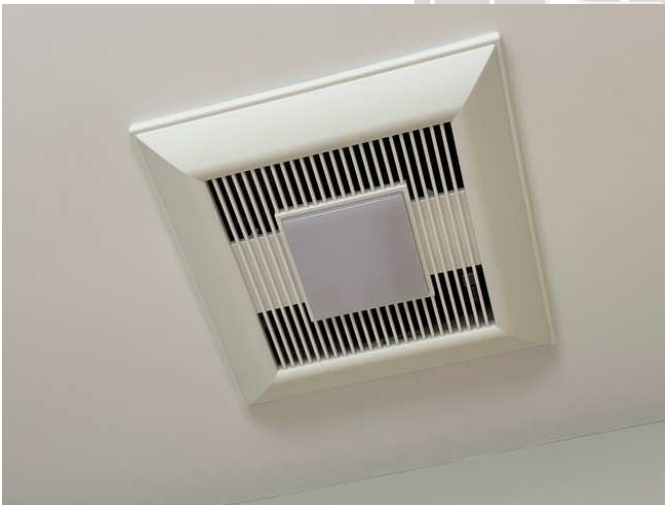
**230:**

The bathroom ventilator was tested and found to be functional on the day of inspection.

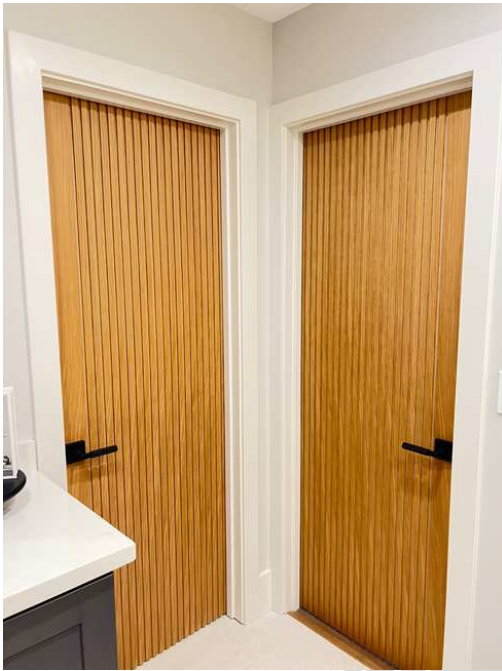
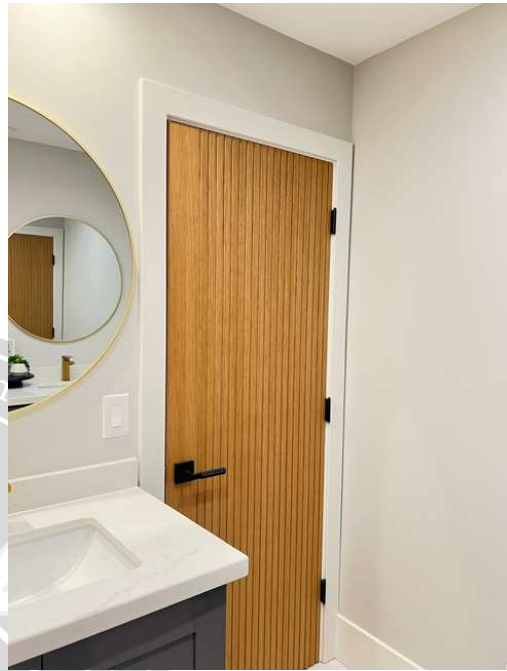
- ✓ **231:**  
The door was in satisfactory condition.

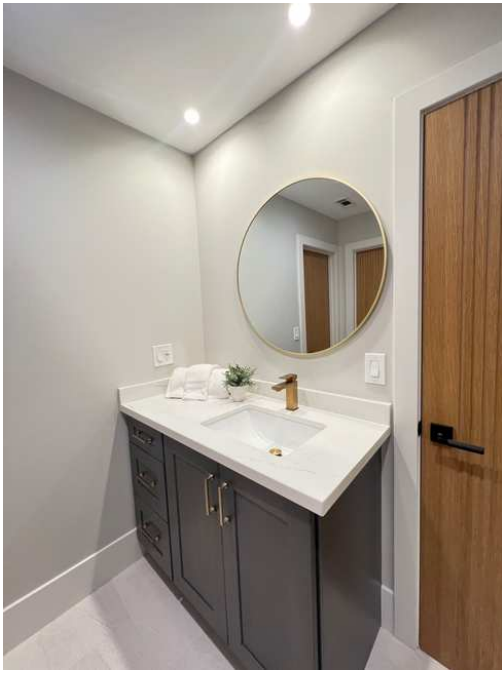
- ✓ **232:**  
The floor, walls and ceiling were in satisfactory condition. There were no significant deficiencies noted.

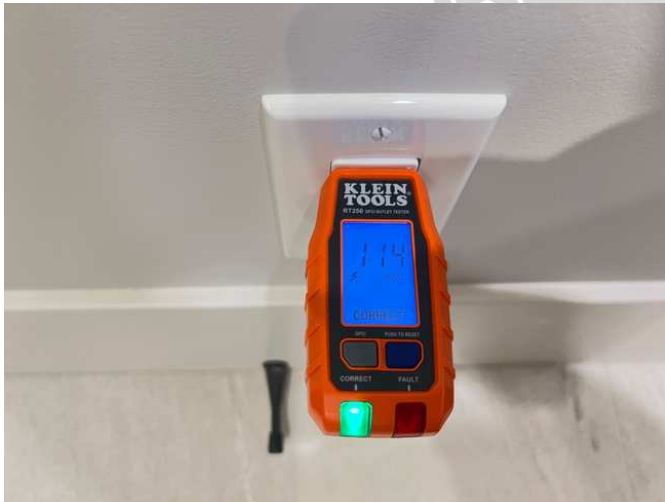
✓ **233: GFCI Satisfactory**

GFCI receptacle was present and functional.

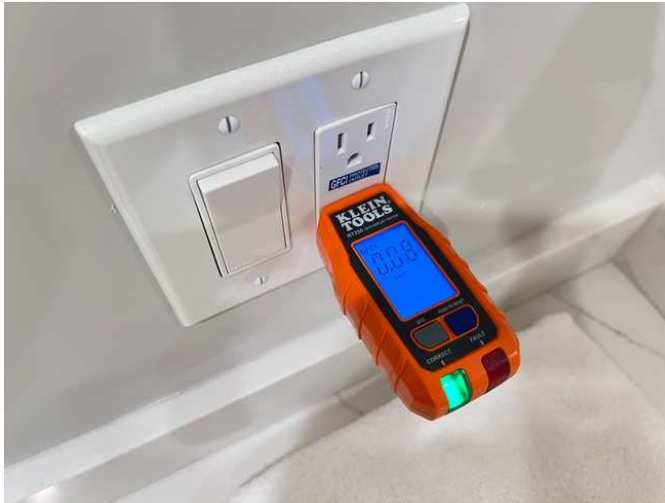
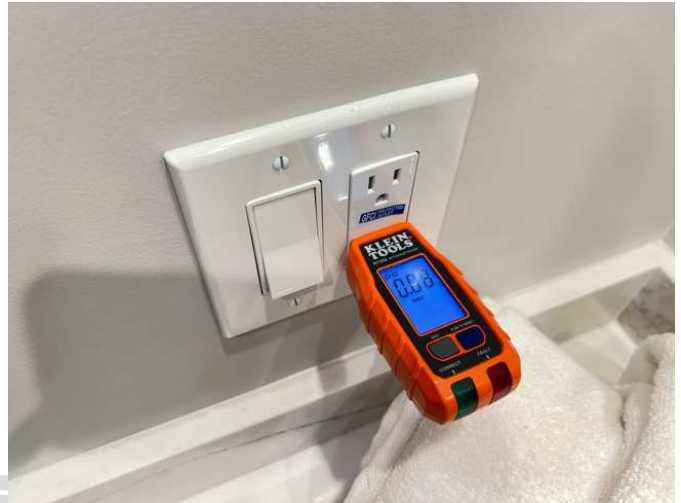
✓ **234: GFCI Protected**

Bathroom receptacle was GFCI protected from another location.

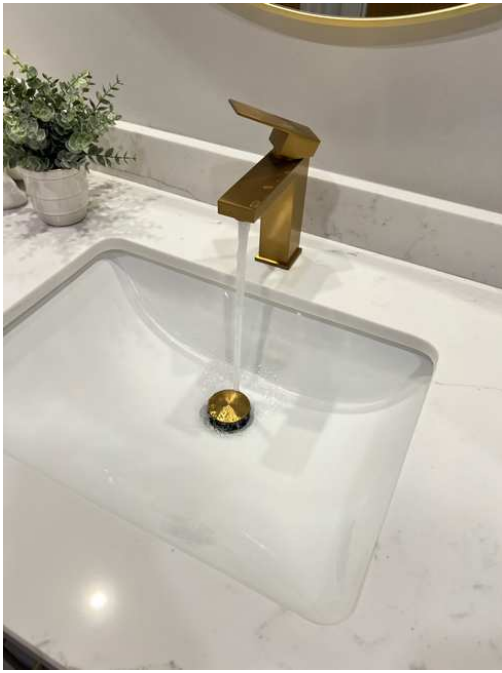
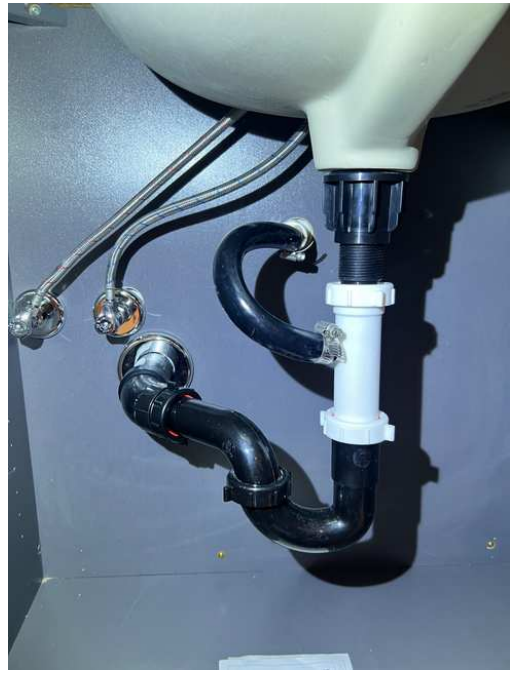
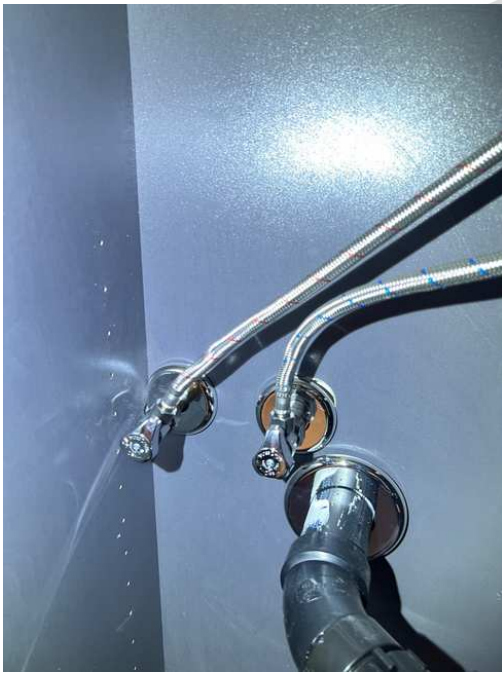
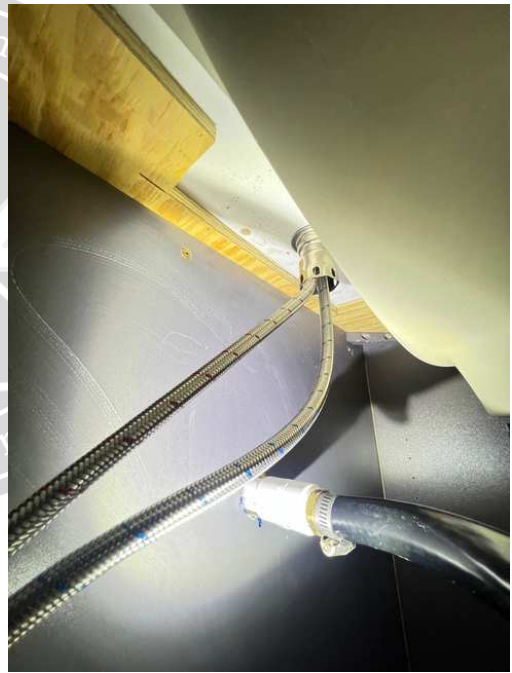
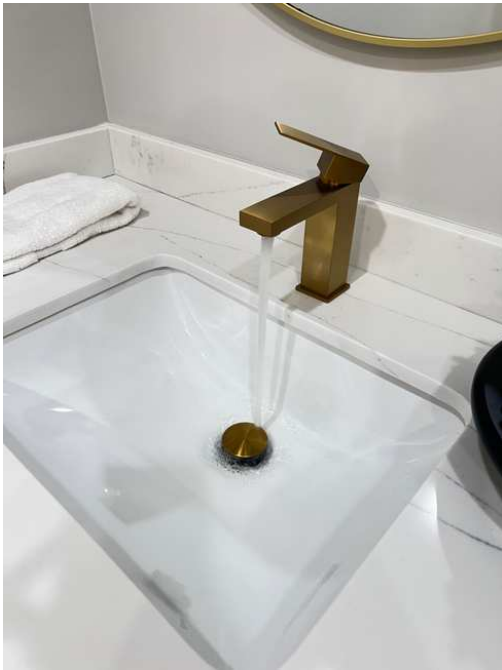
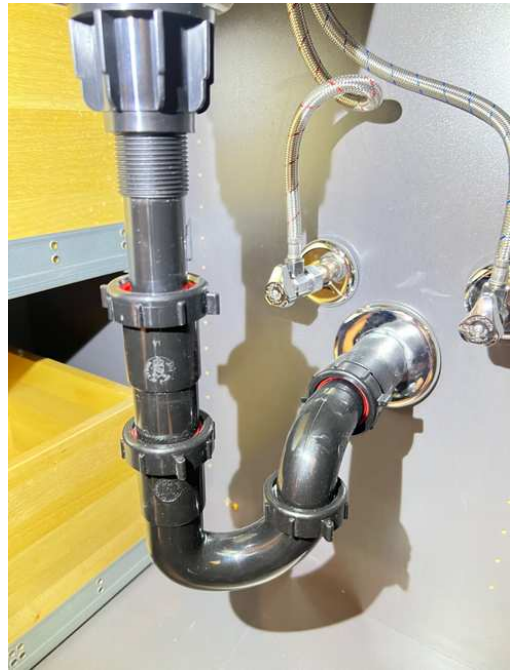
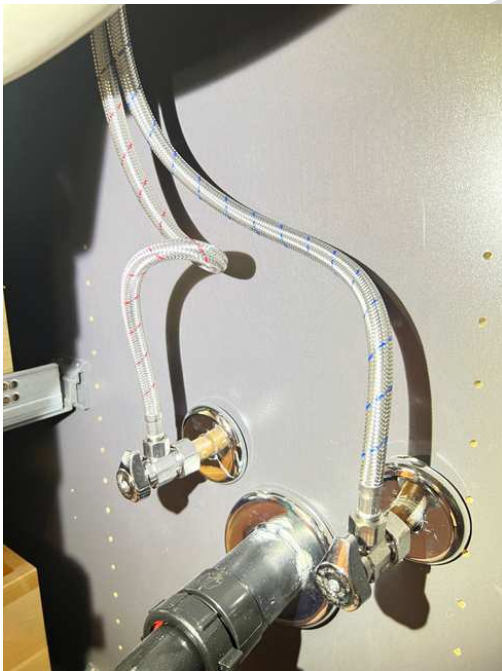
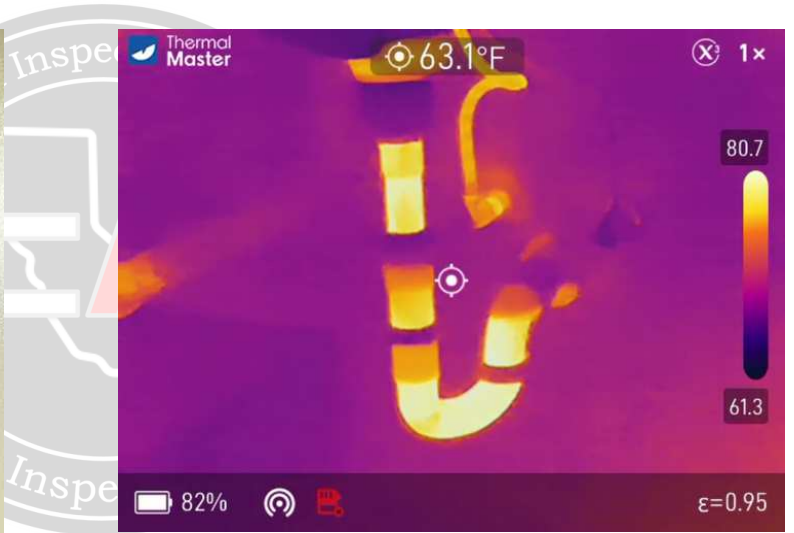
✓ **235:**

Sink and faucet were functional. Hot and cold water were present. And the drain was free flowing.

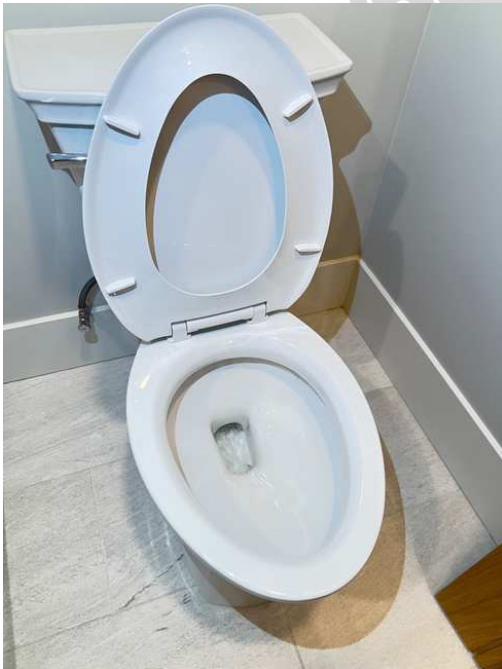
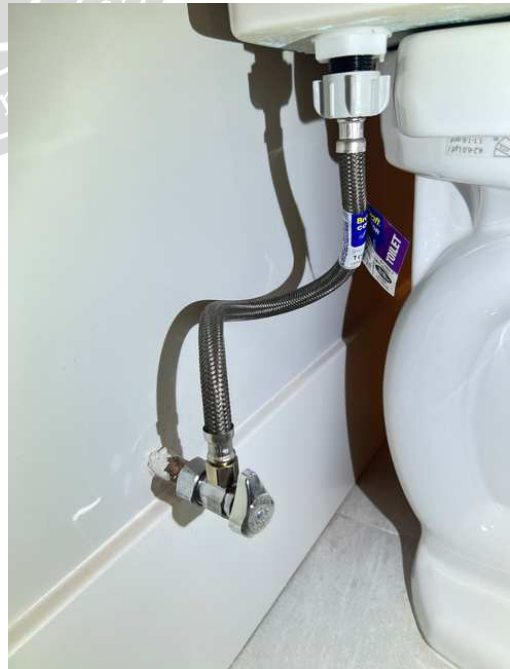
✓ **236: Satisfactory**

The toilet was functional and in satisfactory condition.

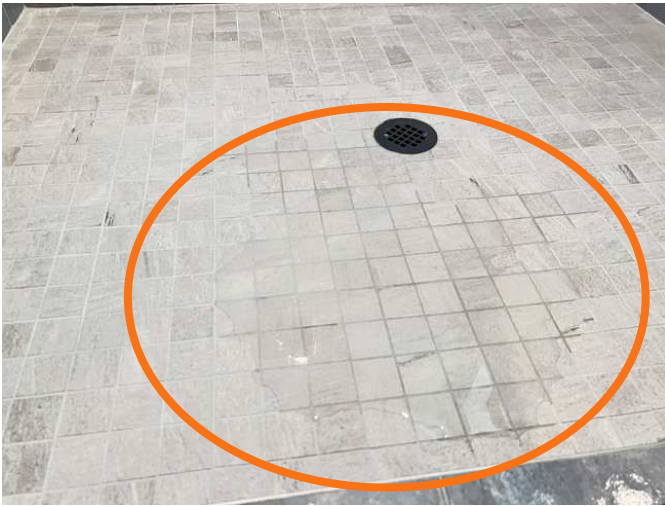
Improper slope was noted in the shower pan of Bathroom #6. Water was observed to collect rather than drain completely toward the shower drain, resulting in standing water. Recommend consultation with the builder to correct the shower pan slope and provide proper drainage to the drain.

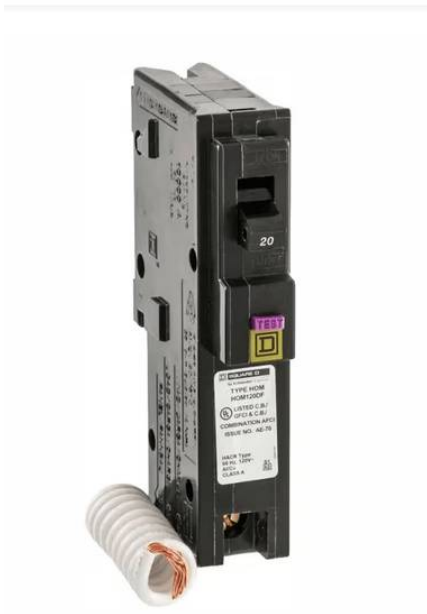
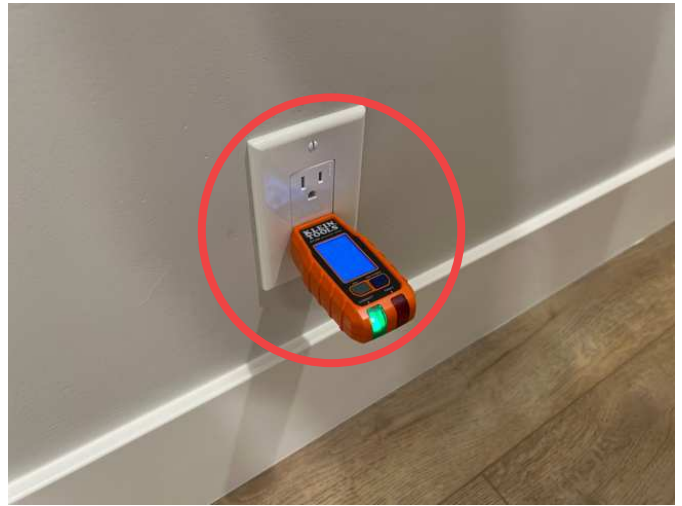
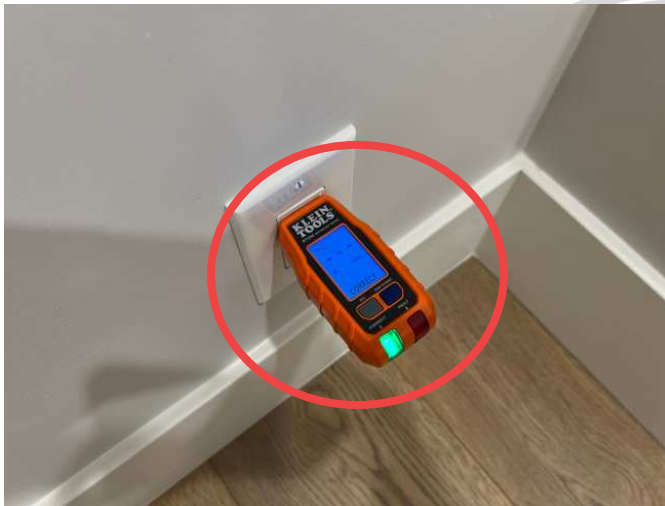
### ⚠ **S252: GFCI Missing**

According to the national electrical code all laundry room receptacles must be AFCI and GFCI protected for occupant safety. Upgrades are needed. Safety hazard. Please click [here](#) for a complete cost guide to GFCI outlet installation.

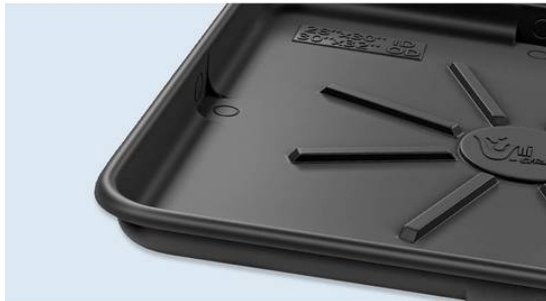
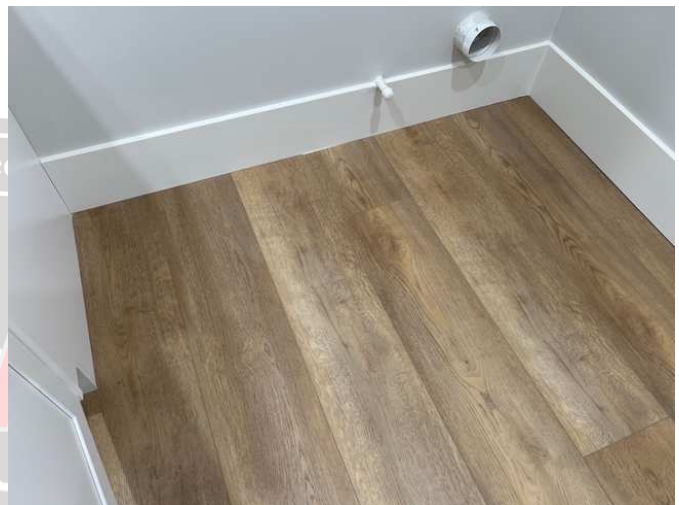
### W255: Drip Pan Recommended

A drip pan with an appropriate floor drain connection is recommended for all second-floor laundry locations. This will help prevent significant water damage during leaks. Consult with a general contractor for cost of installation.
