# HOME INSPECTION REPORT

PROFESSIONAL PROPERTY EVALUATION

INSPECTION DATE

Tuesday, July 7, 2026

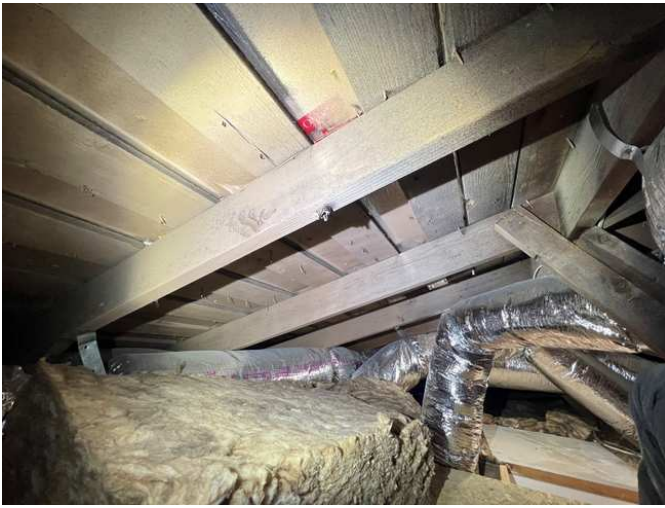
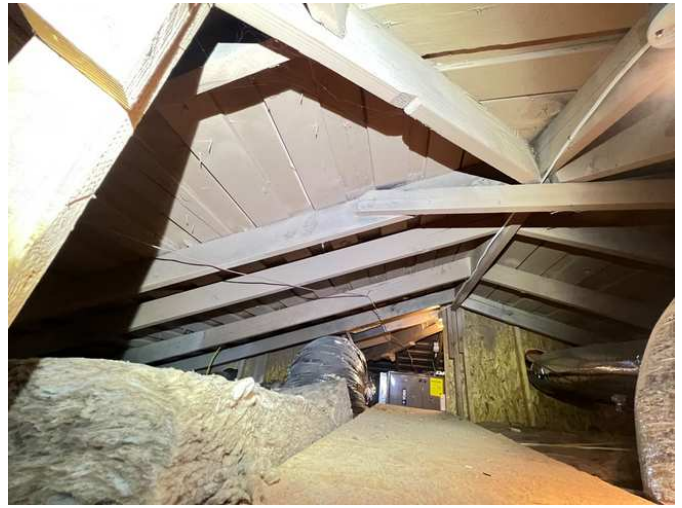
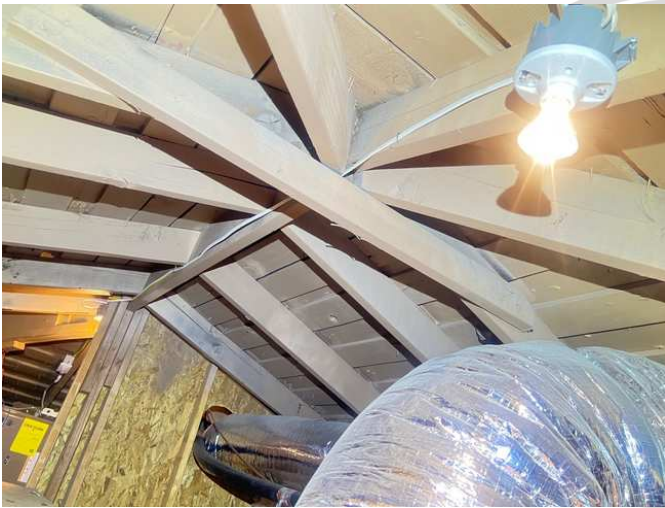
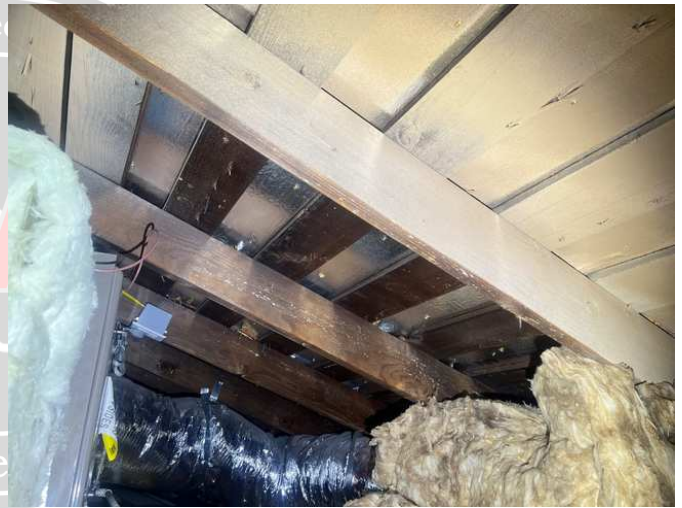
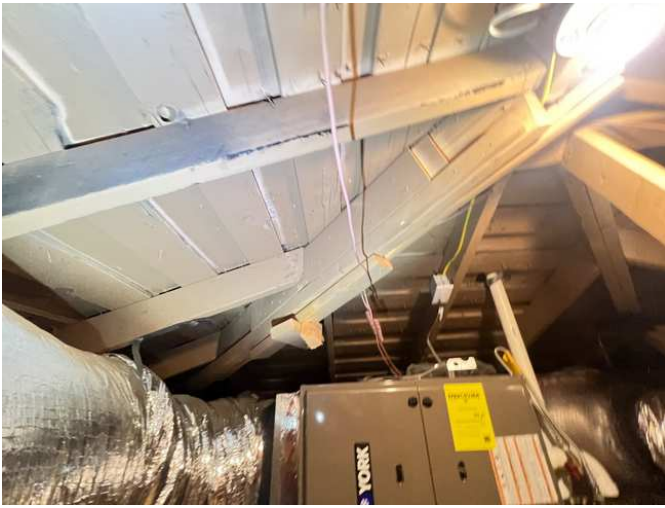
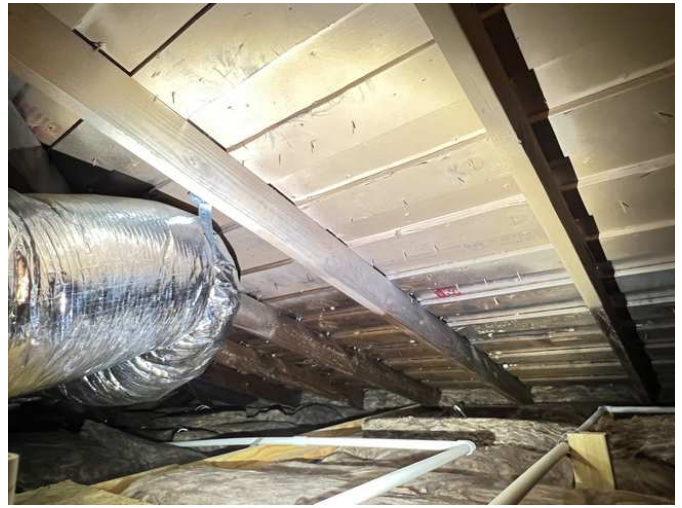
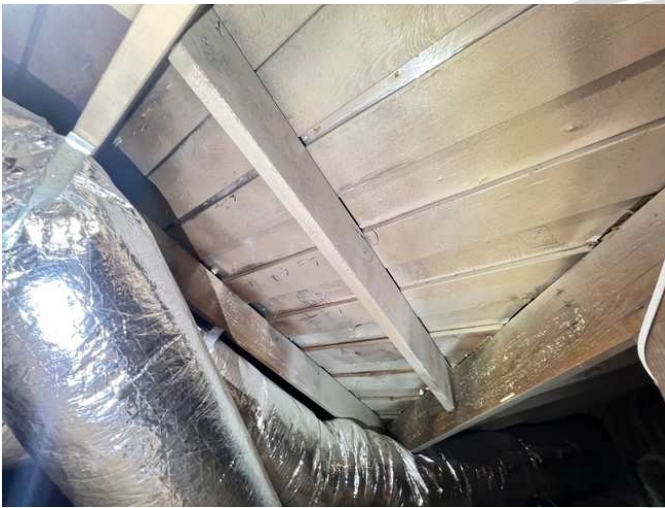
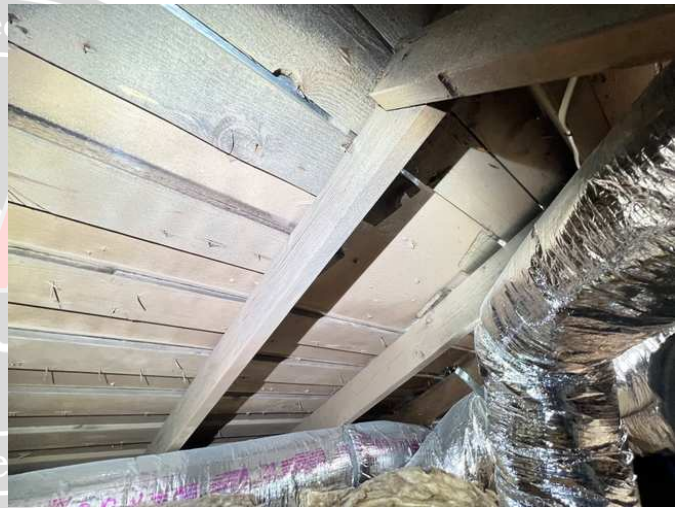
The roof rafters were in good condition. Midspan bracing and collar ties were satisfactory. There were no apparent signs of alterations or damage to the wood frame members.

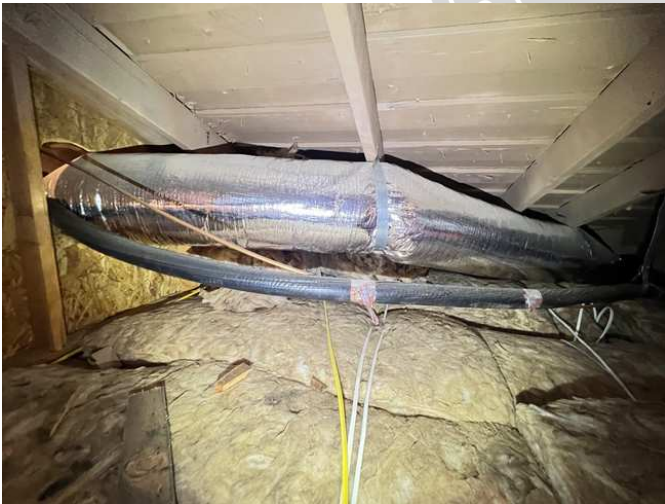
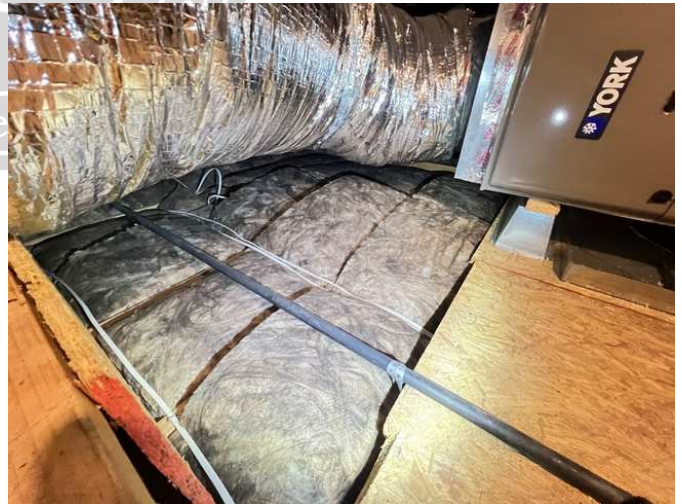
### ✓ 261: Fiberglass Batt Satisfactory

Fiberglass batt insulation was utilized throughout the attic area. The installation was satisfactory.

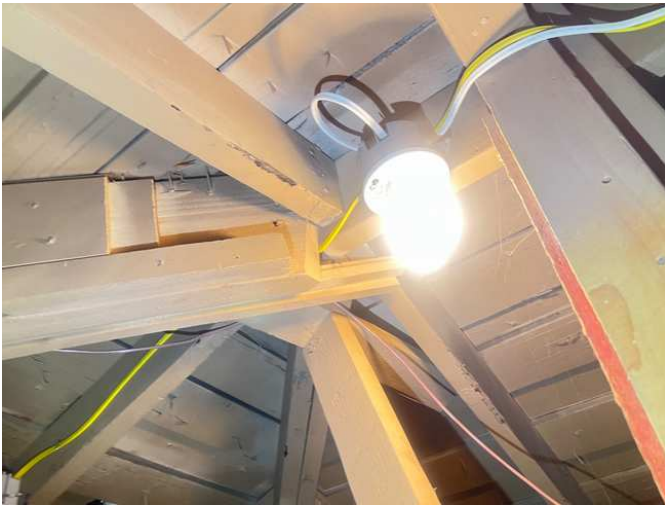
- ✓ **262:**  
The attic light was present and functional.

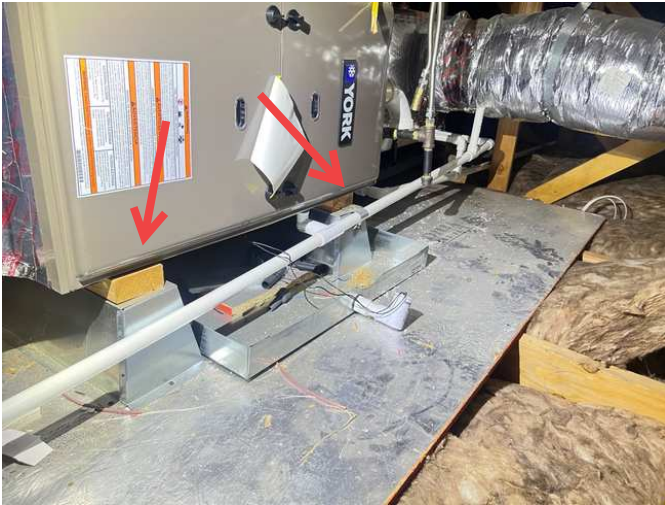
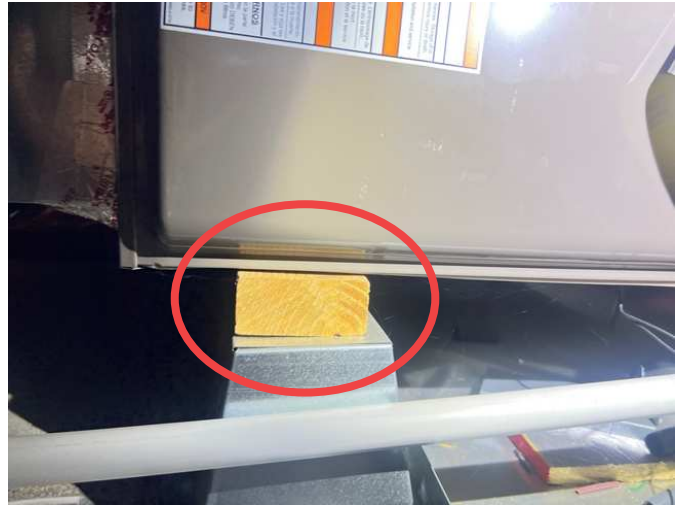
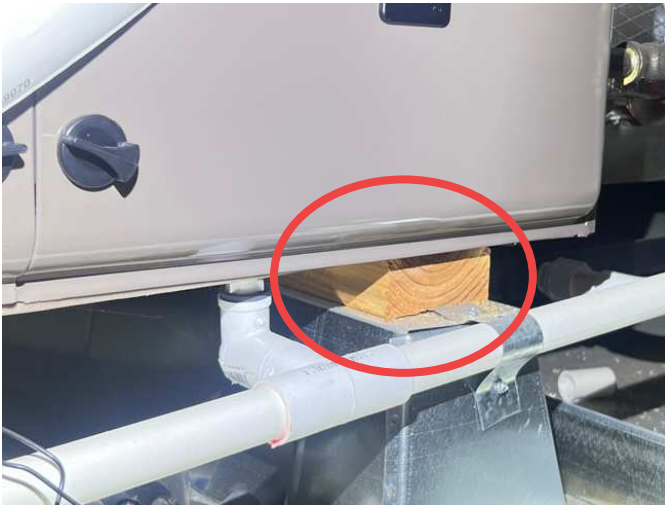
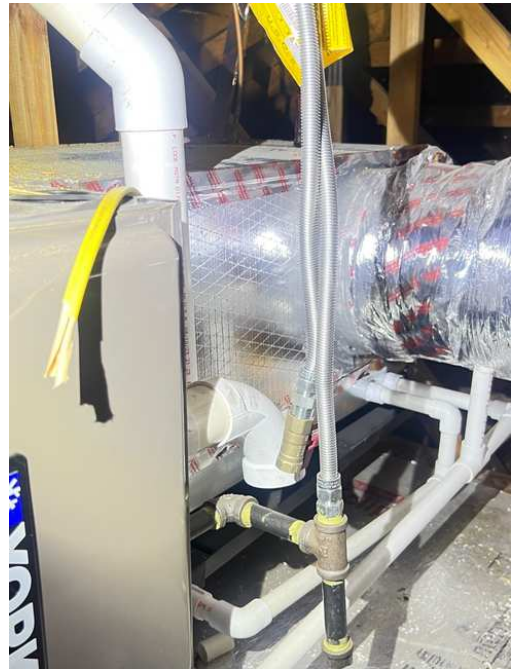
- ⚠ **S265:**  
The horizontal gas furnace was observed to be elevated using wood blocking placed on top of the metal furnace stand supports. While the furnace is supported, the use of combustible wood spacers is not considered an appropriate support method for this type of installation. If additional elevation was required, properly sized code-compliant metal furnace stands or supports should have been used. Recommend consultation with the builder or a qualified HVAC contractor to evaluate the installation and provide proper support as necessary.

AI Estimated Cost: \$460 - \$1,035 \*

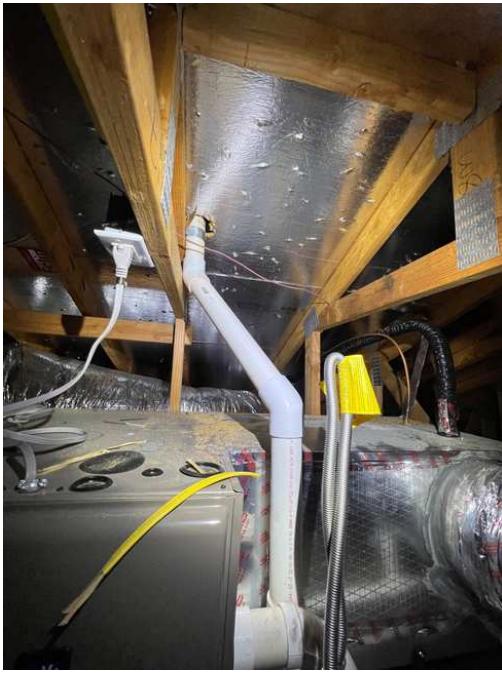
**266:**

Heater vent was in satisfactory condition and directly vented through the roof.

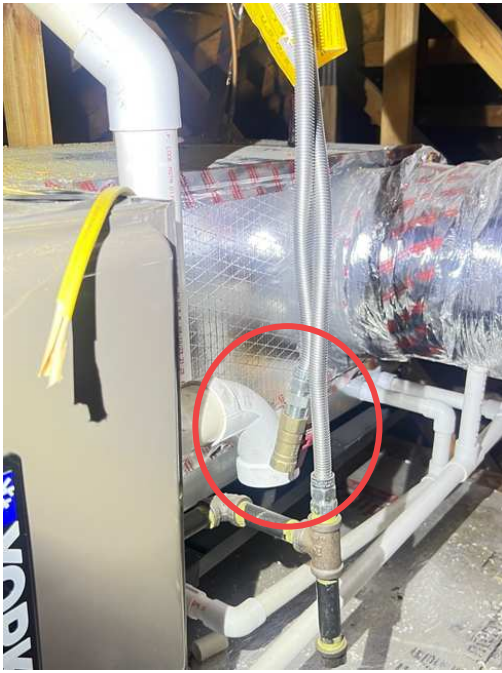
The gas supply line for the ADU furnace unit was not connected to the gas supply at the time of the inspection. As a result, the furnace could not be operated or evaluated for proper function. Recommend consultation with the builder to complete the gas connection and verify proper operation of ADU furnace unit prior to occupancy.

AI Estimated Cost: \$402 - \$752 \*

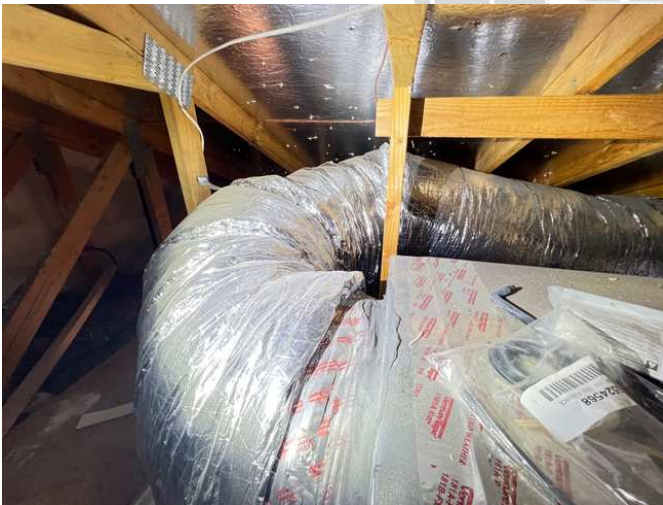
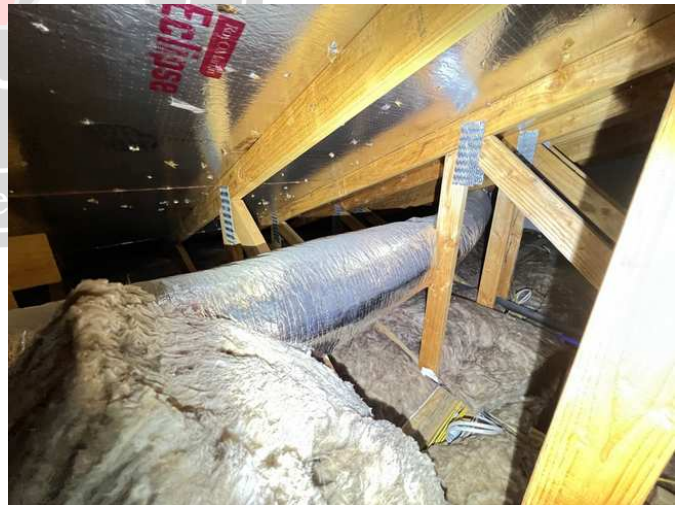
✓ **268:**

Flexible insulated duct work was utilized. The duct work was in satisfactory condition where visible.

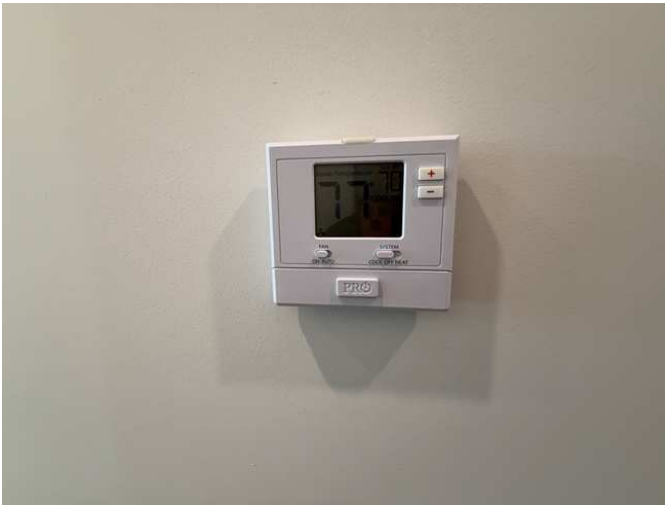
**269:**

The thermostat was located in the hallway. The thermostat appears to be properly installed and the unit responded to the basic controls. This is a programmable device with many options for setback settings, timed events, etc. No attempt was made to test all functions of the thermostat. To do so would be time consuming and outside of the scope of a general home inspection.

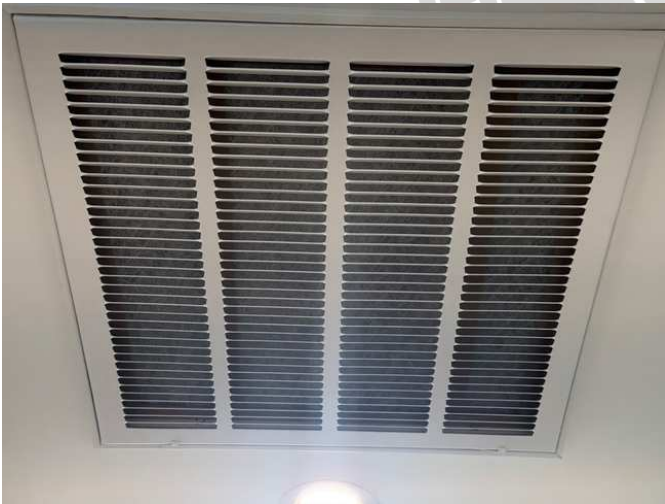
**270:**

The filter is in satisfactory condition. Filter should be replaced every 3 to 6 months as part of regular home maintenance.

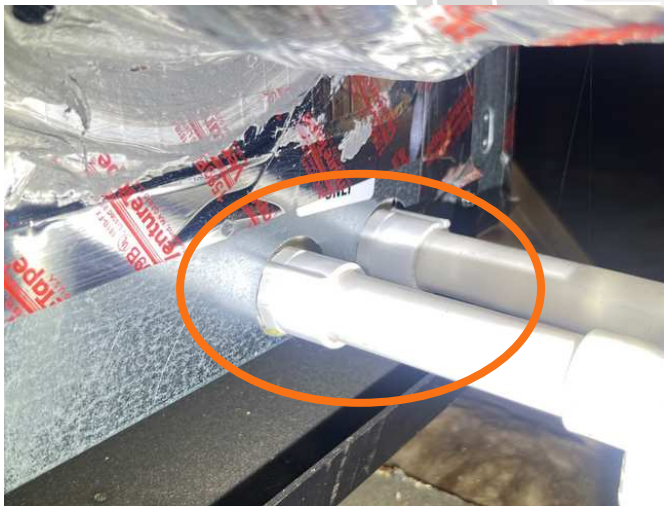
#### R273: Evaporator Leaking Air

The evaporator was leaking a significant amount of air during inspection. Thus reducing energy efficiency. Consult with an HVAC contractor to seal the evaporator.

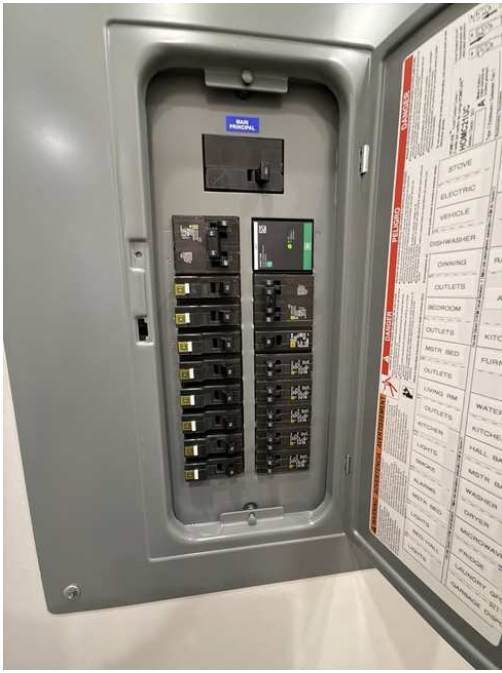
- ✓ **277:**  
The panel was in satisfactory condition overall.

- ✓ **278:**  
The panel was in satisfactory condition overall.

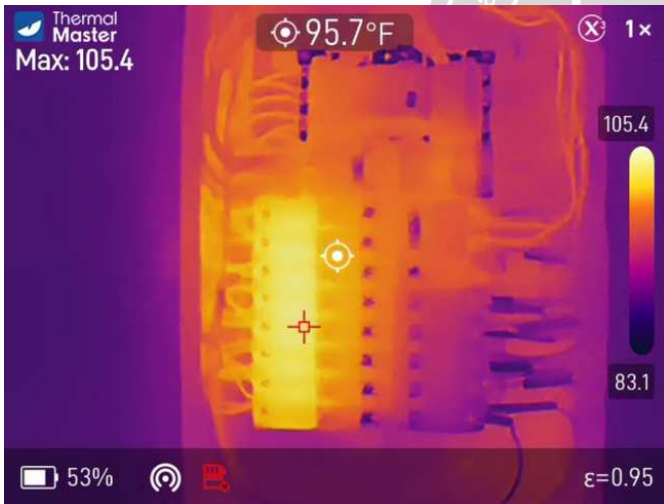
- **279:**  
FLIR scan of sub panel. All temperatures were well within guidelines.

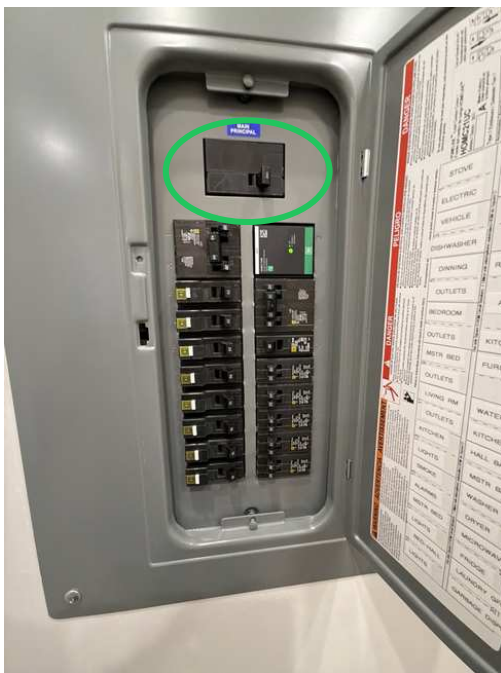
#### **281: At Sub Panel**

Subpanel main disconnect is located within the subpanel and there is an additional main service disconnect located at the exterior of the home near the main electrical panel.

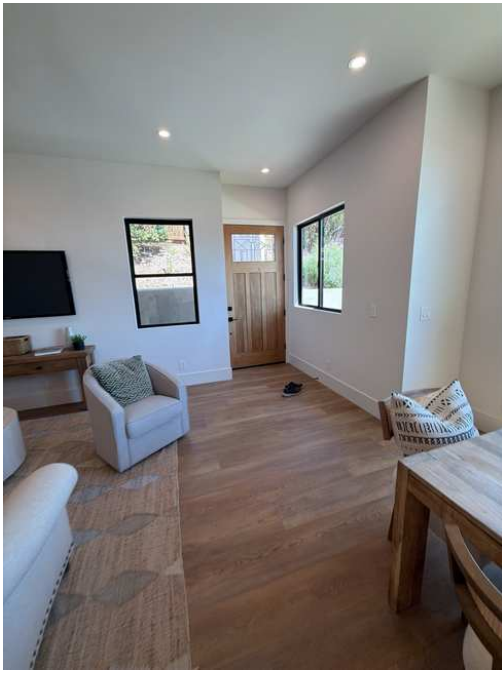
- ✓ **285:** Foyer and hallway condition were satisfactory.

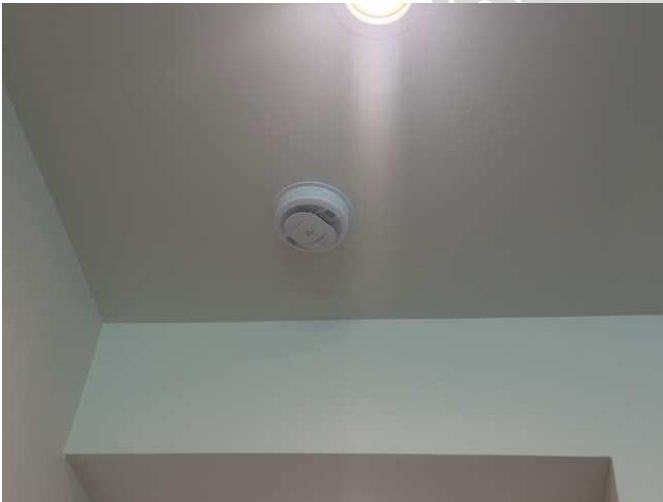
✓ **286: Satisfactory**

Smoke and carbon monoxide detectors were present and functional.

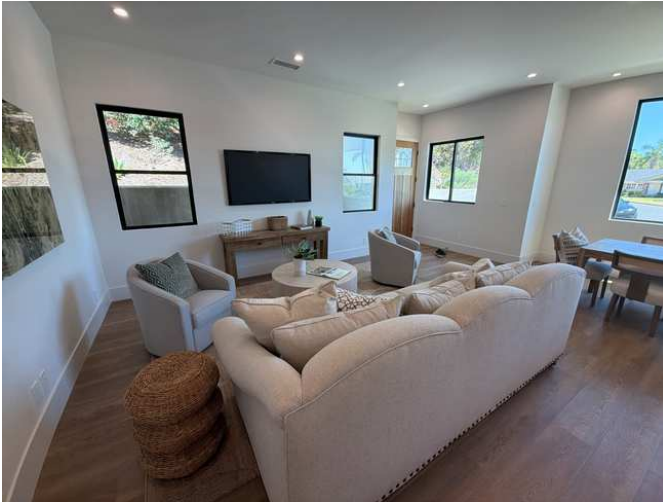
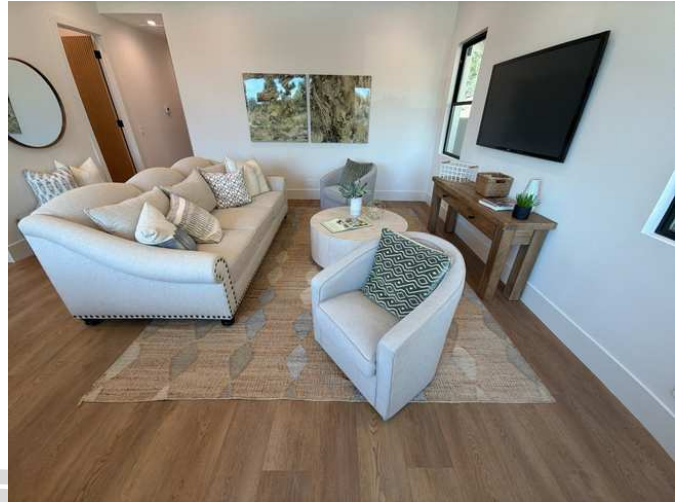
**287:**

The room was in satisfactory condition overall.

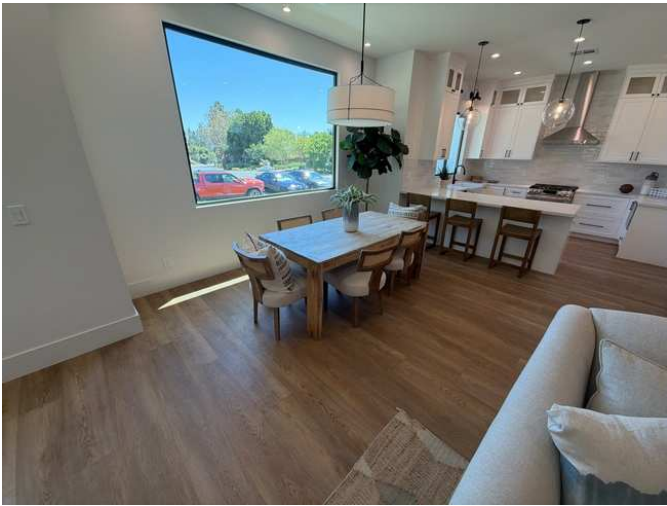
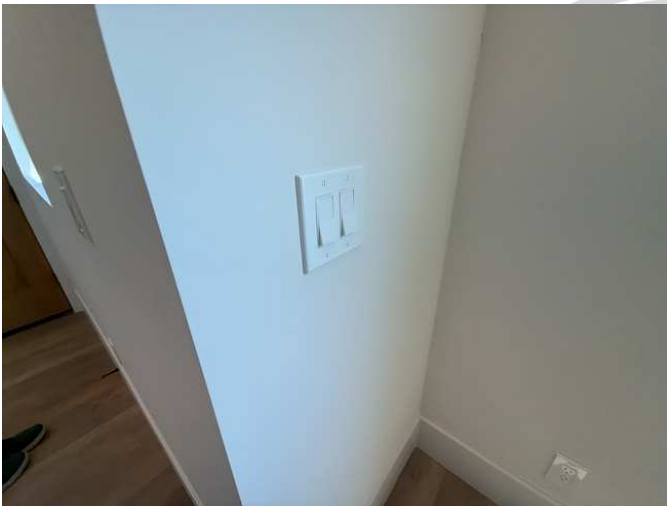
- ✓ **288:**  
The room was in satisfactory condition overall.

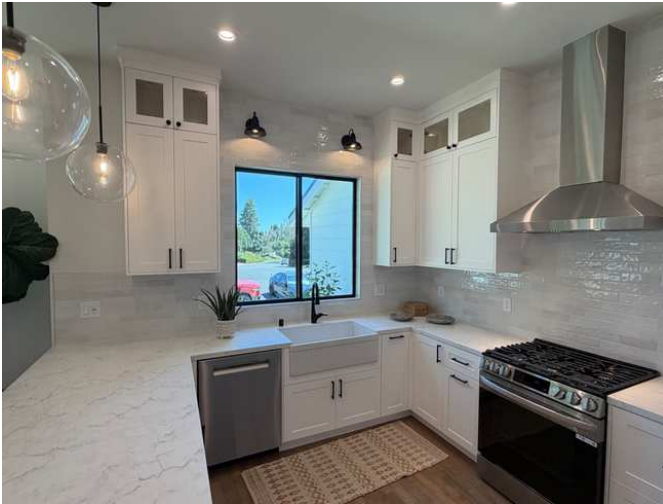
● **289:**

Floor, walls and ceiling in the kitchen area were in satisfactory condition overall.

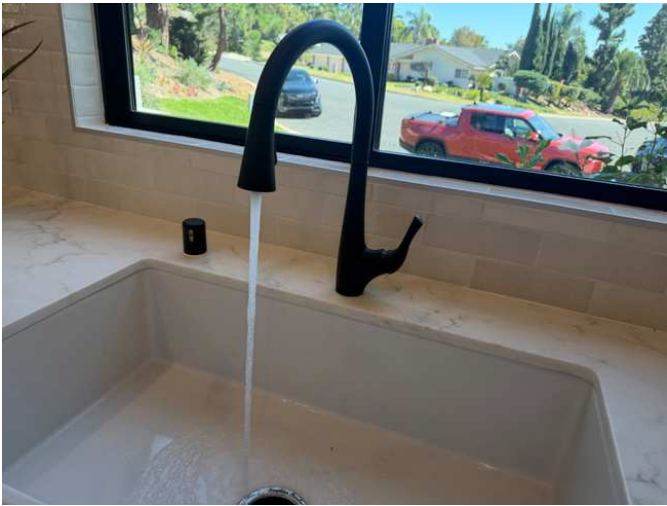
**290:**

The kitchen sink was in satisfactory condition. Faucet was functional.

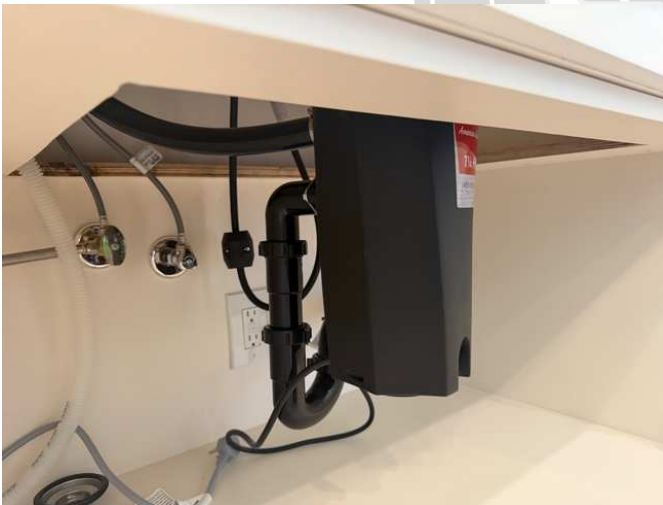
- ✓ **291:**  
The garbage disposal was in satisfactory condition.

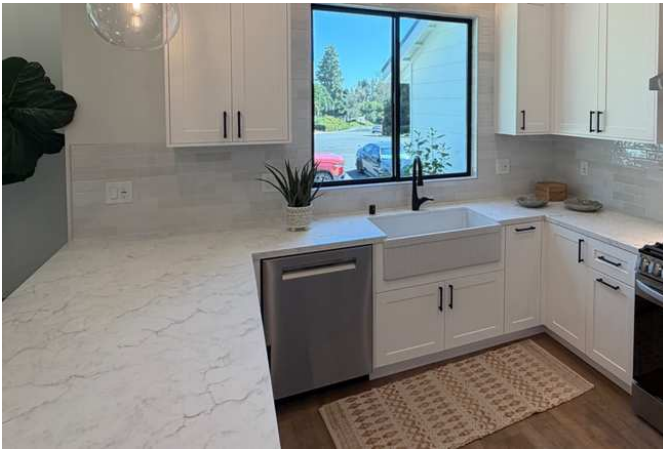
✓ **292: Quartz Satisfactory**

Quartz countertops were in satisfactory condition and professionally finish the edges and seams.

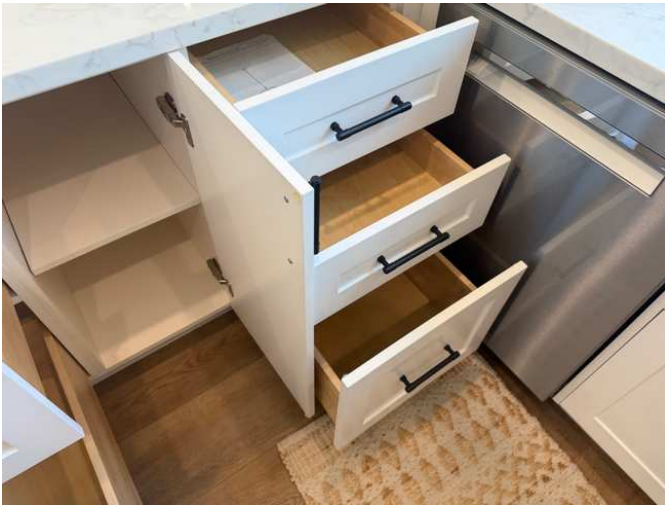
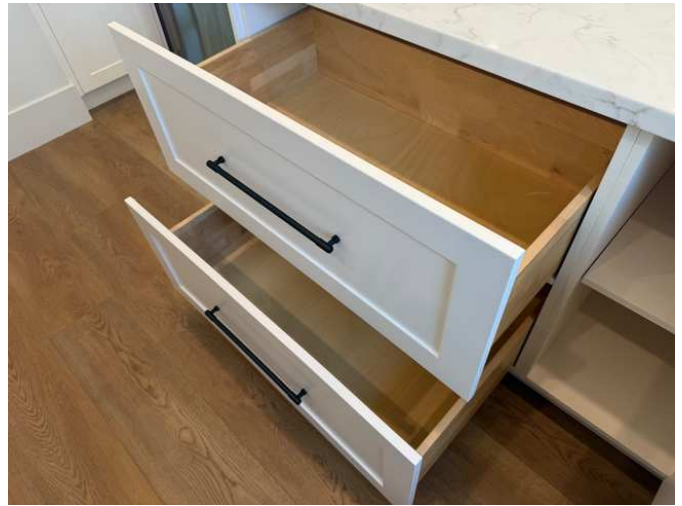
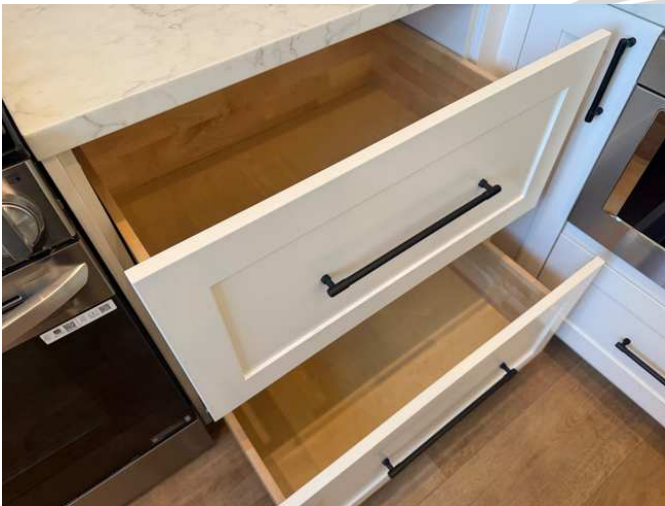
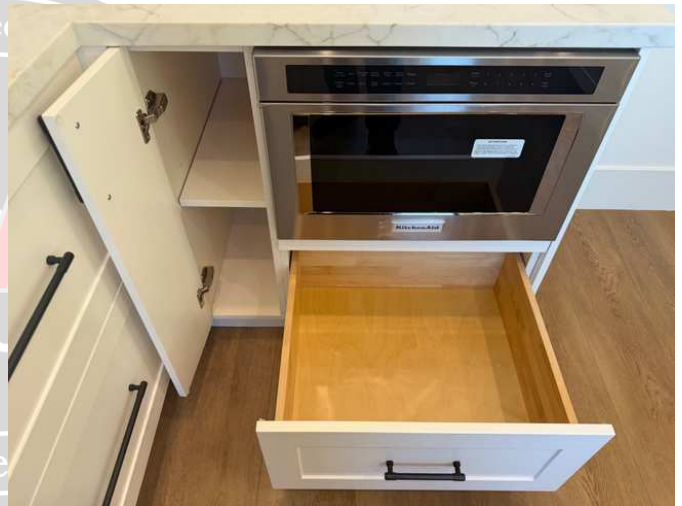
✓ **293: Like New Condition**

Kitchen cabinets are in new condition. All doors and drawers function normally.

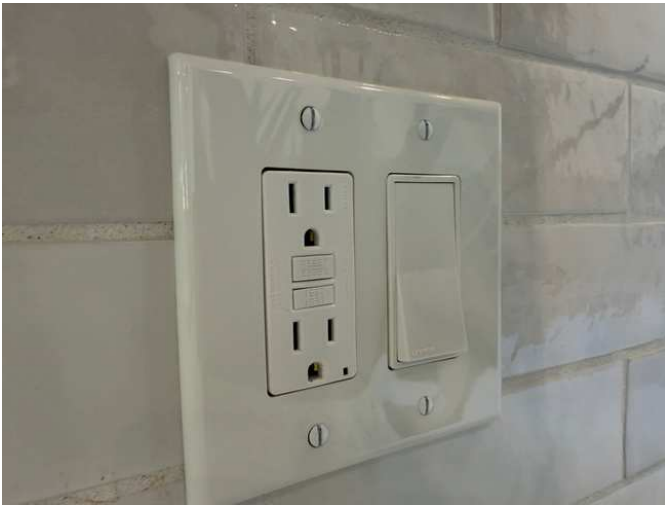
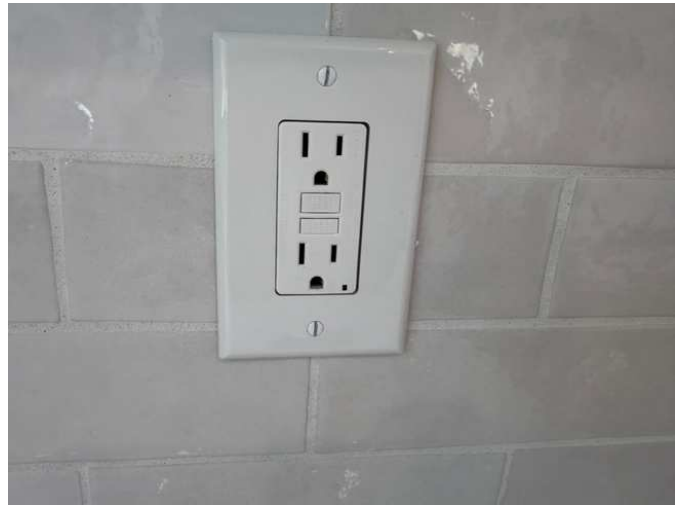
- ✓ **294:**  
All GFCI receptacles were in satisfactory condition.

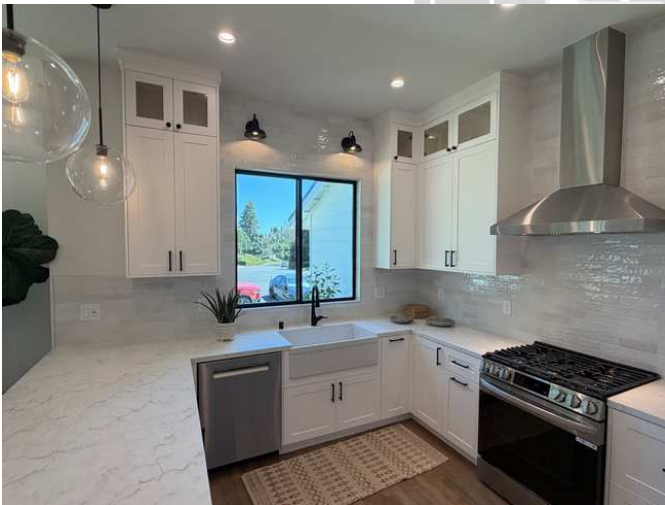
- ✓ **295:**  
Kitchen lighting was satisfactory.

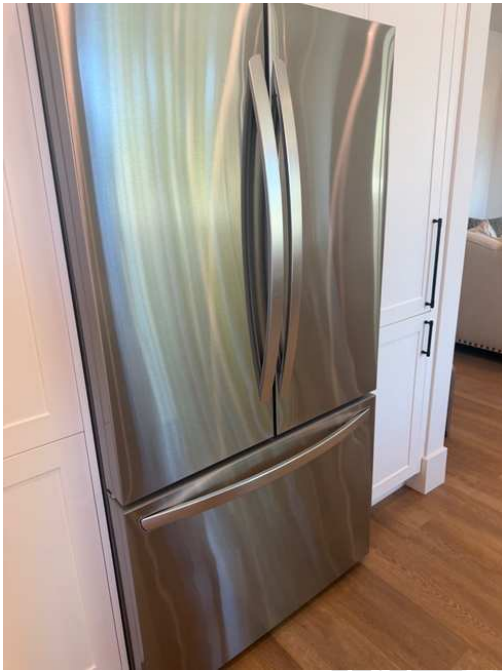
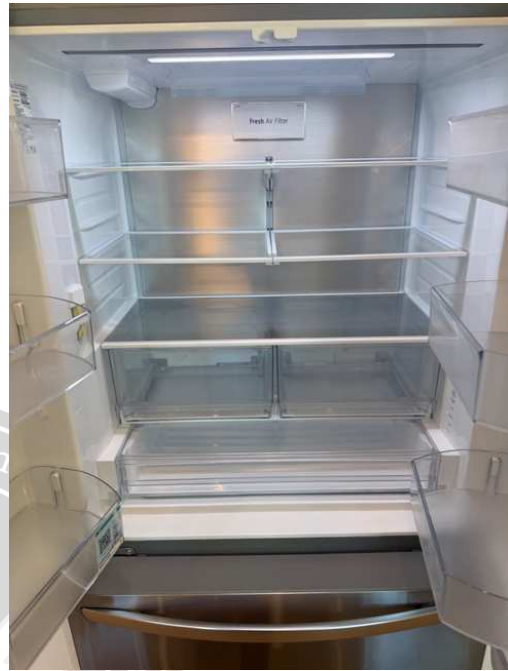
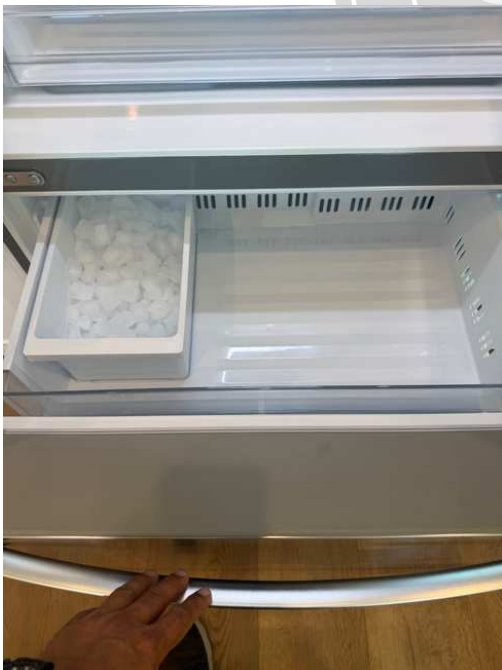
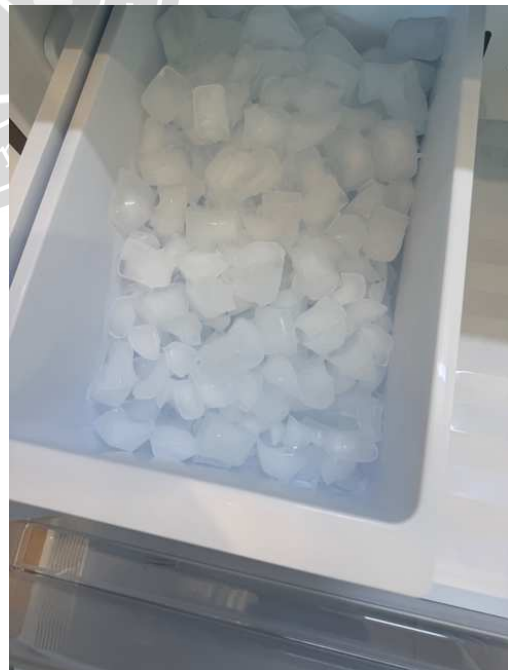
✓ **296: Satisfactory**

The refrigerator was in satisfactory condition.

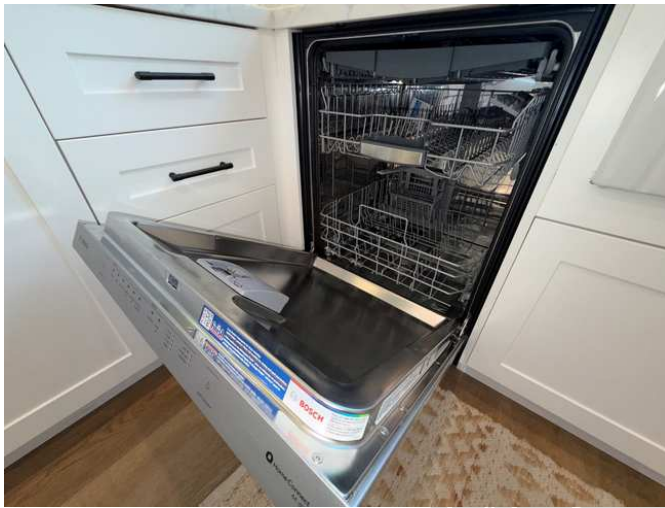
### ✓ 297: Satisfactory

The dishwasher was functional. The dishwasher was run through a full "NORMAL wash "cycle only. There were no defects or deficiencies to report. No representation is expressed or implied as to the effectiveness of the dishwashers cleaning capacity.

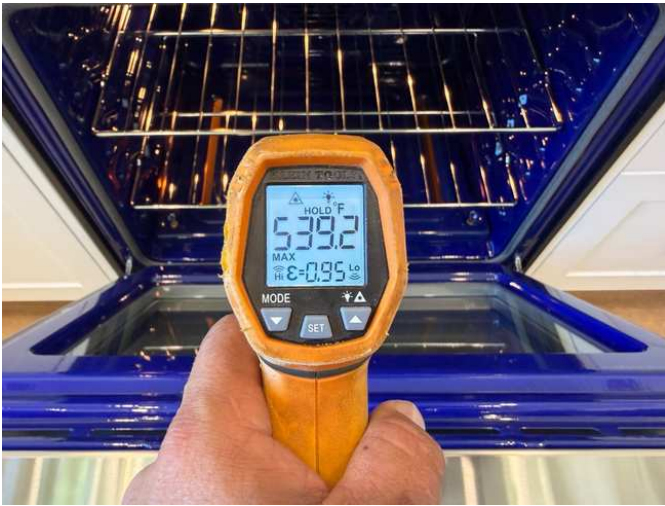
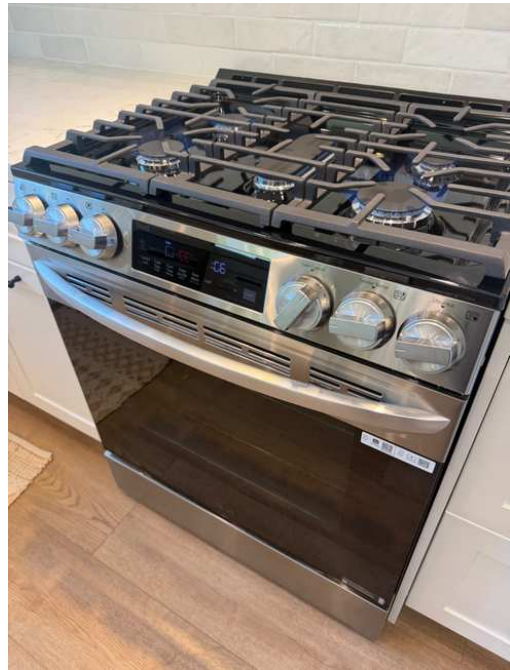
The range was thoroughly tested. Temperatures were satisfactory. The unit was found to be functional.

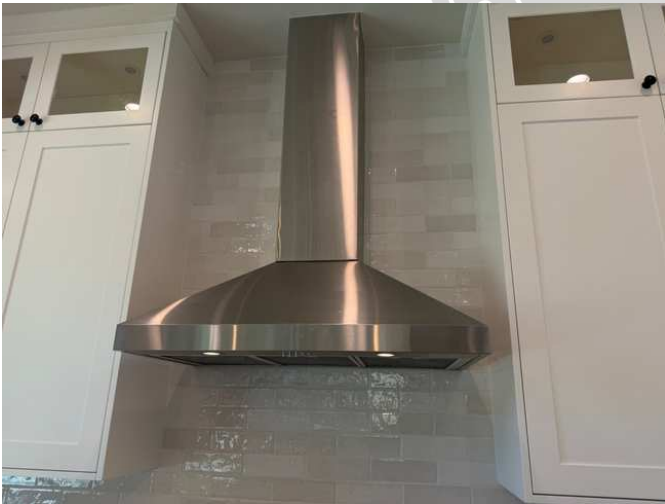
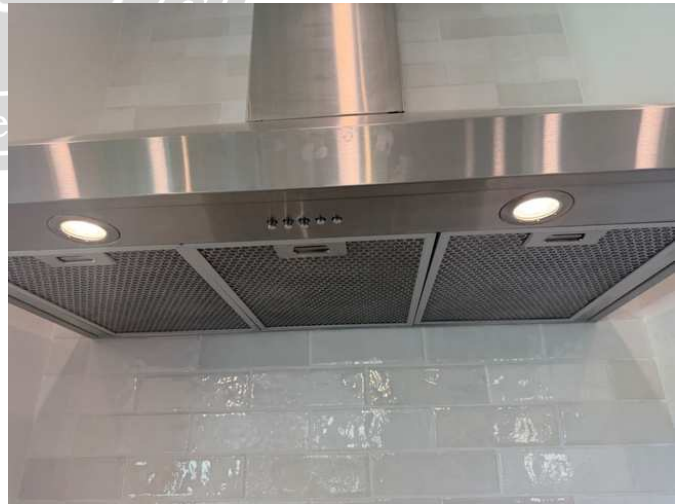
✓ **299: Satisfactory**

The vent hood was in satisfactory condition.

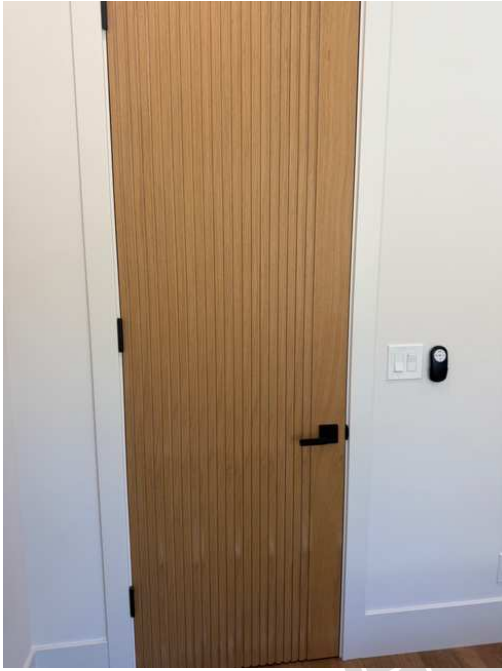
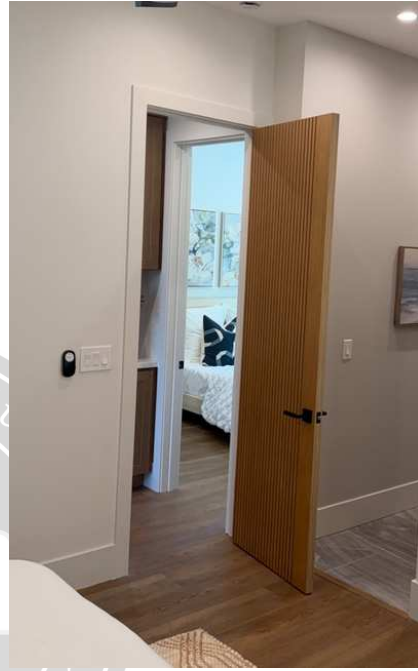
- ✓ **300:**  
The door was in satisfactory condition.

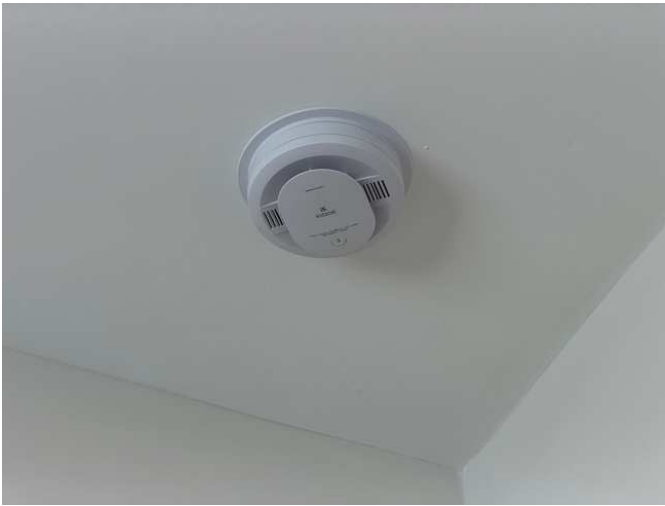
- ✓ **301:**  
Smoke detector present and functional.

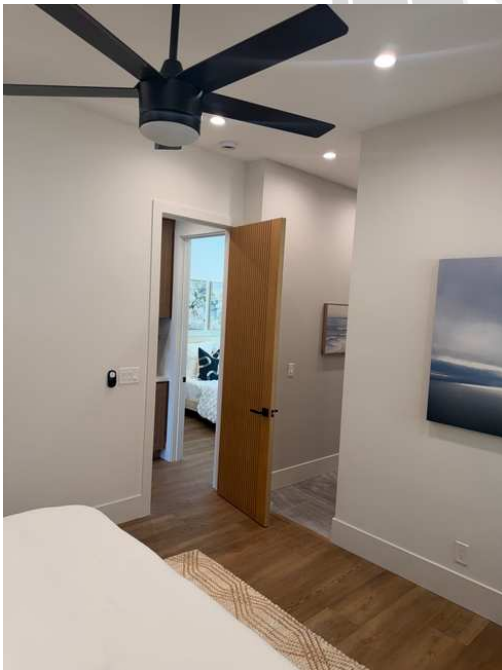
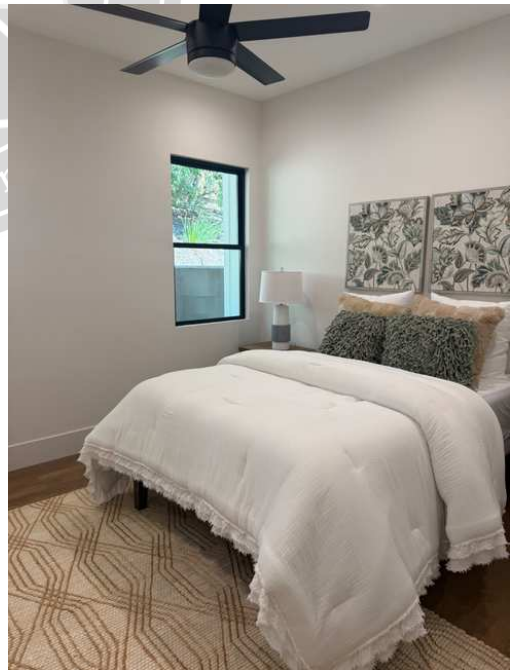
- ✓ **302:**  
Bedroom was satisfactory.

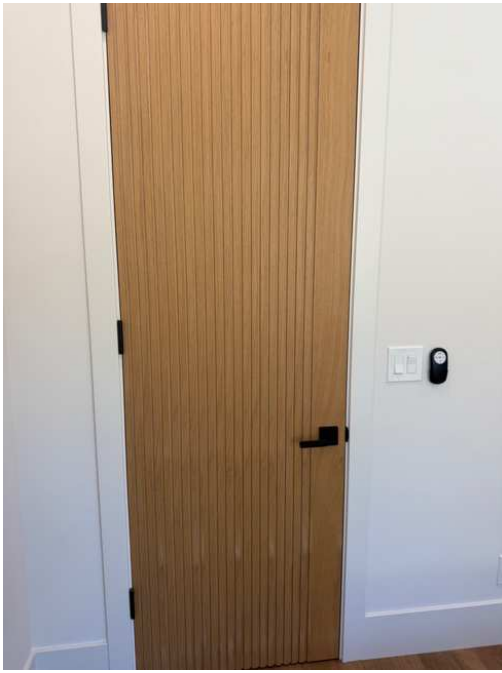
The door was in satisfactory condition.

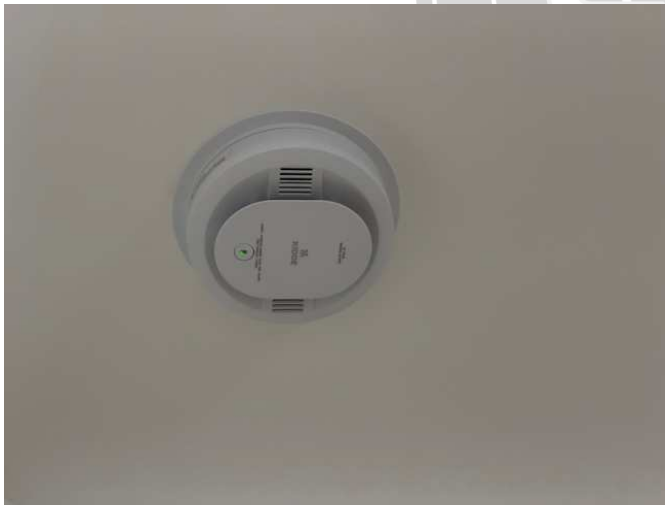
- **304:** Smoke detector present and functional.

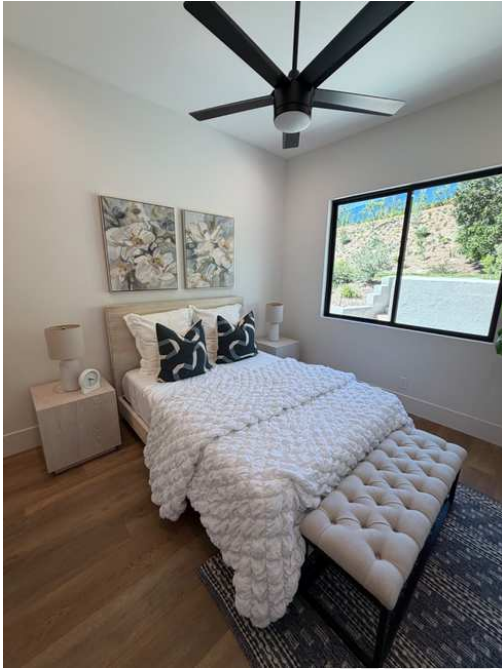
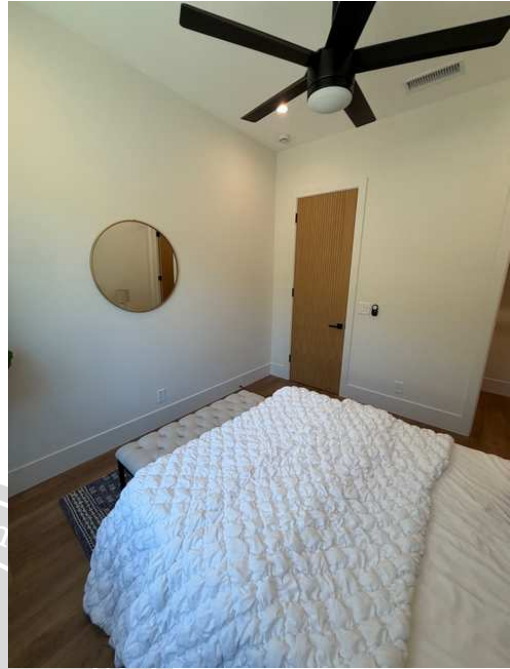
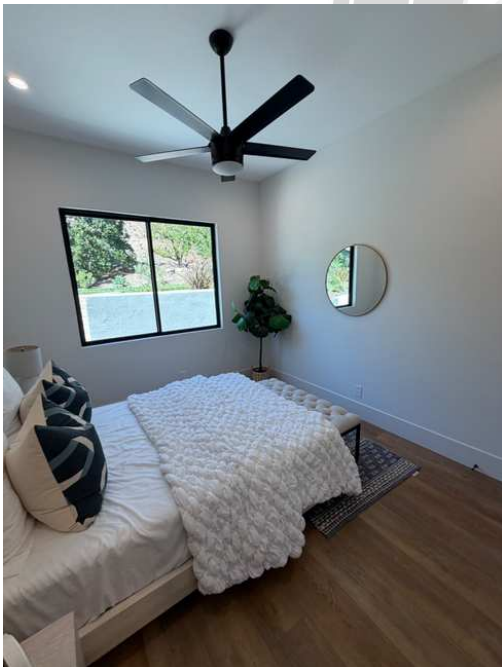
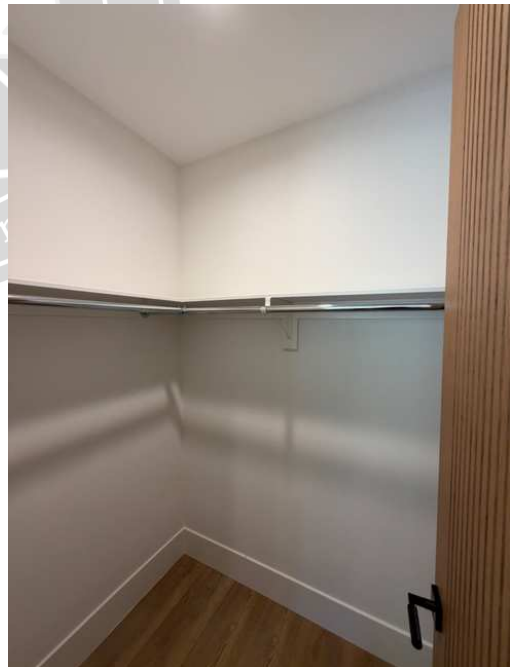
- ✓ **305:**  
Bedroom was satisfactory.

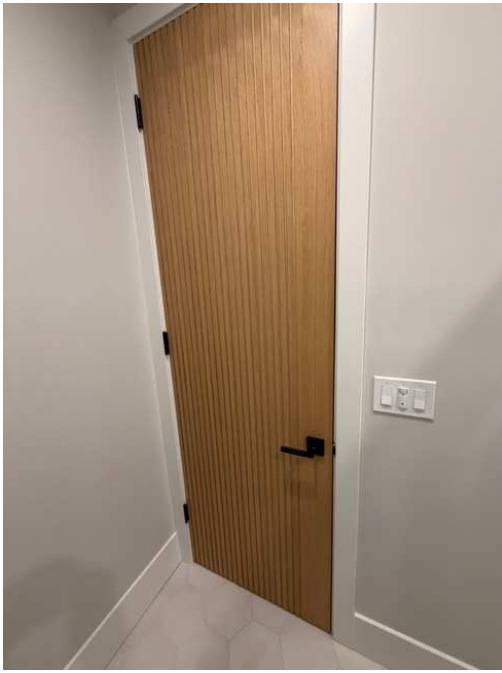
**306:**

The door was in satisfactory condition.

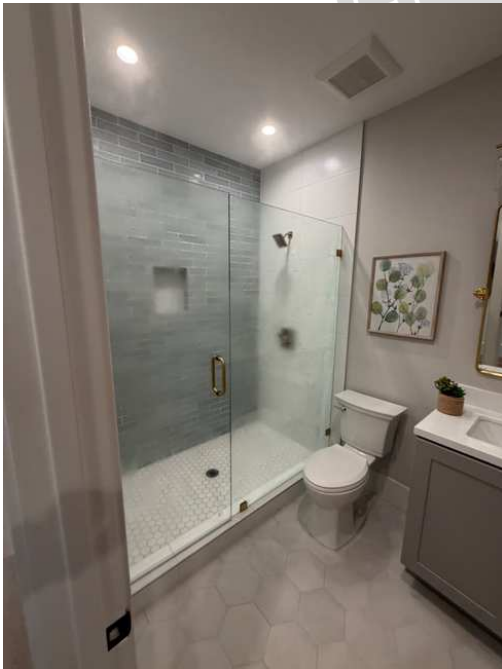
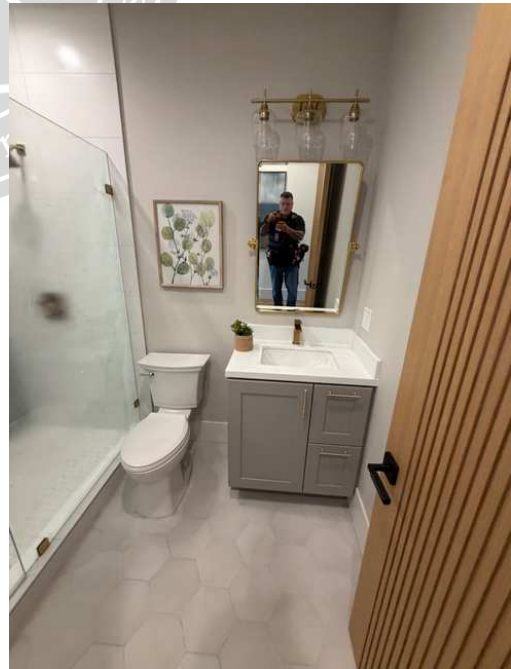
- **307:**  
The floor, walls and ceiling were in satisfactory condition. There were no significant deficiencies noted.
