# HOME INSPECTION REPORT

PROFESSIONAL PROPERTY EVALUATION

INSPECTION DATE

Tuesday, July 7, 2026

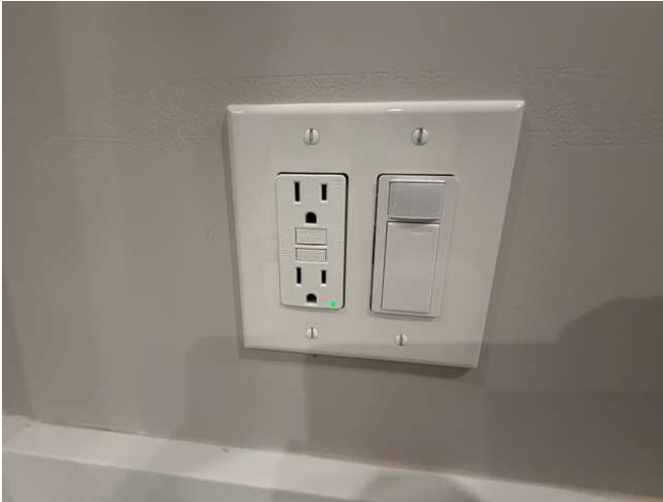
- **308:**  
GFCI receptacle was present and functional.

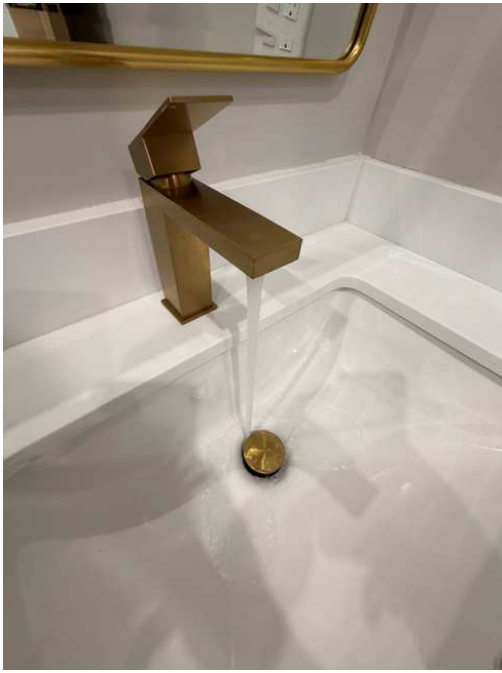
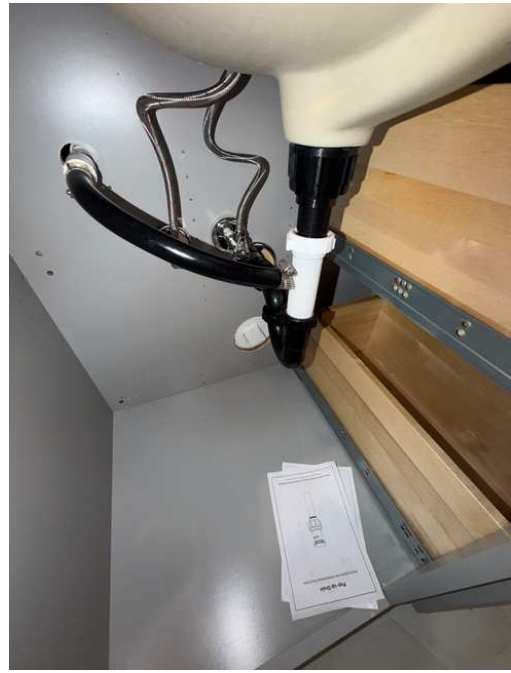
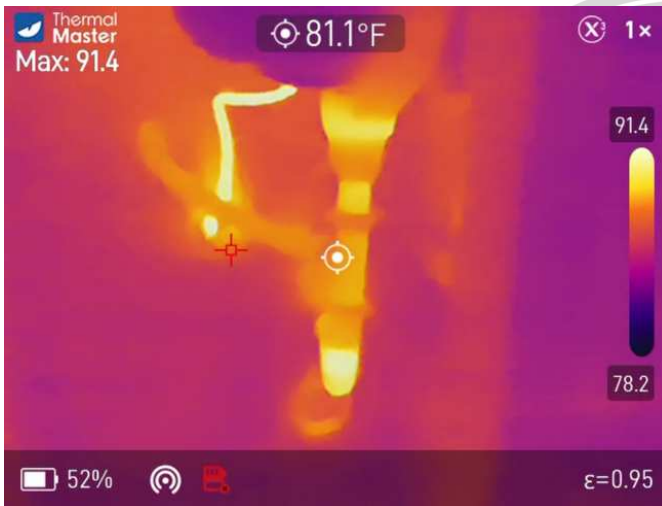
- ✓ **309:**  
Sink and faucet were functional. Hot and cold water were present. And the drain was free flowing.

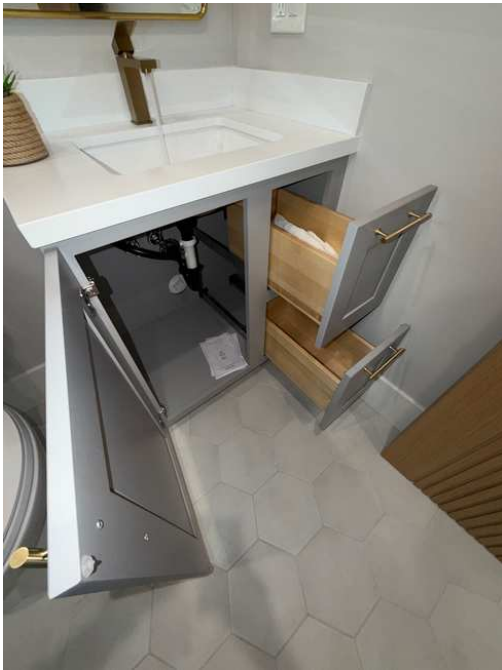
### ✓ 310: Cabinet Satisfactory

Cabinets are showing signs of normal wear and tear. All doors and drawers function normally.

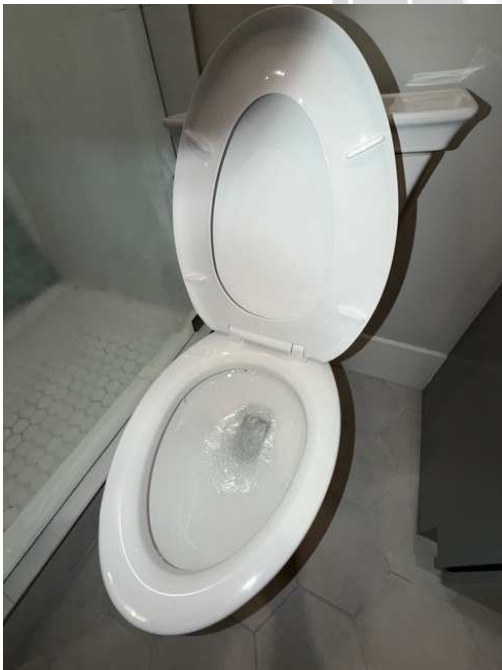
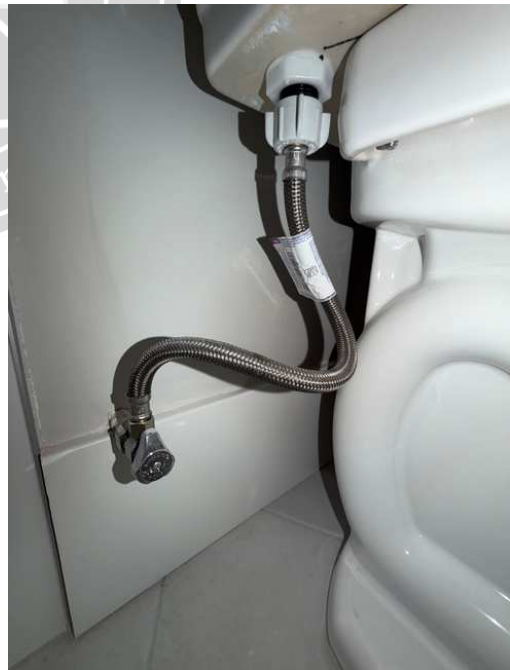
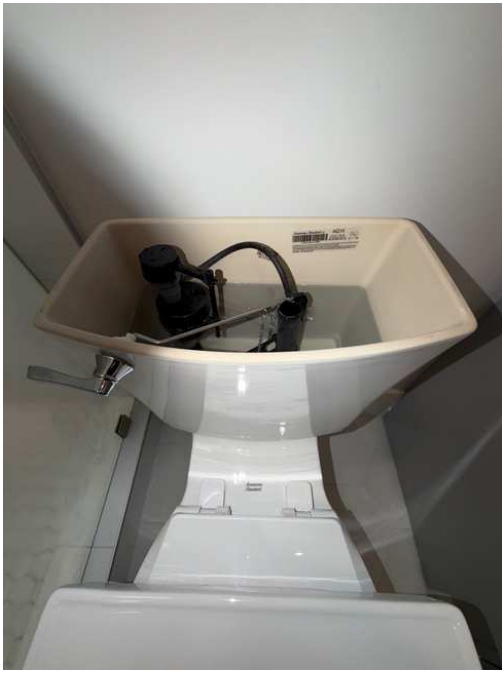
**311:**

The toilet was functional and in satisfactory condition.

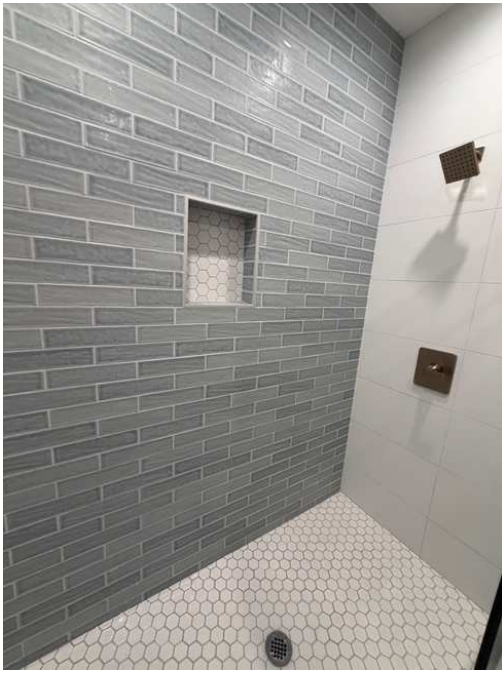
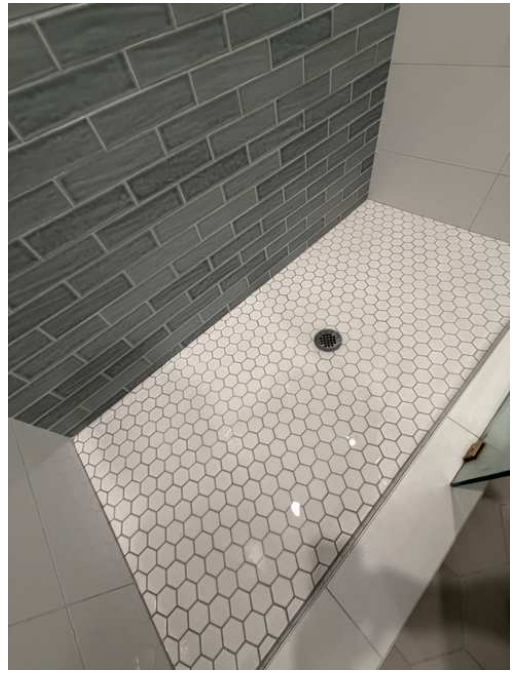
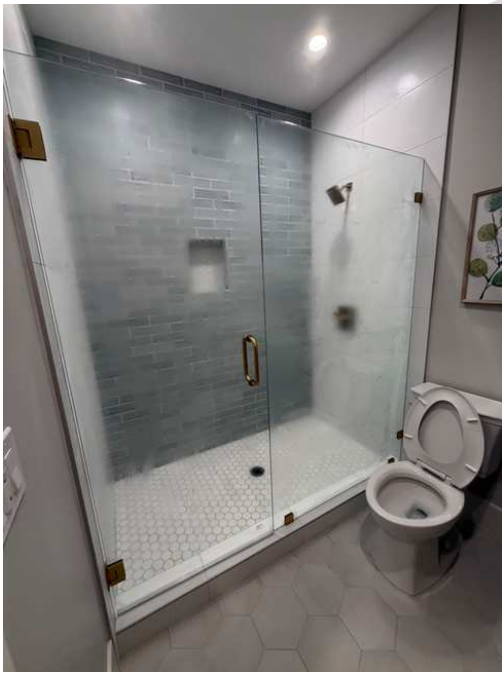
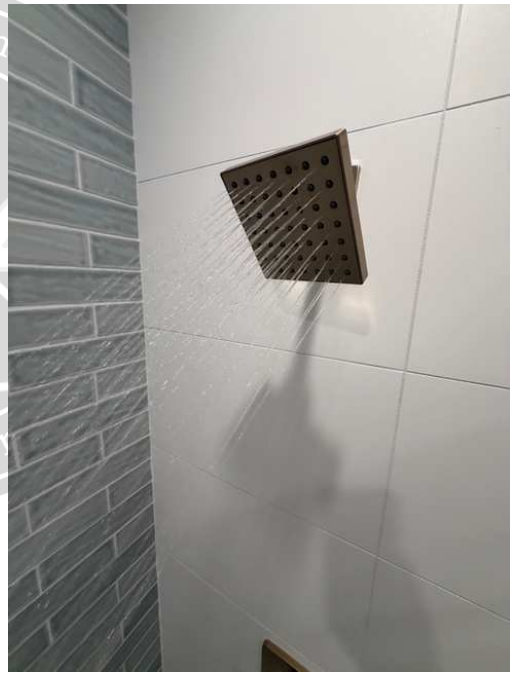
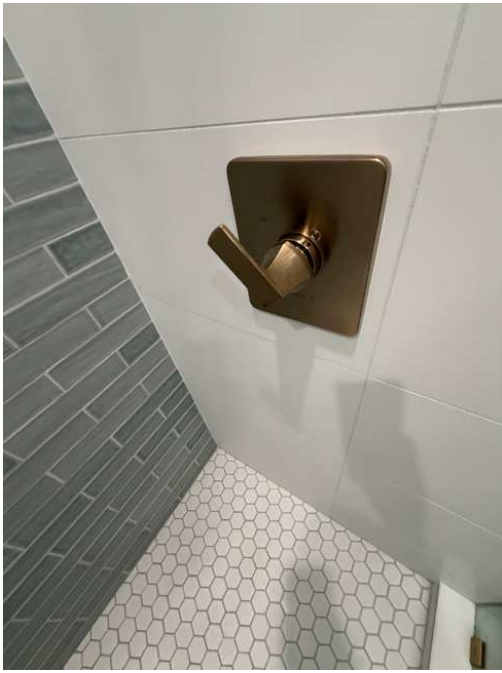
✓ **312: New Shower**

The shower was in new condition. Hot and cold running water was present. The drain was free flowing.

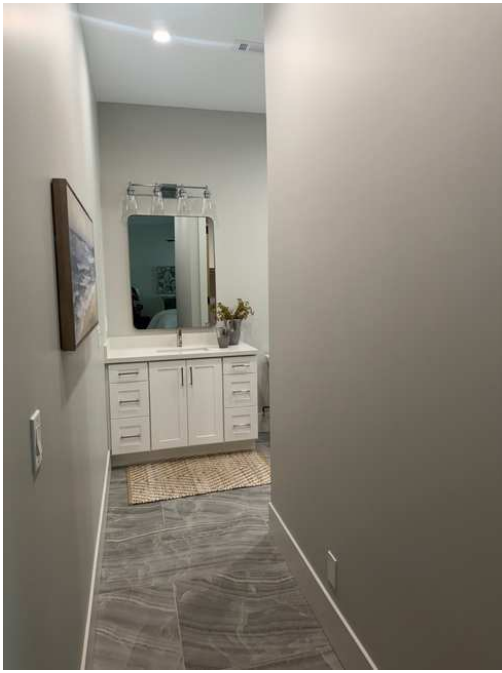
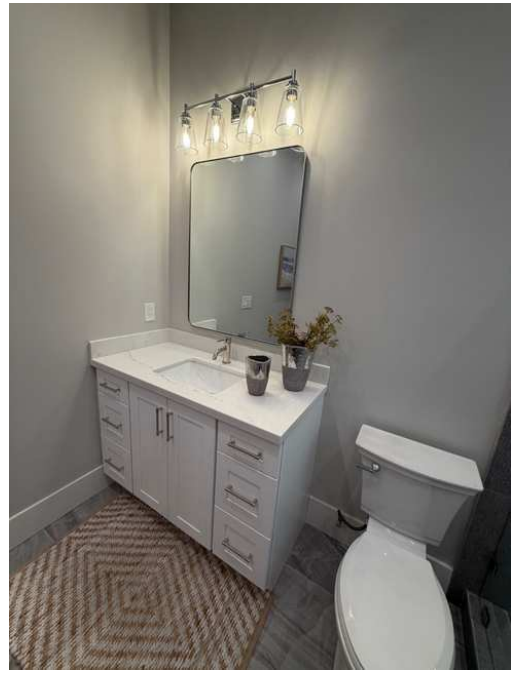
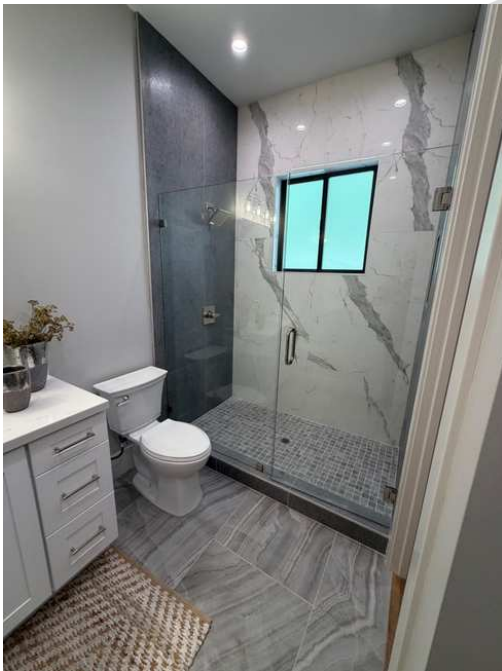
- **314:** The floor, walls and ceiling were in satisfactory condition. There were no significant deficiencies noted.

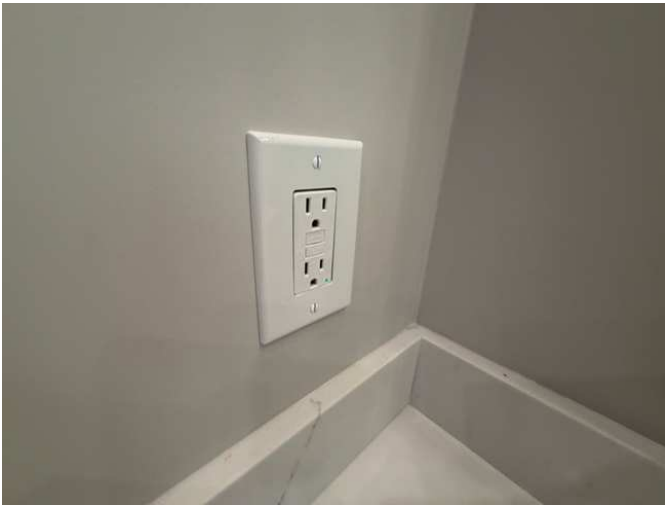
- **315:**  
GFCI receptacle was present and functional.

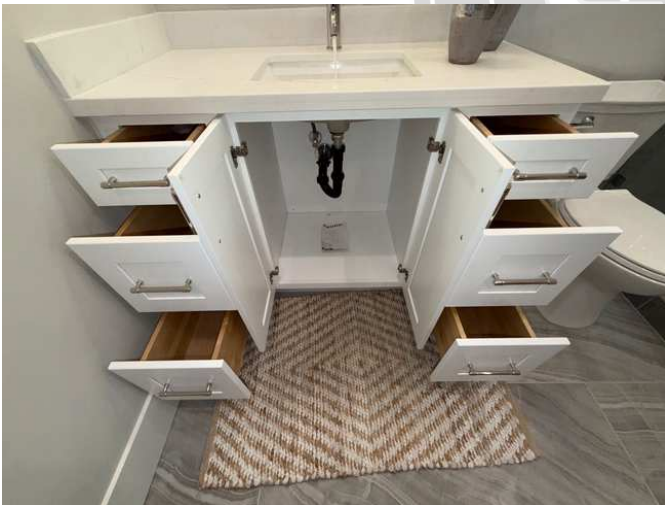
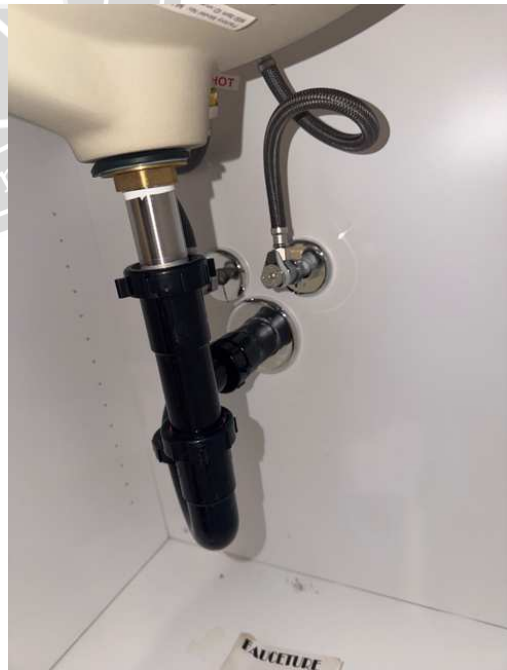
**316:**

Sink and faucet were functional. Hot and cold water were present. And the drain was free flowing.

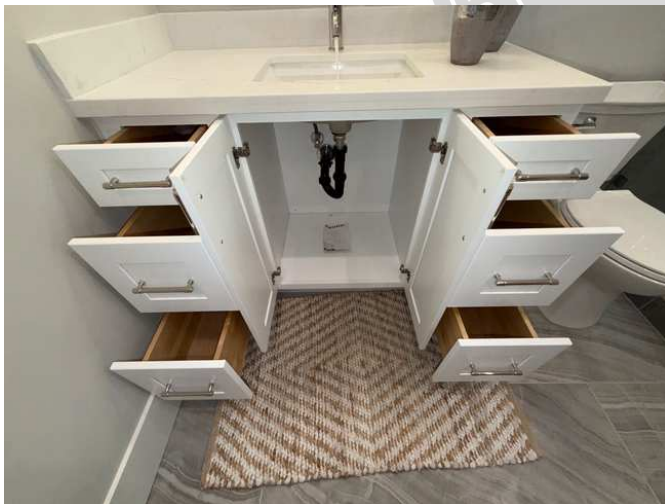
✓ **317: Like New Condition**

Bathroom cabinets are in new condition.

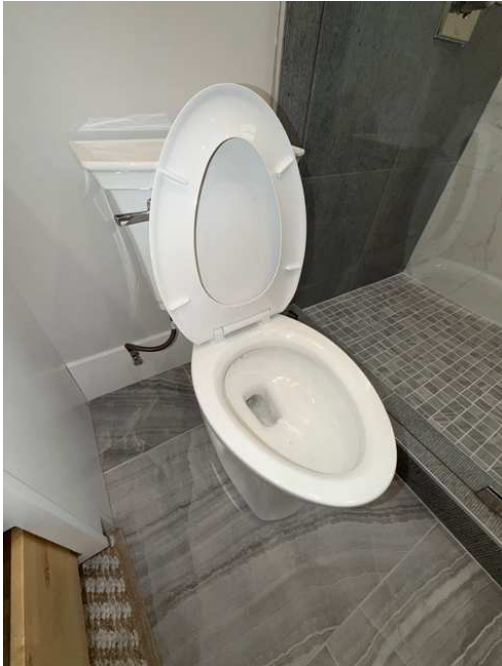
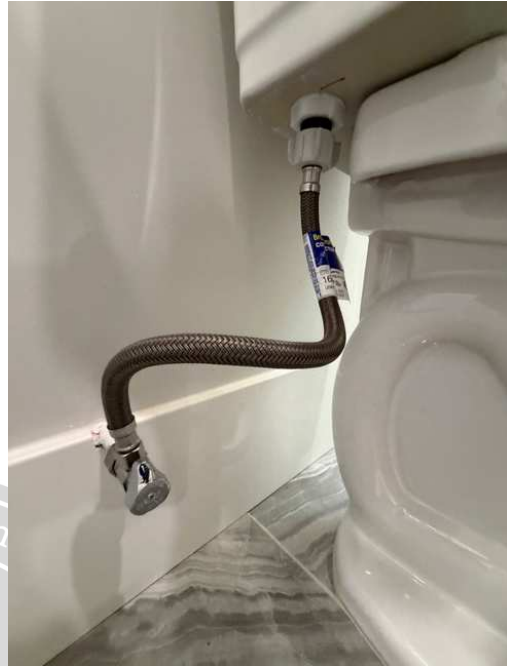
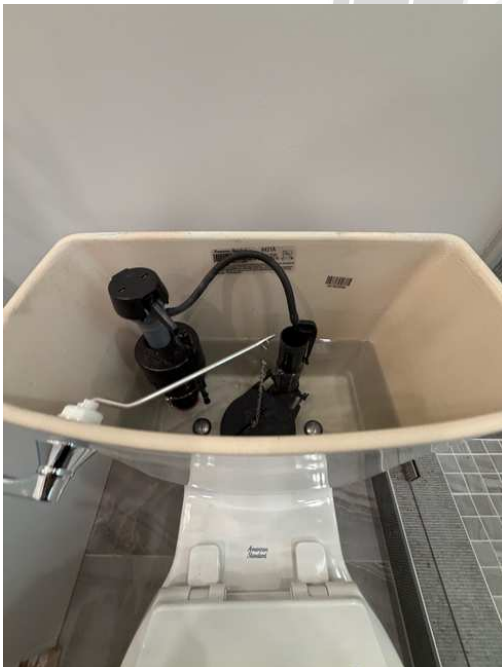
- ✓ **318:**  
The toilet was functional and in satisfactory condition.

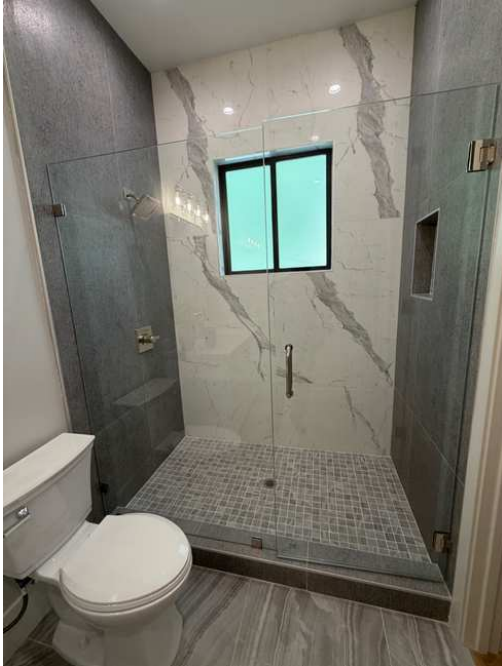
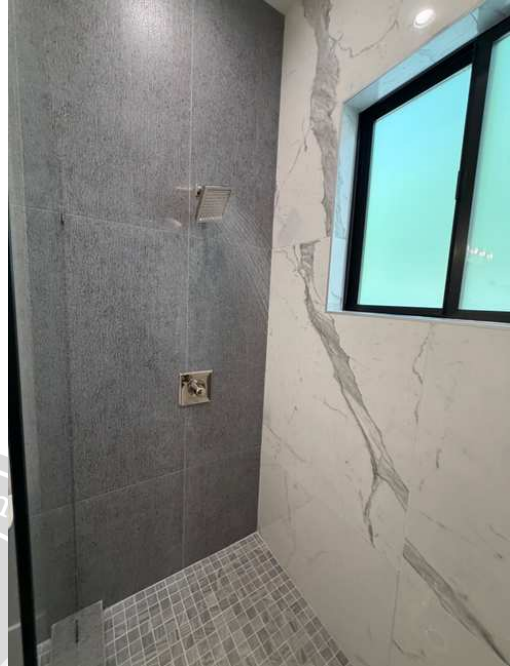
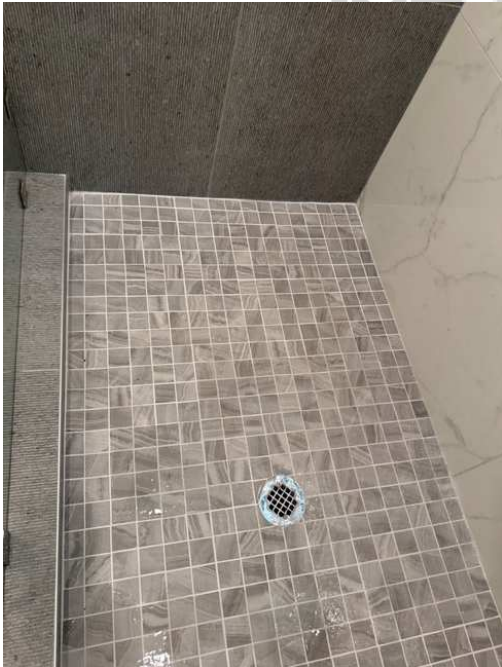
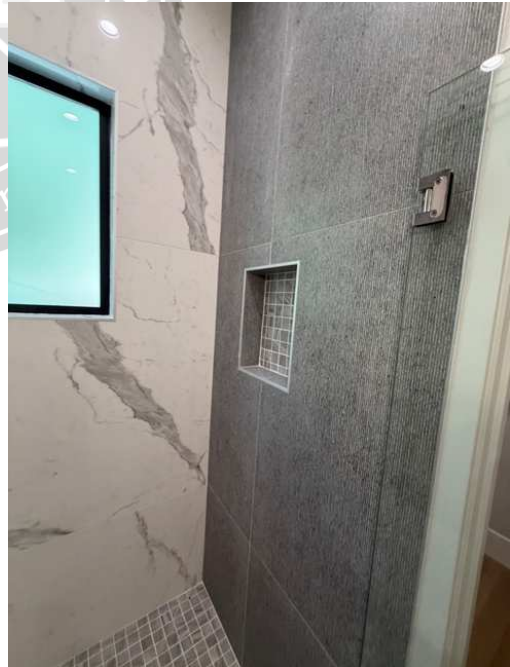
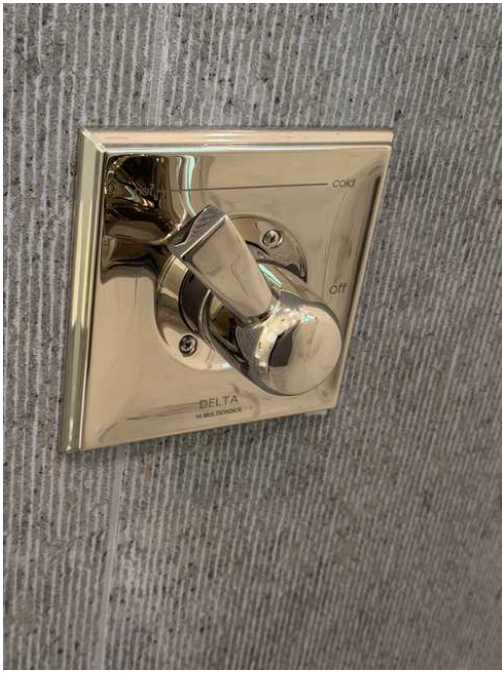
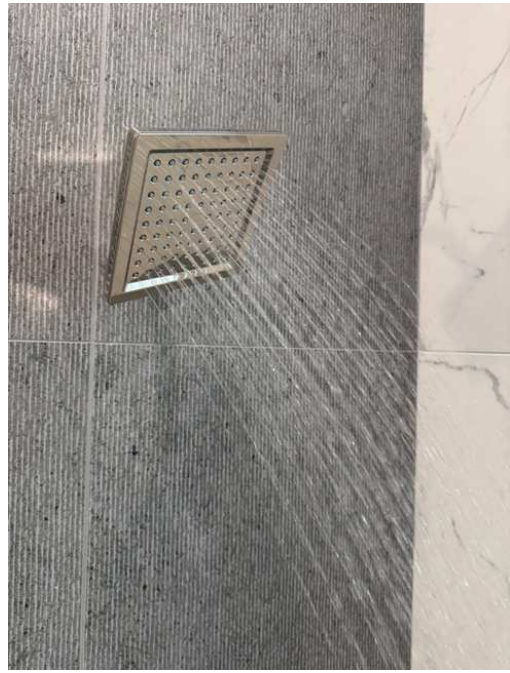
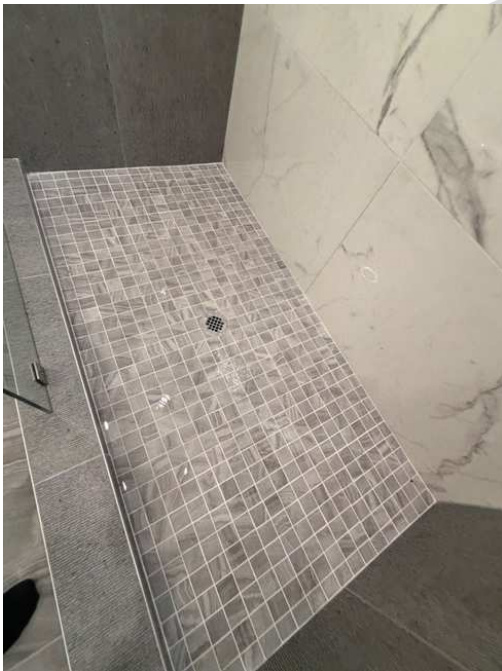
✓ **319: New Shower**

The shower was in new condition. Hot and cold running water was present. The drain was free flowing.

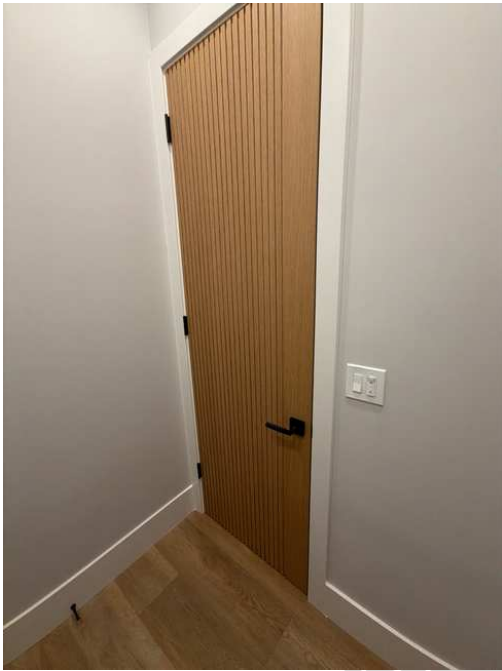
- ✓ **321:**  
The door was in satisfactory condition.

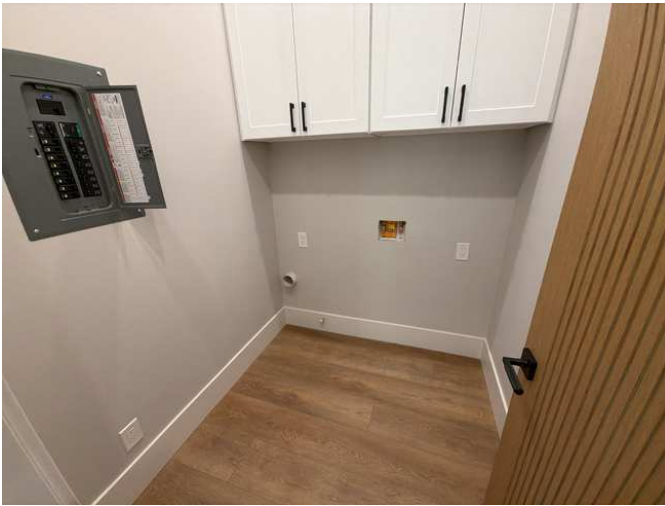
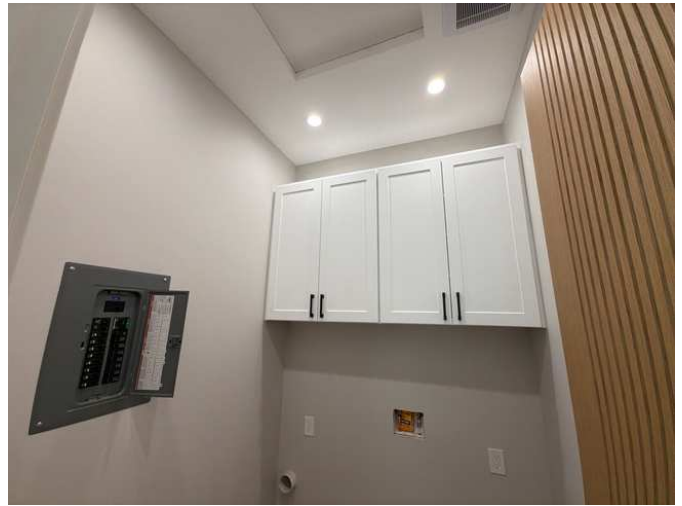
- **322:**  
The laundry room was in satisfactory condition overall.

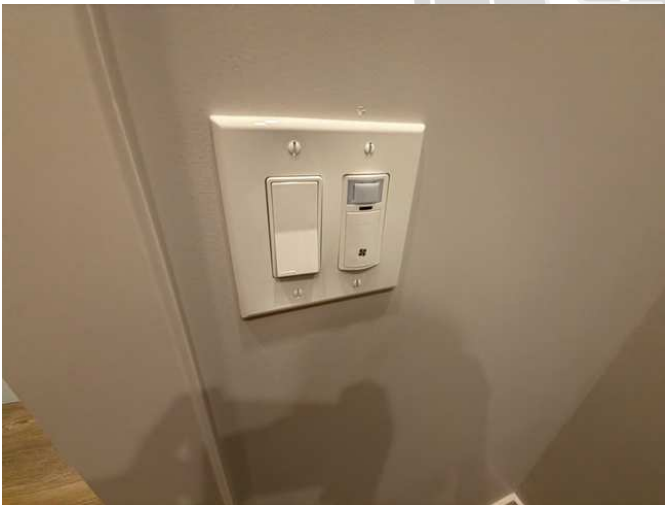
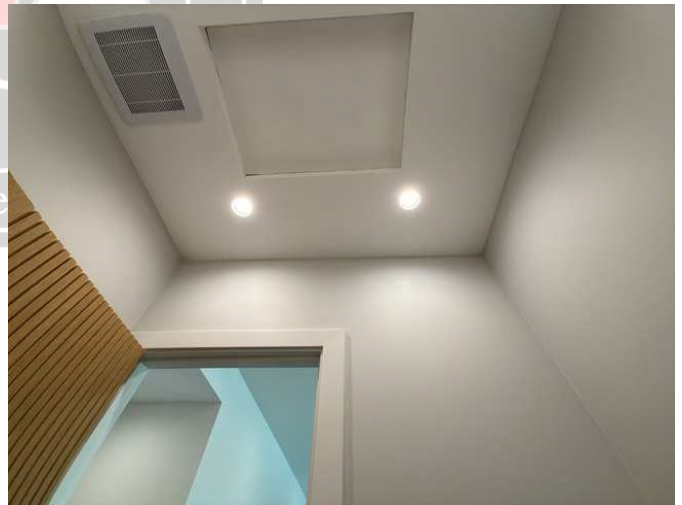
- **323:**  
The light fixture was functional.

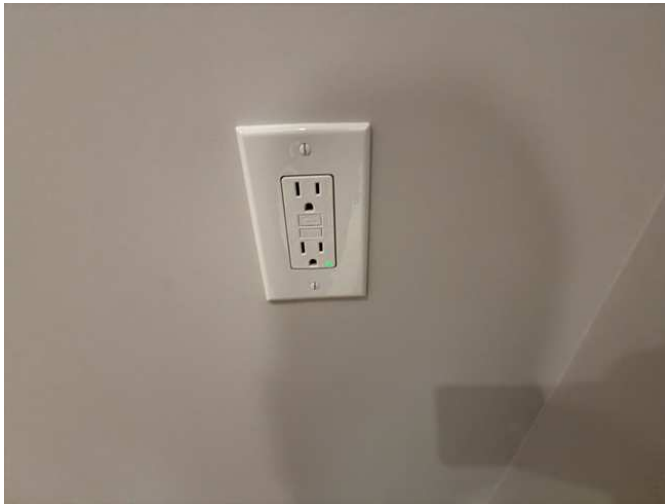
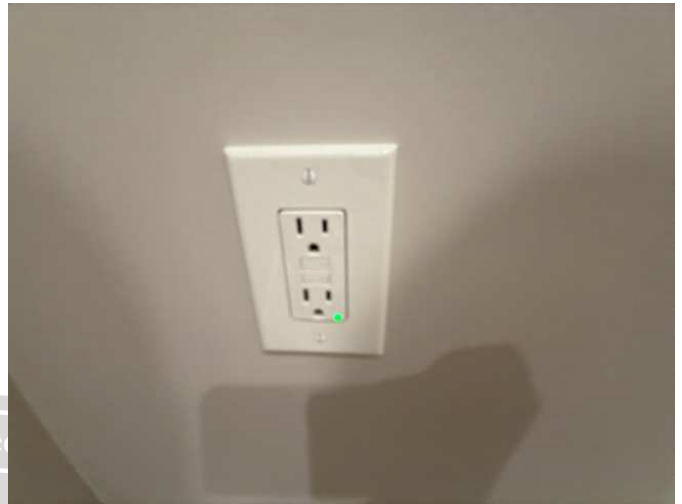
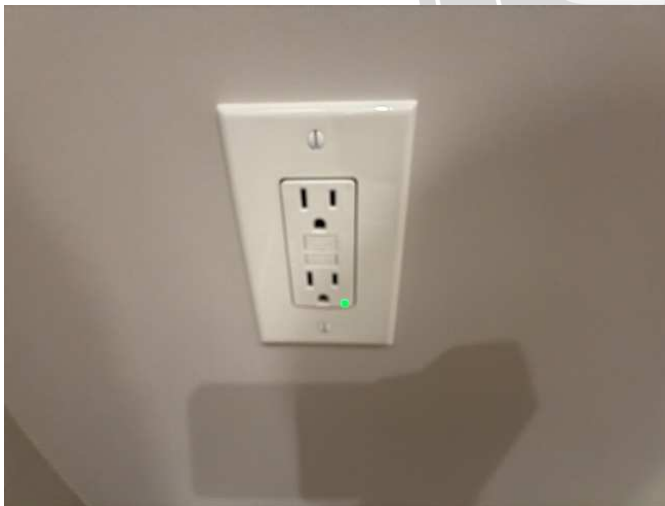
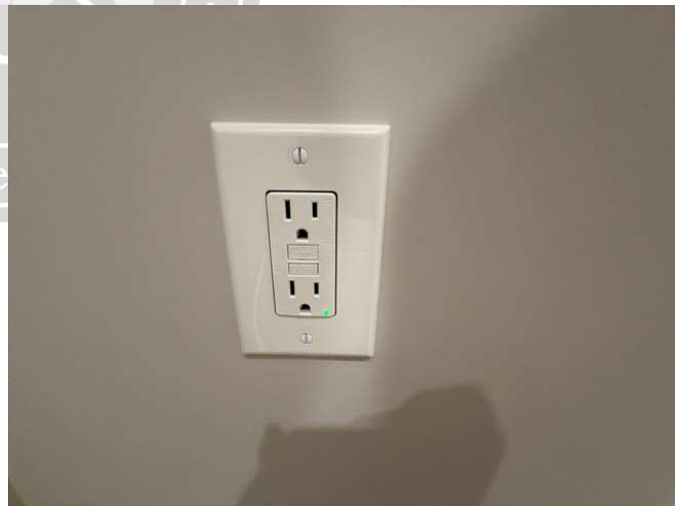
✓ **324: Satisfactory**

The laundry area receptacle was tested and found to be functional on the day of inspection.

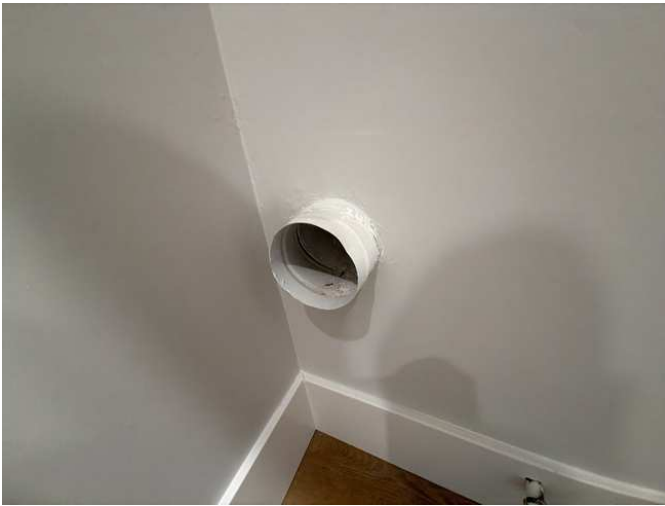
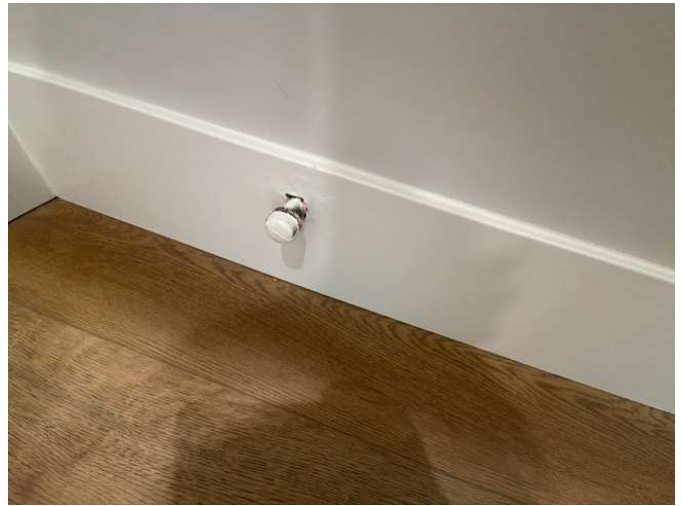
**326:**

The gas line and dryer connection was satisfactory.

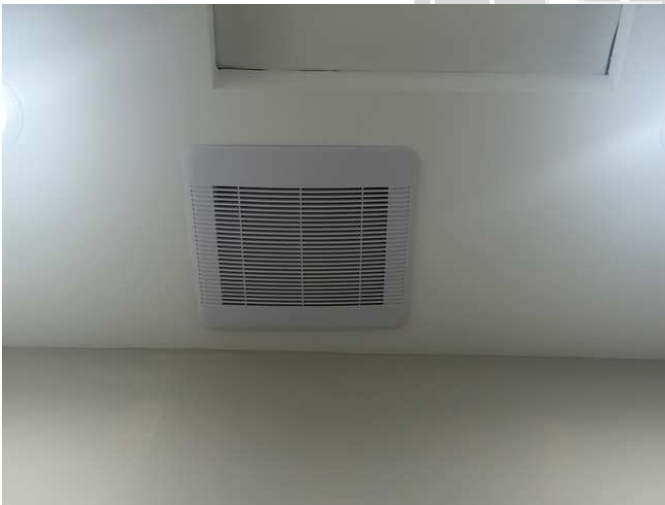
**327:**

Laundry room ventilator was satisfactory.

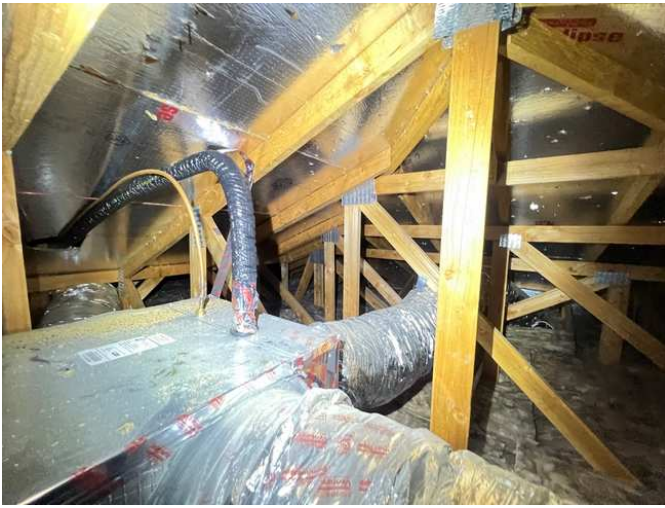
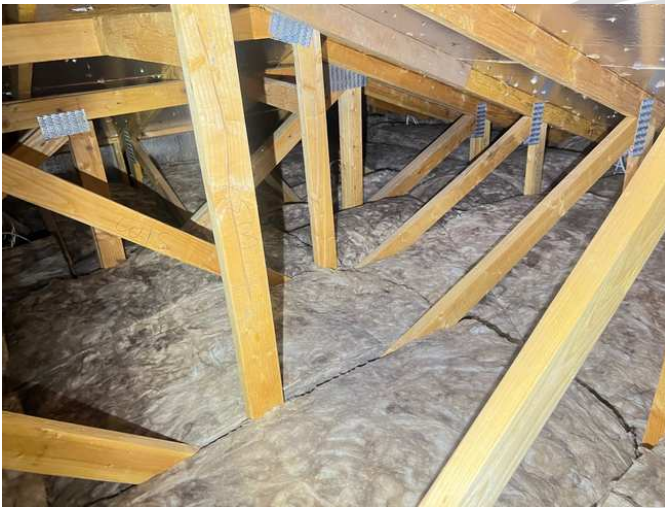
- ✓ **329:** The visible portions of the roof trusses were in good condition. There were no apparent signs of damage or alterations. There was no rust or corrosion noted on the visible truss connector plates.

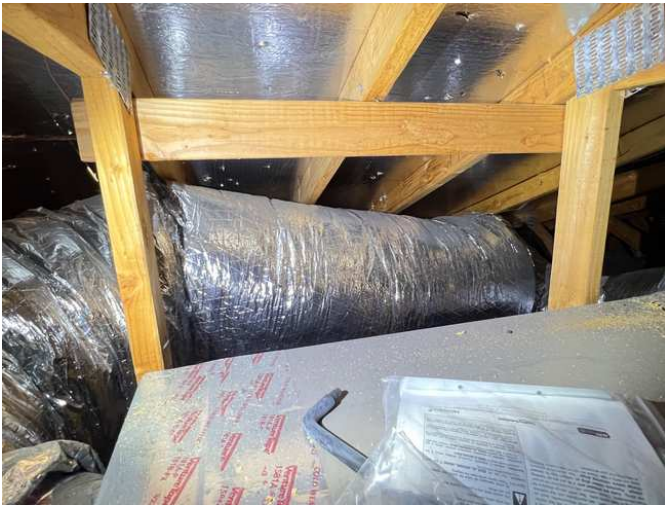
**330:**

Fiberglass batt insulation was utilized throughout the attic area. The installation was satisfactory.

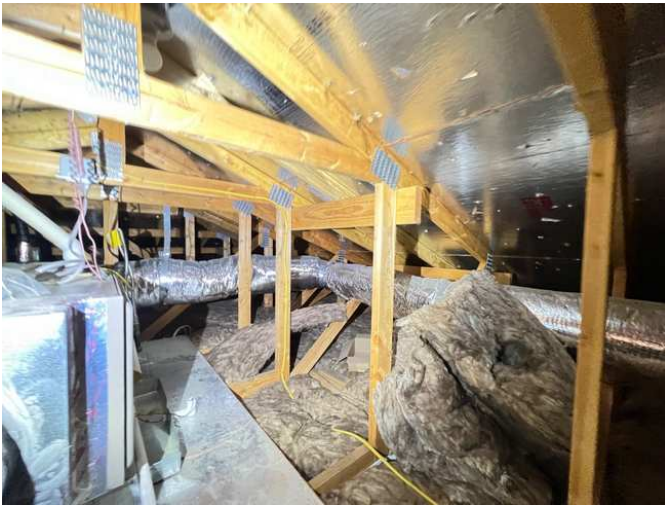
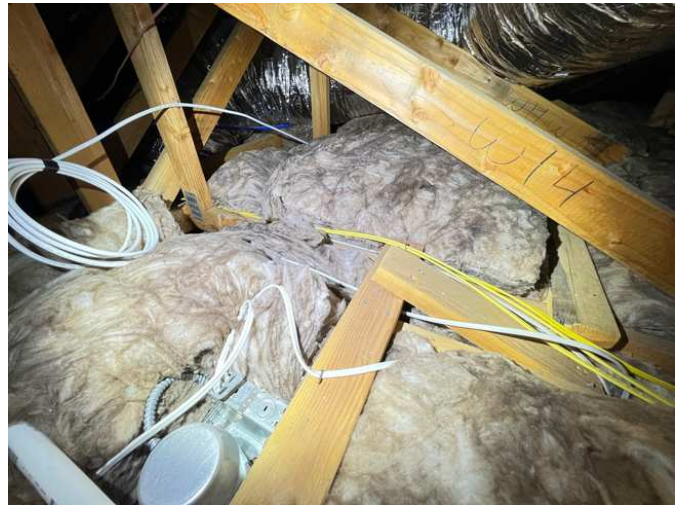
Attic lightbulb was burnt out on the day of inspection replace it as needed
